DESIGNATED SUBSTANCES SURVEY

**GORD AND IRENE RISK
COMMUNITY CENTRE
2650 FINCH AVENUE WEST
TORONTO, ONTARIO**

Project No. FE-P 21-11201

June 2, 2021

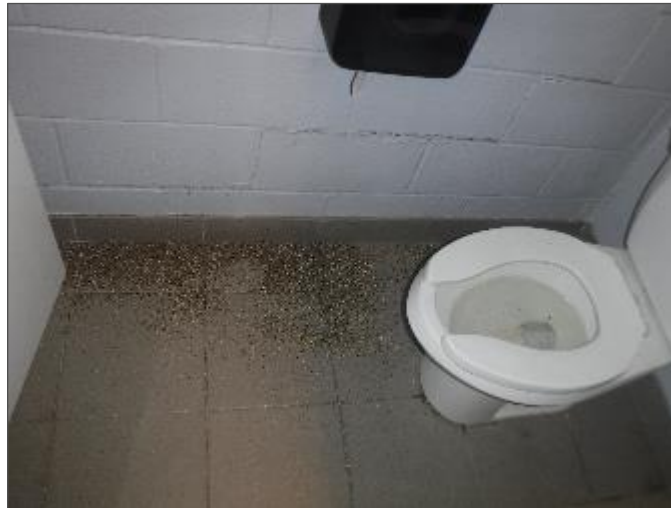
Pinchin observed a suspect material spilling from the concrete block wall in the Washroom (Location 1-22) (adjacent to the Tiny Tots Room) and Hallway around the Ice Rink (Location 1-25) in the Gore and Irene Community Centre. Approximately 8 square feet of suspect material was observed present at the time of the site visit.

Photo 1 - Non-asbestos vermiculite in the Washroom (Location 1-22).

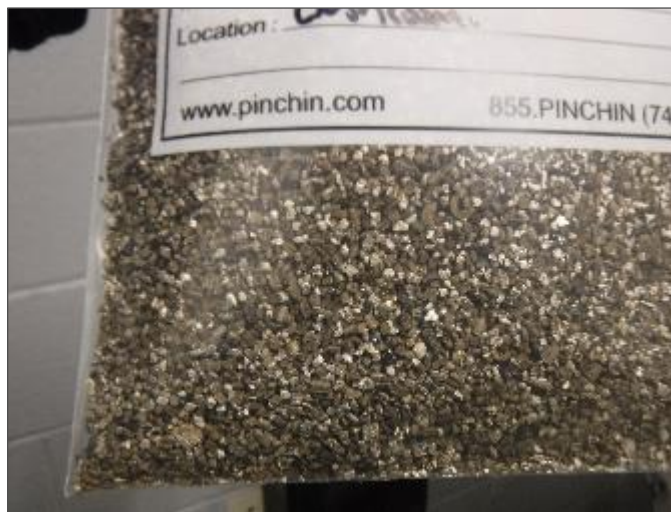
Photo 2 - Sample collected, of non-asbestos vermiculite, from the Washroom (Location 1-22).

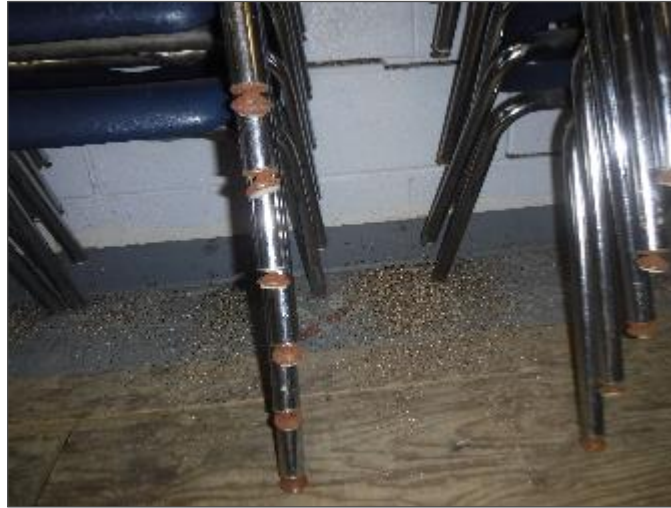
Photo 3 - . Non-asbestos vermiculite in the Hallway around the Ice Rink (Location 1-25).

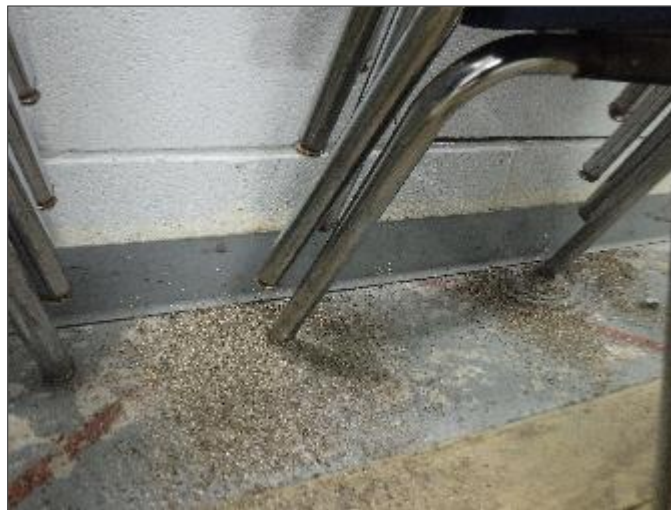
Photo 4 - Non-asbestos vermiculite in from the Hallway around the Ice Rink (Location 1-25).

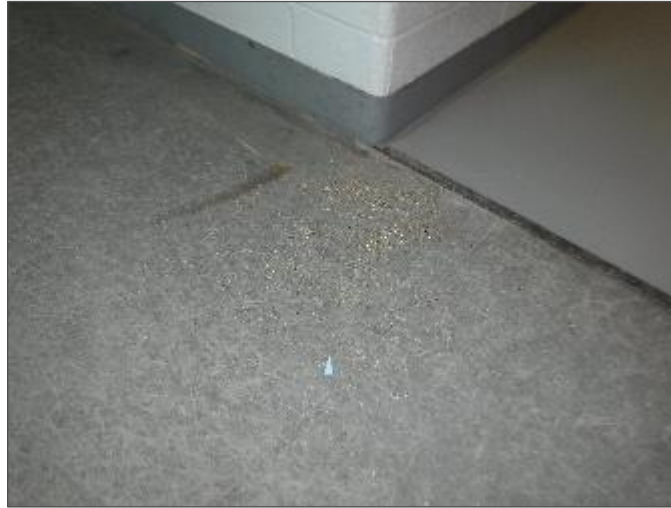
Photo 5 - Non-asbestos vermiculite in from the Hallway around the Ice Rink (Location 1-25).

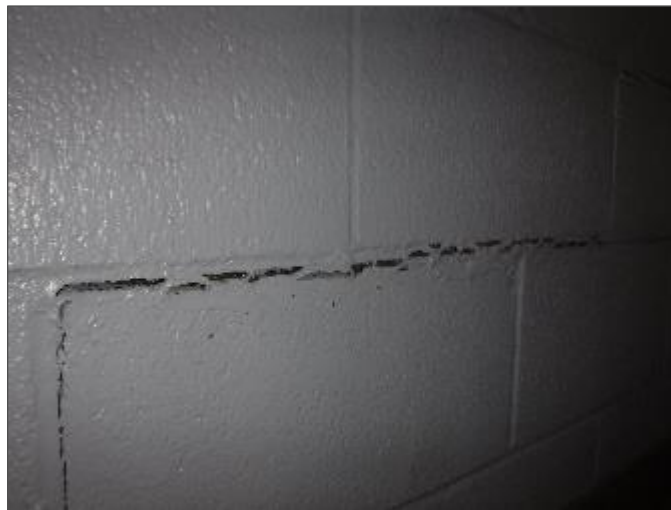
Photo 6 - Non-asbestos vermiculite is coming out of cracks in the concrete block wall.

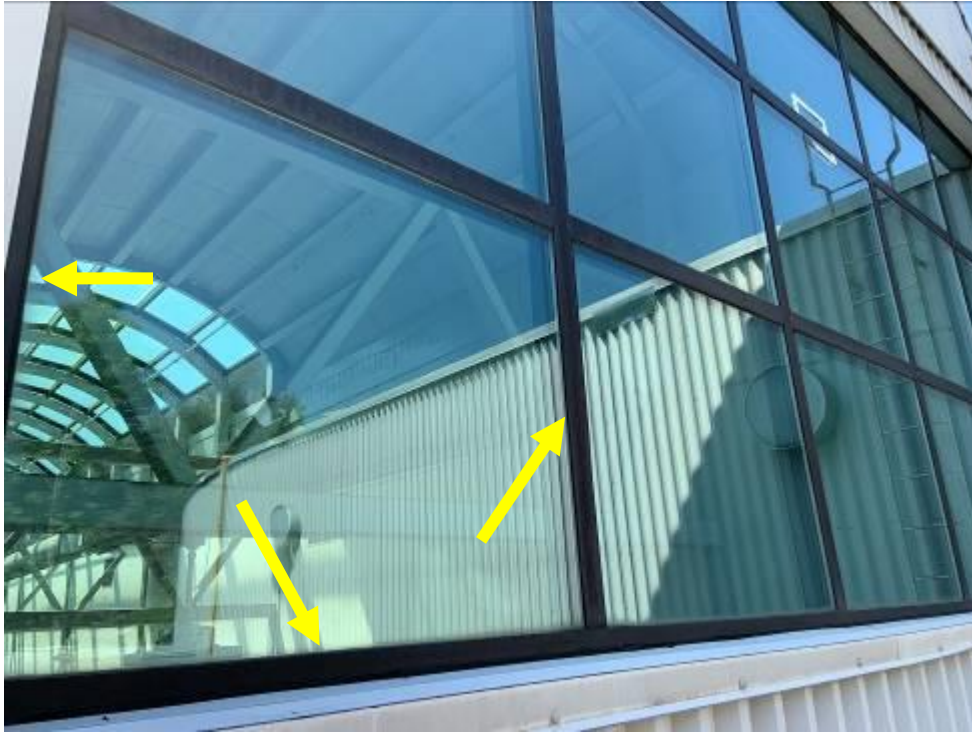
Black putty was observed along the joints of the glass and the skylight frames in Construction Area 5. Three (3) samples (21-6558-37 to 39), of the black putty were collected and submitted for analysis. The results of analysis revealed that this **black putty contains 0.5-5% Chrysotile asbestos**. At the time of the survey, this material was observed to be in good condition.

Photo 1: Asbestos-containing black putty along the joints of the interior and exterior glass and the skylight frames, in Construction Area 5.

Asbestos-containing black putty was revealed along the joints of the glass and the skylight frames in Construction Area 5. At the time of the survey, this material was observed to be in good condition. If the planned construction activities require the disturbance or removal of the asbestos-containing black putty, Type 1 asbestos abatement procedures, as outlined in O. Reg. 278/05, must be followed.
