DESIGNATED SUBSTANCES AND HAZARDOUS BUILDING MATERIALS ASSESSMENT REPORT

Renovation Project
Humber College (North Campus)
Building E & H
205 Humber College Boulevard
Toronto, Ontario
M9W 5L7

Safetech Project Number: 3191221

Date of Site Work: December 18, 2019
Date of Issue: January 10, 2020

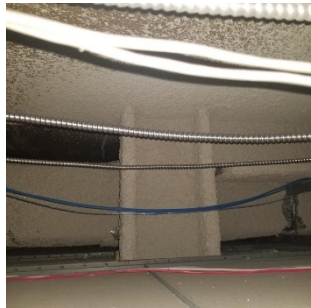
Sprayed and Loose Fill Insulating Materials	Location/Description	
Sprayed Fireproofing	<p>Sprayed fireproofing was observed in the subject building. Bulk samples were collected during the assessment and results of analysis confirmed that this building material contains 20% chrysotile asbestos. Refer to sample set 2 in Table 2 and the location, condition, friability, and estimated quantity in Appendix A.</p> <p>Given the presence of asbestos-containing sprayed fireproofing within the areas assessed, all components of the ventilation system (e.g. ductwork) within the Print Shop and Bookstore are assumed to be contaminated with asbestos fibre as per the requirements of O.Reg. 278/05.</p>

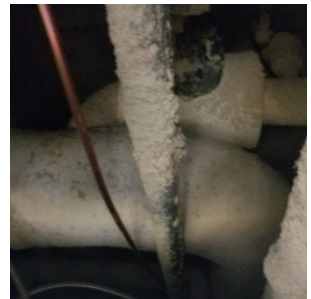
Thermal System Insulation	Location/Description	
Mechanical Pipe Insulation – Straights	Linear sections of mechanical piping were observed to be uninsulated or insulated with fiberglass.	
Mechanical Pipe Insulation – Fittings (elbows, valves, tees, hangars, etc.)	As per the school's ACM database, asbestos containing mechanical pipe fittings have been identified to be present in E105. This material was confirmed to be present at the time of the assessment.

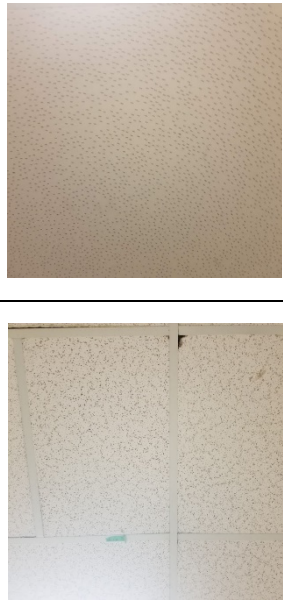
Ceiling Tiles	Location/Description	
<p>Lay-in Acoustic Ceiling Tiles</p>	<p>2x4 Lay-in ceiling tiles (textured pinhole & fissure/pinhole) were observed in the subject building. Bulk samples were collected during the assessment and results of analysis confirmed that this building material is not asbestos-containing. Refer to sample set 4 and 5 in Table 2.</p>

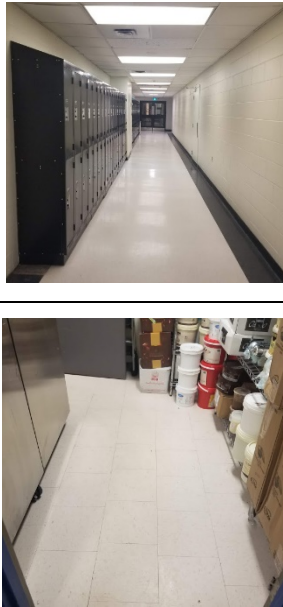
<p>Glued-on Acoustic Ceiling Tiles</p>	<p>None identified in subject building.</p>	
<p>Cement Ceiling Panels</p>	<p>None identified in subject building.</p>	
Flooring	Location/Description	
<p>Vinyl Floor Tiles</p>	<p>Vinyl floor tiles were observed in project specific areas. Bulk samples were collected during the assessment and results of analysis confirmed that this building material is not asbestos-containing. Refer to sample sets 9 and 10 in Table 2.</p>

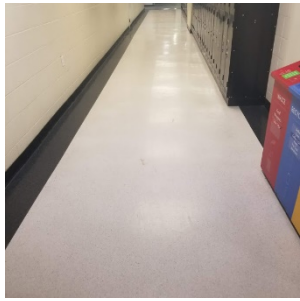
<p>Vinyl Sheet Flooring</p>	<p>Vinyl sheet flooring was observed project specific areas. Bulk samples were collected during the assessment and results of analysis confirmed that this building material is not asbestos-containing. Refer to sample set 8 in Table 2.</p>

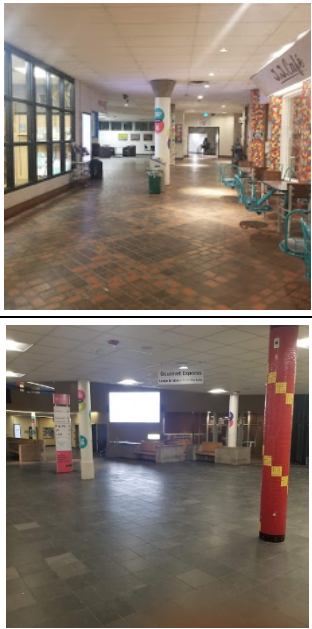
<p>Other Cement Products</p>	<p>Ceramic floor tiles grout was observed in project specific areas. Bulk samples were collected during the assessment and results of analysis confirmed that this building material is not asbestos-containing. Refer to sample sets 5 and 6 in Table 2.</p>

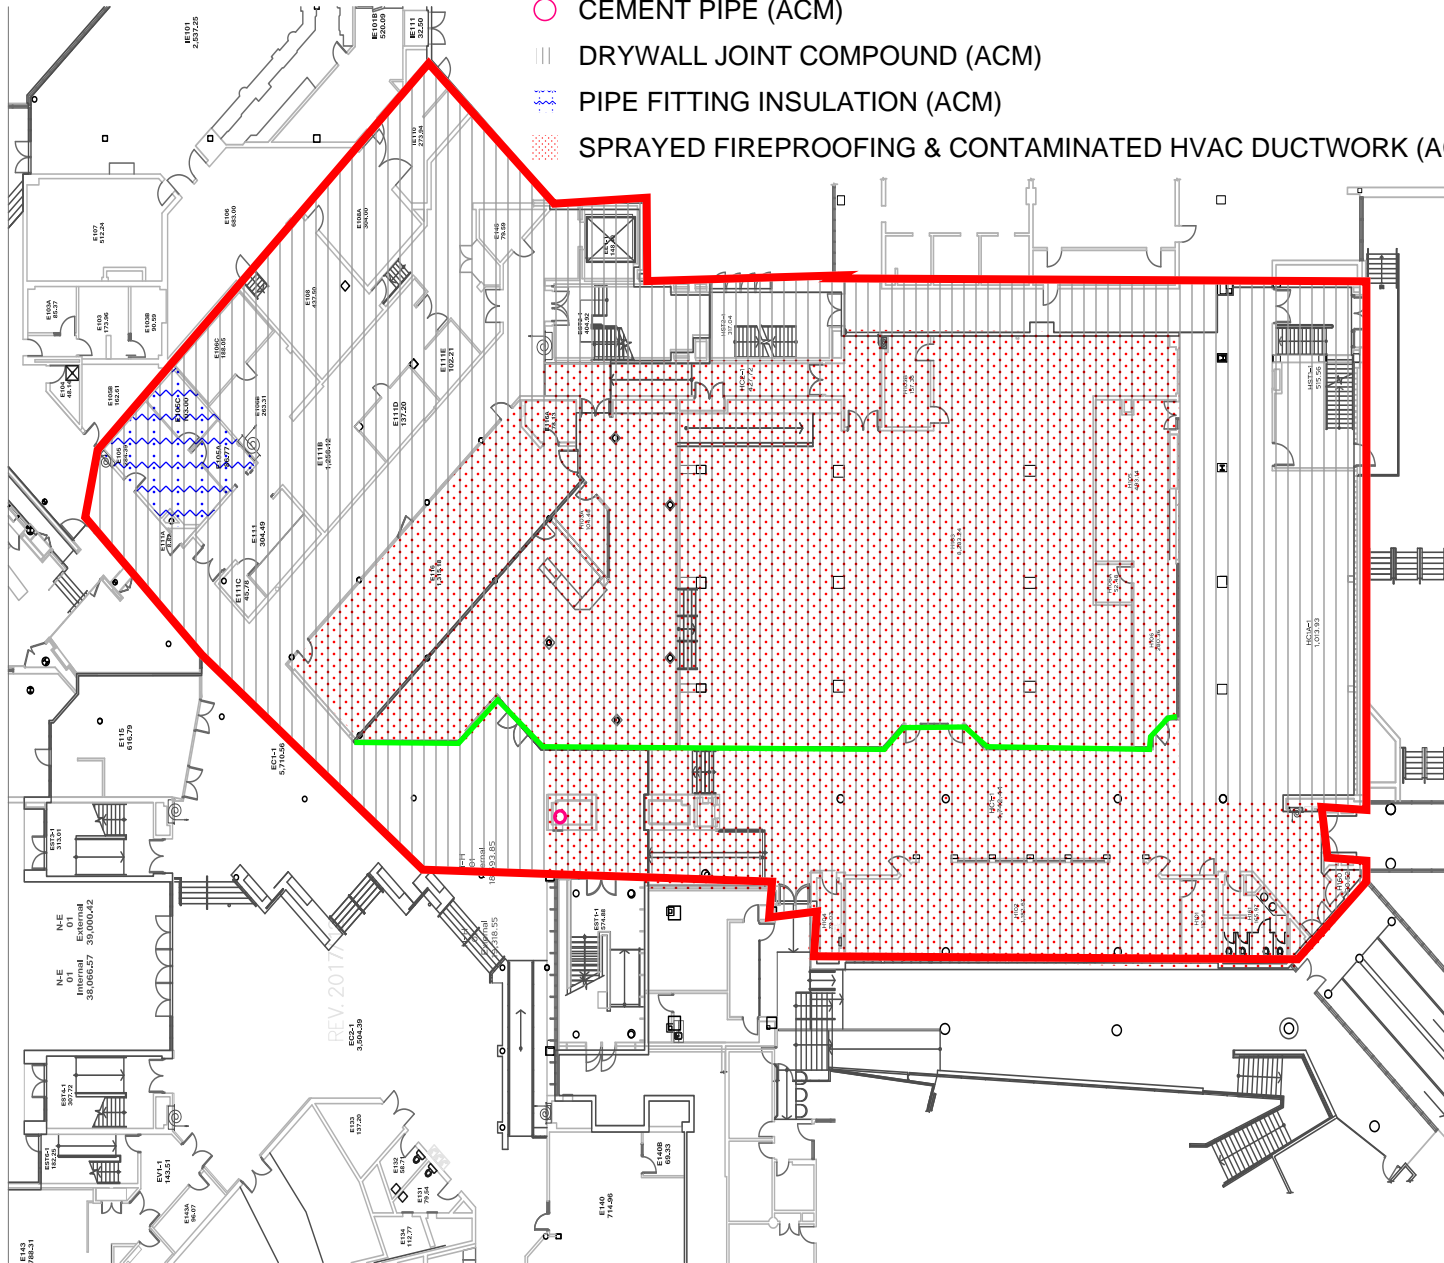
Description:
Location of Areas
Assessed

- AREA ASSESSED
- / CAULKING (ACM)
- CEMENT PIPE (ACM)
- DRYWALL JOINT COMPOUND (ACM)
- ~ PIPE FITTING INSULATION (ACM)
- SPRAYED FIREPROOFING & CONTAMINATED HVAC DUCTWORK (ACM)

- Notes:
- 1) This floor plan must be read in conjunction with the hazardous building materials report for the project.
 - 2) Asbestos-containing sprayed fireproofing is present throughout projects areas. Disturbance must be conducted following Type 3 procedures (O.Reg. 278/05).
 - 3) Cleaning or removing HVAC equipment such as ventilation ducts must be conducted following Type 3 procedures outlined in O.Reg. 278/05.
 - 4) Asbestos-containing drywall joint compound is present on all gypsum fire separations, bulkheads, columns and perimeter walls.
 - 5) Removal of asbestos-containing caulking associated with windows can be conducted following Type 1 procedures.
