Hazardous Building Materials Assessment (Pre-construction)

North Wing, 3rd Floor
Cummer Lodge
205 Cummer Avenue,
Toronto, Ontario

September 19, 2022

Pinchin File: 313221.000

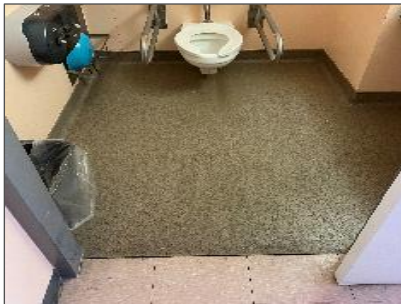
Non-asbestos, VSF2, beige with black flecks (Loc. 3-074).

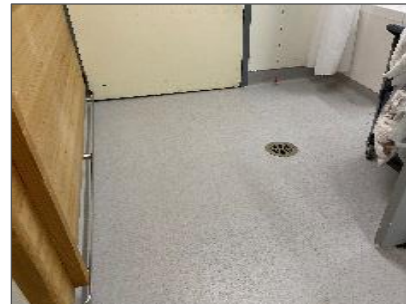
Non-asbestos, VSF11, light grey with black flecks (Loc. 3-081).

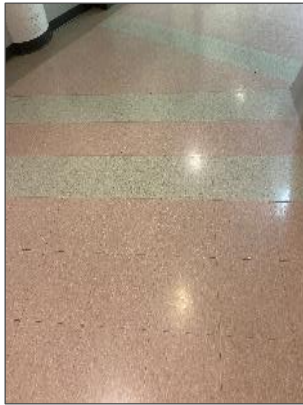
Non-asbestos VFT2 present throughout the corridors in northern portion of 3rd floor.

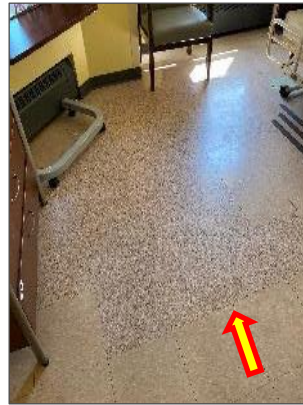
Non-asbestos VFT9 in Room N390 (Loc. 3-074).

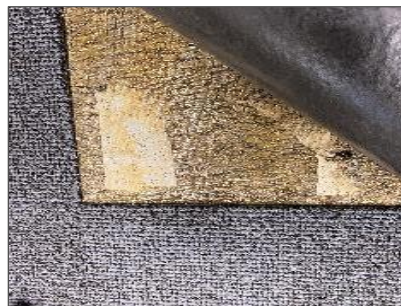
Non-asbestos yellow carpet mastic, office (Loc. 3-038).

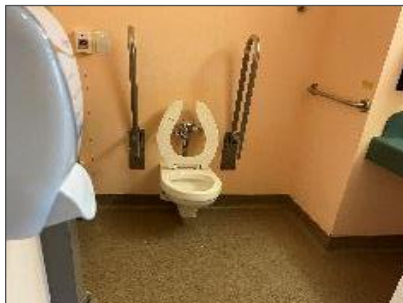
Insignificant level lead light pink paint on drywall present throughout the floor.

. Exposure from construction disturbance of paints containing lead less than 0.009% (90 mg/kg) is assumed to be insignificant.

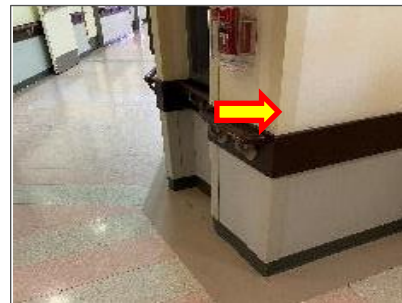
Insignificant level light yellow paint on drywall present throughout the floor.

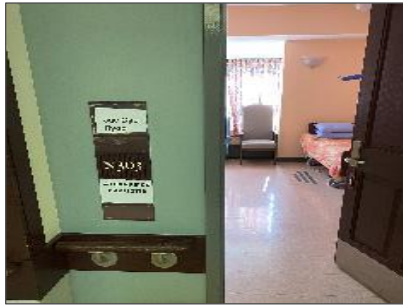
Insignificant level lead light blue paint on drywall wall, Loc.3-036.

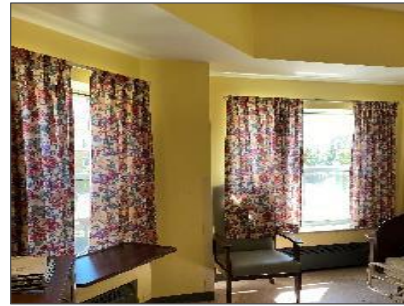
Insignificant level lead yellow paint on drywall wall, Loc. 3-019.

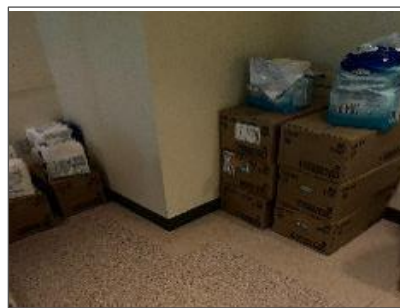
Insignificant level white paint on drywall present throughout the floor.
