Hazardous Building Materials Assessment (Pre-construction)

2nd Floor, Fudger House
439 Sherbourne Street,
Toronto, Ontario

September 21, 2022

Pinchin File: 314531.000

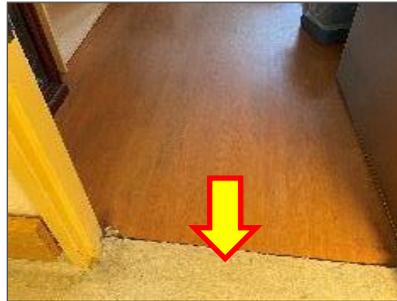
Non-asbestos VSF03 present in corridors (Loc. 2-062).

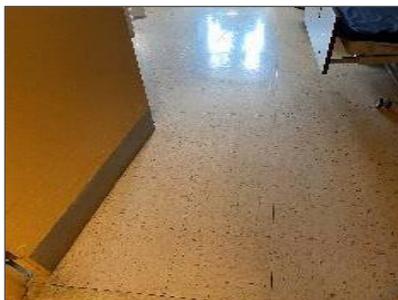
Non-asbestos VFT14 12 x 12 mauve with smears (Loc. 2-008)

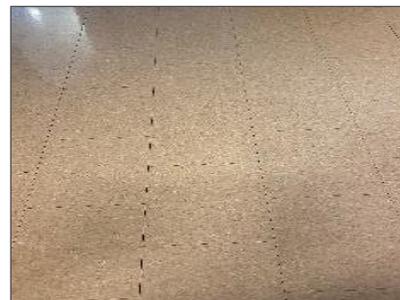
Non-asbestos VFT07 12 x 12 beige mosaic (Loc. 238).

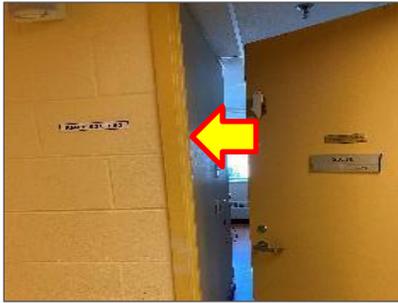
Insignificant level lead yellow paint on metal door frames, Corridor (Loc. 2-030).

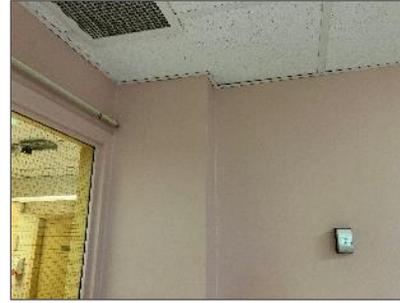
Low-level lead Lilac paint on drywall, Lounge (Loc. 2-048).

For paints identified as having low levels of lead (i.e., less than the EACC guideline of 0.1% (1,000 mg/kg) for lead-containing paints but equal to or above 0.009% (90 mg/kg)) special precautions are not recommended unless aggressive disturbance (grinding, blasting, torching) is planned. Exposure from construction disturbance of paints containing lead less than 0.009% (90 mg/kg) is assumed to be insignificant.
