Hazardous Building Materials Assessment (Pre-construction)

1st and 2nd Floor Hand Railings
Seven Oaks Long Term Care
Home
9 Neilson Road,
Scarborough, Ontario

September 19, 2022

Pinchin File: 314479.000

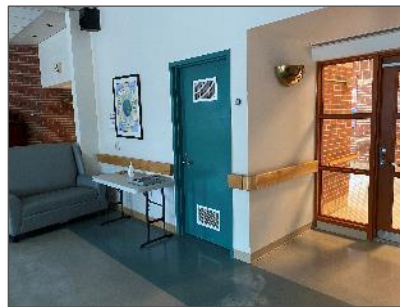
Drywall joint compound present on wall and ceiling finishes throughout Locations 1-089, 1-092, 1-051, 1-058, 2-019, 2-045, 2-071 does not contain asbestos (samples S0002A-C, S0003A-E, S0004A-G).

Non-asbestos joint compound on drywall walls, Auditorium (Loc. 1-089).

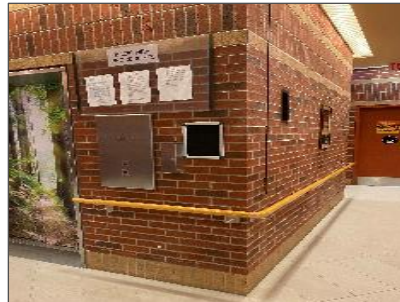
Mortar present between bricks in location 1-097 does not contain asbestos (samples S0001A-C).

Non-asbestos mortar on brick walls, corridor (Loc. 1-097).

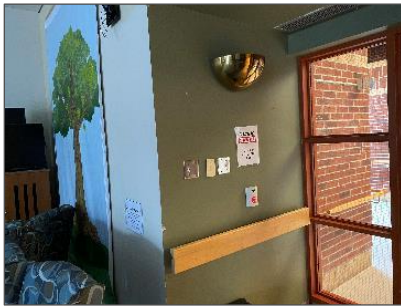
All paints sampled were below 0.009% (90 mg/kg). Paints containing less than 0.009% (90 mg/kg) lead is assumed to be insignificant.

Insignificant level of lead in olive green paint on drywall, Auditorium (loc. 1-092).

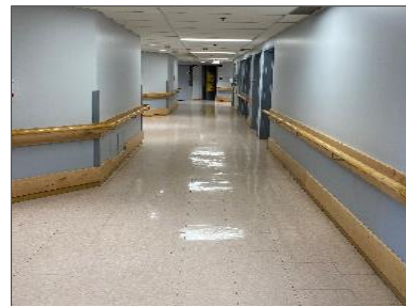
Insignificant level of lead in light blue and pale blue paint (loc. 1-051).
