LIMITED DESIGNATED SUBSTANCES AND HAZARDOUS MATERIALS SURVEY

**CFB Borden, A-150
21 Parade Avenue
Borden, Ontario**

**DCC Project Number: BN300075
Contract Number: KN71023**

DST File No.: GV-OT-038848

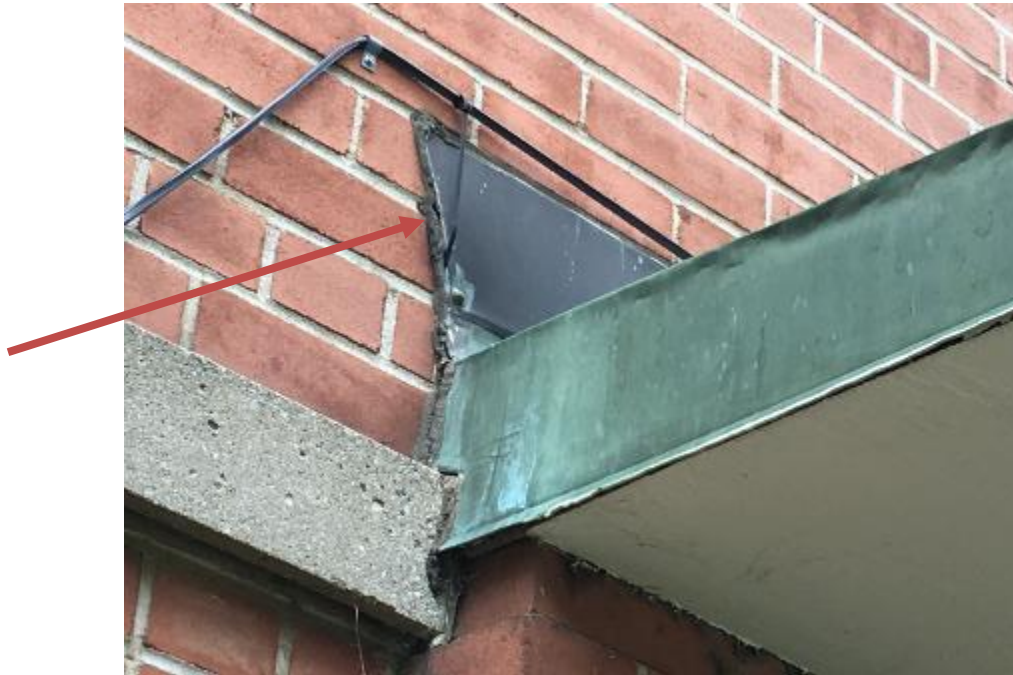
- Non-friable exterior white caulking was confirmed to contain 2% Chrysotile asbestos, on the exterior canopy (DST Sample ID A-150-02A, Photograph 1). All white exterior caulking should be considered asbestos-containing. This material was identified to be in good condition, total quantity of approximately 2 m, DND Management Action Level 6;

Photo 1: Non-Friable exterior white (weathered) caulking was confirmed to contain 2% Chrysotile Asbestos (DST Sample ID A-150-02A-C). The material was observed on the south entrance canopy.

The removal of non-friable materials (caulking and cast-iron drain joint packing) can be completed using Low-Risk procedures, provided only non-powered hand tools are used and the material is wetted during removal. If these conditions cannot be met, then more stringent (Moderate Risk or High-Risk) procedures are required.

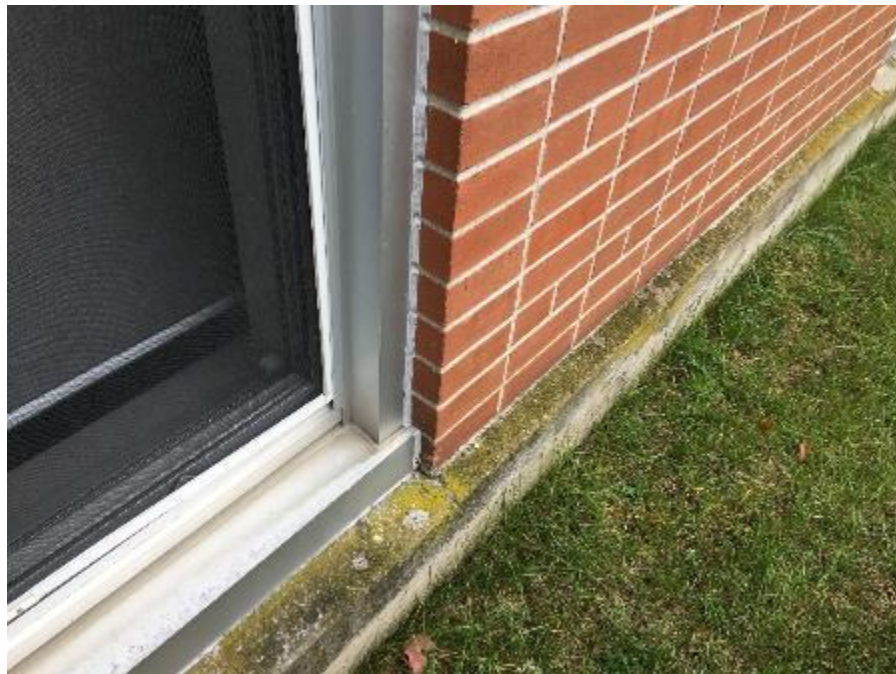
- Non-friable exterior grey window caulking was confirmed to contain 10% Chrysotile asbestos (DST Sample ID A-150-03A, Photograph 2). All exterior grey window caulking should be considered asbestos-containing. This material was identified to be in good condition, total quantity of approximately 46 m, DND Management Action Level 6;

Photo 2: Non-Friable exterior grey window caulking was confirmed to contain 10% Chrysotile Asbestos (DST Sample ID A-150-03A-C).

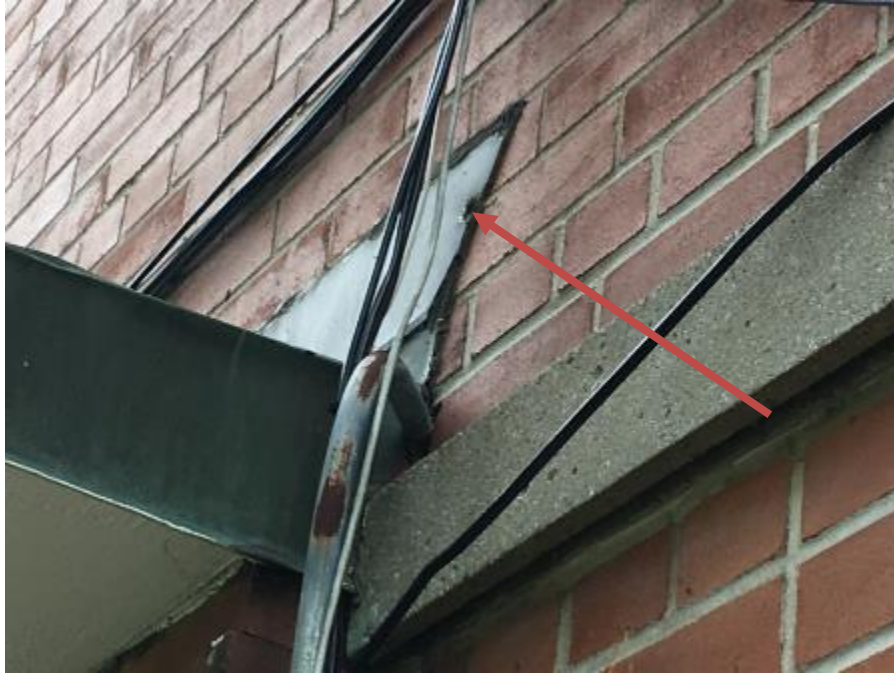
Photo 3: Exterior brown caulking was confirmed to not contain asbestos (DST Sample ID A-150-04A-C).

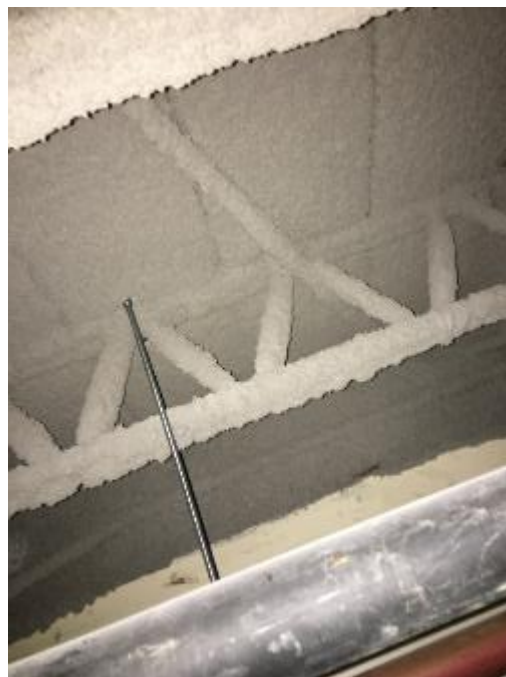
Photo 4: Fireproofing, observed in Corridor 138, was confirmed to not contain asbestos (DST Sample ID A-150-05A-C).

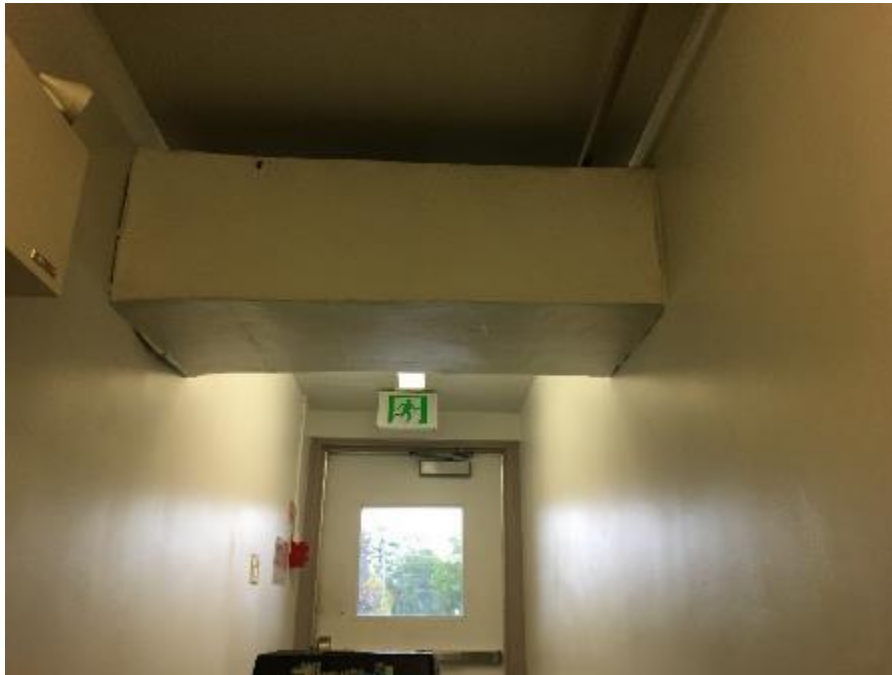
- Friable Parging cement within canvased duct seams was confirmed to contain 60% Chrysotile asbestos in corridor 140 (Maple Sample ID 12233-S-06A, Photograph 5). This material was identified to be in good condition, total quantity of approximately 2 m², DND Action Level 6;

Photo 5: Friable paring cement within canvased duct seams confirmed to contain 60% Chrysotile asbestos, sampled in Corridor 140 (Maple Sample ID 12233-S-06A).

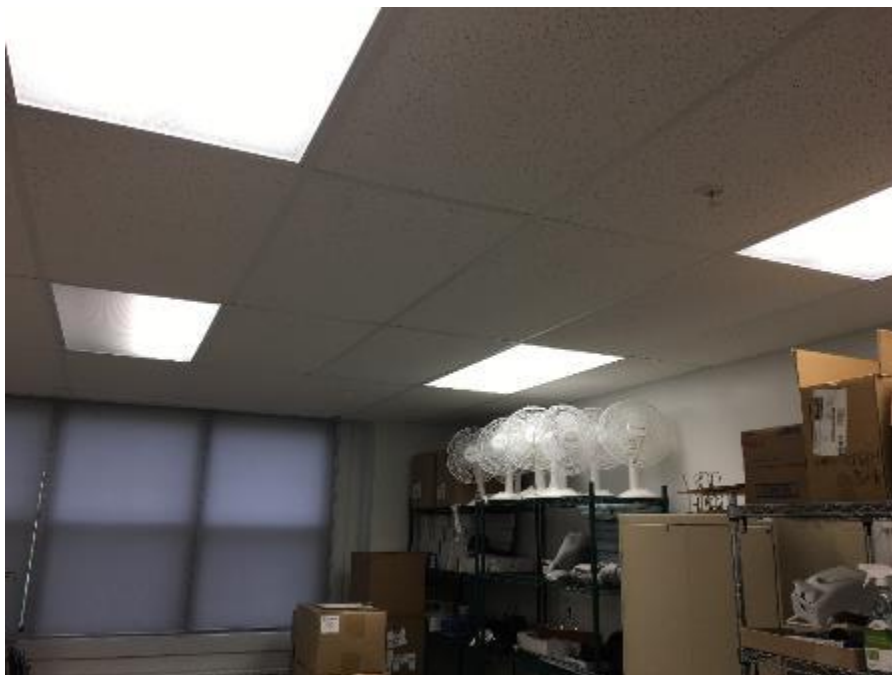
Photo 6: 2' x 4' Acoustic Ceiling Tile, pinhole and fissures confirmed to not contain asbestos (recent manufacture date stamp).

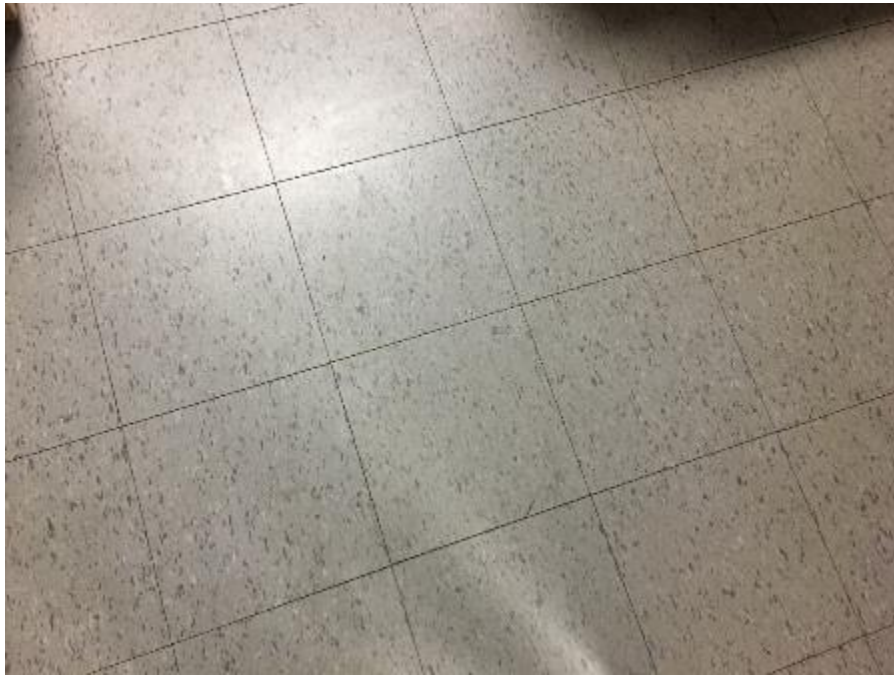
Photo 7: 12" x 12" Vinyl Floor Tile, grey with brown and white flecks confirmed to not contain asbestos, sampled in Room 126, 224 and 324 (Maple Sample ID 12233-S-02a-c).

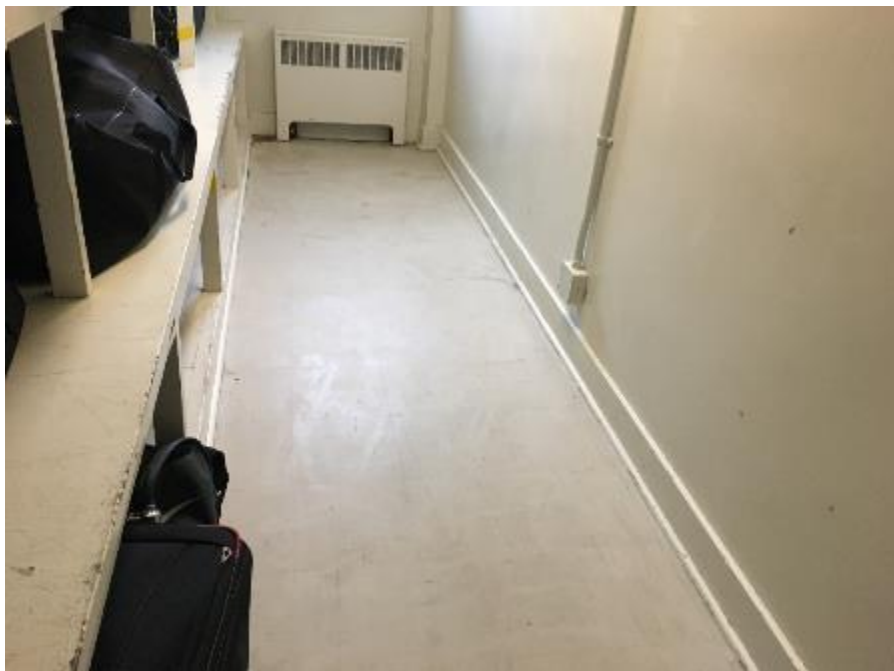
Photo 8: 12" x 12" Vinyl Floor Tile, beige with grey streaks confirmed to not contain asbestos, sampled from room 102 (Maple Sample ID 12233-S-04a-c).
