## **HAZARDOUS BUILDING MATERIALS SURVEY**

### **Williams Parkway Operations Building**

1975 Williams Parkway East  
Brampton, Ontario  
L6S 6E5

**OHE Project No: 24918-097**

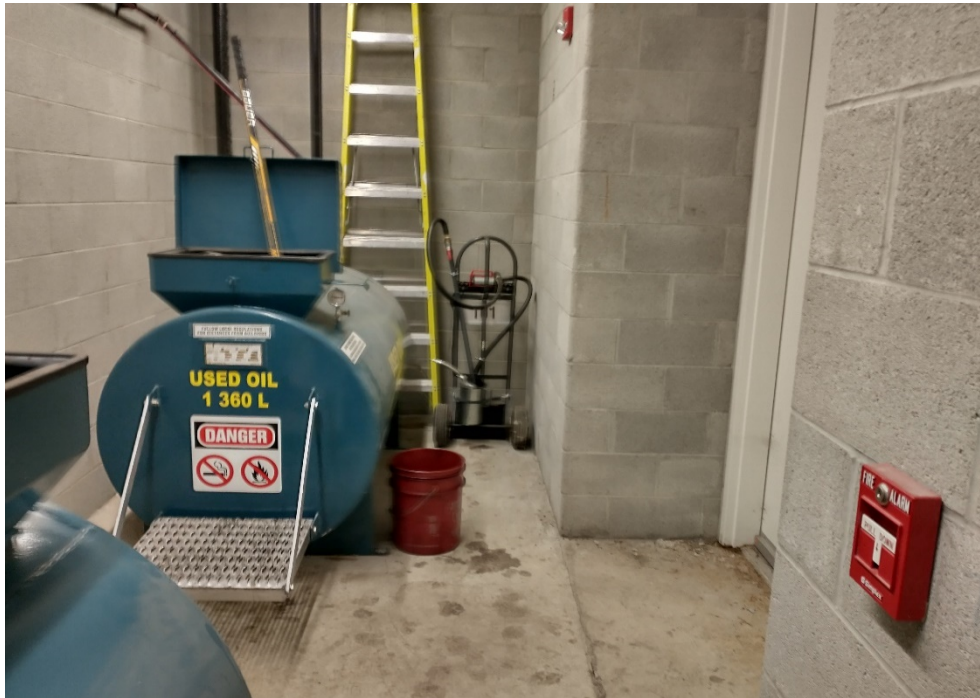
Two (2) aboveground storage tanks containing oil were observed in the Waste Oil Room at the Subject Location.

**Photograph 1:** View of an aboveground storage tank containing oil observed on the Waste Oil Room at the Subject Location.

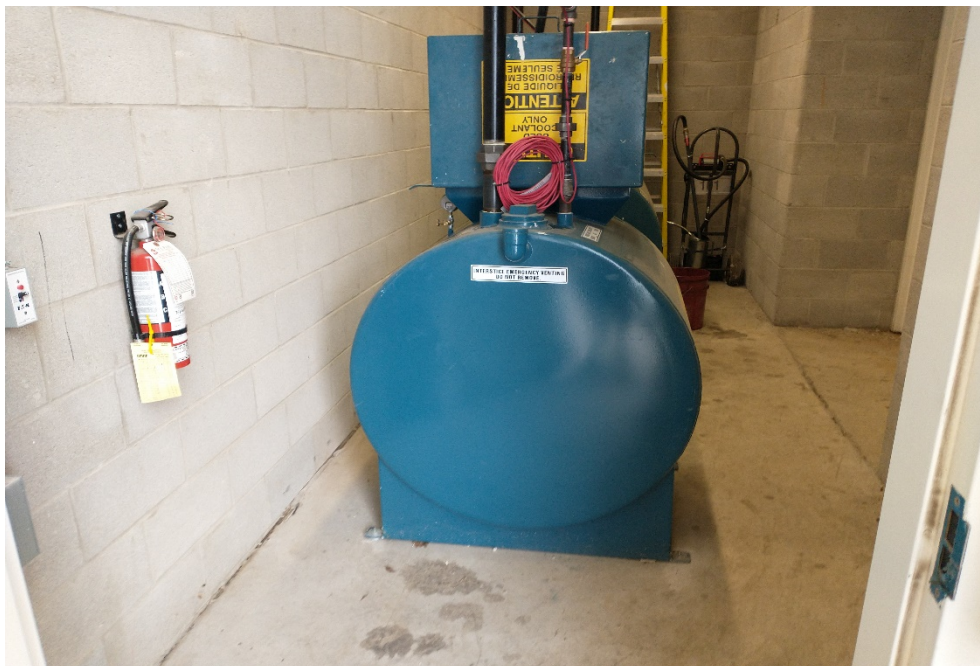
**Photograph 2:** View of an aboveground storage tank containing oil observed on the Waste Oil Room at the Subject Location.

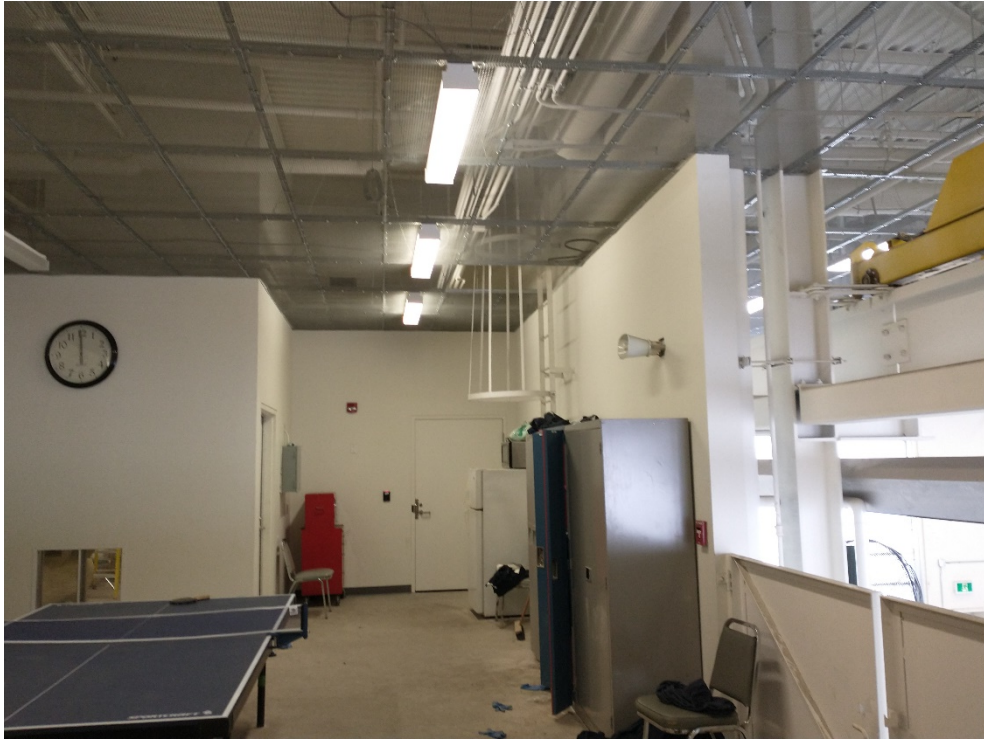
**Photograph 3:** View of a refrigerator suspected to contain ozone depleting refrigerant observed outside IT Room-22 at the Subject Location.
