DESIGNATED SUBSTANCES AND HAZARDOUS BUILDING MATERIALS ASSESSMENT REPORT

**Renovation Project
Ground, 7th, 9th, 10th and 11th Floors
Centre for Addiction and Mental Health (CAMH)
250 College Street
Toronto, Ontario
M5T 1R8**

Safetech Project Number: 3220708

**Date of Site Work: October 14, 2022
Date of Issue: October 27, 2022**

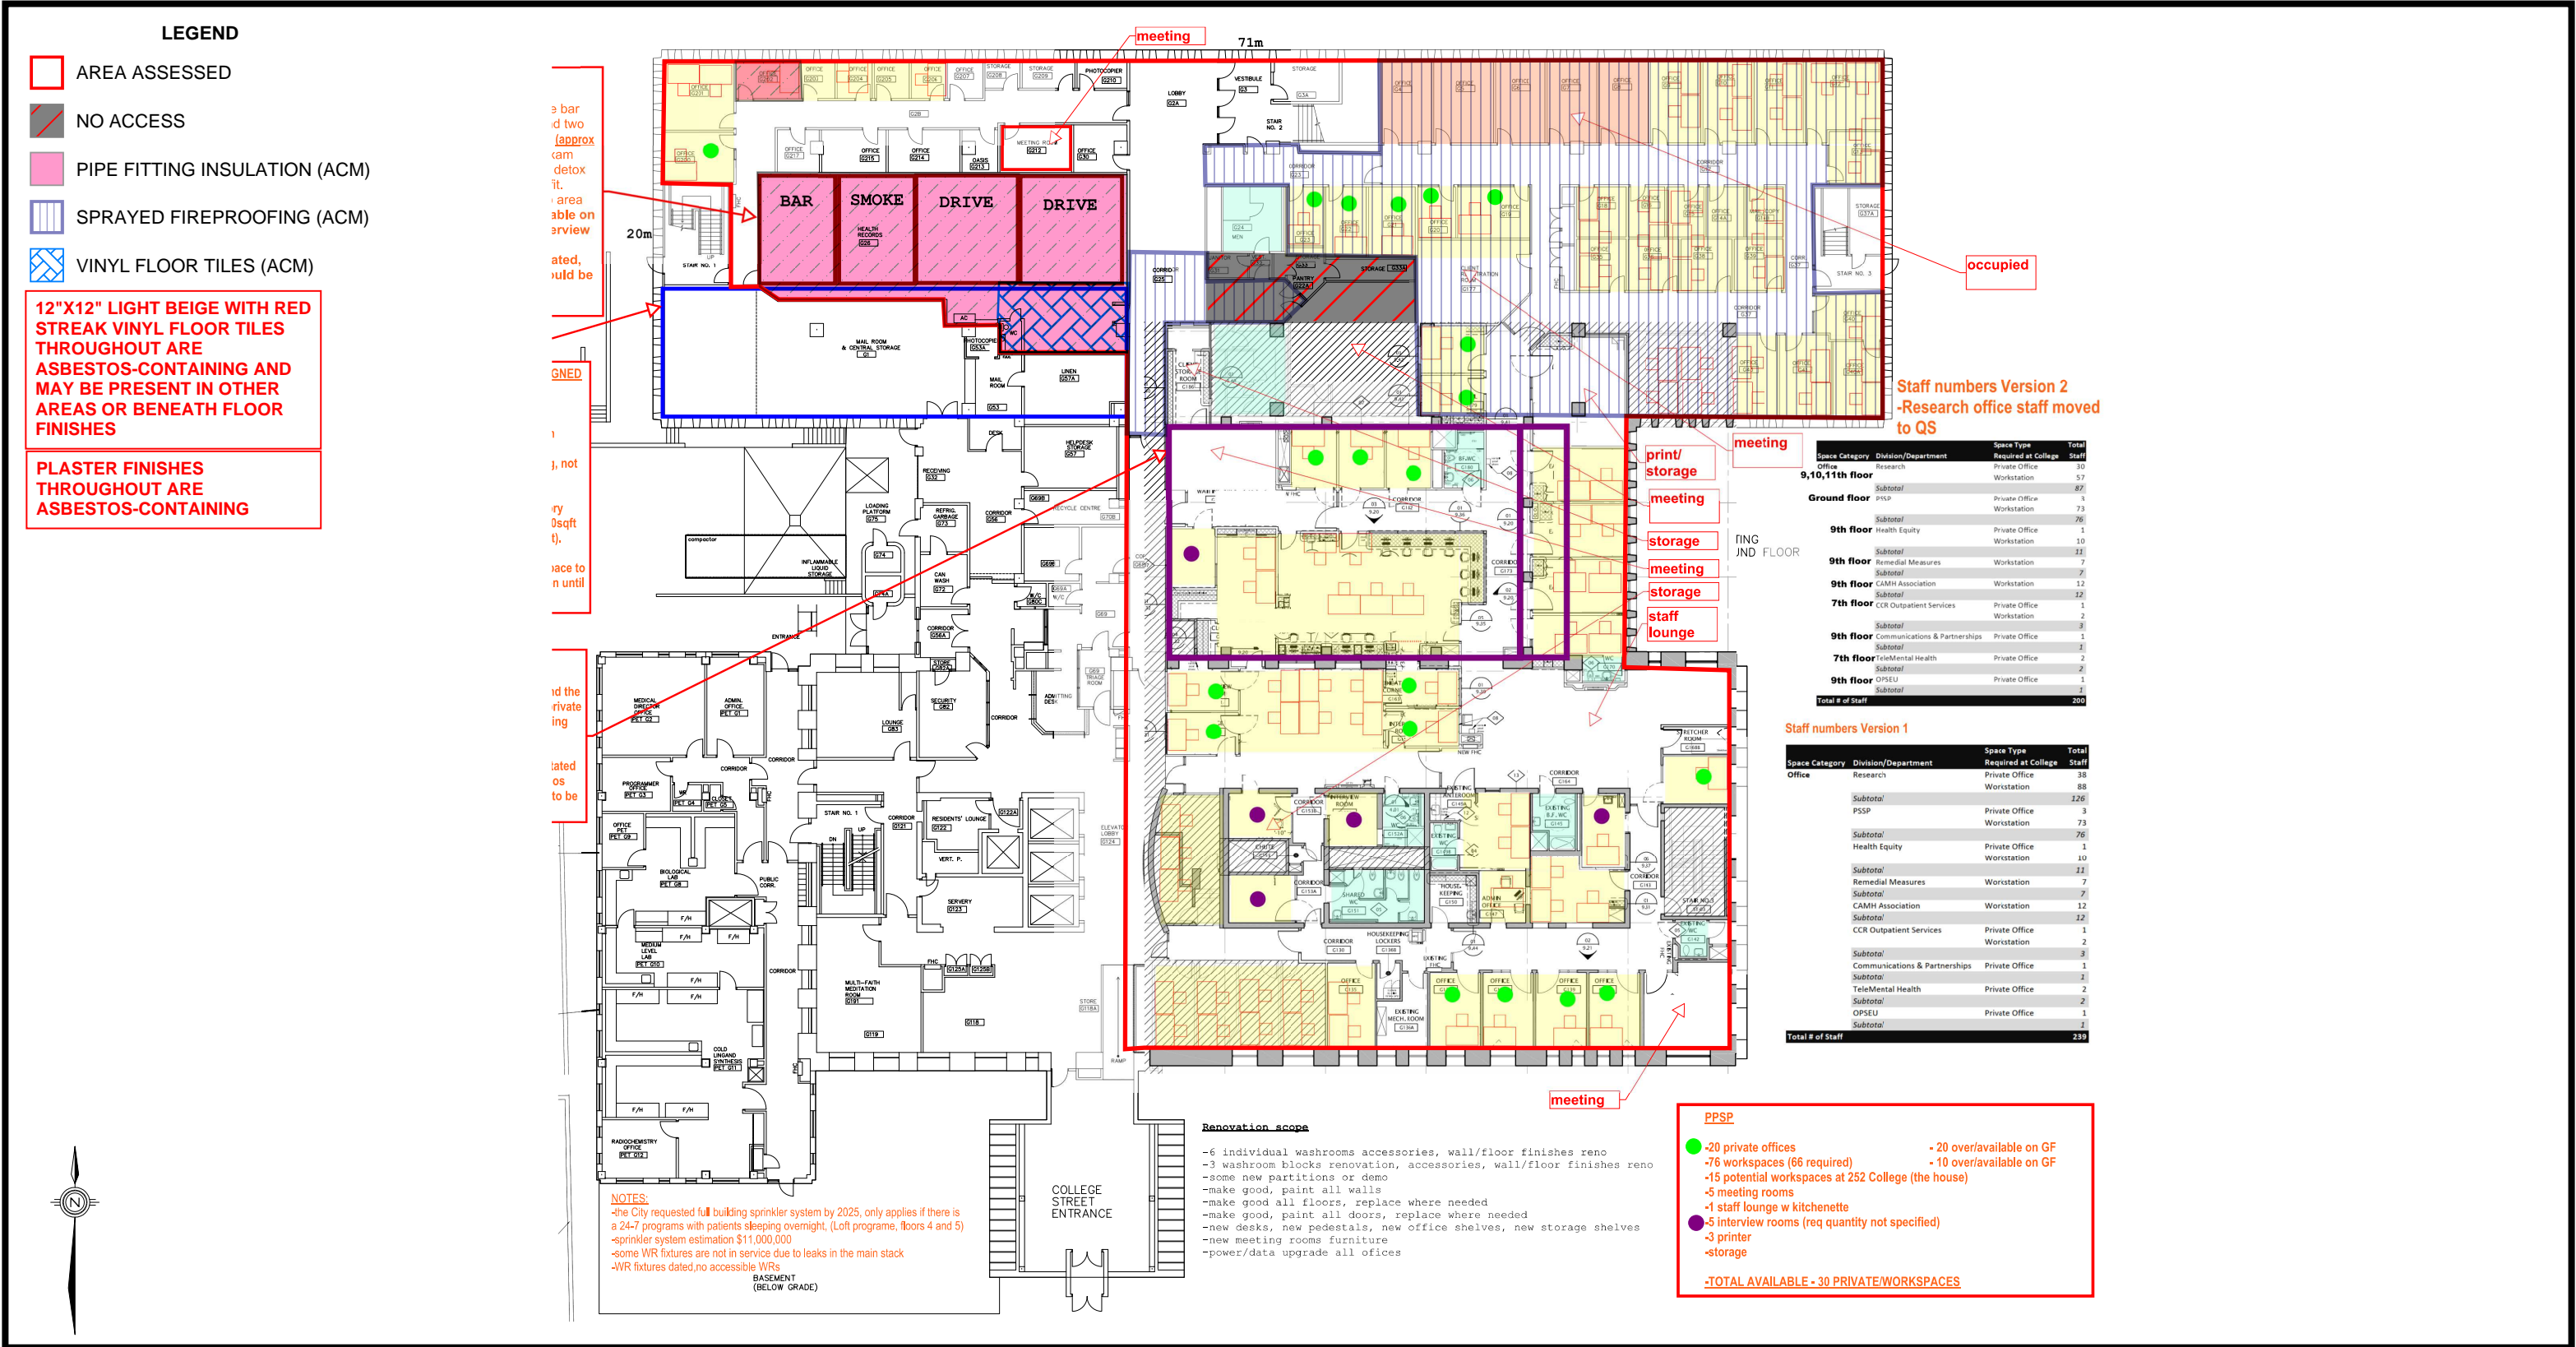
PLASTER FINISHES THROUGHOUT ARE ASBESTOS-CONTAINING

DRYWALL JOINT COMPOUND ASSOCIATED WITH DRYWALL FINISHES THROUGHOUT ARE ASBESTOS-CONTAINING

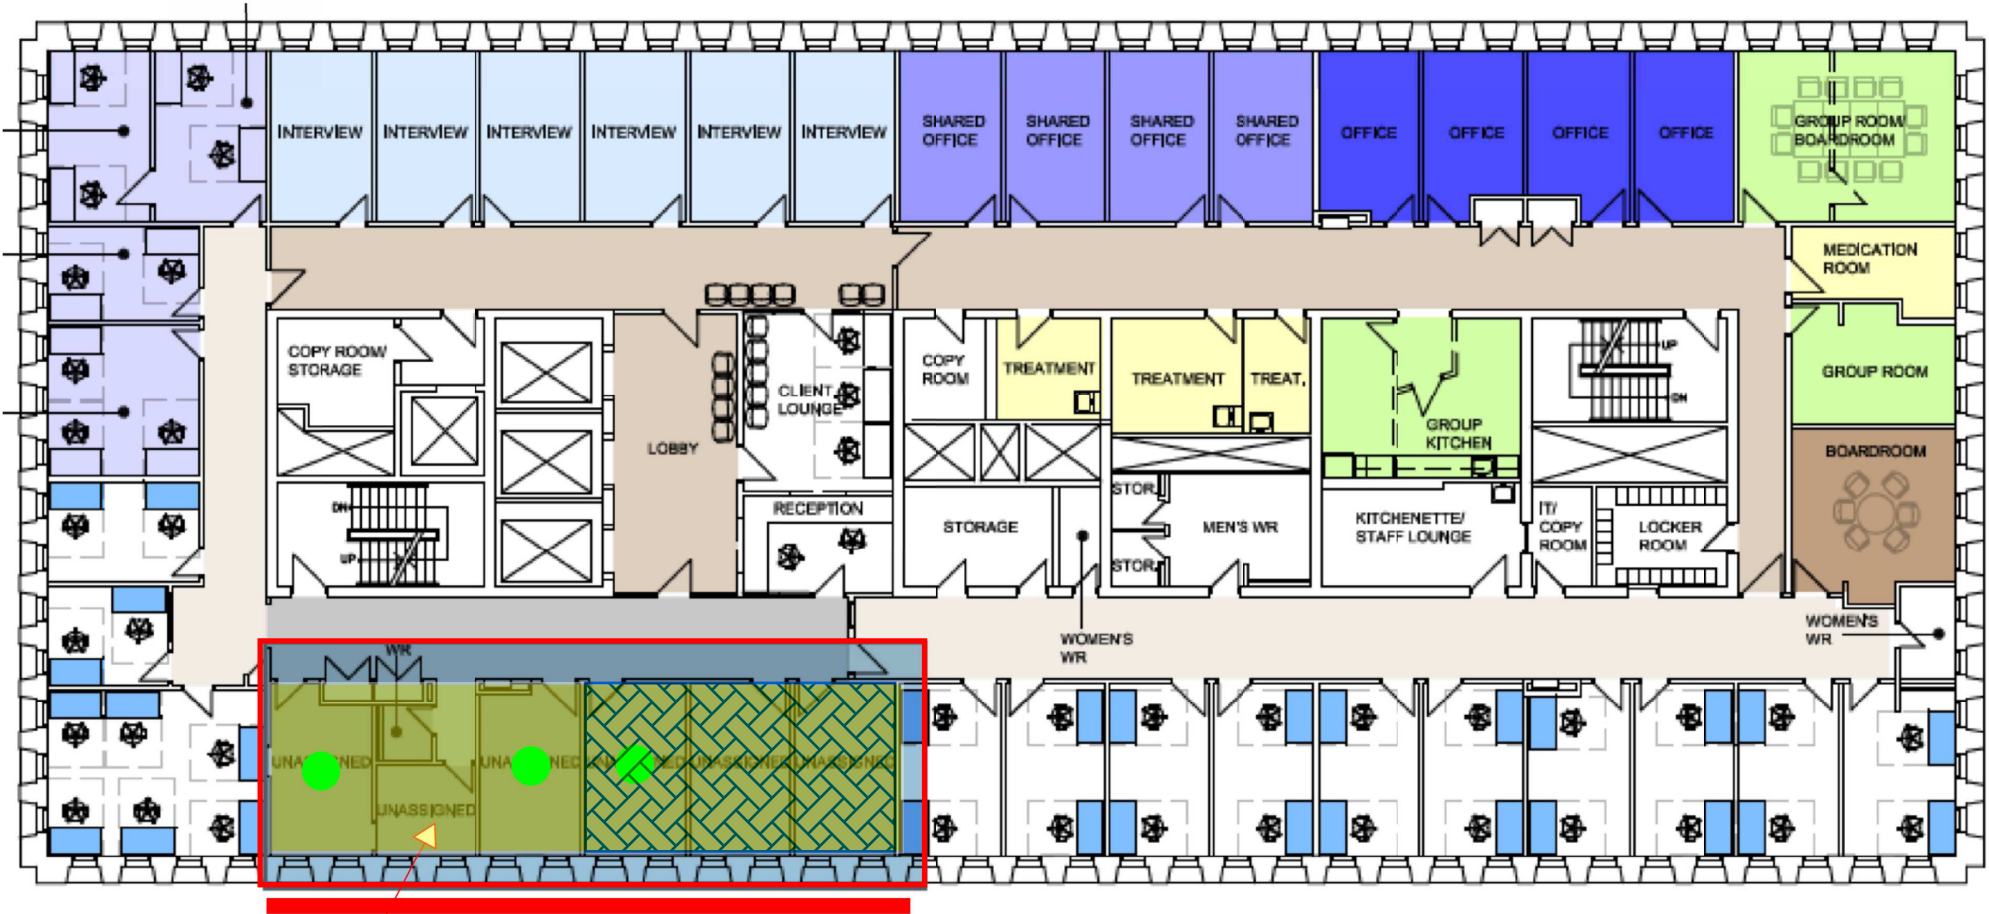
PLASTER FINISHES THROUGHOUT ARE ASBESTOS-CONTAINING

DRYWALL JOINT COMPOUND ASSOCIATED WITH DRYWALL FINISHES THROUGHOUT ARE ASBESTOS-CONTAINING

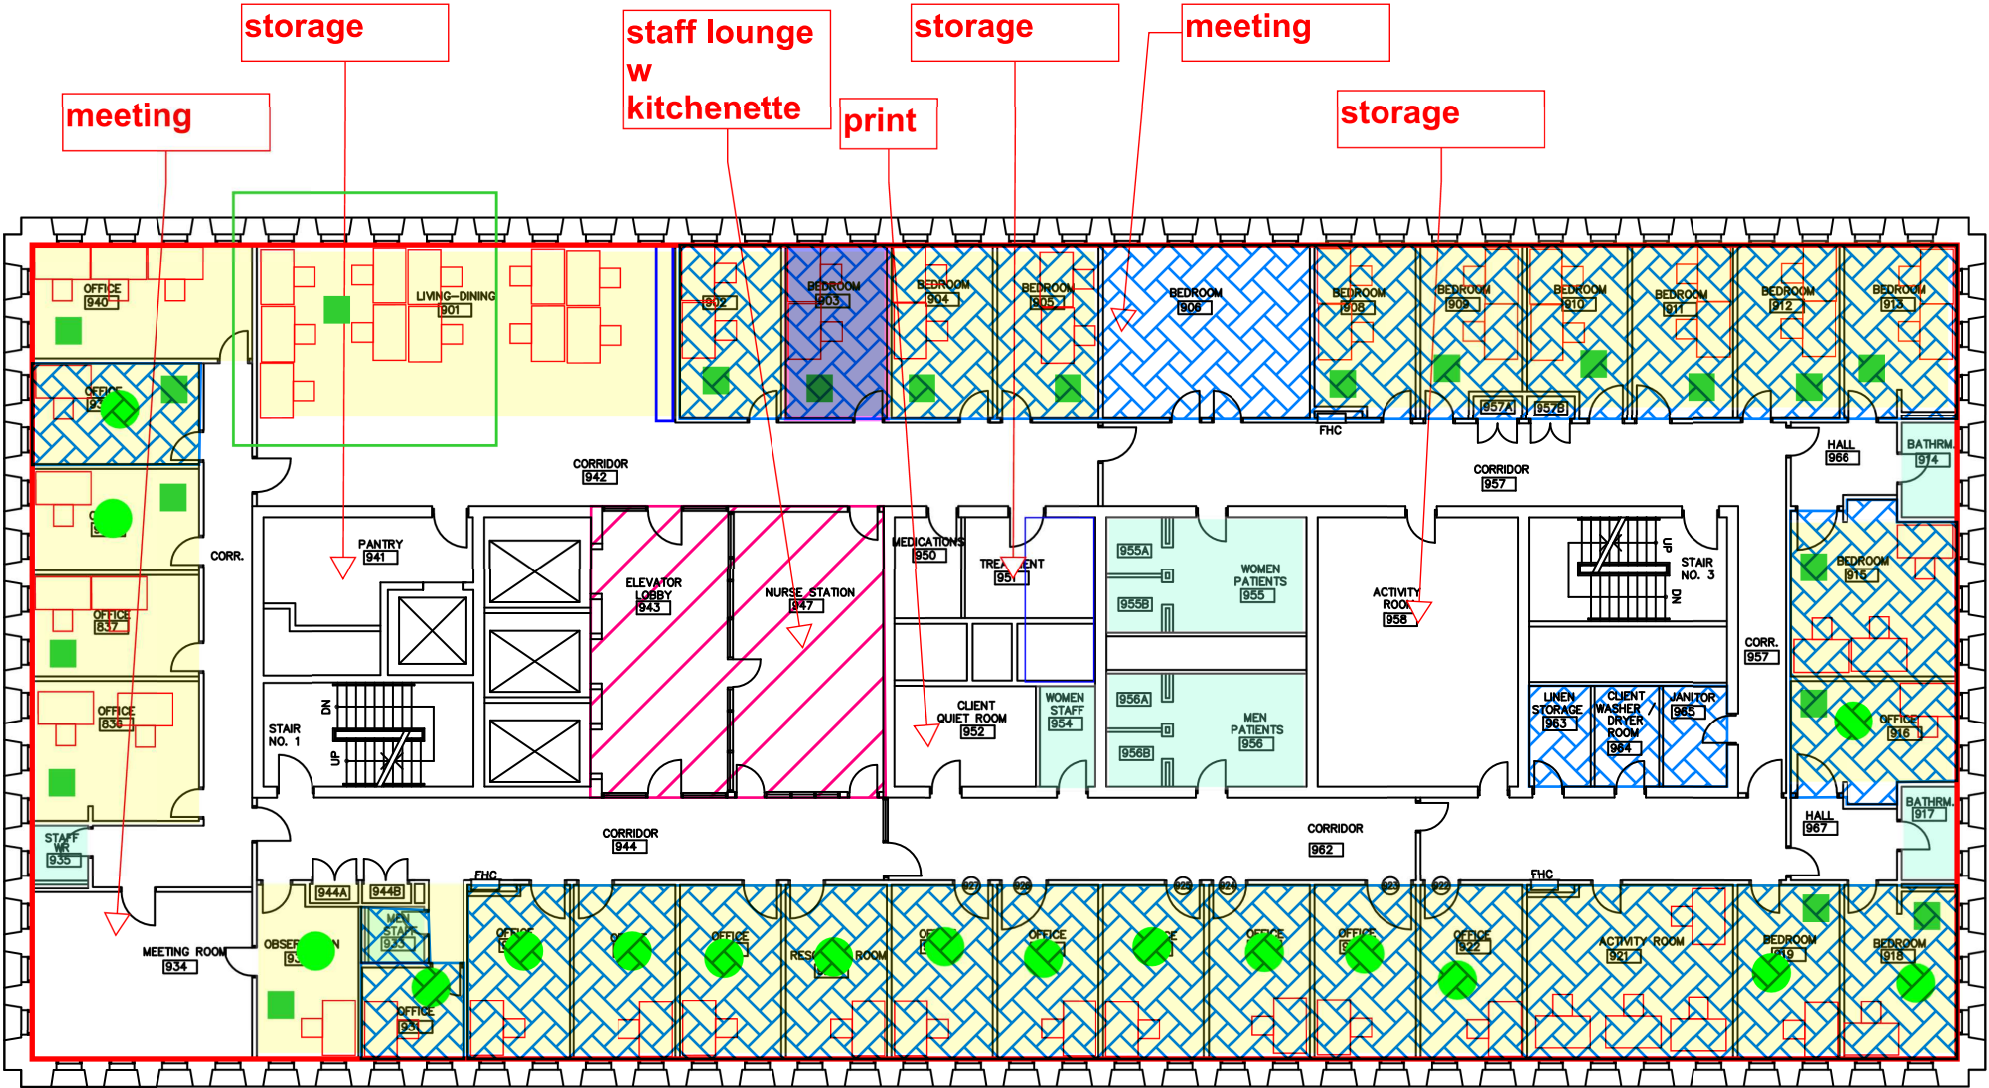
PLASTER FINISHES THROUGHOUT ARE ASBESTOS-CONTAINING

DRYWALL JOINT COMPOUND ASSOCIATED WITH DRYWALL FINISHES THROUGHOUT ARE ASBESTOS-CONTAINING

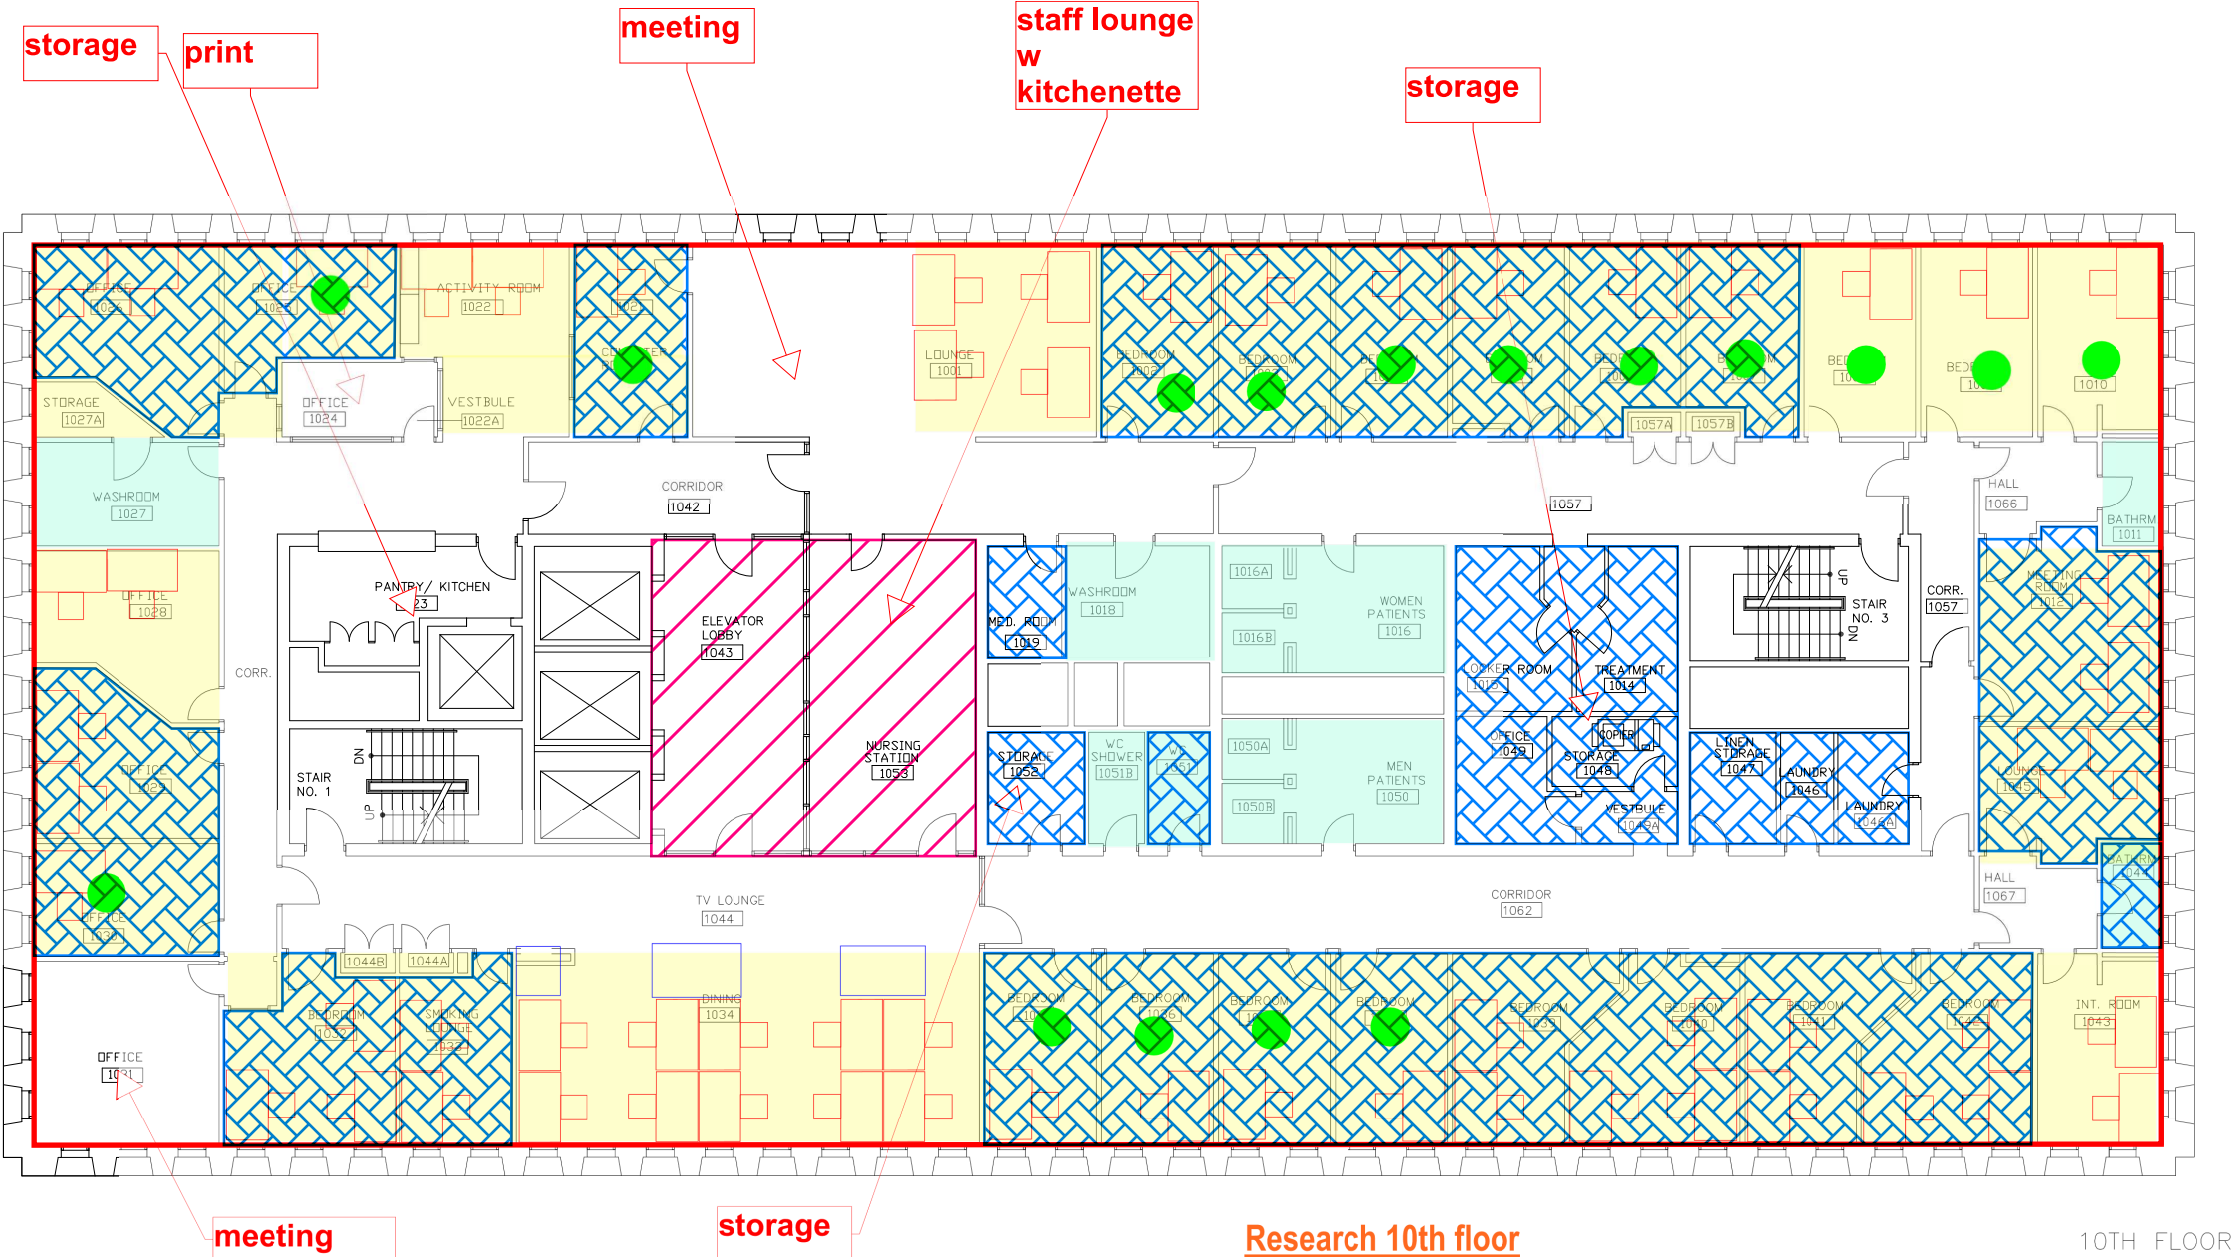
10TH FLOOR

PLASTER FINISHES THROUGHOUT ARE ASBESTOS-CONTAINING

DRYWALL JOINT COMPOUND ASSOCIATED WITH DRYWALL FINISHES THROUGHOUT ARE ASBESTOS-CONTAINING
