DESIGNATED SUBSTANCE SURVEY

Mechanical Equipment Replacement

Terry Miller Recreation Centre

1295 Williams Parkway, Brampton, ON

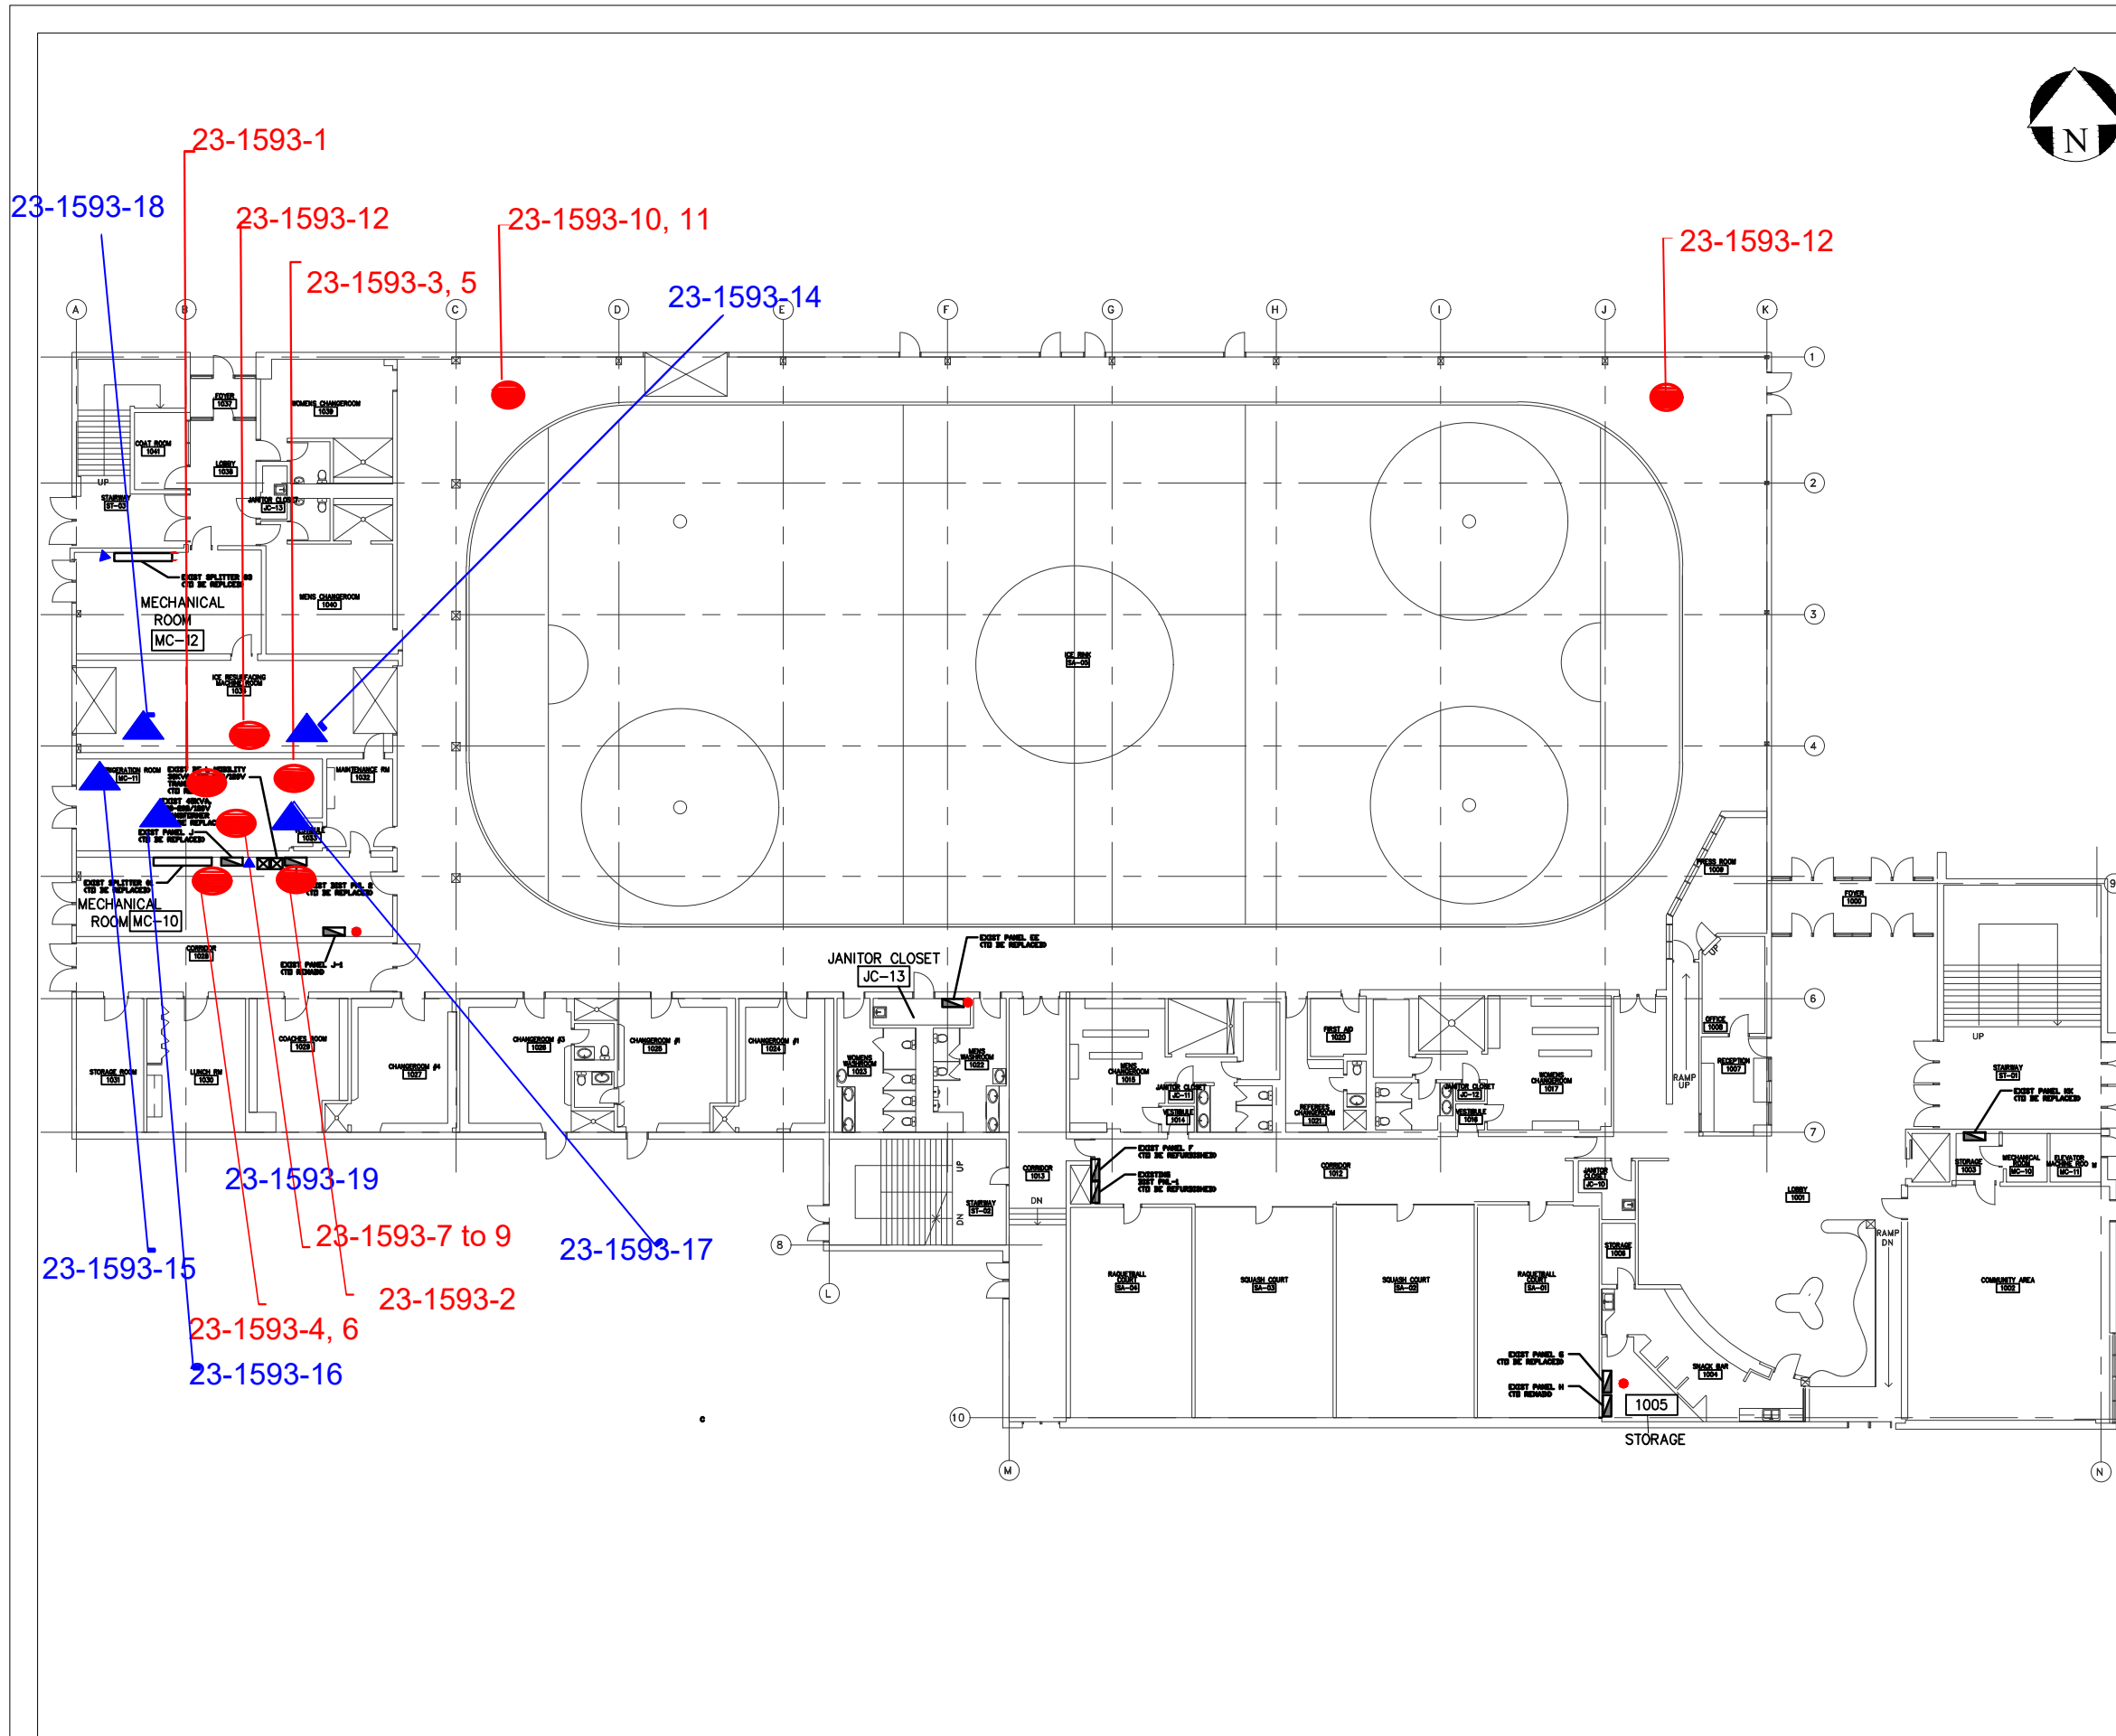
Figure 1

First Floor Plan
Asbestos and Lead Sample Locations

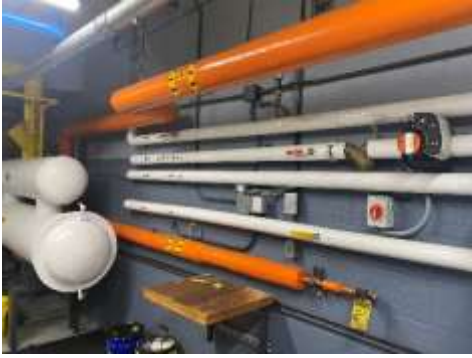
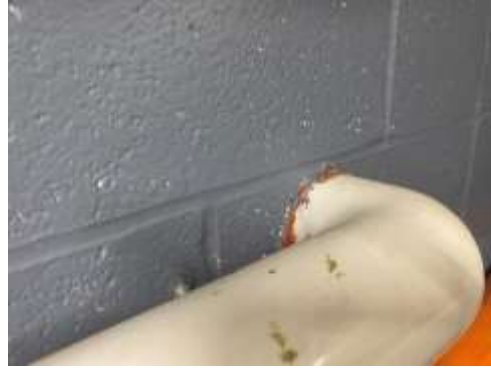
Picture 1, 2: non-asbestos-containing pipe, sealant and non-lead-containing paint.

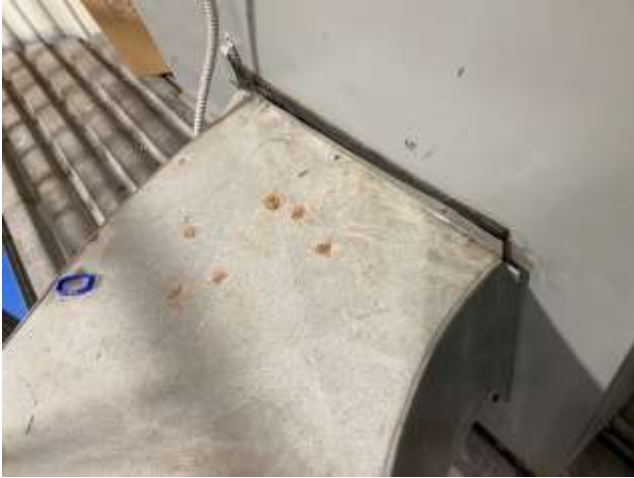
Picture 3: Non-asbestos-containing black sealant around the dehumidifiers
