HAZARDOUS BUILDING MATERIALS SURVEY

Provincial Offences Act Courthouse

5 Ray Lawson Boulevard
Brampton, Ontario
L6Y 5L7

OHE Project No: 24918-149

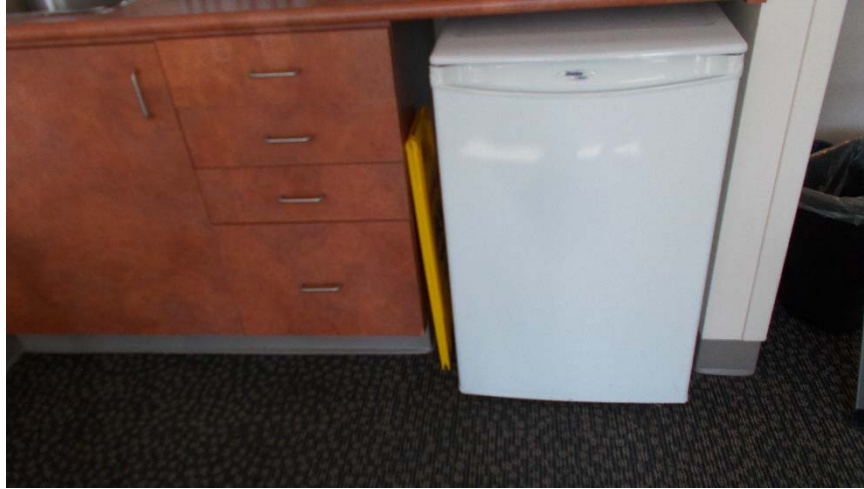
Photograph 1: View of the refrigerator suspected of containing ozone depleting substances observed in Room 1042 at the Subject Location.

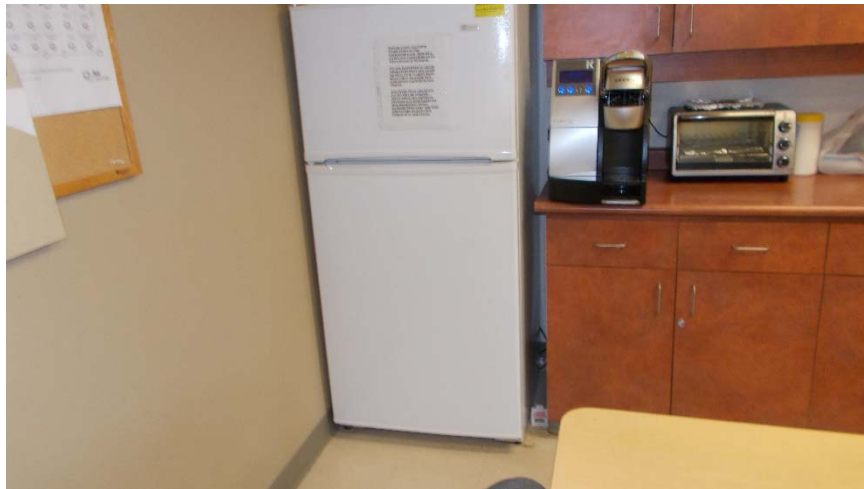
Photograph 2: View of the refrigerator suspected of containing ozone depleting substances observed in Room 1030 at the Subject Location.

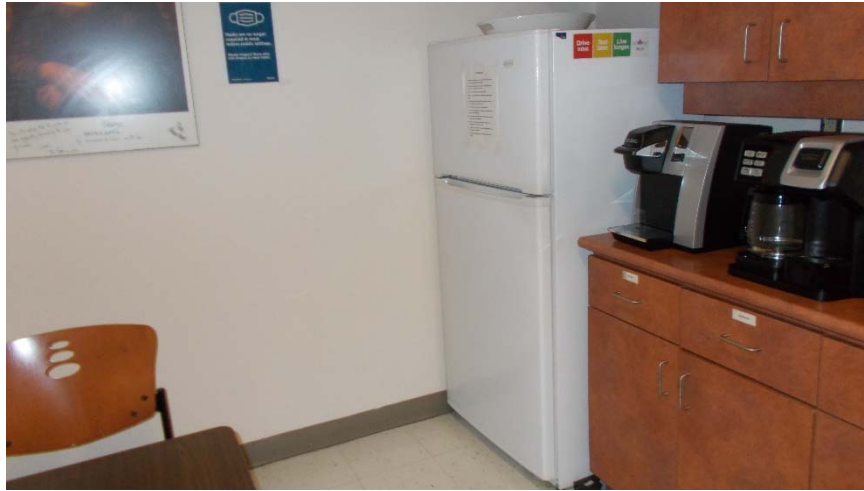
Photograph 3: View of the refrigerator suspected of containing ozone depleting substances observed in Room 2032 at the Subject Location.

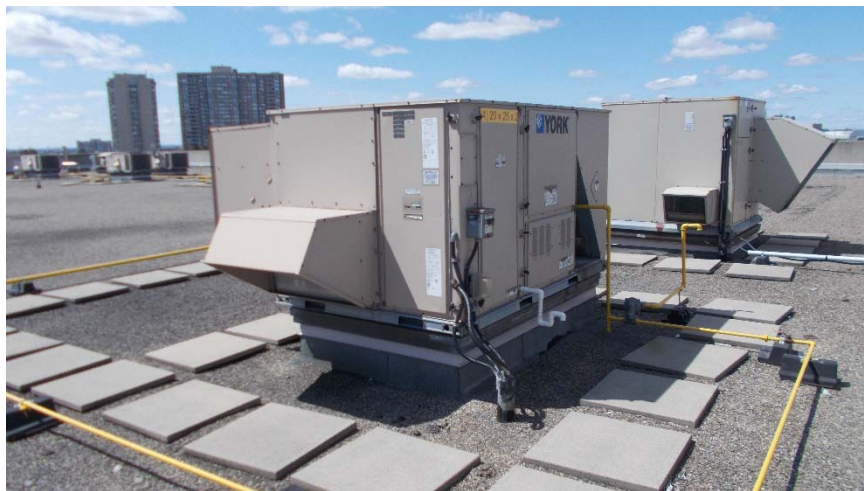
Photograph 4: View of the AHU suspected of containing ozone depleting substances observed on the roof at the Subject Location.
