# **DESIGNATED SUBSTANCES SURVEY**

Building A - 253

31 Hangar Road, Borden, Ontario

March 18, 2022

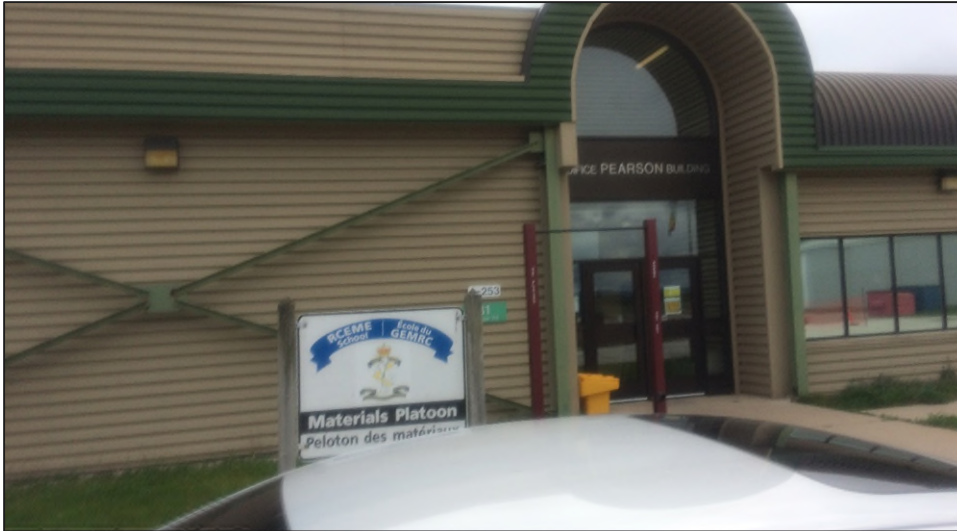
**Photo: 1**

**Location/Description:**  
General South view of Building A-253.

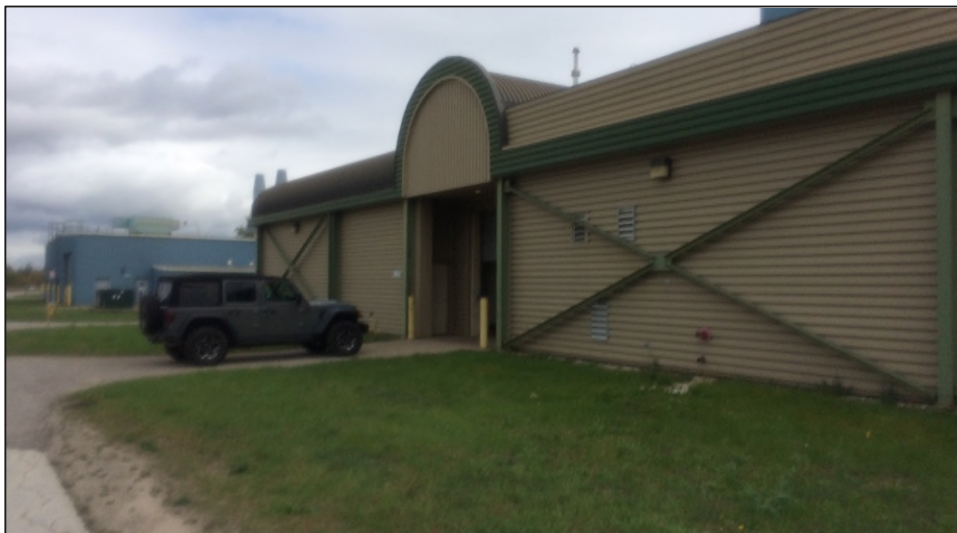
**Photo: 2**

**Location/Description:**  
General west view of Building A-253.

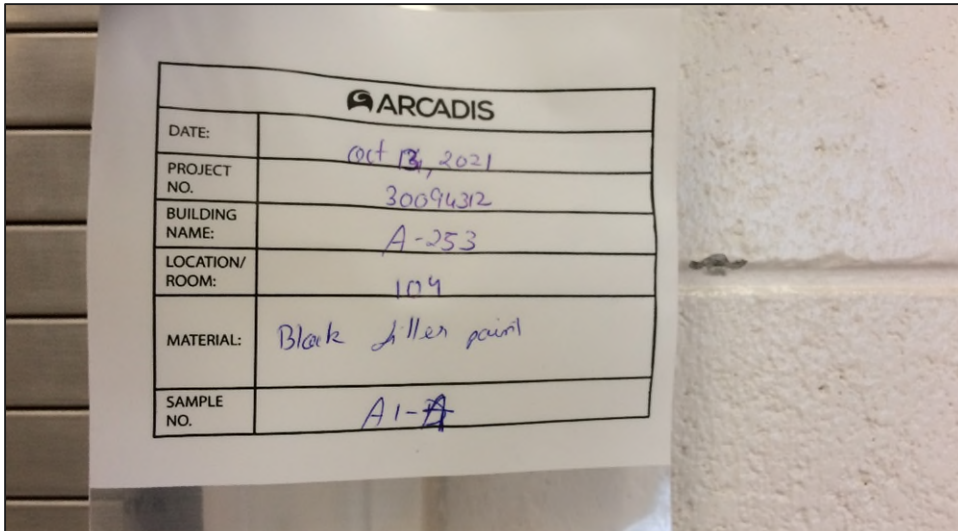
**Photo: 4**

**Location/Description:**  
Room 104/Sample A1-A –  
Non-asbestos-containing  
block filler paint.

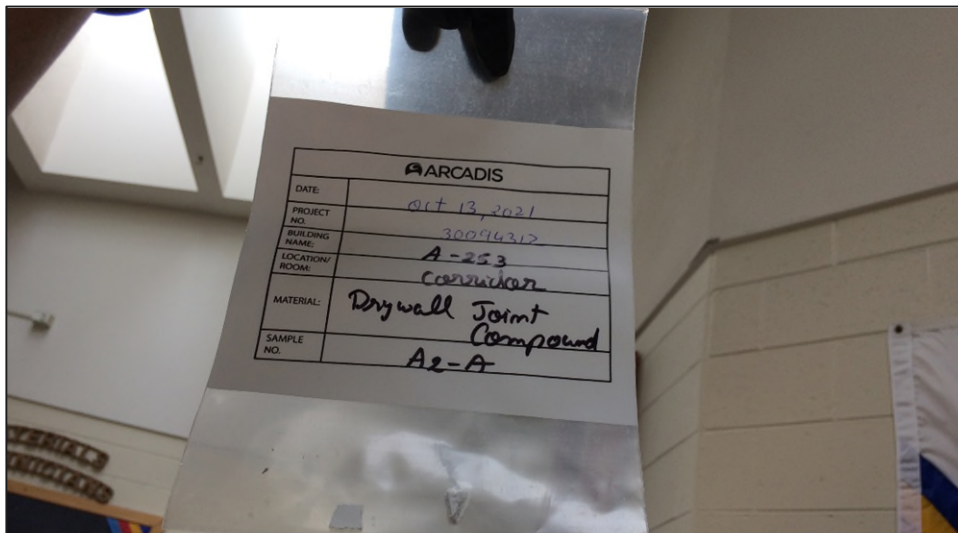
**Photo: 5**

**Location/Description:**  
Corridor/Sample A2-A – Non-  
asbestos-containing drywall  
joint compound.

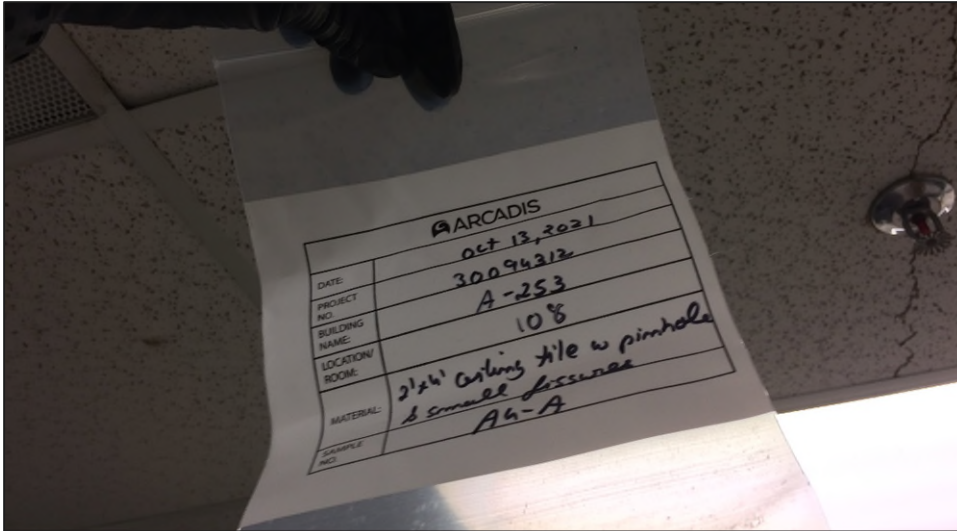
**Photo: 7**

Room 108/Sample A4-A – Non-asbestos-containing 2'x4' ceiling tile – pinholes and small fissures.

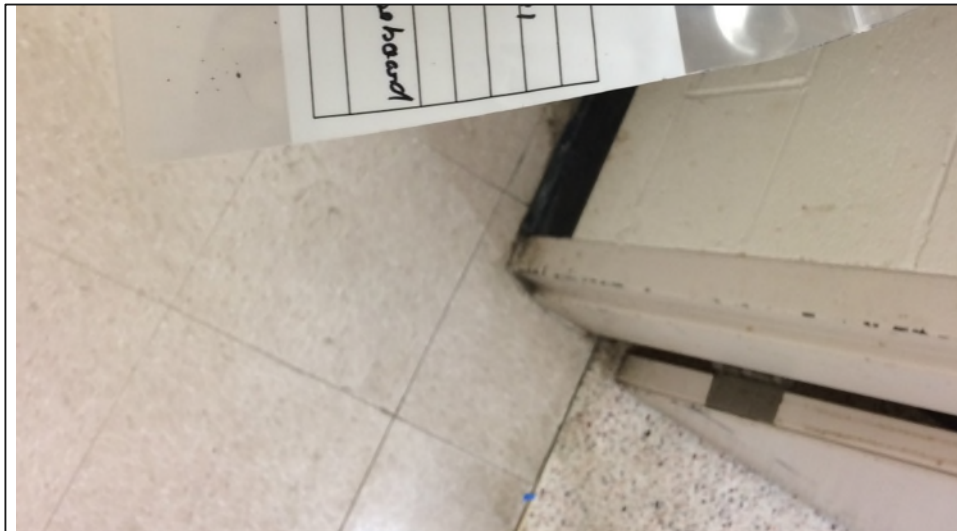
**Photo: 8**

Room 106/Sample A5-B – Non-asbestos-containing vinyl baseboard – black.

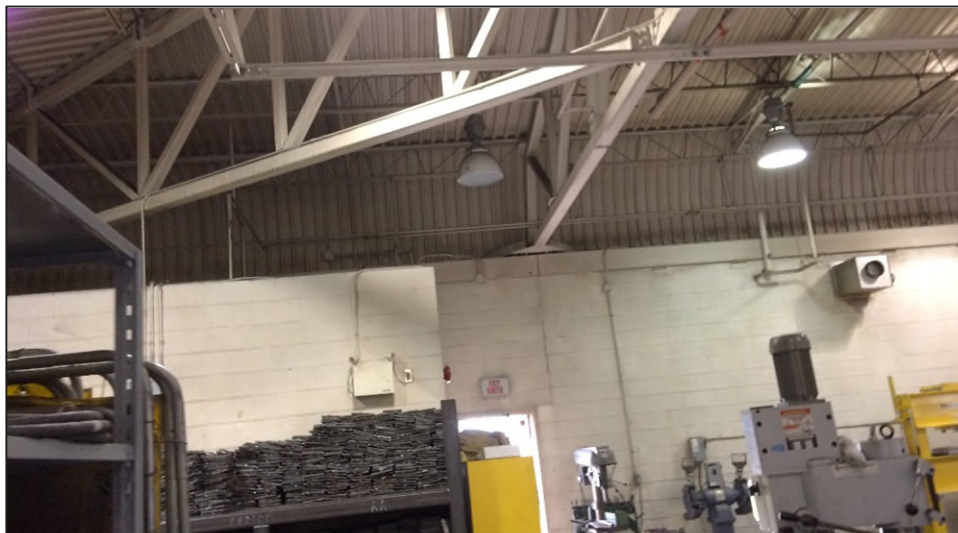
**Photo: 11**

General view of the workshop  
in Building A-253.
