**Re: Mechanical Spaces Lead Abatement**  
145 Sir William Hearst Avenue, Toronto, Ontario  
Pinchin File: 329906

# Bid Form

## **PART 1        GENERAL**

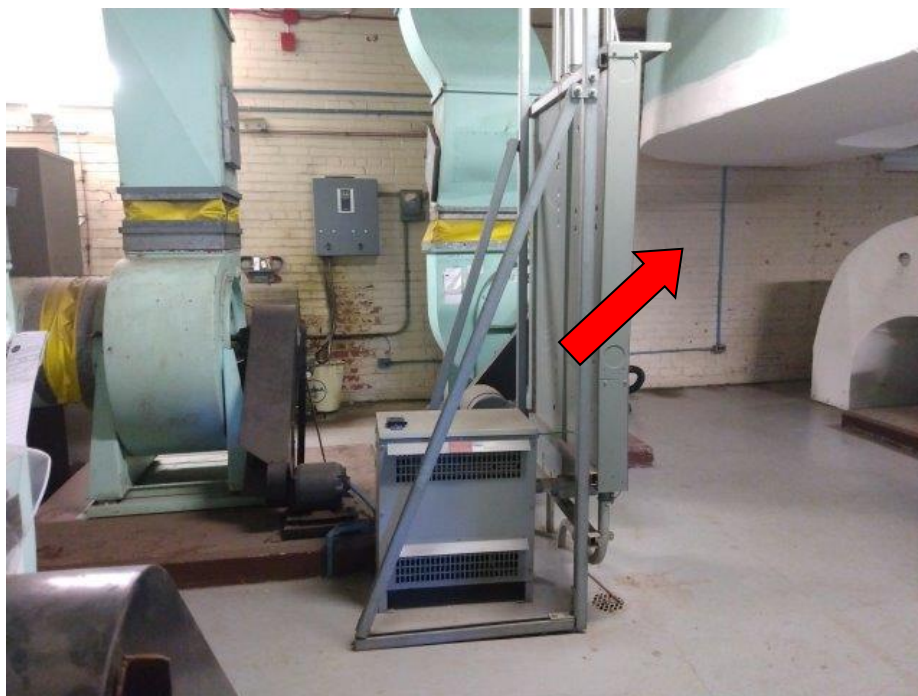
- .6        Light green paint on masonry wall West Penthouse Mechanical Room.
    - .7        Light yellow paint on masonry walls West Penthouse Mechanical Room.

**Photograph 1:** View of the damaged (peeling and flaking) lead-containing light yellow paint on the brick wall in the west penthouse at the Subject Location.

- .1 Remove and dispose of all flaking paint as outlined during the site visit.
  - .2 Prime and paint all areas of removal to match existing.
- .3 Refer to Specification Sections identified in the Related Work for specified personnel protective measures for the safe handling, removal, clean-up of hazardous materials in each phase or work area.

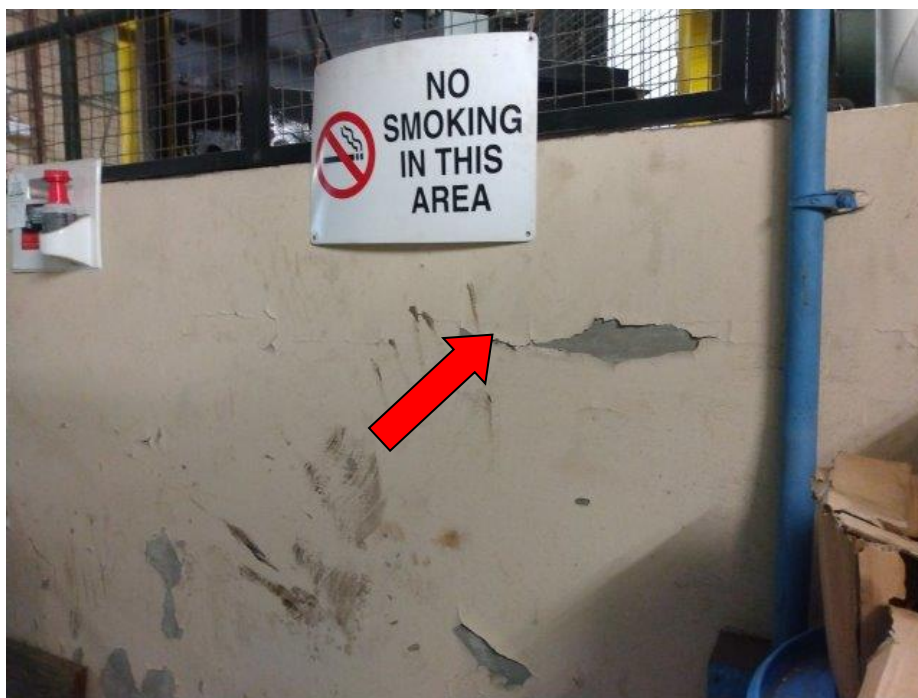
- .1        Light yellow paint on concrete walls, East Penthouse Mechanical Room.
    - .2        Grey paint on fan supply unit, East Penthouse Mechanical Room.

**Photograph 2:** View of the damaged (peeling) lead-containing light yellow paint on the concrete wall in the east penthouse at the Subject Location.

- .1 Remove and dispose of all flaking paint as outlined during the site visit.
  - .2 Prime and paint all areas of removal to match existing.
- .3 Abatement Work Area 3: East Penthouse Mechanical Room.

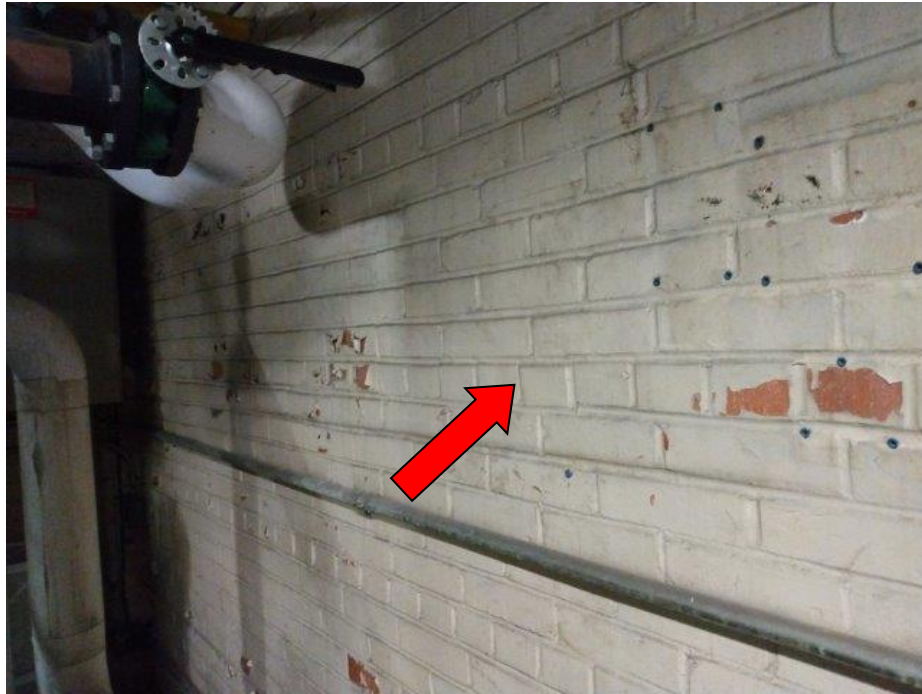
- .8        Light yellow paint on masonry walls East Penthouse Mechanical Room.

**Photograph 3:** View of the damaged (peeling and flaking) lead-containing light yellow paint on the brick wall in the east penthouse at the Subject Location.

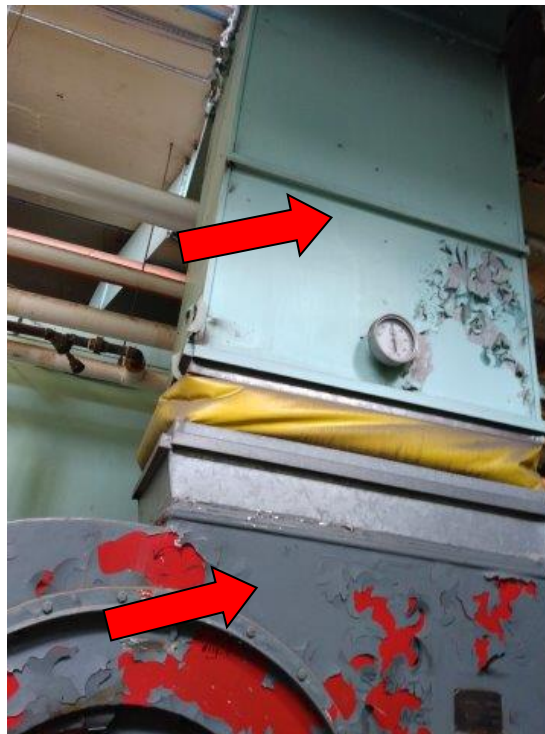
- .3        Light green paint on fan supply East Penthouse Mechanical Room.
    - .4        Green/off-white paint on masonry wall Plumbing Room 32.
    - .5        Light yellow paint on masonry wall Basement Mechanical Room 18.

**Photograph 4:** View of the damaged (peeling and flaking) lead-containing gray paint on the lower section and damaged (peeling and flaking) lead-containing light green paint on the upper section of the fan supply unit in the east penthouse at the Subject Location.

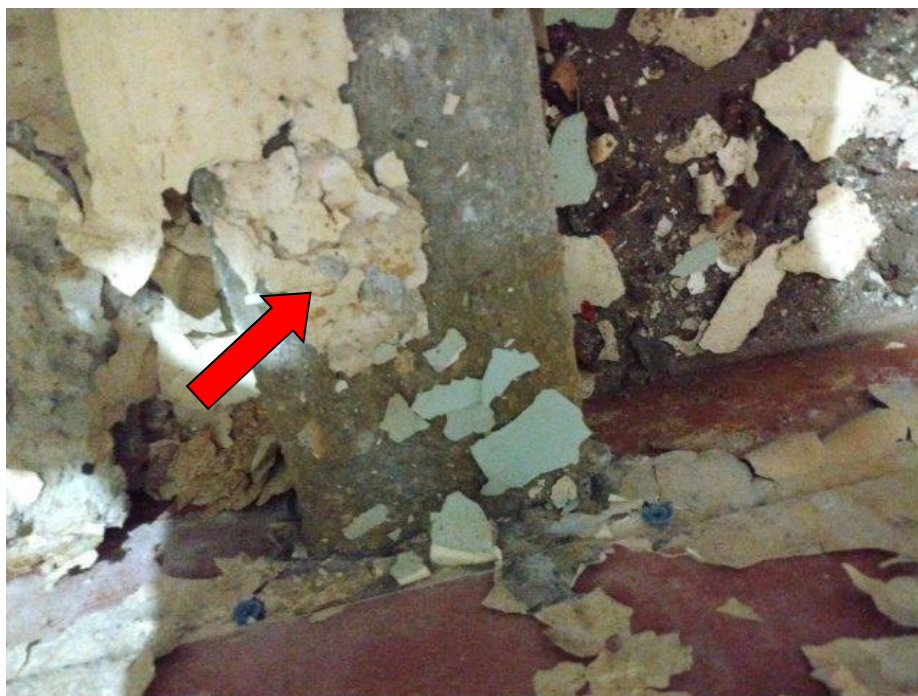
**Photograph 5:** View of the damaged (peeling and flaking) lead-containing multiple layer (green/off-white) paint on the wall in the basement sprinkler room at the Subject Location.

- .1 Remove and dispose of all flaking paint as outlined during the site visit.
  - .2 Prime and paint all areas of removal to match existing.
- .2 Abatement Work Area 2: Basement Plumbing Room 32.

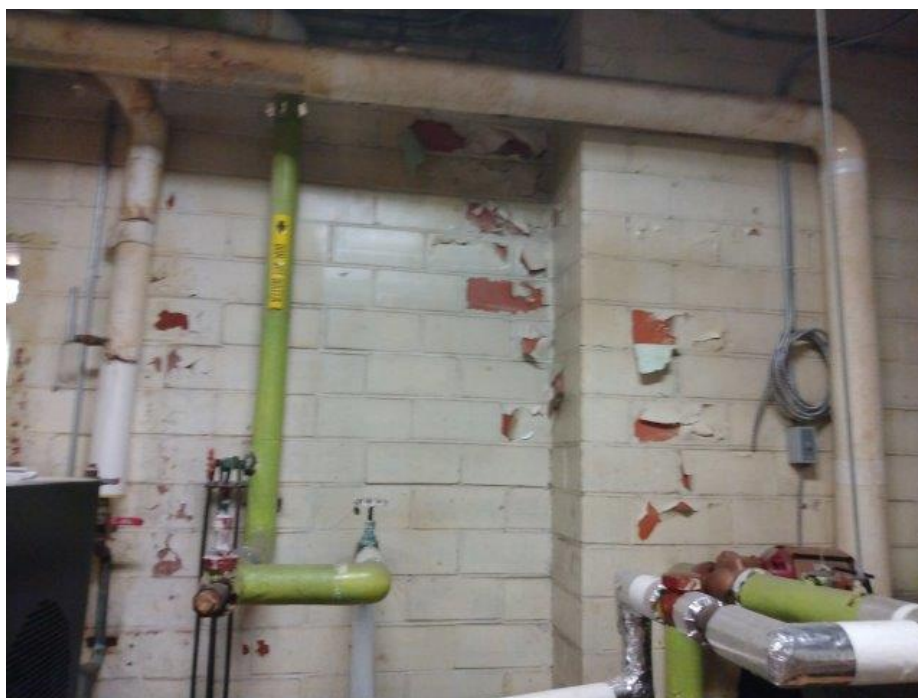
**Photograph 6:** View of the damaged (peeling and flaking) lead-containing light yellow paint on the brick wall in the boiler room 18 in the basement at the Subject Location.

- .1 Coordinate the following items with the Owner's Project Manager and the Construction Manager, including but not limited to: electrical isolations, GFI connection, water connections, HVAC and exhaust ventilation system isolation, bin placement, schedule, disconnects, etc.
- .2 Using procedures prescribed in the Section identified in Related Work, remove and dispose of the following.
  - .1 Abatement Work Area 1: Basement Mechanical Room 18.

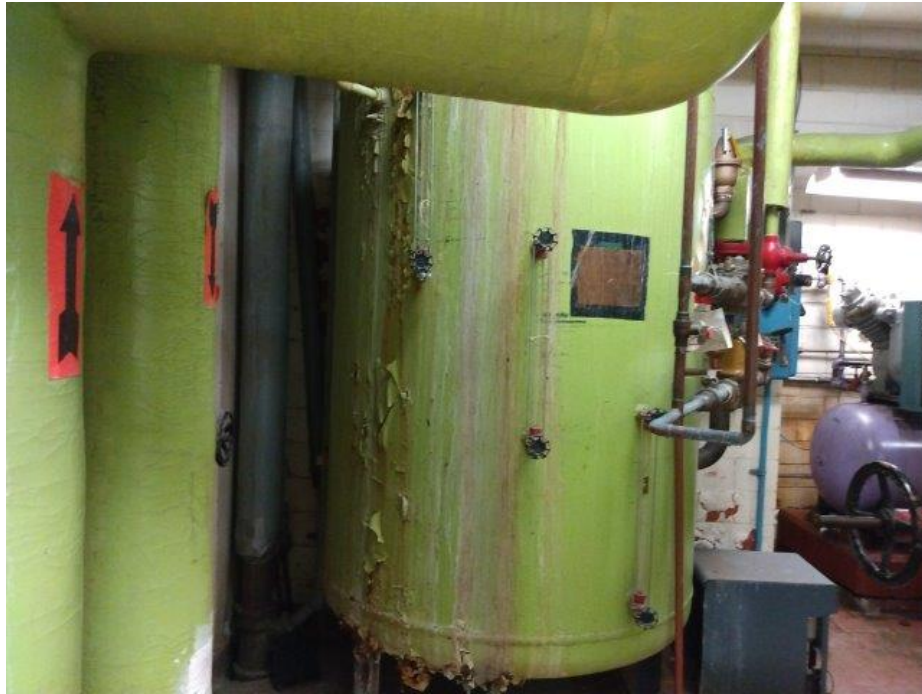
**Photograph 7:** View of the damaged (peeling and flaking) lead-containing light green paint on the mechanical systems insulation and on the tank in the boiler room 18 in the basement at the Subject Location.
