**1080578-273841 –
Basement AHU Repairs,
1080472-273842 – VAV
Box Repairs &
1105347-274246 –
Replace Compressors**

Designated Substance Audit Report

135 St. Clair Avenue West, Toronto, ON

October 31, 2023

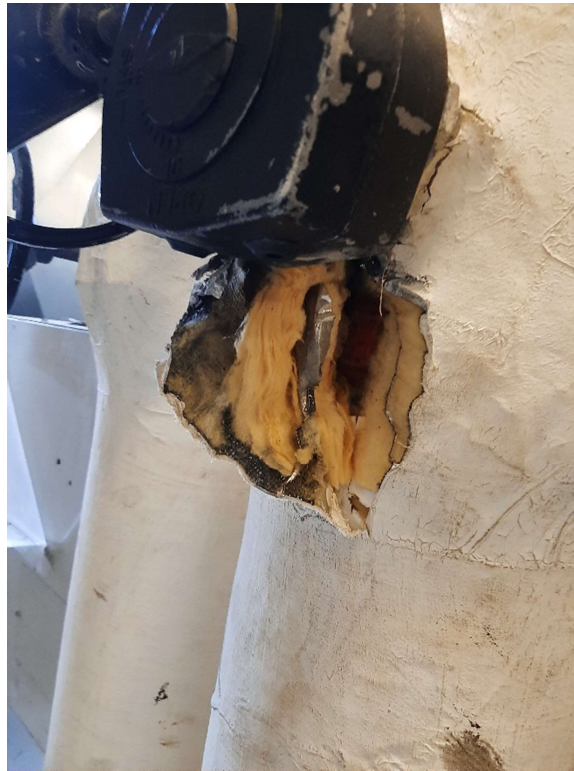
Photograph No. 1 – Fibreglass insulation was observed on pipe straights and elbows within the Penthouse Mechanical room.

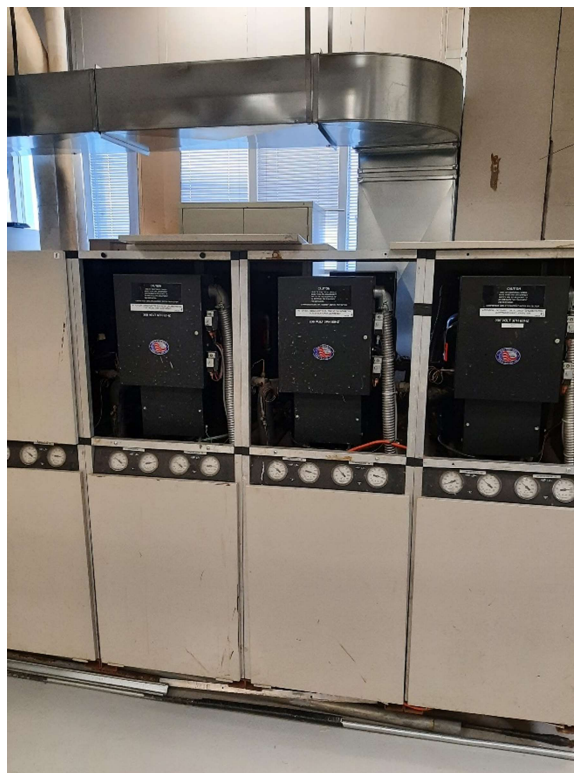
Photograph No. 2 – Ozone Depleting Substances are assumed within the chiller system.

Building components presumed to contain ODS were identified and special requirements for management, handling and disposal by the owner, constructor, contractor, sub-contractors and workers apply.

Under current legislation, there are no requirements to remove ODSs from service simply because they are present. However, prior to commencing any work where this equipment will be dismantled, destroyed or disposed of, the refrigerant must be drained by a licensed technician and tagged with a notice indicating that the equipment no longer contains refrigerant. The appropriate notices or records shall be maintained in accordance with O. Reg. 463/10 for a minimum of two (2) years and shall include, but not be limited to, service records, transfers/releases of refrigerants, refrigerant types and refrigerant systems.

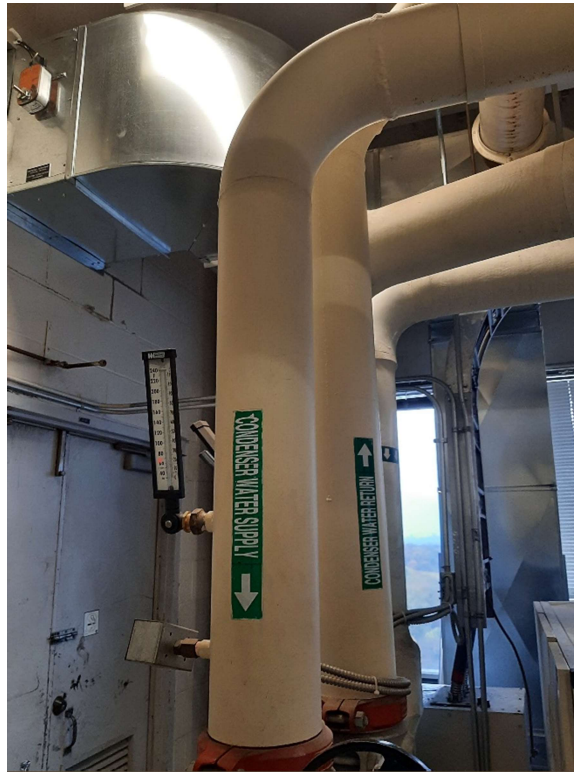
Photograph No. 3 – The white paint on pipe straights in the penthouse mechanical room was sampled (LP01) and was reported as low level lead-containing.

Low level lead-containing paint is also present, and the following general procedures are recommended as a precautionary measure as per Environmental Abatement Council of Canada's (EACC) *Lead Guideline for Construction, Renovation, Maintenance or Repair (October 2014)*:

- General dust control;
- The washing of hands and face at on-site facilities;
- No smoking, eating, chewing gum or drinking in the work area; and
- No removal of painted surfaces by means of abrasive blasting.

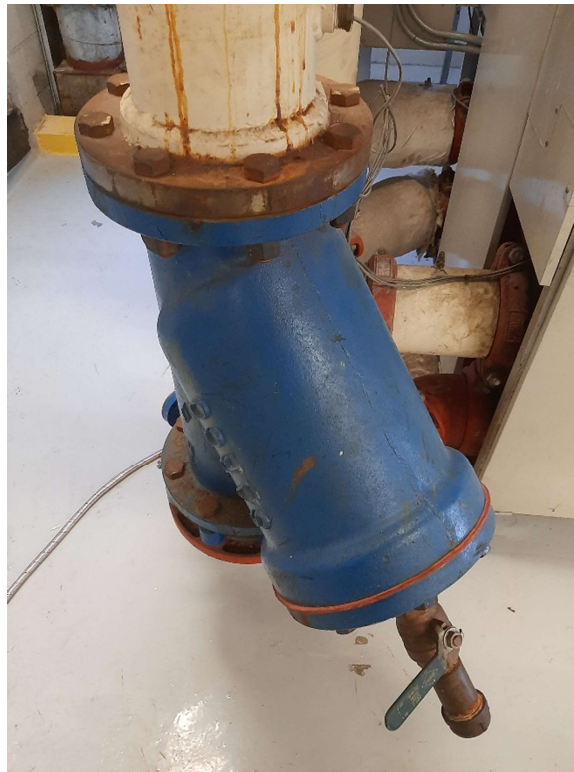
Photograph No. 4 – The blue paint on valves was observed in the penthouse mechanical room was sampled (LP02) and was reported as low level lead-containing.

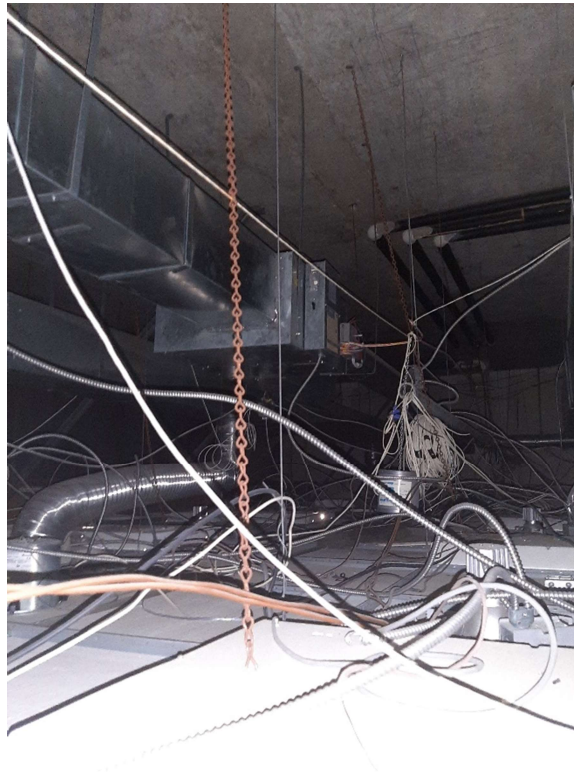
Photograph No. 5 – The variable air volume boxes were observed above ceiling spaces on the 15th floor. No suspect asbestos material associated with the equipment was observed at the time of inspection.

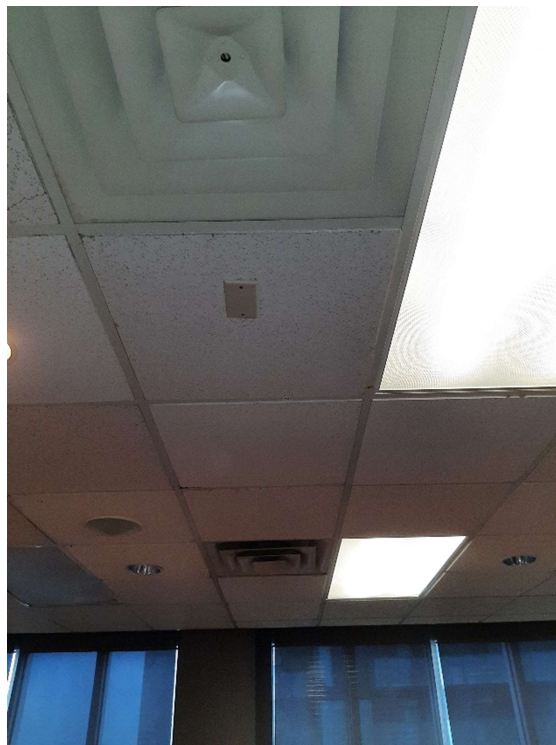
Photograph No. 6 – 2'x2' Small fissure random pinhole ceiling tiles were observed throughout the office spaces and sampled (S01A,B,C). The lab report indicates that no asbestos was detected within the ceiling tiles.

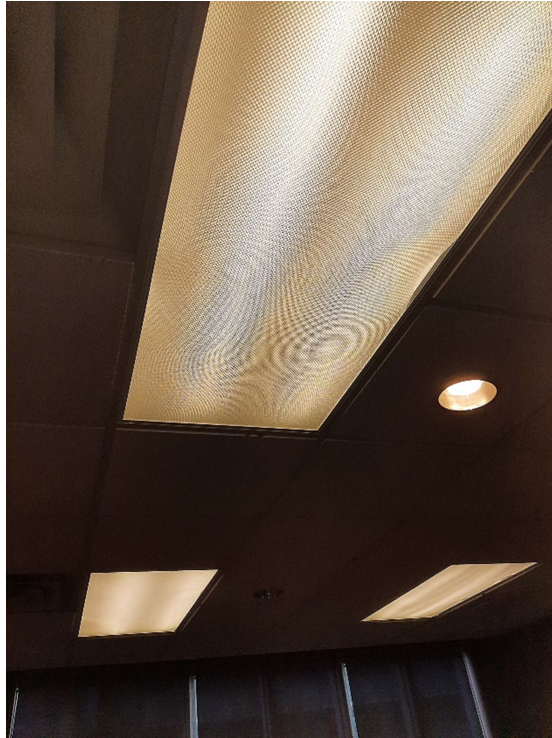
Suspect PCB-containing fluorescent light ballasts were identified but could not be conclusively classified as PCB-containing or non-PCB-containing.

Photograph No. 7– Mercury containing fluorescent light tubes were observed throughout the interior of the building. The light ballasts may potentially contain PCBs, but the equipment could not be de-energized for inspection.

Mercury-containing materials were identified. All mercury containing materials or sources should be removed, intact, prior to any work which may disturb or damage them and cause worker exposure to mercury liquid and/or vapour.

It is the responsibility of the owner to inspect, or ensure the inspection of all light ballasts as they are removed from service to make certain they are properly classified as PCB-containing or non-PCB containing. Fixtures will require dismantling to access date stamps (located on the back of the ballast) in order to be correctly classified in accordance with Environment Canada's document "*Identification of Lamp Ballasts Containing PCBs, Report EPS 2/CC/2 (revised), August 1991*".

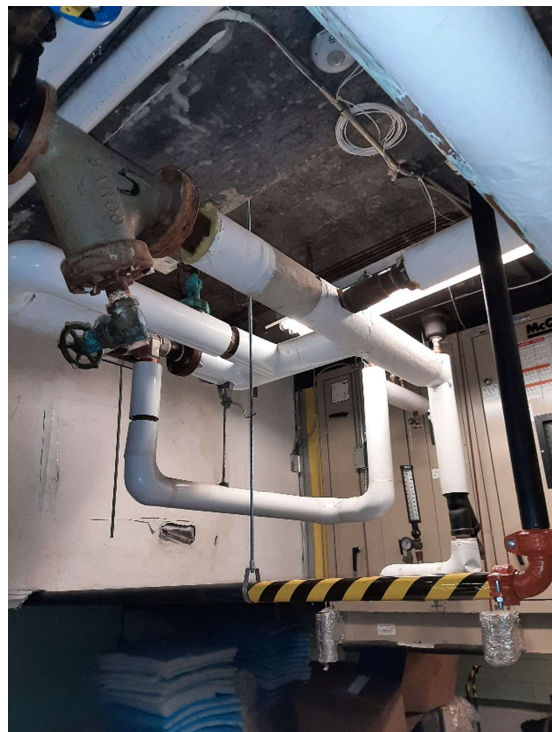
Photograph No. 8– The pipe network associated with the basement air handling unit in the basement mechanical room is a combination of fiberglass and PVC over fiberglass; therefore no suspect asbestos material is suspected present. The insulation on the ducts is also fiberglass.

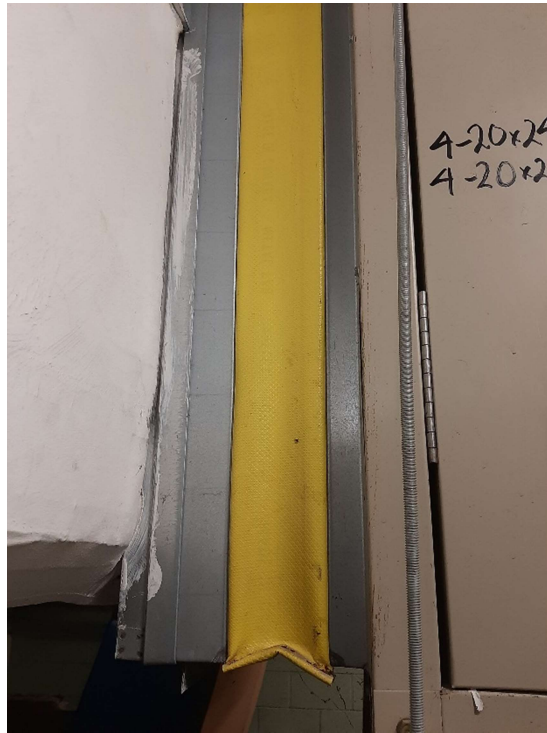
Photograph No. 9– Rubber expansion joints were observed on the air handling unit which connects to the intake ducts. No asbestos is suspected present.

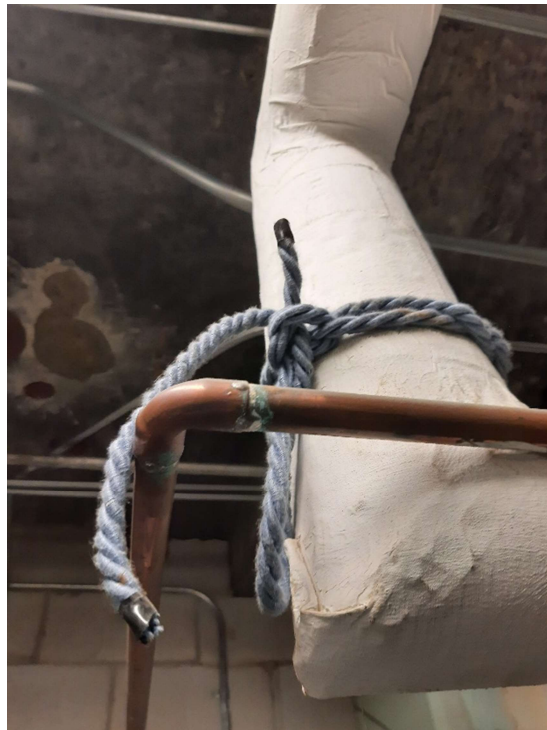
Photograph No. 10– Suspect lead solder on copper pipe connections was observed in the basement mechanical room.

Suspect lead-containing solder on plumbing connections were identified. As such special requirements for the management, handling and disposal of lead-containing materials by the owner, constructor, contractor, sub-contractors and workers apply. The abatement contractor should consult Environmental Abatement Council of Canada's (EACC) *Lead Guideline for Construction, Renovation, Maintenance or Repair (October 2014)* for the procedures and methods required to remove and dispose of lead-containing materials.

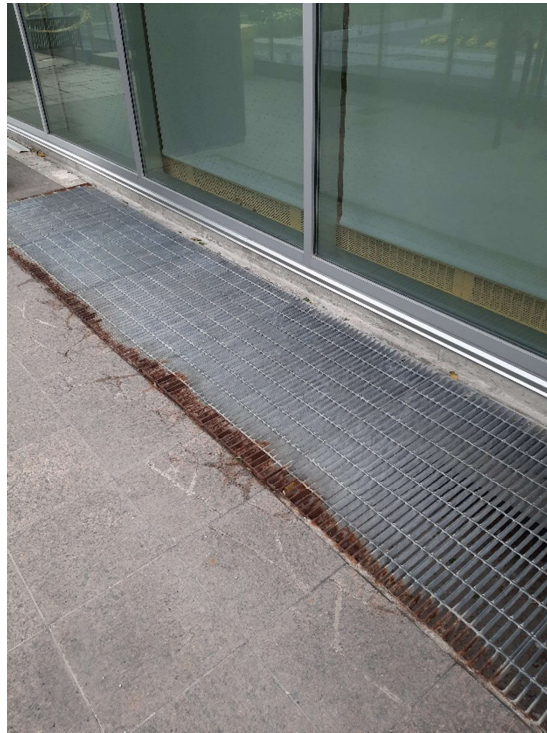
Photograph No. 10– The exterior intake grating was inspected, and no suspect asbestos-containing material were observed; however, the masonry adjacent to the intake contains silica.

Silica is presumed to be present; therefore, special requirements for management and handling are required. The contractor should also consult MOL Occupational Health and Safety Branch's Guideline: *Silica on Construction Projects* (April 2011) for the procedures and methods required to remove and dispose of silica-containing materials.
