**C13-31-23 - General Contractor Required for Victoria Park Field House Renovations**

**ADDENDUM 2**

## **Hazardous Building Materials Assessment (Pre-construction)**

Victoria Park  
500 King Street West, Hamilton,  
Ontario

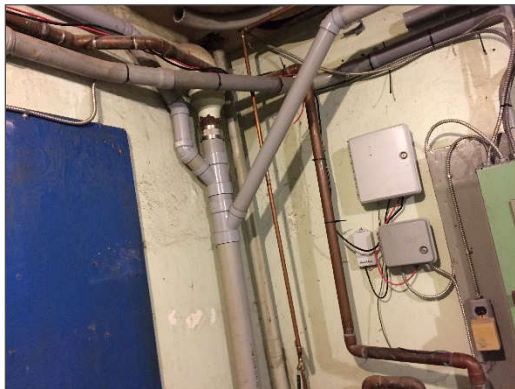
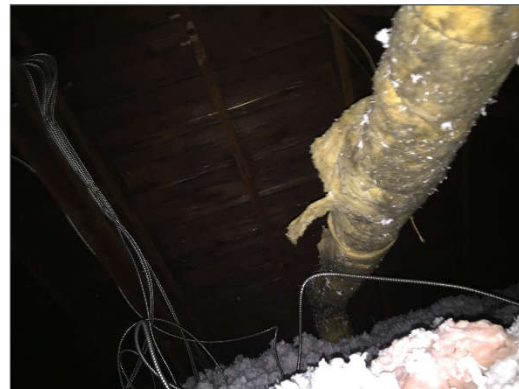
Pipes are insulated with fibreglass, or other non-asbestos insulation such as mineral fibre or elastomeric foam insulation (photo 1 and 2).

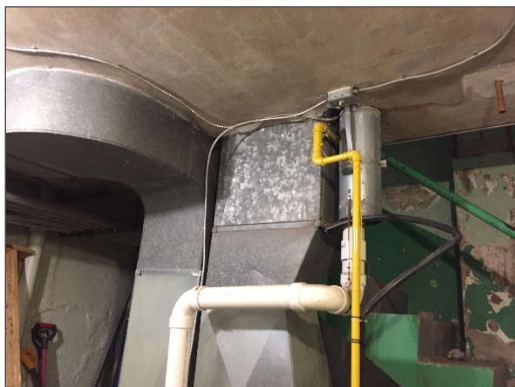
Photo 1

Ducts are uninsulated.

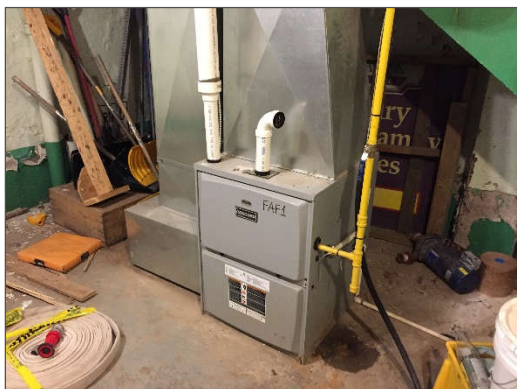
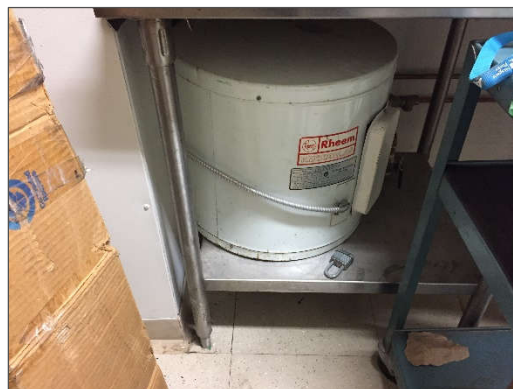
Mechanical equipment (e.g. furnace, hot water tanks) is either uninsulated or insulated with non-asbestos fibreglass.

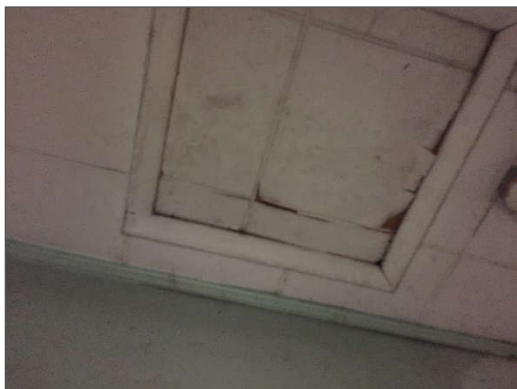
Photo 1

| Size, Type, Pattern and Photo # | Sample Locations | Sample Number or Date Code | Asbestos Type |
|---|---|---|---|
| 12" wood (mechanically fastened) photo 1 | Back Entrance (Location 2) and Washroom (Location 5) | N/A | Non-Asbestos |

All ceiling tiles are presumed to be non-asbestos based on the composition of the tiles (e.g. wood fibre).

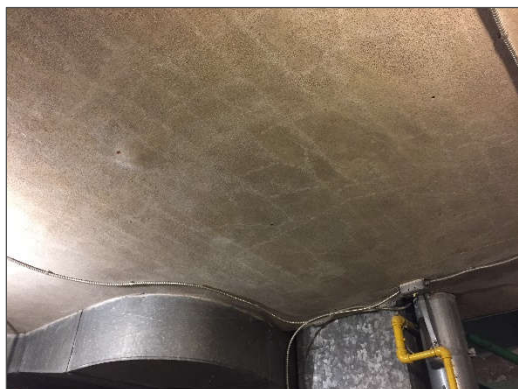
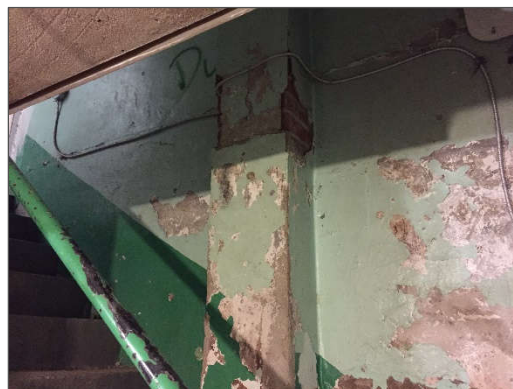
Plaster present on walls and ceilings throughout the building does not contain asbestos (samples S0002A-C and S0003A-E, photo 1 and 2).

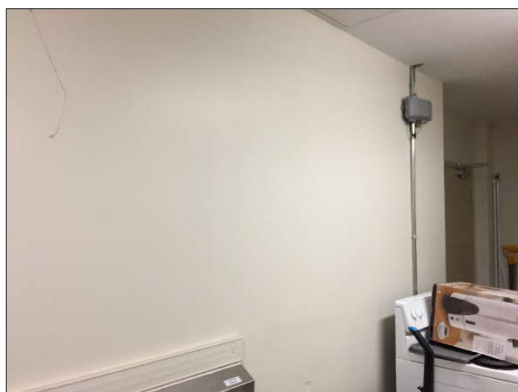
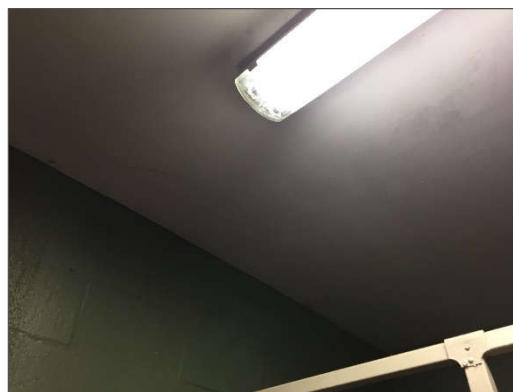
Drywall joint compound present on wall and ceiling finishes throughout the building does not contain asbestos (samples S0004A-E).

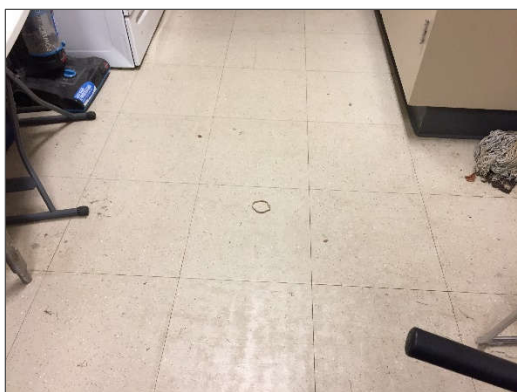
Photo 1

| Description and Photo # | Sample Locations | Sample Number | Asbestos Type (tile) | Asbestos Type (mastic) |
|---|---|---|---|---|
| 24" beige with fleck, photo 1 | Supply Area (Location 3) and Open Area (Location 4) | S0005A-C | None Detected | None Detected |

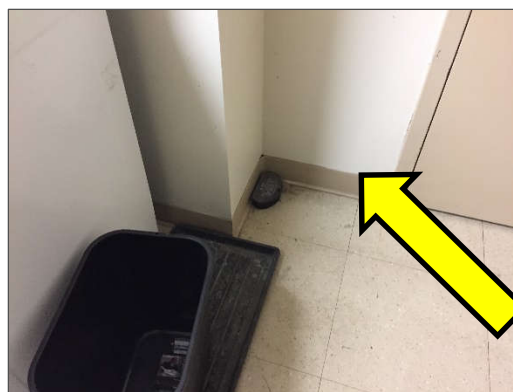
Photo 2

| Description and Photo # | Sample Locations | Sample Number | Asbestos Type (tile) | Asbestos Type (mastic) |
|---|---|---|---|---|
| 4" baseboard mastic, photo 2 | Supply Area (Location 3), Open Area (Location 4) and Washroom (Location 5) | S0006A-C | N/A | None Detected |

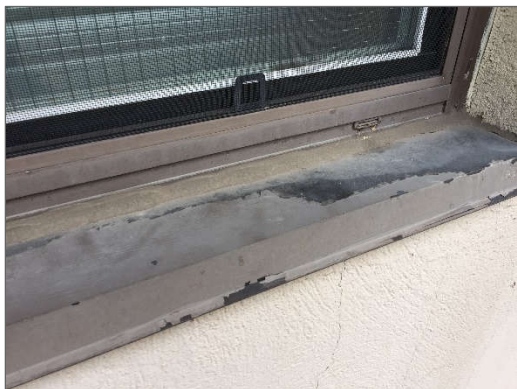
Photo 1

| Material, Colour and Photo # | Application | Sample Locations | Sample Number | Asbestos Type |
|---|---|---|---|---|
| Caulking, brown, photo 1 | Around exterior windows | Exterior (Location 8) | S0007A-C | None Detected |

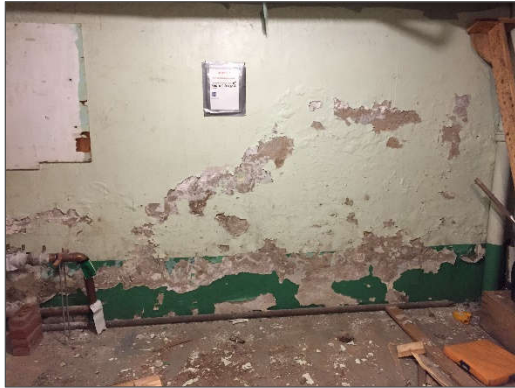
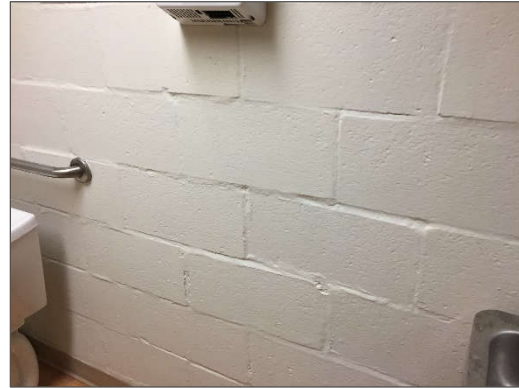
Various colours of paint are present on concrete and block walls throughout the building does not contain asbestos (samples S0001A-E, photo 1 and 2).

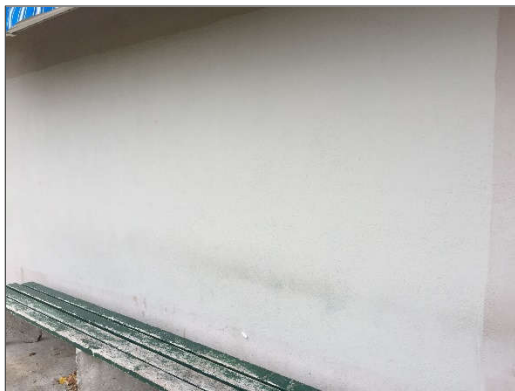
Photo 3

Textured paint present on the exterior of the building does not contain asbestos (samples S0008A-C, photo 3).

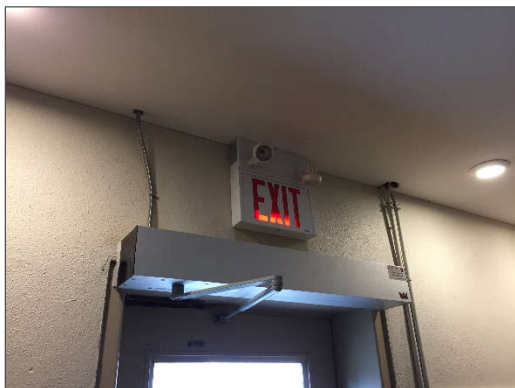
Photo 1

Lead-containing batteries are present in emergency lighting.

Lead caulking is present in bell and spigot fittings on cast iron pipes.

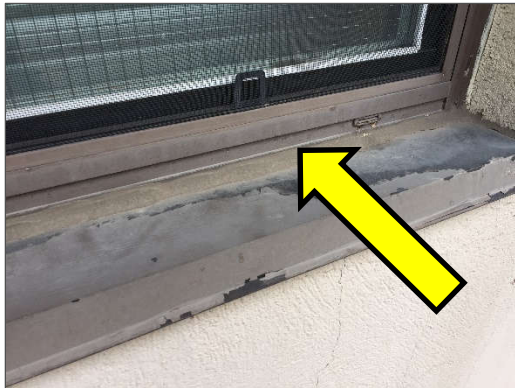
Photo 1

| Material, Colour and Photo # | Sample Location (Location #) | Sample Number | PCB concentration mg/kg |
|---|---|---|---|
| Caulking, brown, photo 1 | Around exterior windows – Exterior (Location 8) | P0001 | <0.2 |

Caulking in the table above is not considered a PCB solid based on the threshold (50 mg/kg).
