**REVISED**  
**Hazardous Building  
Materials Assessment**

4267 Bridge Street, Niagara  
Falls, Ontario

**The Regional Municipality of  
Niagara**

December 20, 2018

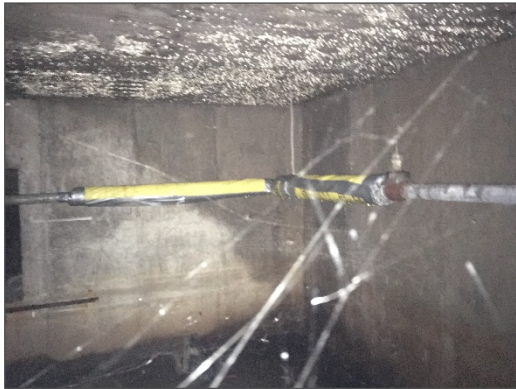
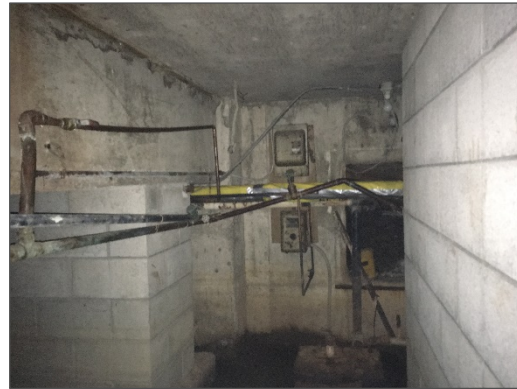
It is important to note that asbestos-containing pipe insulation has been previously identified within the crawlspace, Location 23 and Pinchin observed approximately 10 linear feet of piping covered with yellow asbestos labelled bags within the crawlspace, Location 23. Pipe insulation is presumed to be a friable materials.

Presumed asbestos-containing pipe insulation within the crawlspace

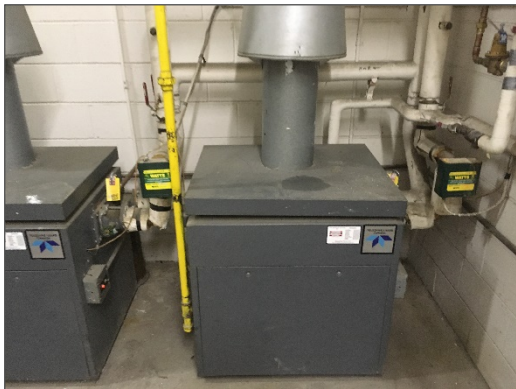
Furnace externally uninsulated

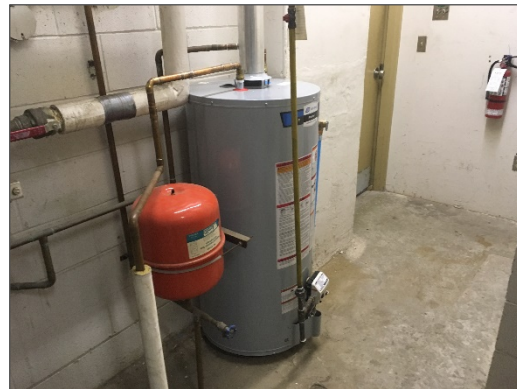
Hot water tank externally uninsulated

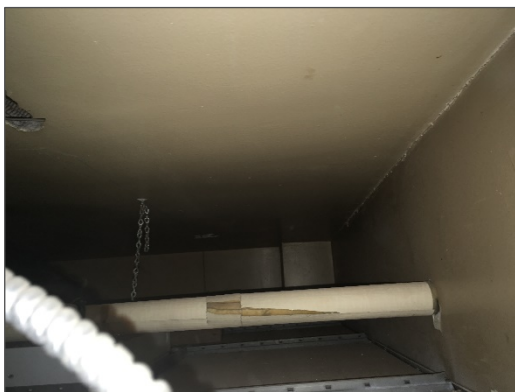
Non-asbestos plaster ceiling within the Men's Washroom,  
Location 8

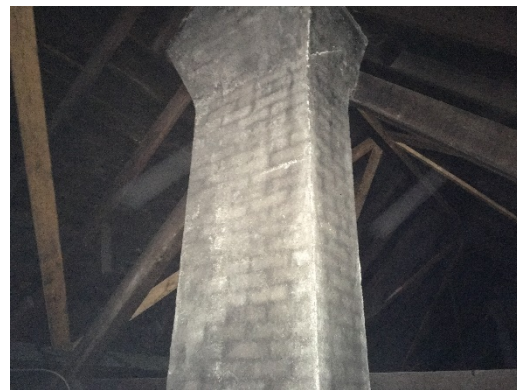
Non-asbestos plaster present on the chimney within the Attic,  
Location 15

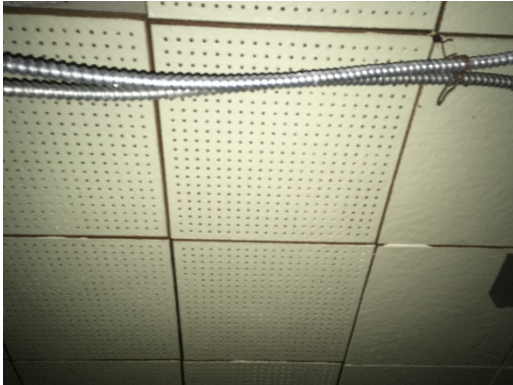
Non-asbestos grey textured plaster ceiling finish behind the 12"x12" order pinhole (wood fibre) ceiling tiles within the VIA OTS, Location 10

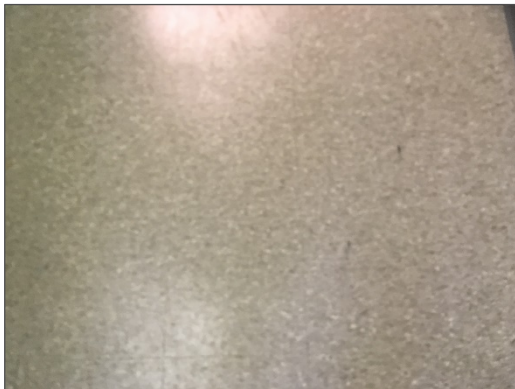
| Size, Pattern, Colour and Photo # | Locations | Sample Number | Asbestos Type (tile) | Asbestos Type (mastic) |
|--|---|---|---|---|
| 12"x12", light grey flakes, Photo 3 | VIA OTS, Location 10<br>VIA Train Operations, Location 11<br>VIA Office, Location 12 | 0008A-C | None Detected | Presumed |

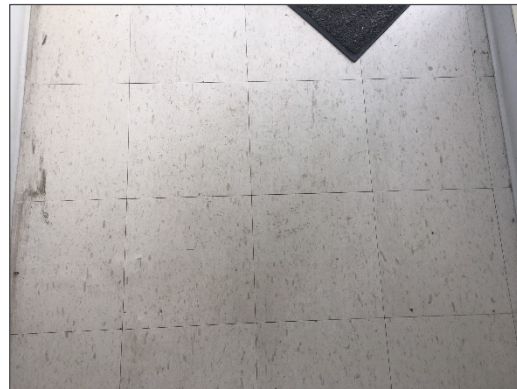
| Size, Pattern, Colour and Photo # | Locations | Sample Number | Asbestos Type (tile) | Asbestos Type (mastic) |
|--|---|---|---|---|
| 12"x12", white with | East Stairs, Location 7 | 0009A-C | None | None |

| Size, Pattern, Colour and Photo # | Locations | Sample Number | Asbestos Type (tile) | Asbestos Type (mastic) |
|--|---|---|---|---|
| beige specks, Photo 4 | Lunch Room, Location 19 | | Detected | Detected |

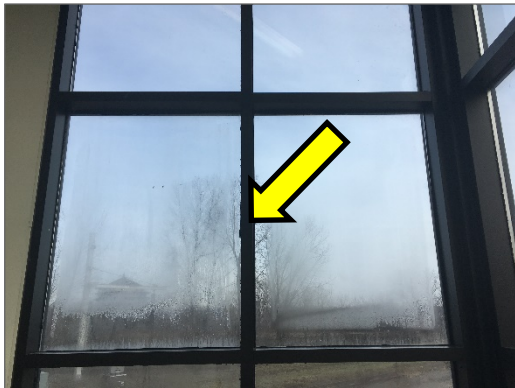
| Colour, Type, Photo # | Locations (Quantity) | Sample Number | Asbestos Type |
|---|---|---|---|
| Black, butyl tape, Photo 1 | Located between the glass and metal window frames within the East Stairs, Location 7 and 17 (250 LF) | 0012A-C | Chrysotile |

Caulking and sealants are a non-friable material and in good condition.

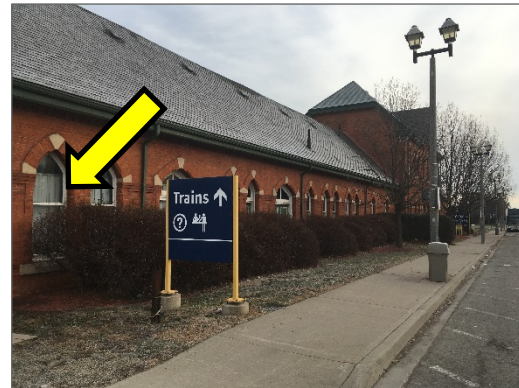
| Colour, Type, Photo # | Locations (Quantity) | Sample Number | Asbestos Type |
|---|---|---|---|
| Red and green, caulking, Photo 2 | Located around exterior side of all window and door frames | 0013A-C | Chrysotile |

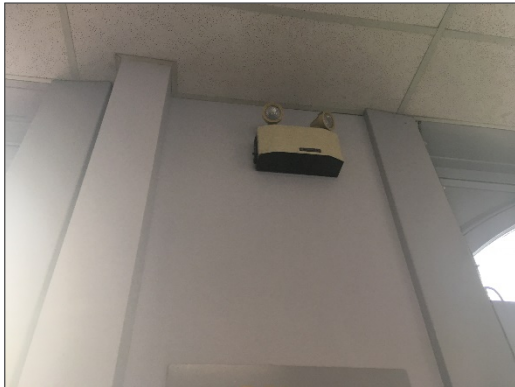
Lead-containing batteries are present in emergency lighting.

Lead-acid batteries within emergency lighting

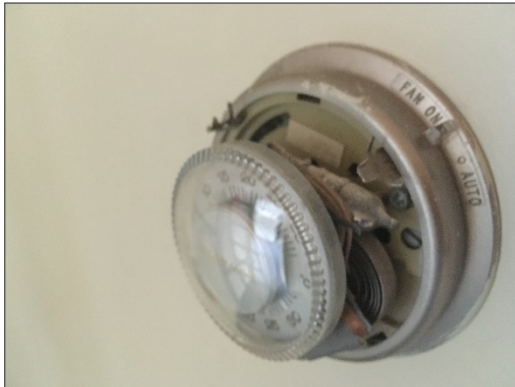
Mercury is present as a liquid in thermostats ampules.

Liquid mercury in thermostats within the 2<sup>nd</sup> Floor

Recycle and reclaim mercury from fluorescent lamps and thermostats when taken out of service. Do not break lamps or separate liquid mercury from components. Mercury is classified as a hazardous waste and must be disposed or recycled in accordance with local regulations.

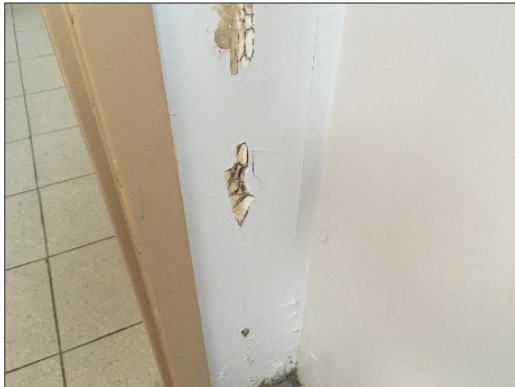
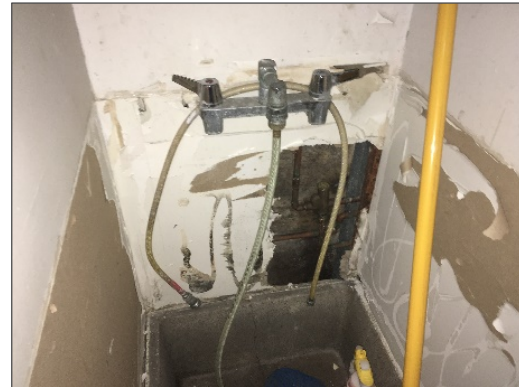
Visible mould growth is present on drywall wall finishes around the custodial sink and door frame within the Women's Washroom, Location 3. There is approximately 3 square feet of visible mould growth.

Visible mould growth around the door frame in the Women's Washroom, Location 3

Visible mould growth around the custodial sink in the Women's Washroom, Location 3

Conduct an intrusive mould investigation to determine the extent of mould growth. The investigation should identify the source of the water intrusion that contributed to the mould growth and water damage observed during this assessment.
