**VIA RAIL CANADA**

**Asbestos Management Program**

Niagara Falls Train Station

**Re-Inspection Report (2008)**

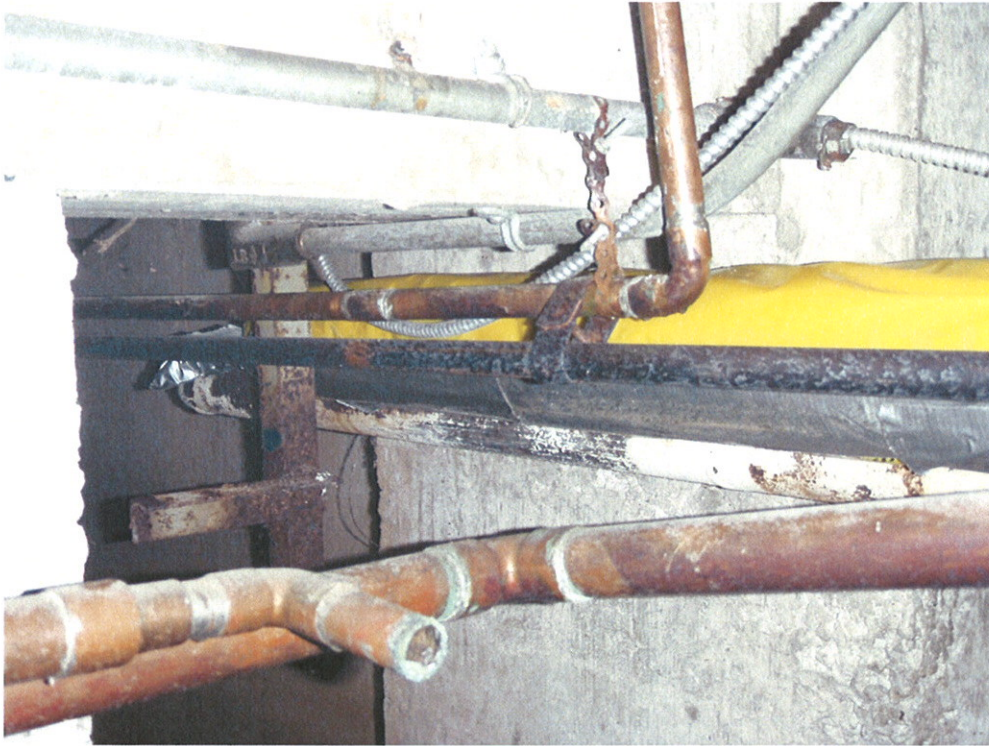
The thermal insulation on the hot water piping in the basement of the train station is generally in poor condition, however, as a temporary mitigation measure, the insulation was wrapped in polythene membrane as shown on the following picture. In addition, in the initial survey, 9"x9" floor tiles present in the 2<sup>nd</sup> floor toilet room were suspected to contain asbestos fibre. At the time of the re-inspection these tiles were removed. Lab test confirmed that these tiles did not contain asbestos.

Typical temporary jacketing of asbestos containing insulation in the basement

Since the only ACM in this building consist of the thermal insulation on the hot water piping in the basement, we recommend to abate it under type 2 work (Glove bags). Considering there is approximately 30 linear meters, the estimated cost of removal is lower than 5000\$.

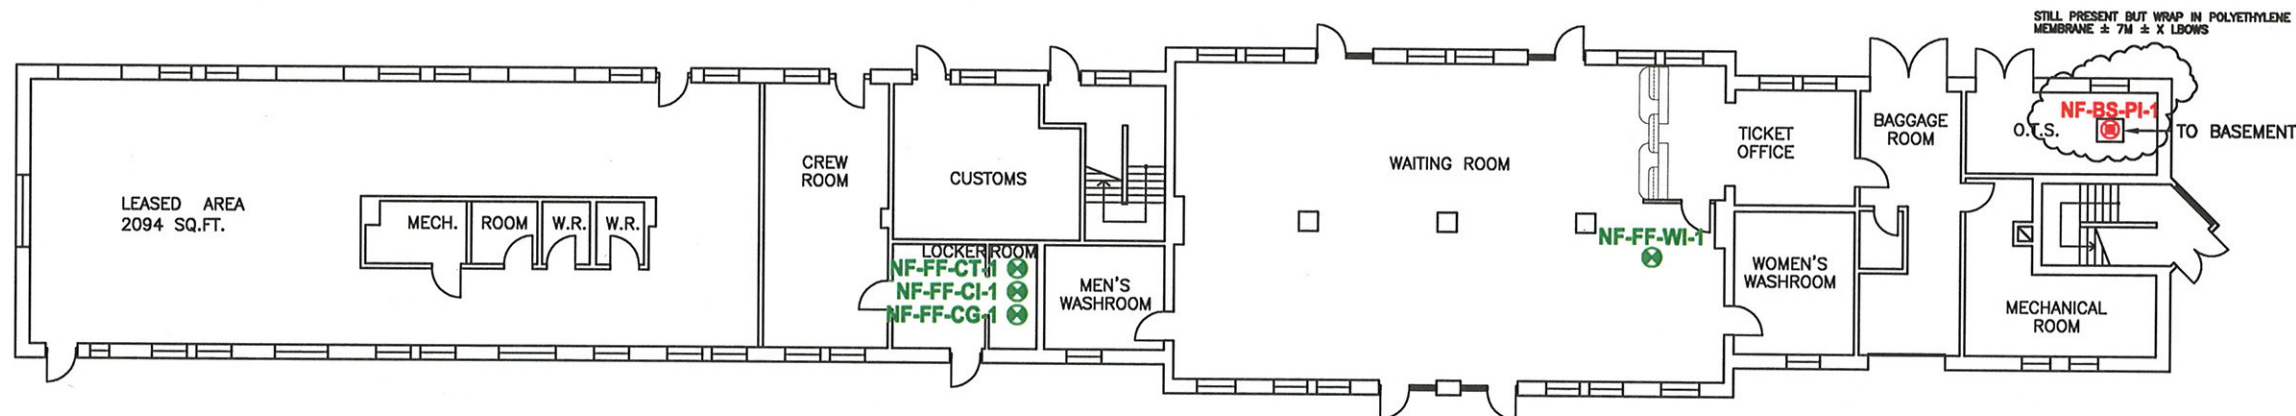
**FIRST FLOOR PLAN**

**NF-BS-PI-1** BASEMENT FRIABLE INSULATION AND CARDBOARD INSULATION ON HOT WATER PIPES CONTAINS ASBESTOS
