Investigation of Mould Growth

4267 Bridge Street, Niagara Falls, Ontario

April 9, 2019

Pinchin File: 236564

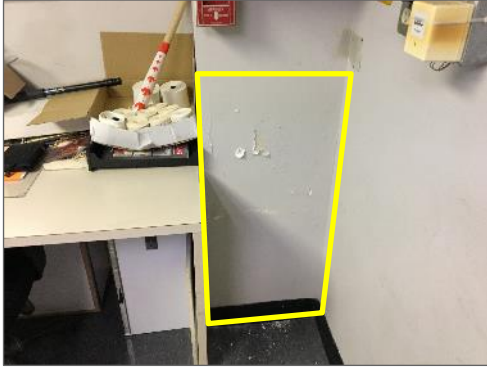
Photo 1 - Wet drywall in the ticket booth office.

Peeling paint and wet drywall was detected up to 4 feet in height in the northwest corner of the ticket booth office and was approximately 8 square feet in total.

- b. Remove wet drywall up to 4 feet in height in the ticket booth office as shown on the attached drawing.
 - c. Remove wet drywall up to 2 feet in height in the waiting area, as shown on the attached drawing.

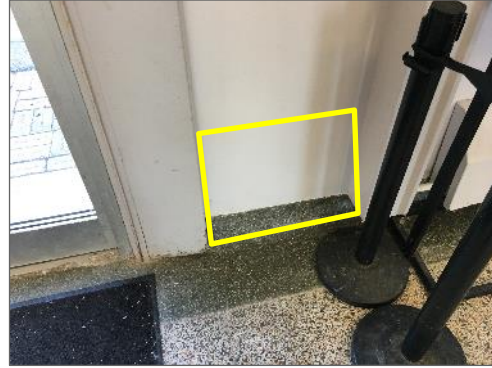
Photo 2 - Wet drywall adjacent to the north entrance

Wet drywall was detected up to four feet in the south east corner of the waiting area adjacent to the women’s washroom and was approximately 25 square feet in total. As well as, on the west side of the north exit and totalled approximately 2 square feet.

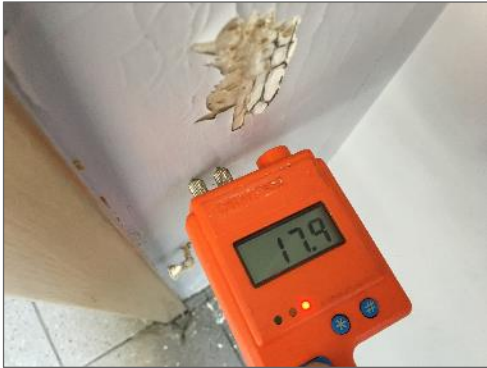
Photo 3 - Moisture meter confirms wet drywall adjacent to janitor's closet in the women's washroom

Mould growth and water damaged drywall was detected in the janitors closet and adjacent drywall in the women’s washroom. Mould growth was approximately 12 square feet and was located on drywall behind the janitor’s sink. Drywall was removed behind the janitor’s sink exposing concealed mould growth in the wall cavity.

3. Arrange for the following mould remediation, following CCA Level 2 methods:
 - a. Remove mould impacted and water damaged drywall up to four feet in the janitor's closet and women's washroom, as shown on the attached drawing.

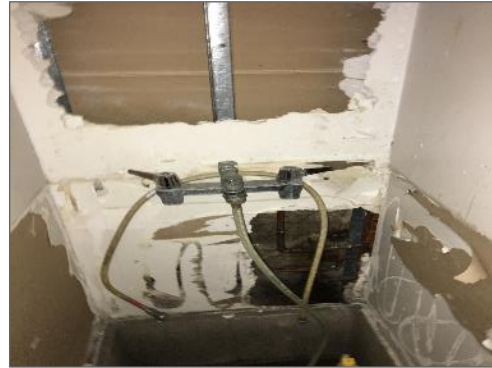
Photo 4 - Mould impacted drywall in the janitor's closet

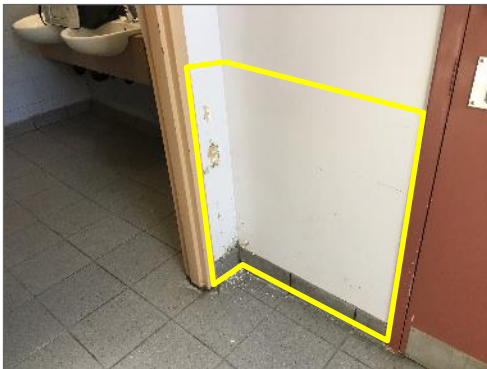
Photo 5 - Area of mould and water impacted drywall in the women's washroom

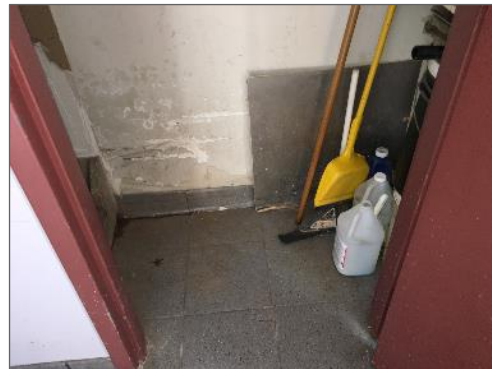
Photo 6 - Wet and water damaged drywall in the janitor's closet

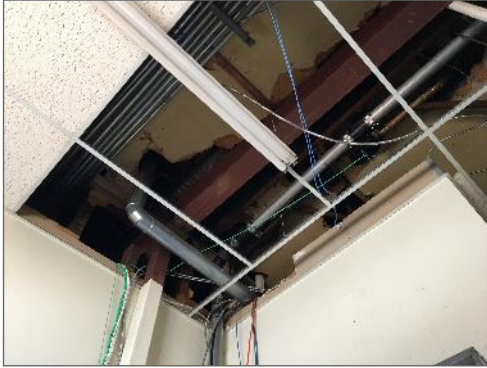
Photo 7 - Damaged hardboard ceiling in the baggage/server room

Missing and water damaged ceiling tiles were observed in the baggage and server room, VIA rail operations room. Water damaged hardboard is also present above the dropped ceiling in the baggage and server room.

The damage to the ceiling in the baggage/server room was likely from the recent plumbing leaks in the washroom above.

- d. Remove water damaged acoustic ceiling tiles and batt insulation in the west stairwell and clean and disinfect stained wooden roof sheathing.
5. Remove and replace all water damaged ceiling tiles and fiberglass batt insulation as required throughout the building and inspect roof for water leaks.

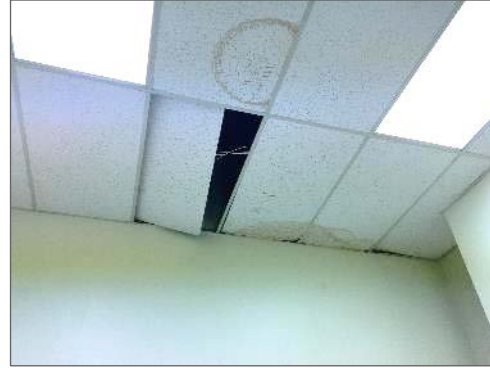
Photo 8 - Water damaged ceiling tile in the VIA train operations (location 12)

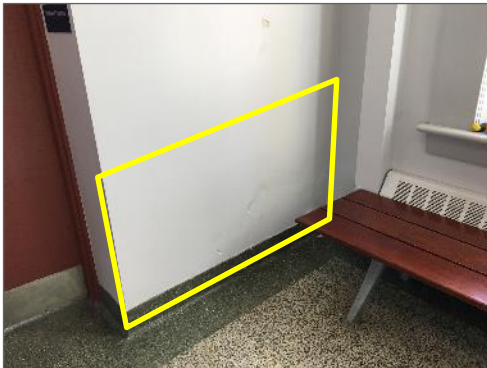
Photo 9 - Wet drywall in the waiting area adjacent to women's washroom

4. Arrange for the following mould remediation, following CCA Level 1 methods:
 - a. Remove wet drywall up four feet in height in the waiting area as shown in the attached drawing.

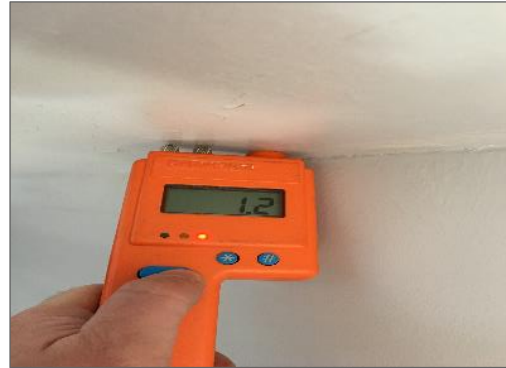
Photo 10 - Moisture reading of wet drywall in waiting area adjacent to the women's washroom

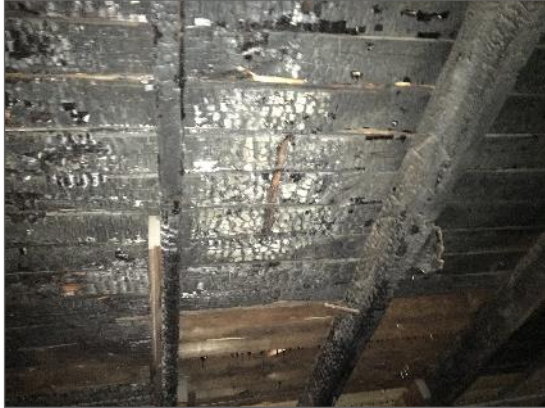
Photo 11 - Charred roof in attic

Charred wood roof framing and sheathing was observed on a section of the south roof in the attic space.

6. Consider assessing and repairing charred wood framing and sheathing in the attic space.
7. Finalize an inspection and testing plan to document the mould remediation. To confirm, Pinchin will perform inspections at the following stages:

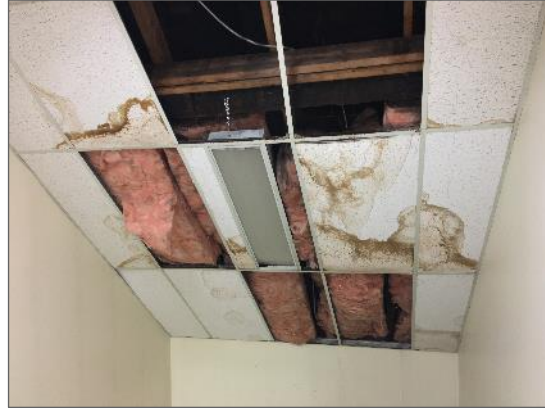
Photo 12 - Missing and water damaged ceiling tiles and insulation in the west stairwell

Missing and water damaged ceiling tiles and batt insulation was observed in west stairwell and dark staining/suspect mould growth was observed on wooden roof sheathing that was exposed.

The Pinchin investigator identified a strong musty odour in the west stairwell.

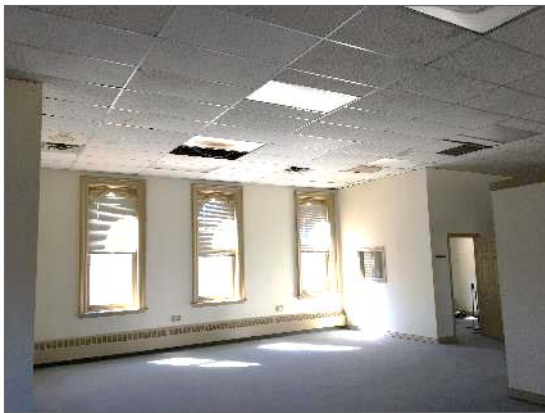
Photo 13 - Missing and water stained ceiling tiles in the open area

Missing and water stained acoustic ceiling tiles are prevalent throughout the second floor.

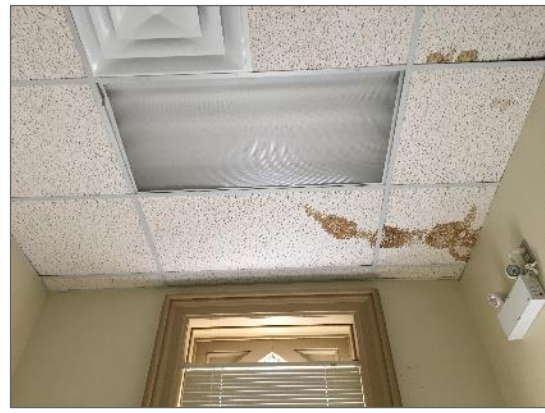
Photo 14 - Water stained ceiling tiles in the lunchroom
