Baseline Property Condition Assessment

4267 Bridge Street, Niagara Falls,
Ontario

December 20, 2018

Pinchin File: 233767

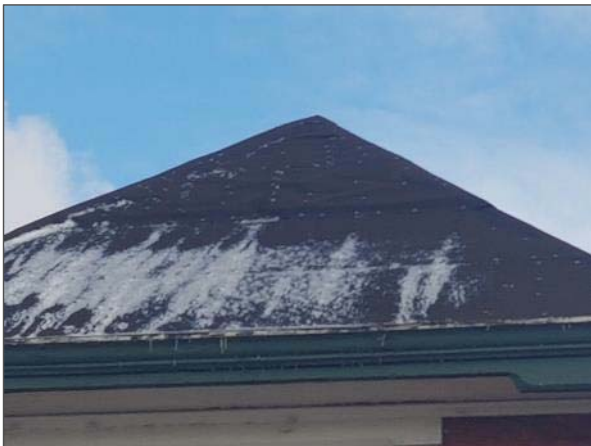
View of the west portion of the roof system which has reportedly been temporarily covered due to leaks.

while the north, east and west portions are 15+ years old with areas of active roof leaks. Pinchin has carried allowances for replacement of the asphalt shingled roof systems on the north, east and west portions of the Site Building within the early portion of the term. In addition, due to the fire damage Pinchin recommends a Structural Engineer be retained to determine any further reinforcement or replacements of the structural roof members prior to roof replacement. This has been addressed in section 3.4 Structural Elements of this report. Pinchin also recommends that regular annual maintenance be performed on the roof systems throughout the term of the analysis.

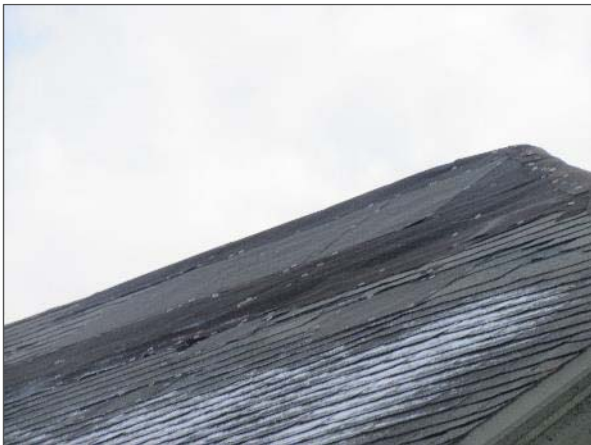
View of the roof on the north portion of the asphalt roof system which has also reportedly been temporarily patched.

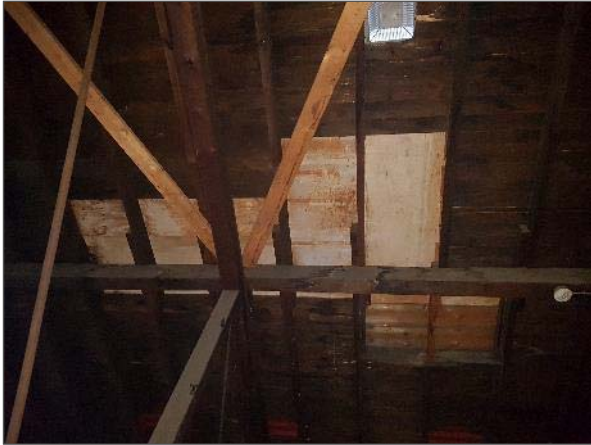
View of patch work within the attic of the west portion of the Site Building.

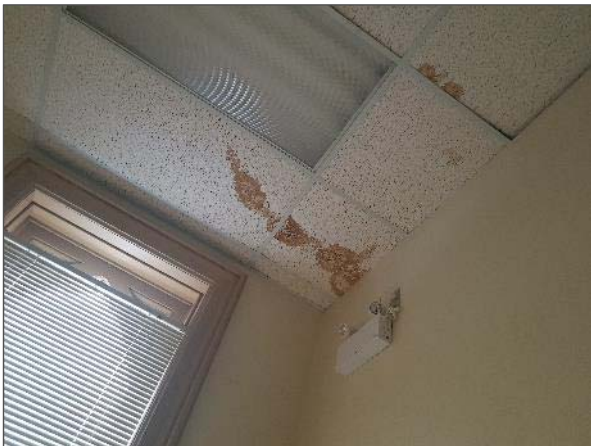
View of typical water staining noted throughout the second floor area of the Site Building.

- Pinchin recommends and has included allowances to perform a mould survey of the Site Building due to active roof leaks as well as preliminary repair allowances;

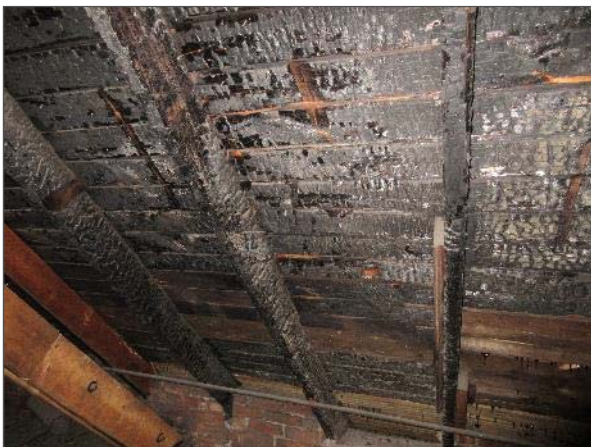
View of fire damage noted within the attic of the west portion of the Site Building.

- Pinchin recommends further investigation by a Structural Engineer in regards to the fire damage within the attic;
- Allowances to repair the deteriorated areas of asphalt pavements and brick walkways on Site;

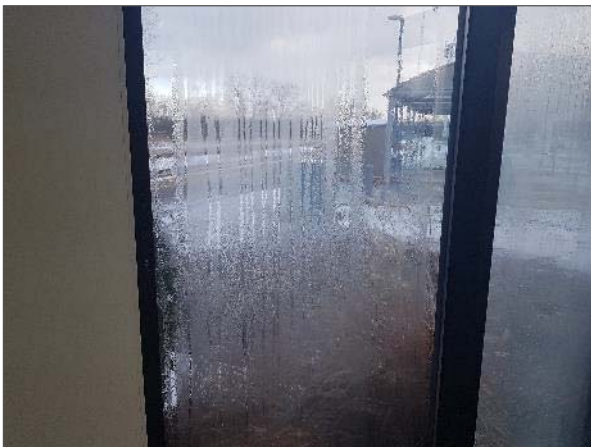
View of the failed IG curtain wall system at the east elevation.

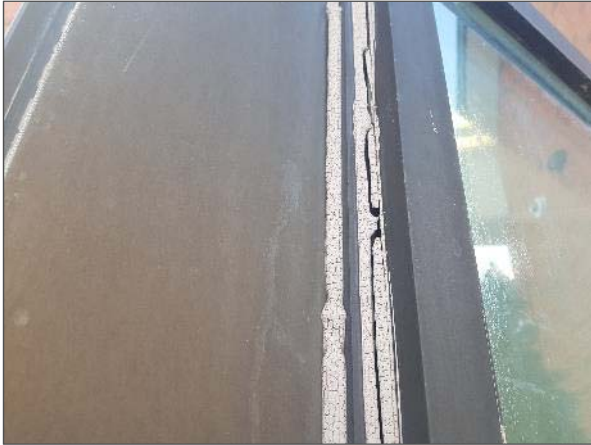
View of a typical failed perimeter window sealant at the east curtain wall system.

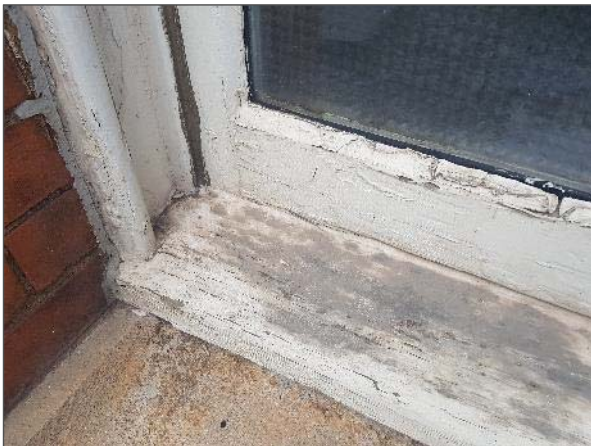
View of a typical wood window frame with peeling paint and deterioration.

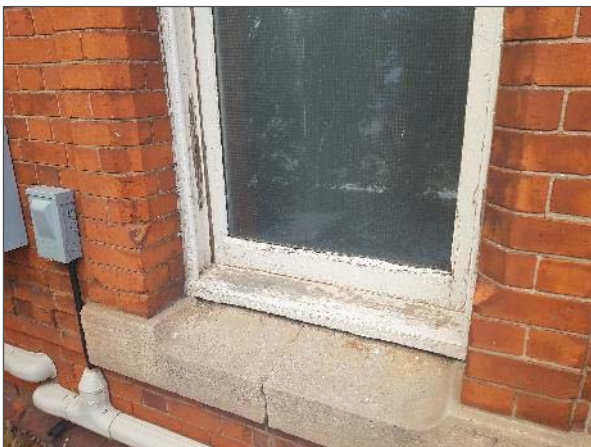
View of a cracked stone window sill.

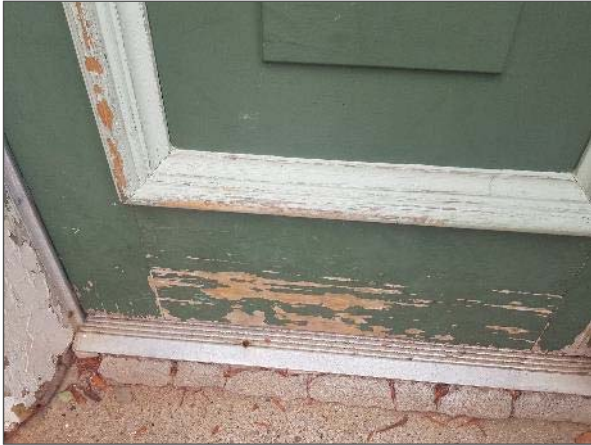
View of typical peeling paint and deterioration noted at the wood doors.

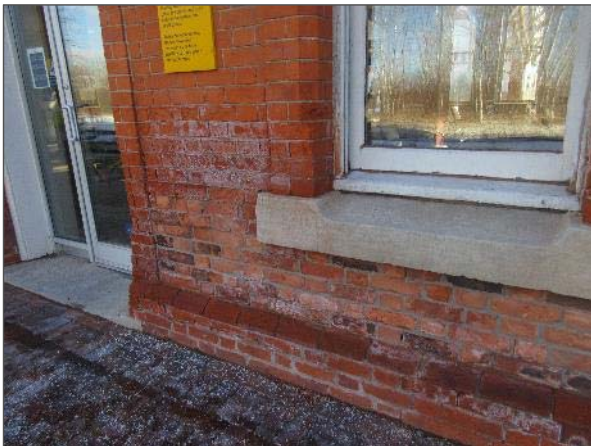
View of typical efflorescence noted at the lower portion of the brick masonry walls on all elevations.

Based on visual observation, localized areas of peeling paint, efflorescence, spalled brick masonry and deteriorated mortar were noted at various elevations. As such, Pinchin recommends general masonry and wall repairs which include re-pointing of failed and deteriorated mortar joints as well as rebuilding of cracked or spalled areas noted at various elevations of the Site Building. Additionally, selective windows serving the Site Building are aged and have exceeded their PUL with cracked wooden frames, deteriorated window glazing spacers, and poor/missing perimeter sealants and thermal efficiency. Accordingly, Pinchin recommends restoration/replacement of the aged windows within the term of analysis while on-going allowances for repairs and localized replacement of the window and door systems have been carried throughout the term of analysis.

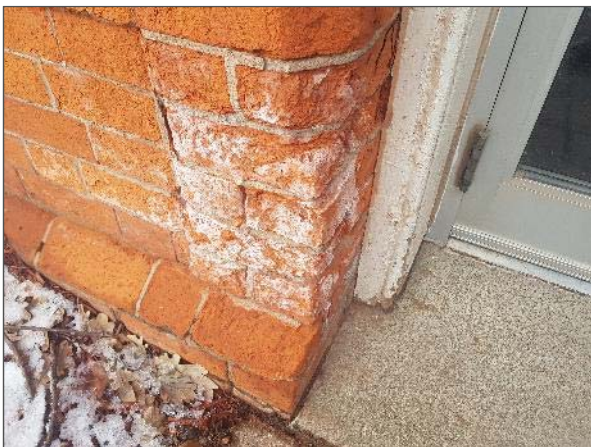
View of spalled brick masonry noted.

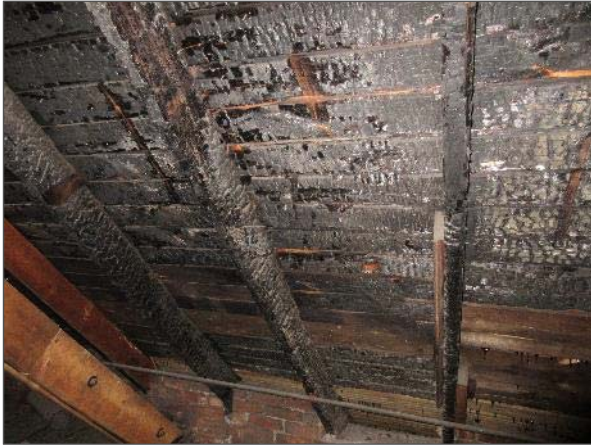
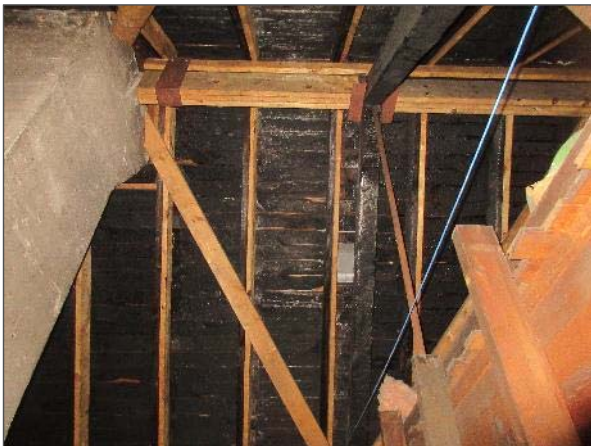
View of charred and damaged wood trusses and decking noted throughout the west attic spaces.

Note: Replacement/repairs appear to have been completed.

Pinchin’s visual review of the structural elements and information provided by the Site Representatives indicated that no major deterioration existed within the visibly accessible components of the Site Building apart from the fire damage within the attic spaces. The assessment did not reveal any visual evidence of major structural failures, soil erosion or differential settlement apart from the fire damage. As reported by the Site Representative, the fire damage has been previously assessed and repaired. Documentation reflecting the repairs was not available to Pinchin. As such, based on the fire damaged structural members within the attic, Pinchin recommends further review by a Structural Engineer to verify its condition and structural adequacy of the repairs.

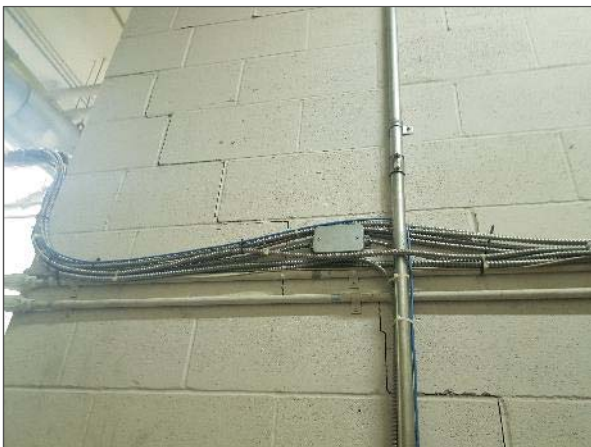
View of step cracking noted within a demising wall of the mechanical area.

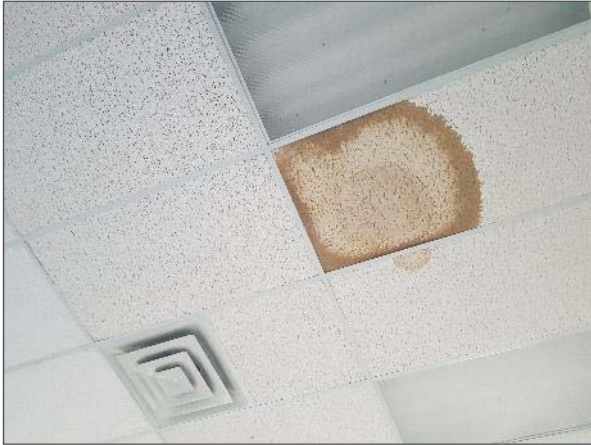
View of stained ceiling tiles noted throughout the second floor spaces of the Site Building.

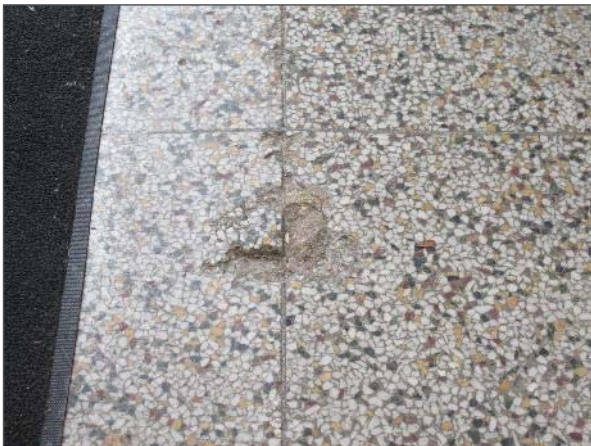
View of damaged terrazzo flooring noted within the lobby area of the Site Building.

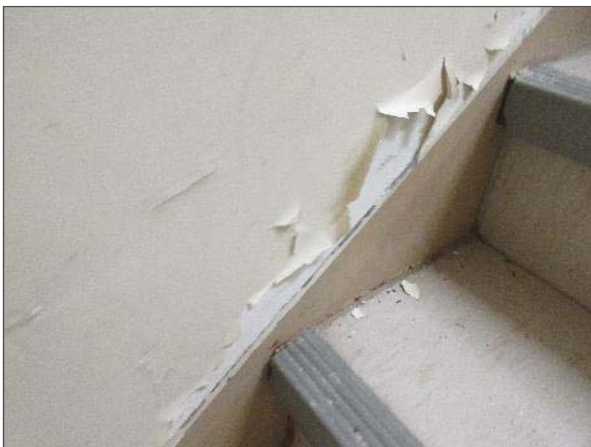
View of peeling paint noted within the central stairwell of the Site Building.

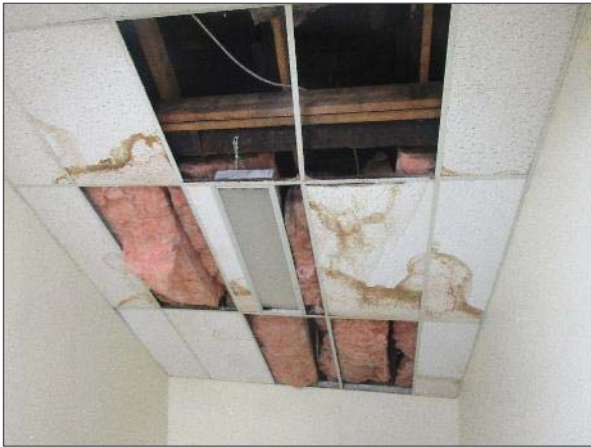
View of stained ceiling tiles and active roof leaks noted within the central stairwell of the Site Building.

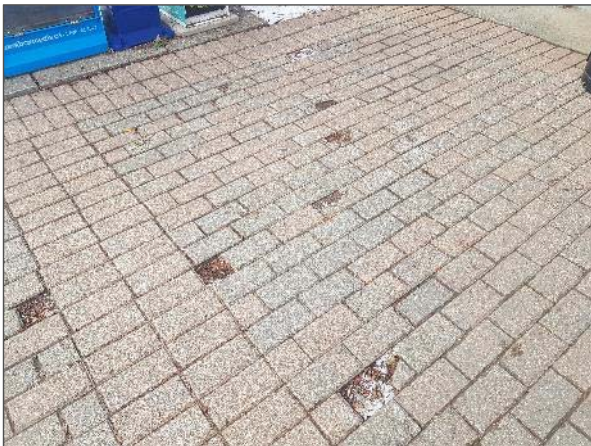
View of missing/damaged stone pavers noted on the south portion of the Site.

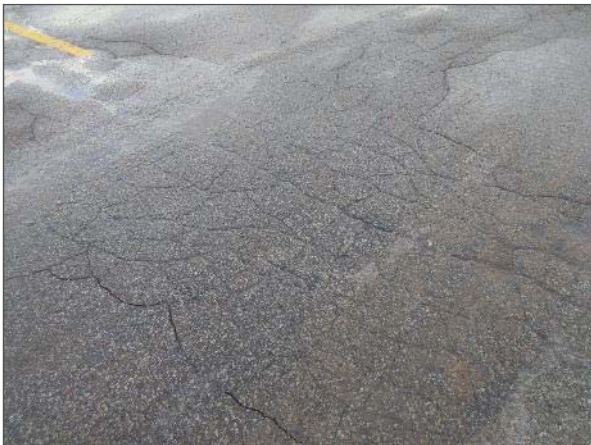
View of alligator cracking noted within the asphalt pavements of the Site.
