CCTV INVESTIGATION REPORT

Project #51842 Niagara Falls VIA

CCTV Report for – VIA rail station 4267 Bridge St,

Niagara Falls, ON

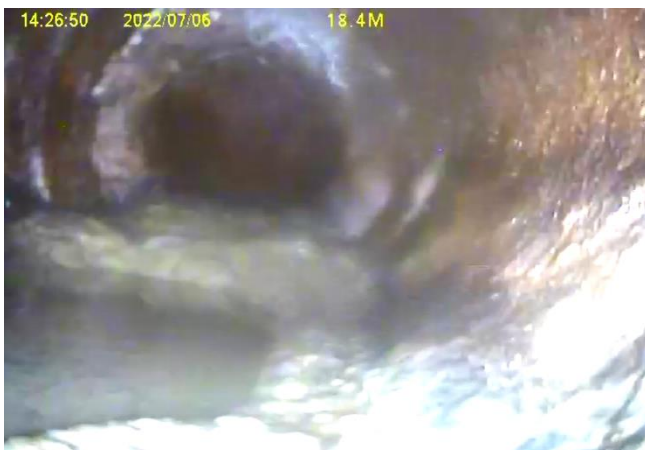
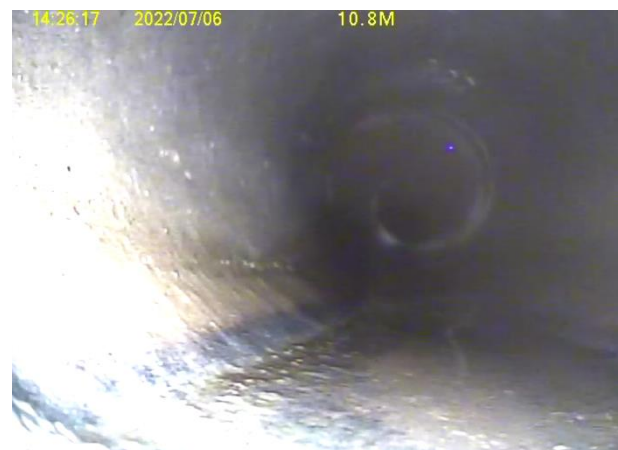
2. Sanitary Main from MH-3000 to Washroom lateral

- CCTV Survey was not successful- Blockage detected in MH-6000 and, difference in pipe elevation in MH-3000 main to men's washroom lateral.
- Refer CCTV Videos/Photos for more details and assessment.
