Re: Revised Hazardous Building Materials Assessment (Preconstruction)
Port Hope Highschool / Dr. MS Hawkins Public School, 130 Highland Drive, Port Hope, ON
Pinchin File: 335495.027

Hazardous Building Materials Assessment (Preconstruction)

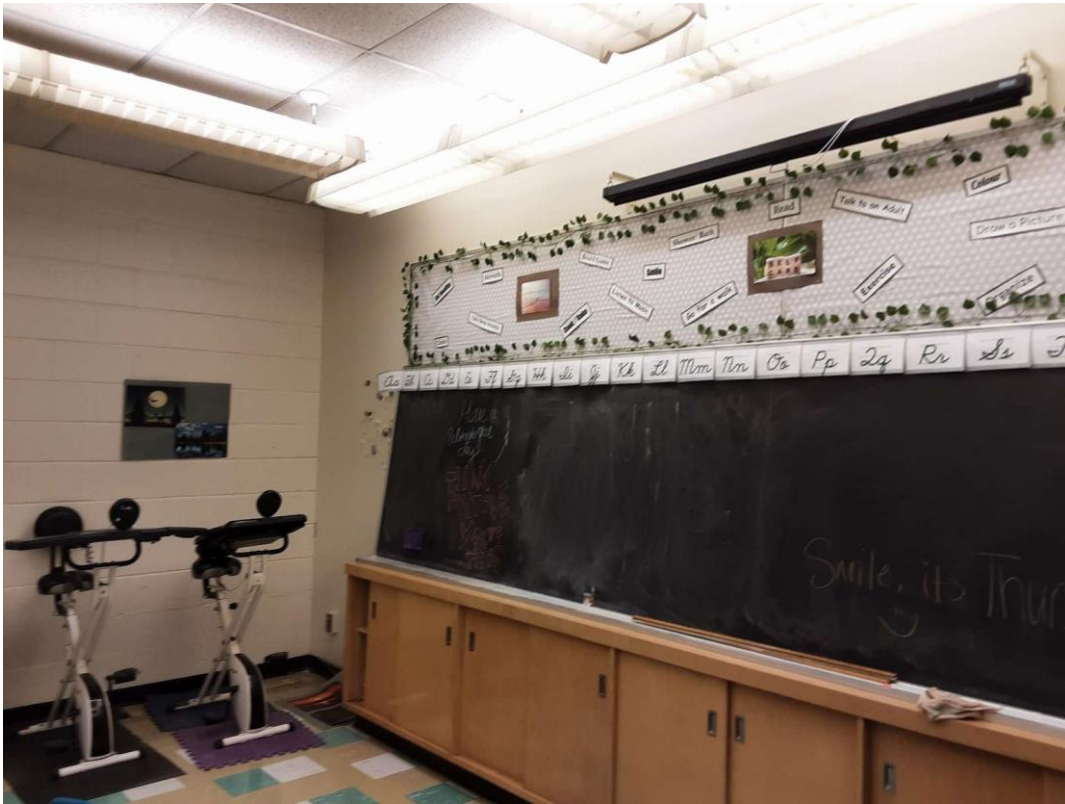
S0158C (Confirmed Asbestos), Drywall and joint compound on wall of Location #: 261

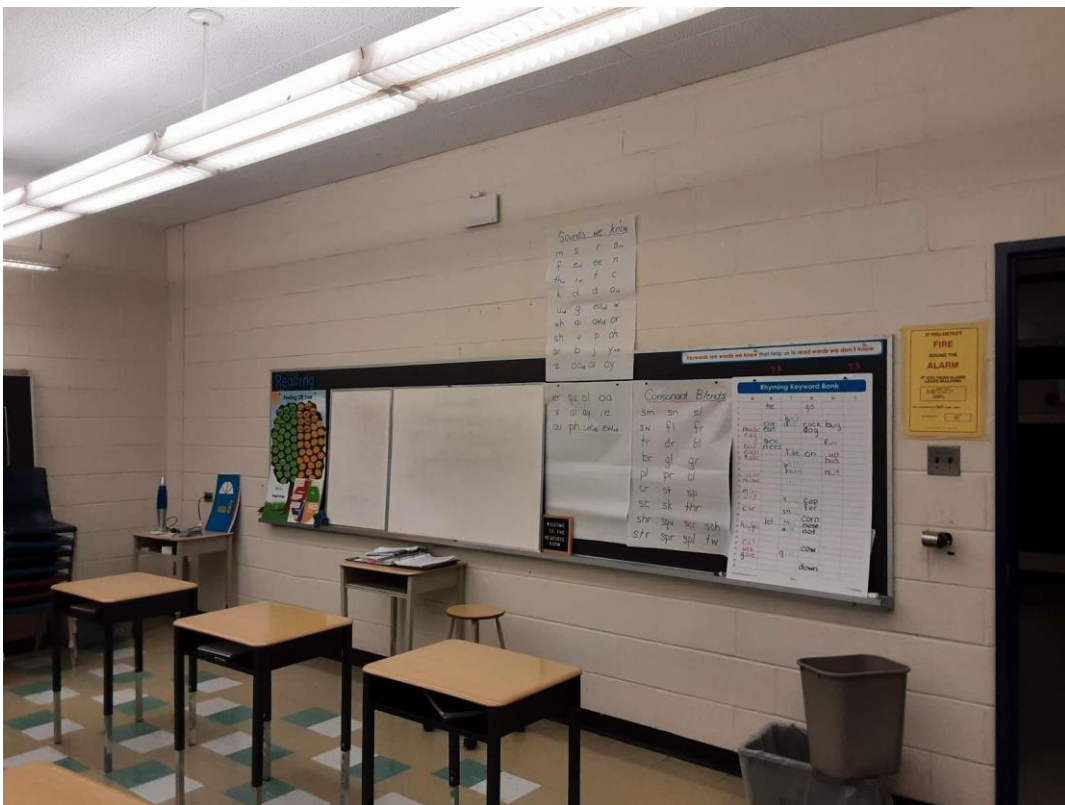
S0159C (Confirmed Asbestos), White paint on block wall in Location #: 262

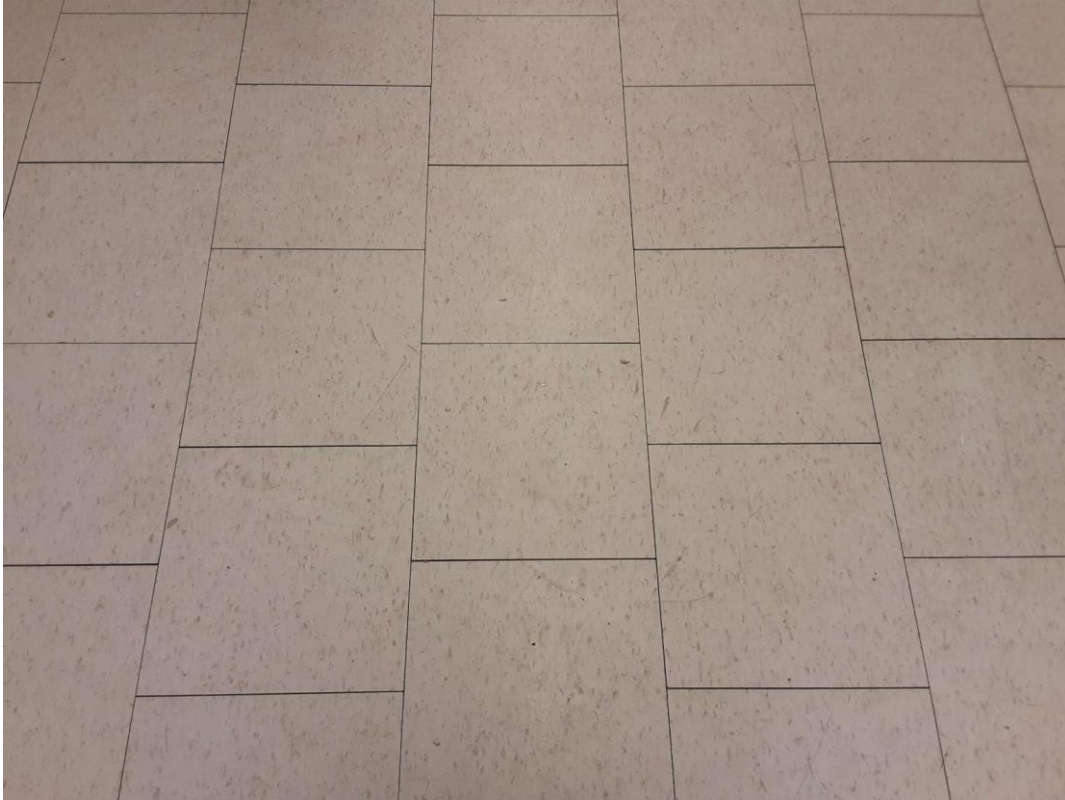
S0163C (None), 12in by 12in white mottled vinyl Floor Tile and Mastic in Location #: 259

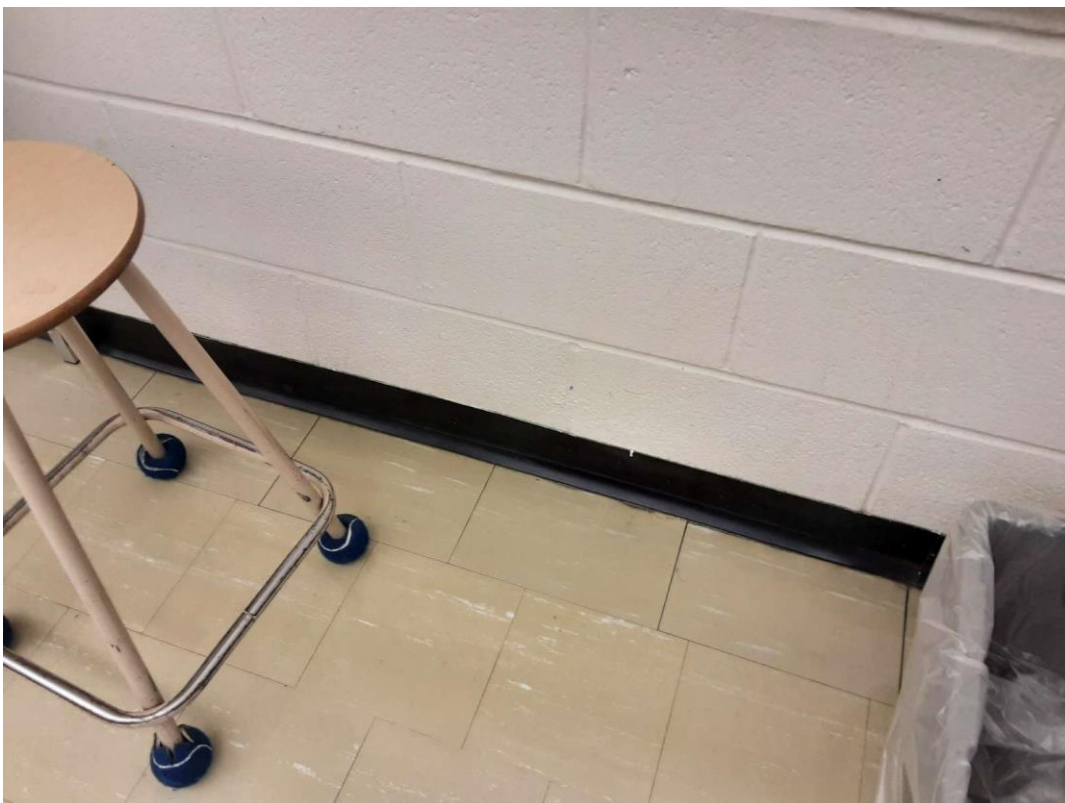
S0164A (None), Mastic behind vinyl baseboard in Location #: 262

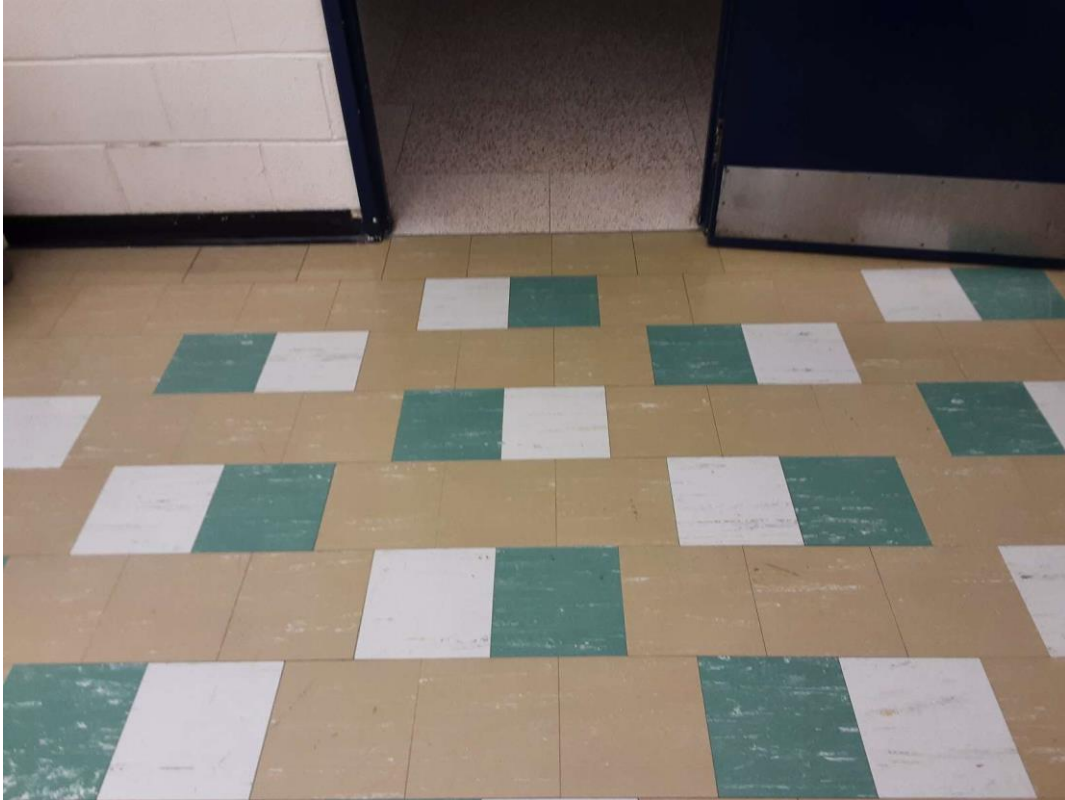
1. Sample of mastic also contained ceiling tile. The tile contains asbestos, mastic does not.
2. Sample S0168A had an additional phase. Phase C was a homogeneous, light grey, consolidated, vinyl floor tile containing chrysotile asbestos. The material was note observed and may be remnants from a prior renovation.

S0168C (Confirmed Asbestos), 9in by 9in light green Vinyl Floor Tile and Mastic in Location #: 262

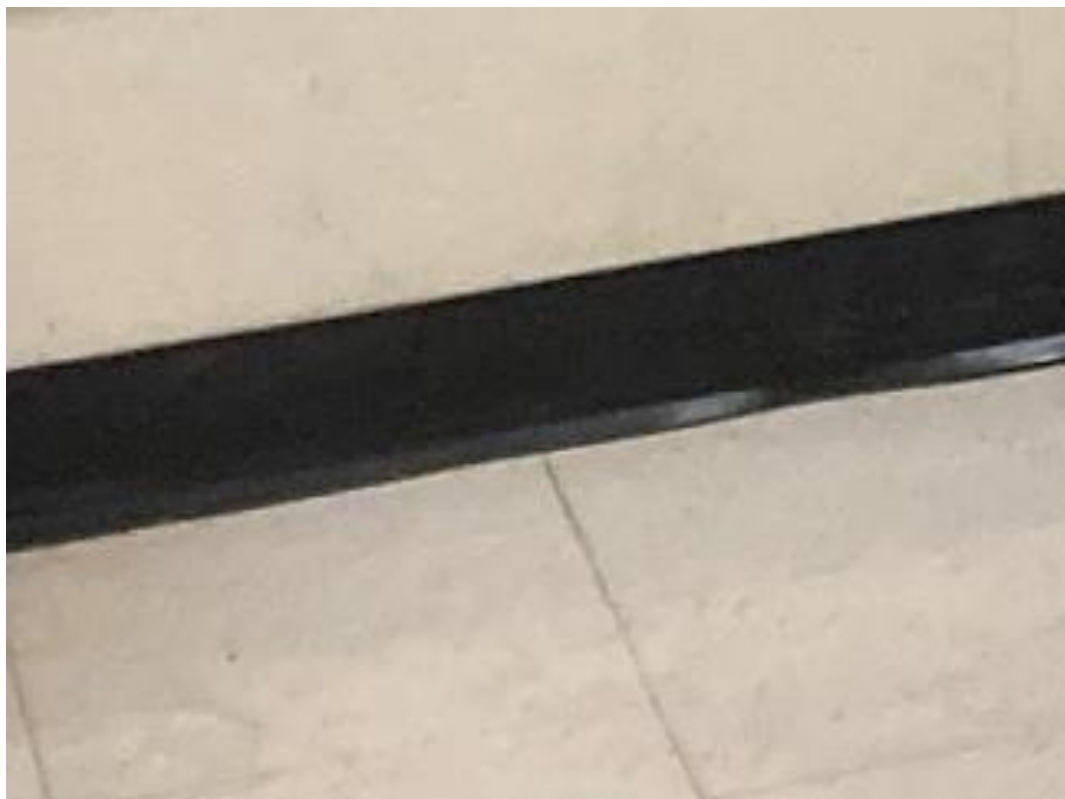
S0170 (Confirmed Asbestos), mastic behind the baseboard in Location #: 260

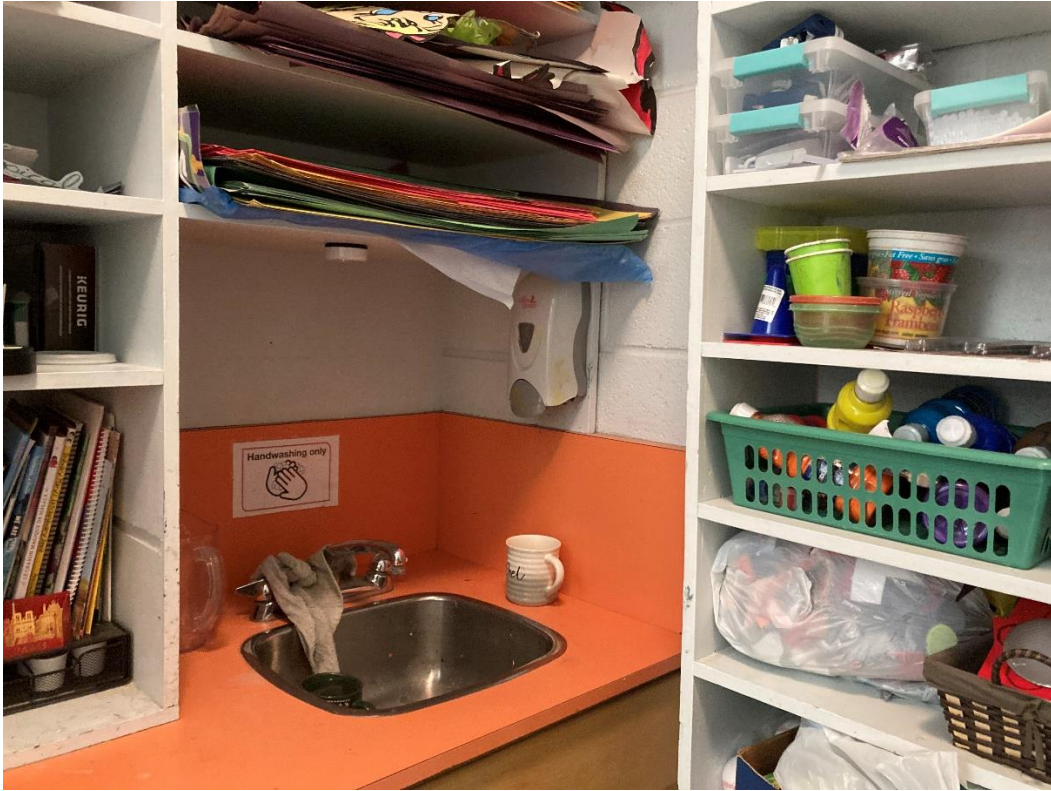
S0171 (Confirmed Asbestos), Sink mastic on the underside of the sink in Location #: 260

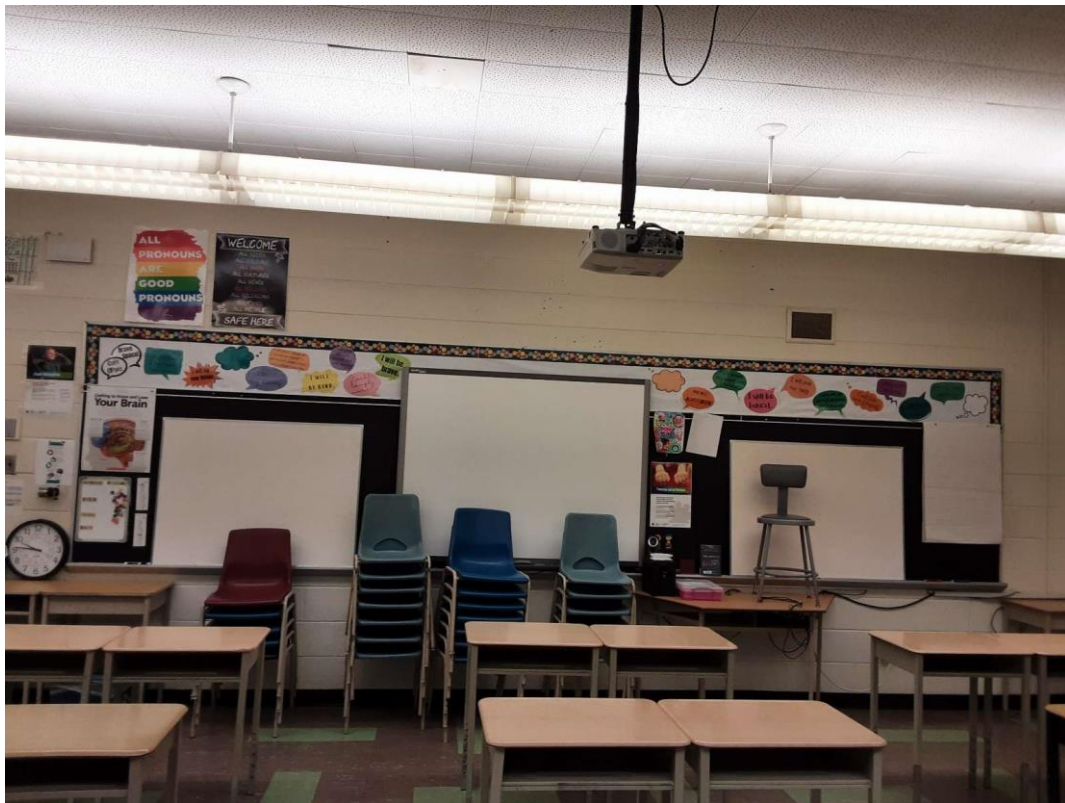
V9500 (Presumed Asbestos), Mastic behind chalkboard and corkboard in Location #: 257

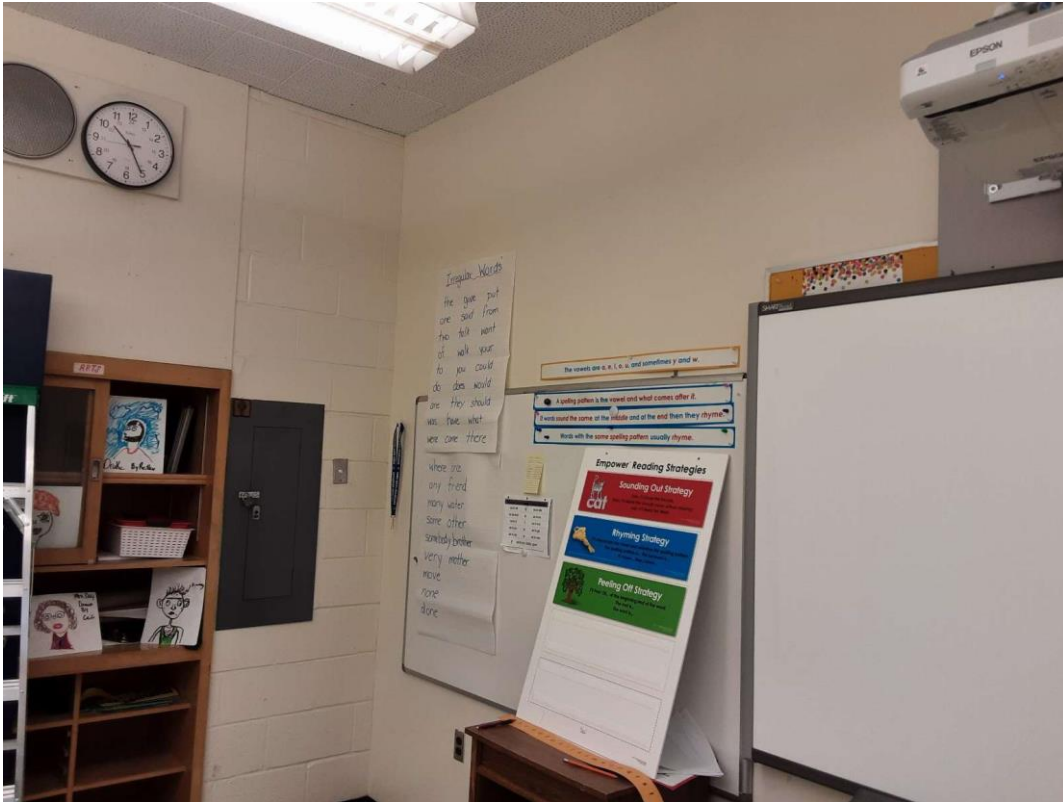
L0037(Lead, Low), White paint on drywall in Location #: 262

For paints identified as having low levels of lead (i.e., equal to or above 0.009% (90 mg/kg) but less than or equal to the EACC guideline of 0.1% (1,000 mg/kg) for lead-containing paints) special precautions are not recommended unless aggressive disturbance (grinding, blasting, torching) is planned. Exposure from construction disturbance of paints containing lead less than 0.009% (90 mg/kg) is assumed to be insignificant.

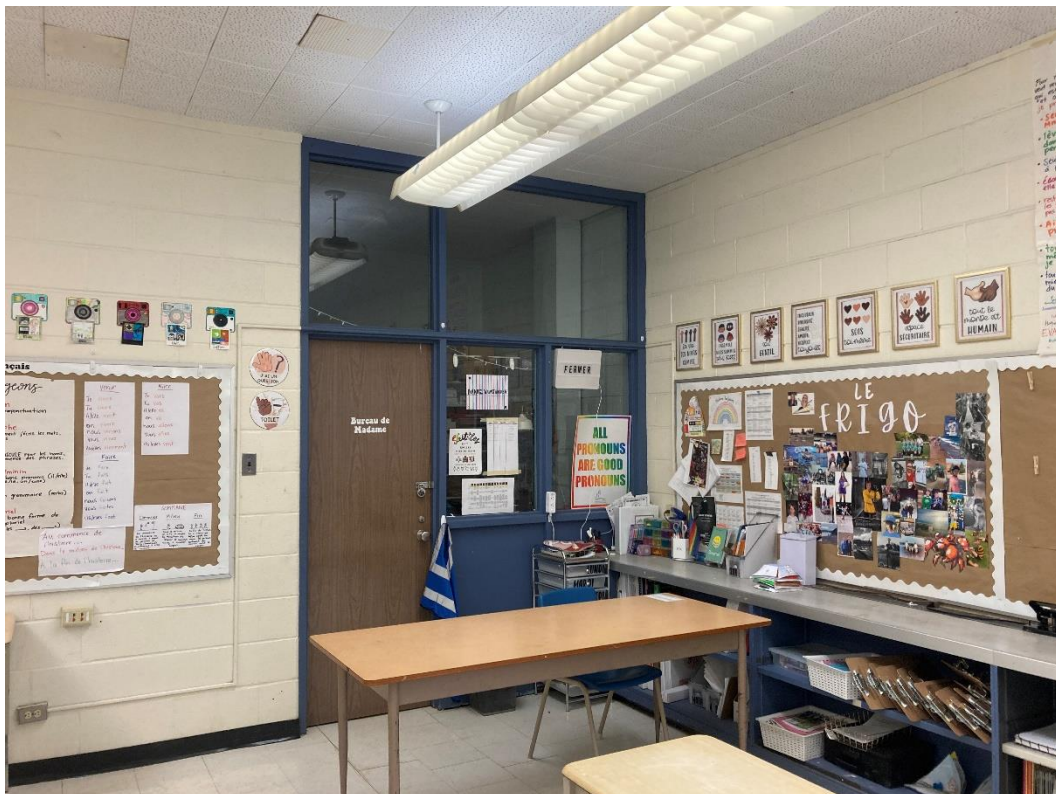
L0039 (Lead Containing), Blue paint on various metal pieces in Location #: 259

Items painted with paints containing elevated levels of lead may be a hazardous waste. Test lead-painted materials for leachable lead and other metals prior to disposal. Metallic components coated with lead paint do not require leachate testing and can be disposed of as non-hazardous construction and demolition (C&D) waste.

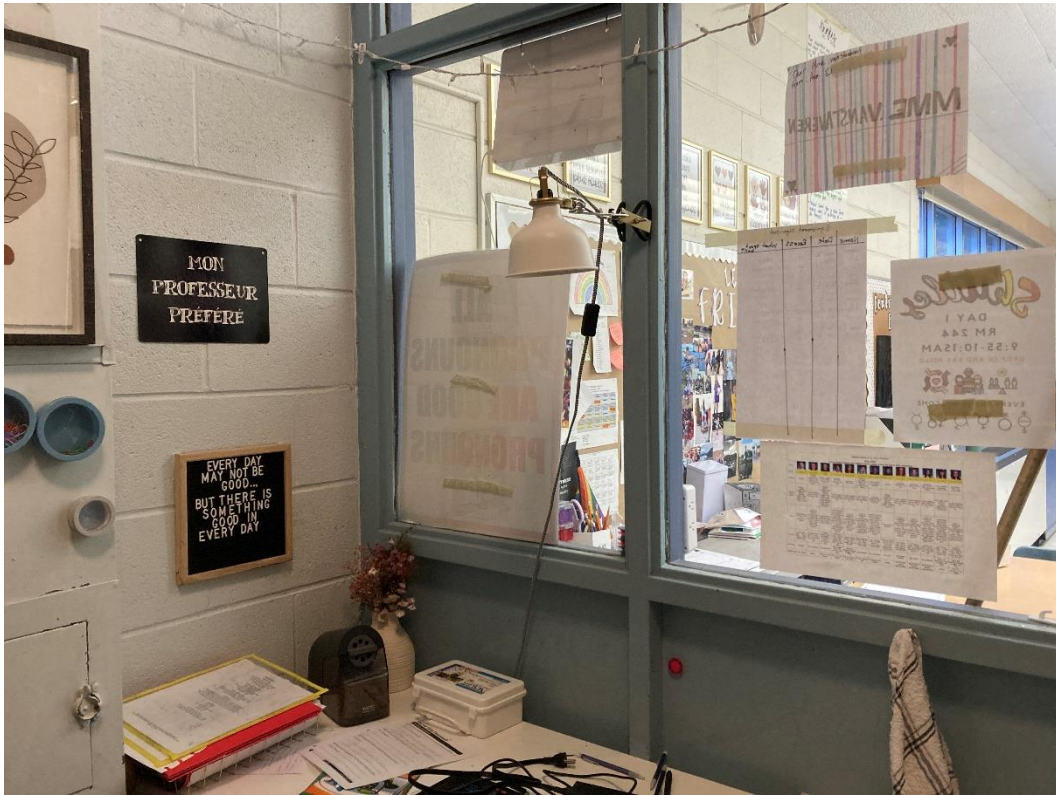
L0040 (Lead Containing), Light blue paint on metal pieces in Location #: 259

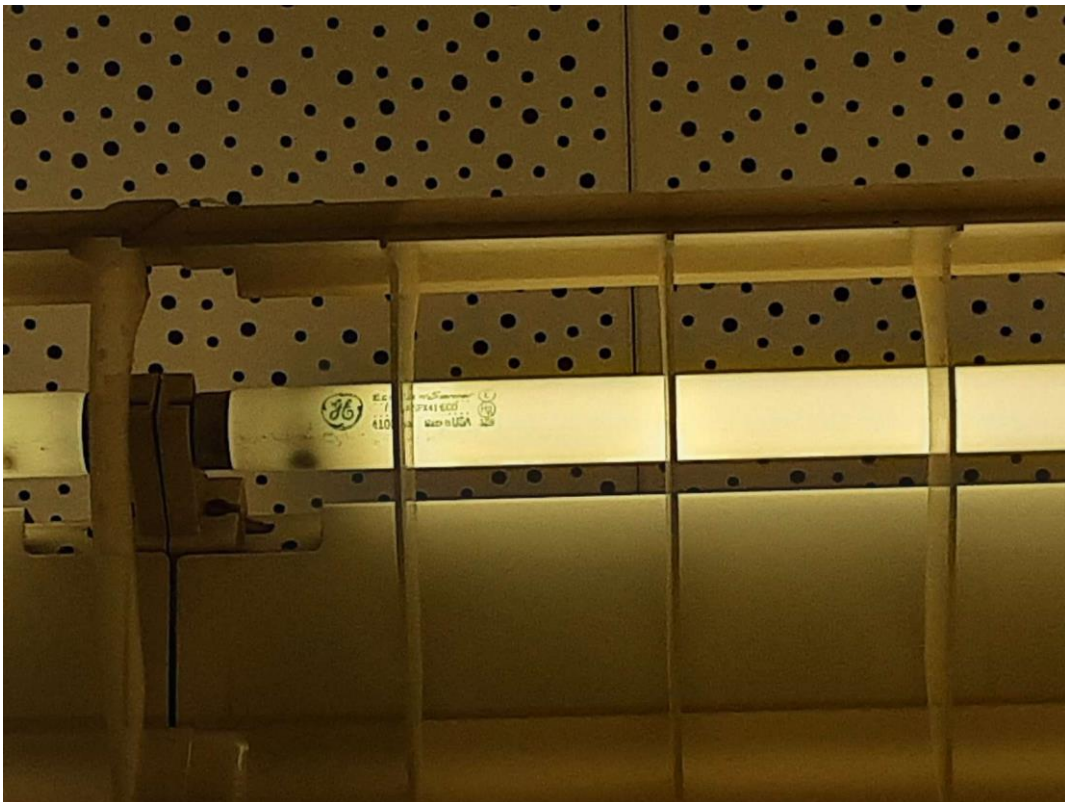
- 1. Items identified as Sample Number V9000 were observed to be present and were determined to contain mercury based on visual observation (e.g., labelled lamps).

Mercury, V9000(Yes), Mercury containing light fixtures in Location #: 259

Do not break lamps. Recycle and reclaim mercury from fluorescent lamps when taken out of service. Mercury is classified as a hazardous waste and must be disposed of in accordance with applicable regulations.

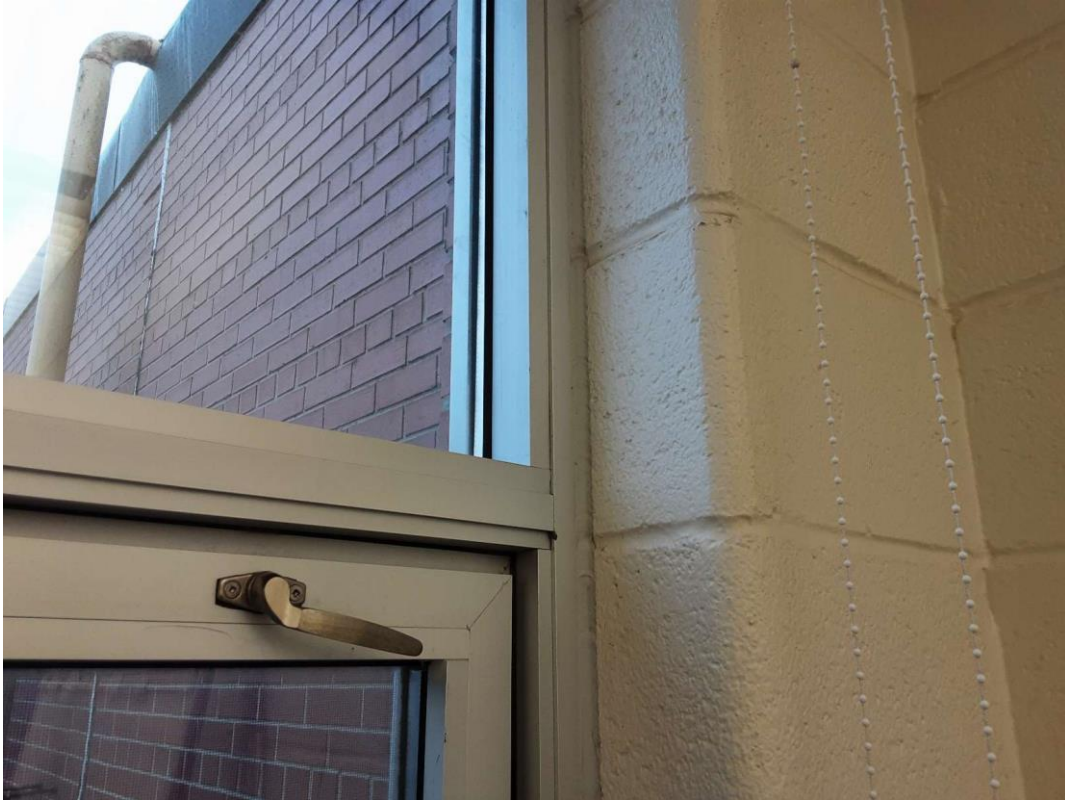
PCB, P0008(No), Grey caulking near windows in Location #: 262
