February 26, 2024

Kawartha Pine Ridge District School Board  
1994 Fisher Drive  
Peterborough, ON K9J 7A1

**Re: Hazardous Building Materials Assessment (Preconstruction)**  
Classroom Refresh, Classrooms 4, 5, 6 and 7  
Kawartha Heights Public School, 11 Kawartha Heights Boulevard, Peterborough, ON  
Pinchin File: 335495.013

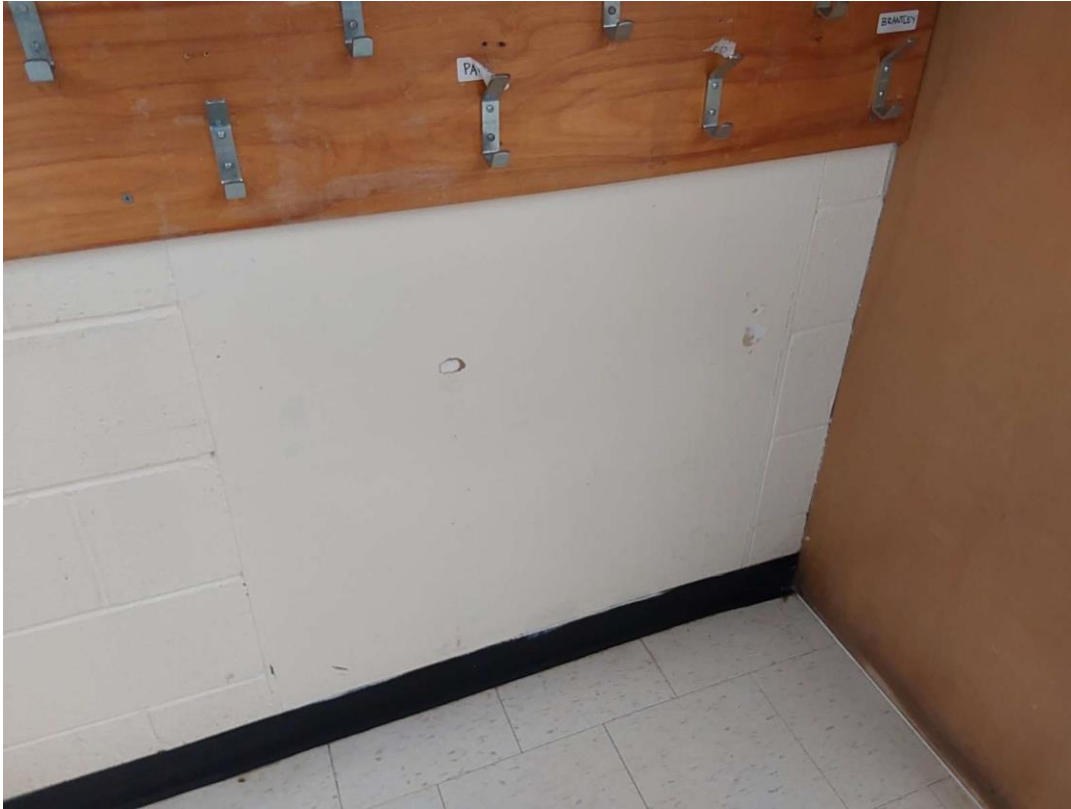
V0001 (None), Wall, Drywall and joint compound, CLASSROOM (Location #: 26)

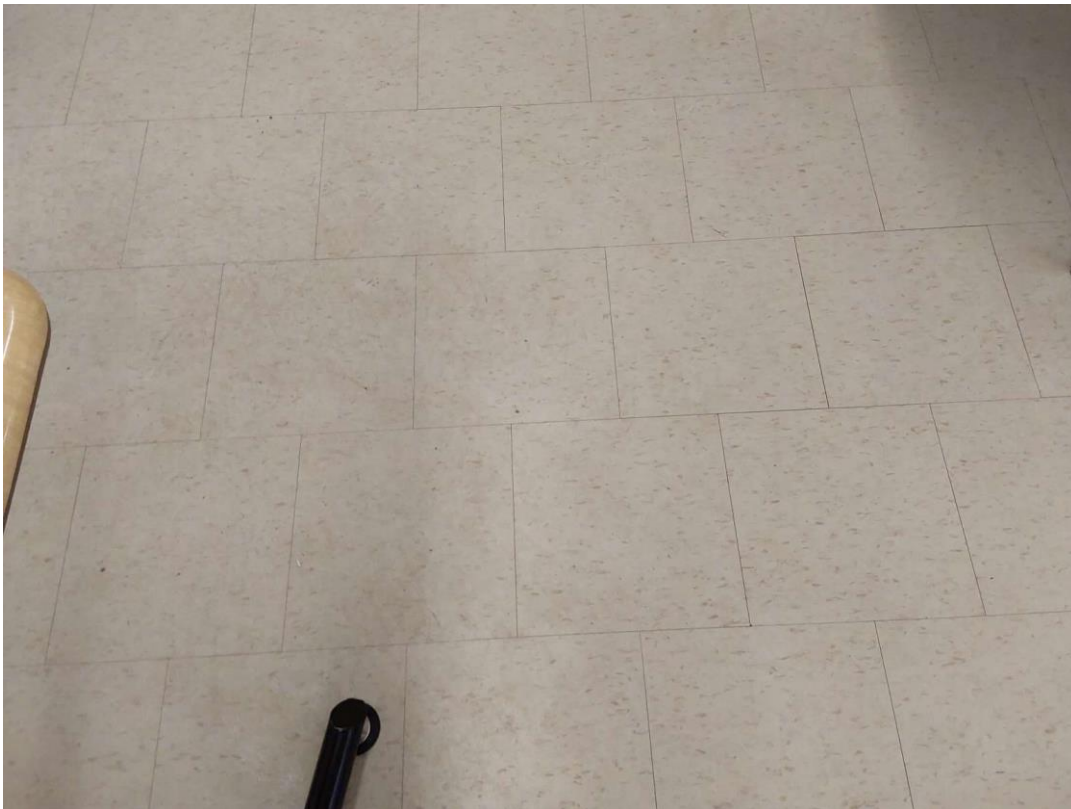
S0018A (None), Sampled mastic, 12" x 12" white with grey fleck, Floor, Vinyl Floor Tile and Mastic, CLASSROOM (Location #: 13)  
New flooring in 2016

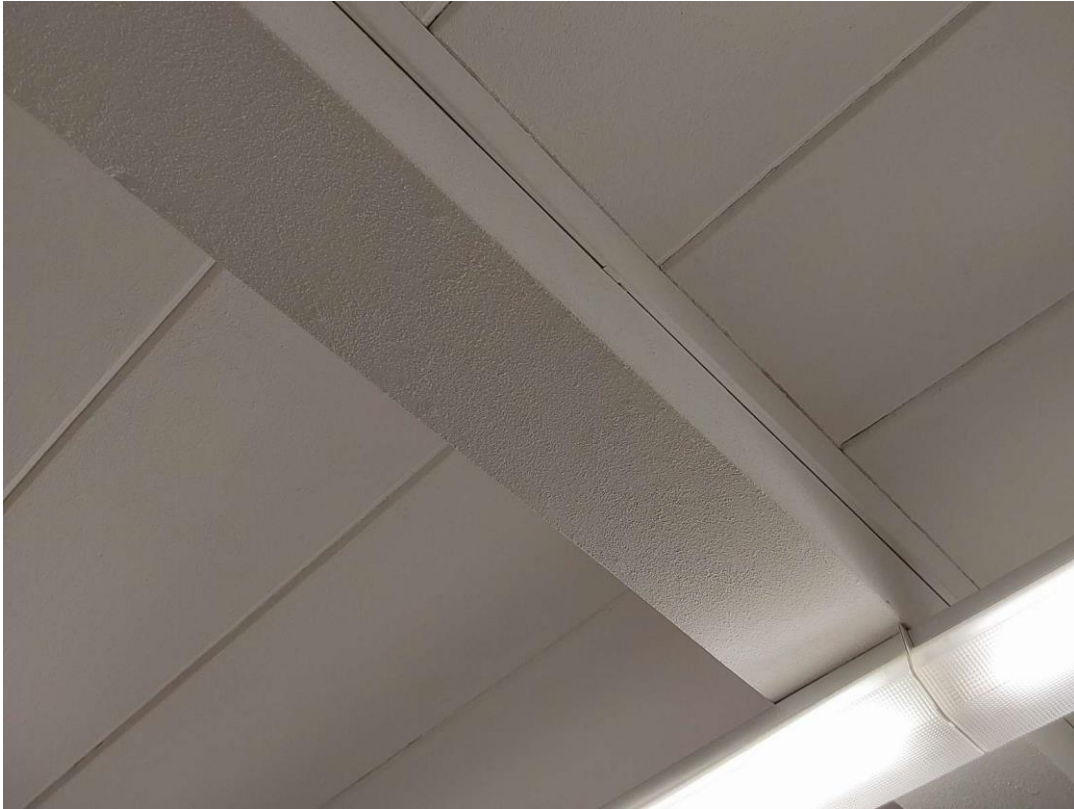
Sample Number	Material Description	Type of Asbestos	Confirmed Hazard	Total Quantity Present	Notes
<b>S0019 ABC</b>	<b>Structure   Texture Coat</b>	<b>Chrysotile</b>	<b>Yes</b>	<b>100 SF</b>	<b>Texture coat on concrete beams on ceilings the deck and columns in the 1968 Phase of Construction</b>
S0020 ABC	Wall   Mastic behind vinyl baseboards	None Detected	No	50 SF	1968 Construction Phase
S0021 ABC	Wall   White paint on masonry	None Detected	No	800 SF	1968 Construction Phase
S0022 ABC	Other   Grey caulking on wood bench	None Detected	No	30 LF	1968 Construction Phase
S0023 ABC	Floor   12"x12" Vinyl Floor Tile (white with grey fleck) and Mastic	None Detected	No	2,000 SF	1958 Construction Phase. <b>See Site Specific Note #3</b>
<b>S0023 A, phase c</b>	<b>Floor   Levelling Compound</b>	<b>Presumed Asbestos</b>	<b>Yes</b>	<b>2,000 SF</b>	1958 Construction Phase. <b>See Site Specific Note #3</b>
<b>S0024 ABC</b>	<b>Structure   Texture Coat</b>	<b>Chrysotile</b>	<b>Yes</b>	<b>300 SF</b>	<b>Texture coat on concrete beams on the deck and columns in the 1958 Construction Phase</b>

S0019A (Confirmed Asbestos), Structure, Texture Coat, CLASSROOM (Location #: 13)

Remove asbestos-containing materials (ACM) prior to renovation, alteration, or maintenance if ACM may be disturbed by the work.

Asbestos-containing materials must be disposed of at a landfill approved to accept asbestos waste.

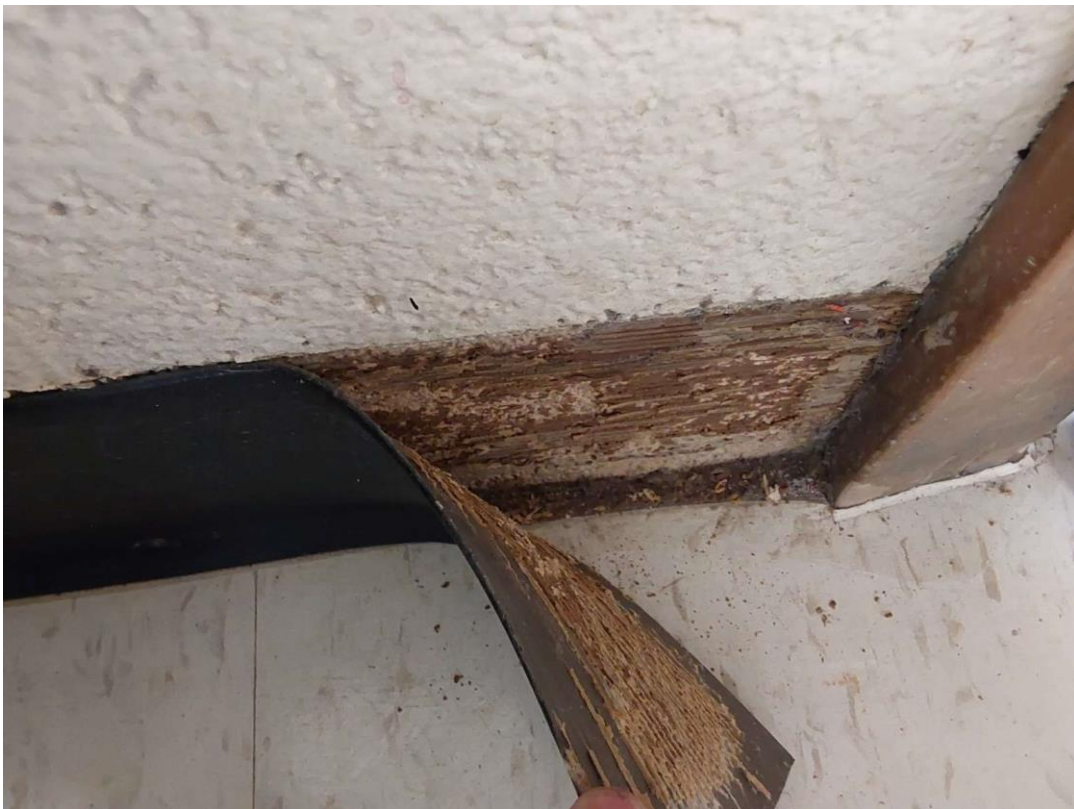
S0020A (None), Mastic behind vinyl baseboards, Wall, Adhesive/mastic, CLASSROOM (Location #: 13)

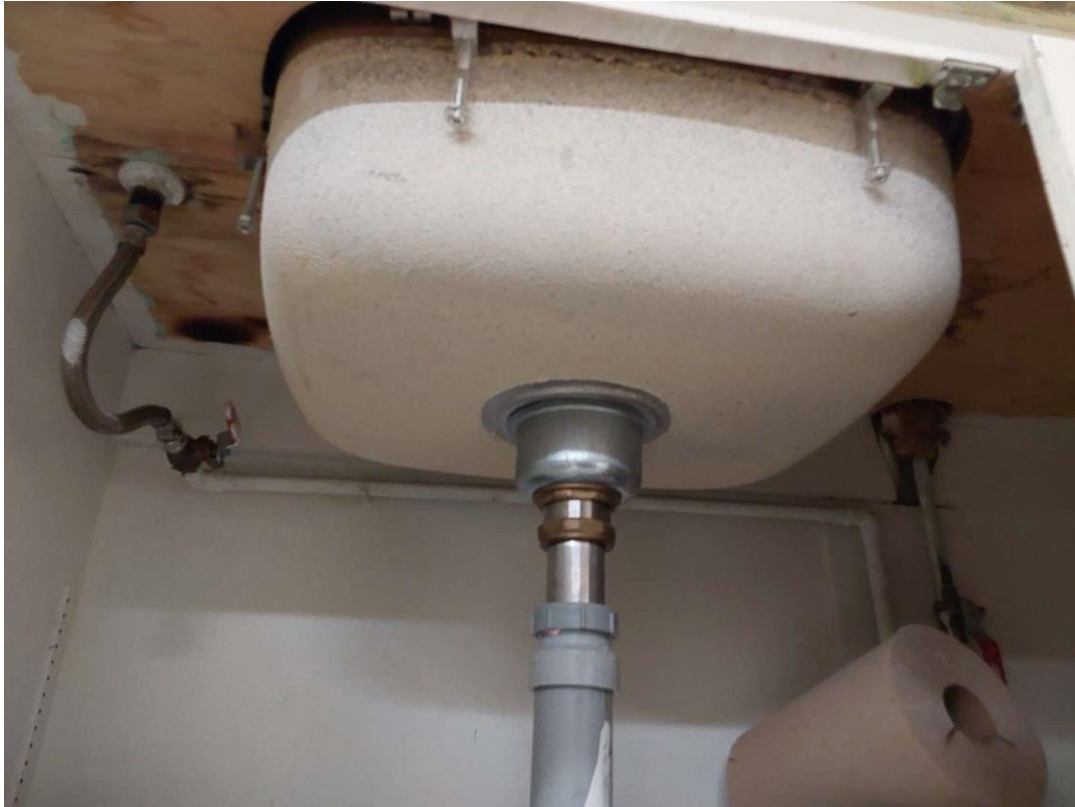
S0027C (None), Other, Adhesive/mastic, CLASSROOM (Location #: 26)  
Grey sink mastic

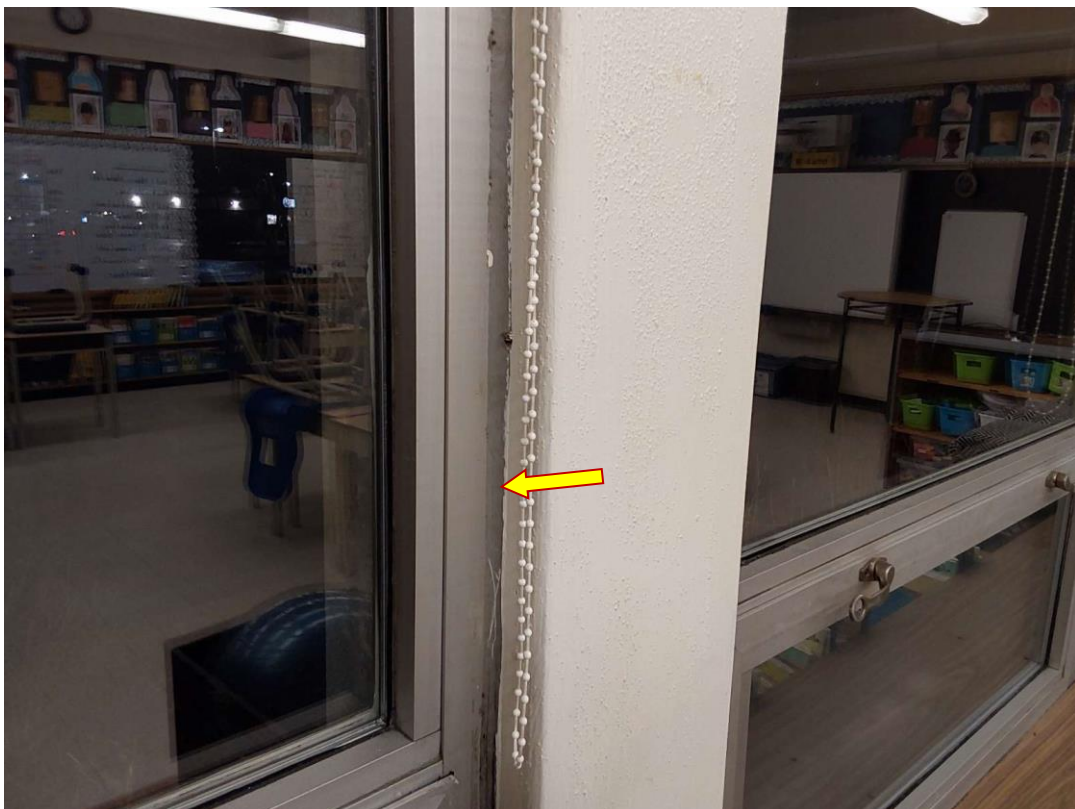
V0028 (None), Grey along windows, Other, Caulking, CLASSROOM (Location #: 30)

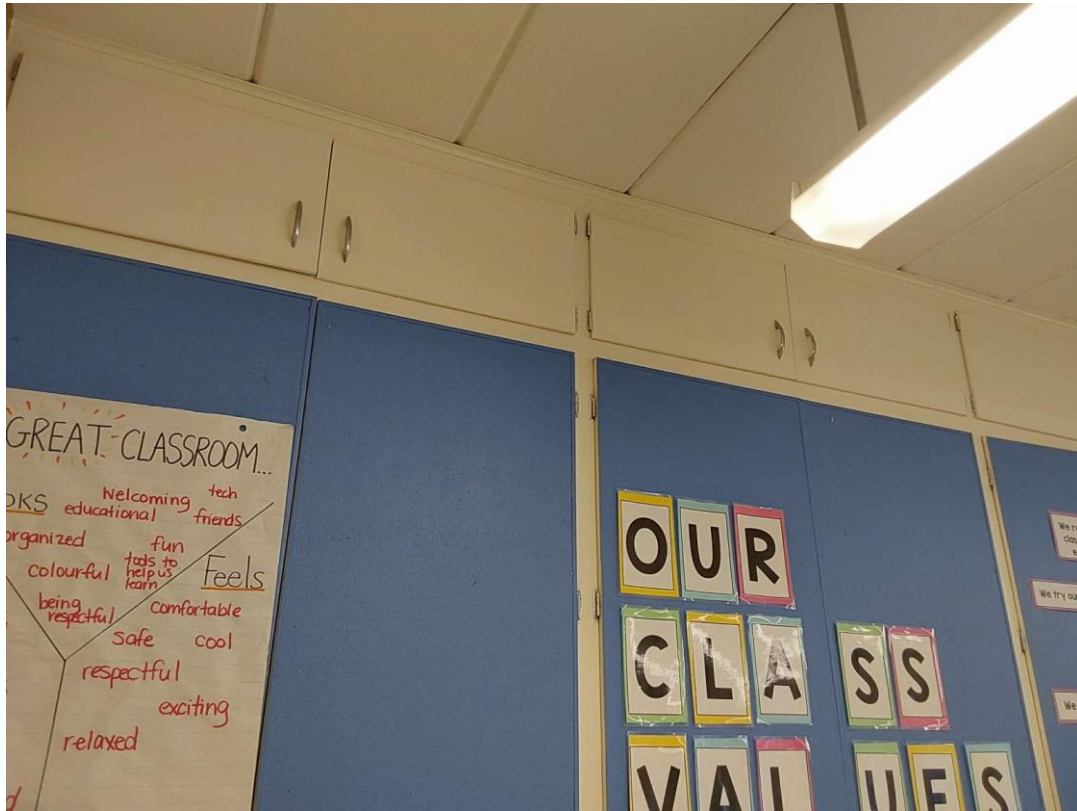
L0003(Lead, None), White on wood, Wall, CLASSROOM (Location #: 13)

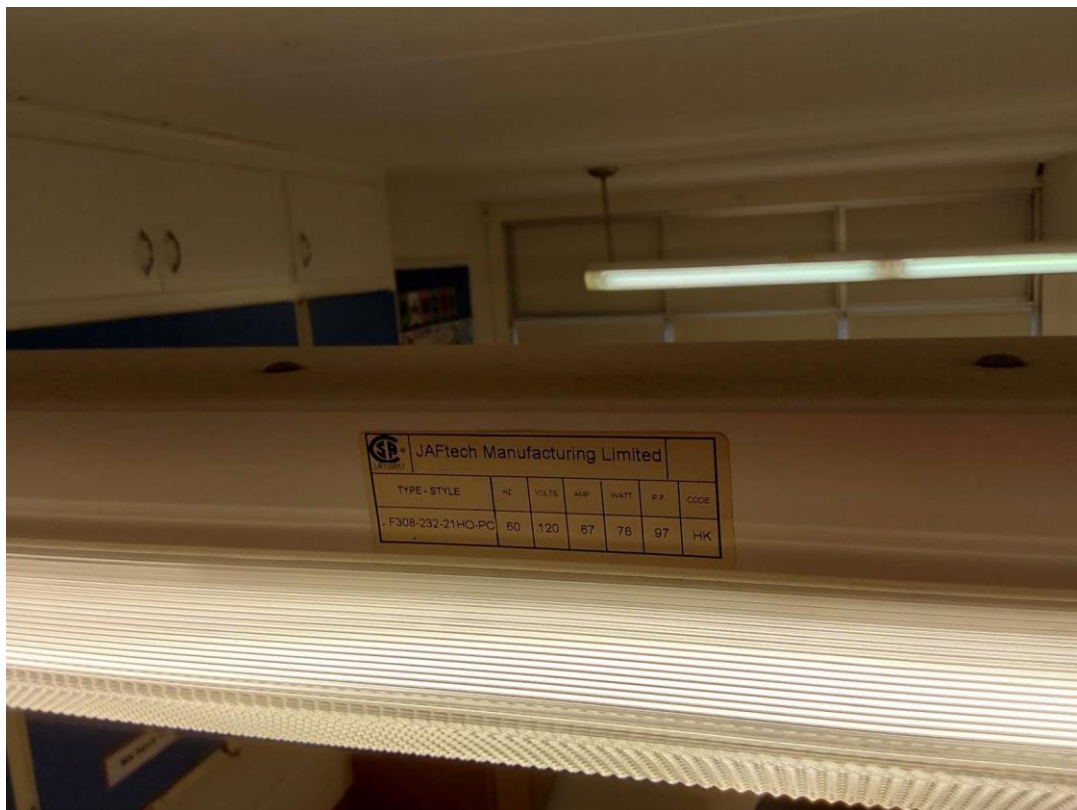
Sample Number	Material Description	Confirmed Hazard	Total Quantity Present	Notes
V9000	Light Fixture	Yes	56 EA	Light tubes

Mercury, V9000(Yes), LIGHT FIXTURE, CLASSROOM (Location #: 13)

Do not break lamps. Recycle and reclaim mercury from fluorescent lamps when taken out of service. Mercury is classified as a hazardous waste and must be disposed of in accordance with applicable regulations.

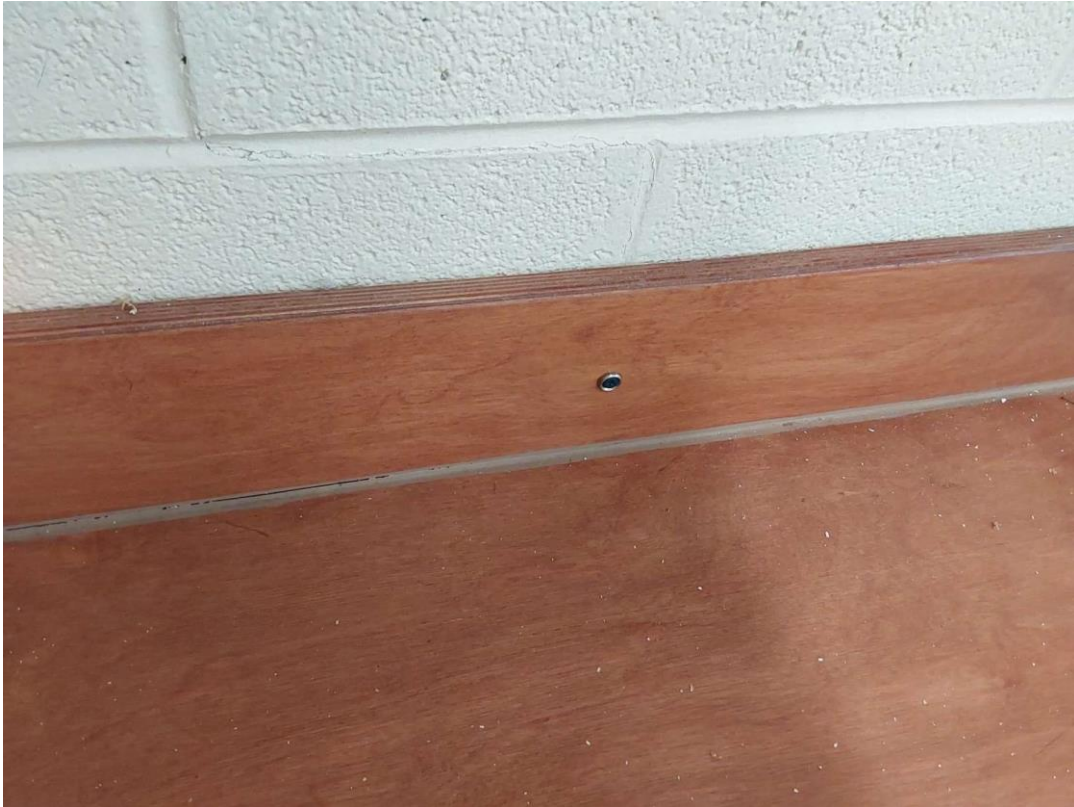
Sample Number	Material Description	Concentration	Confirmed Hazard	Total Quantity Present	Notes
P0001	Grey Caulking On Wood Bench	<0.2mg/kg	No	30 LF

PCB, P0001(No), CAULKING, Grey caulking on wood bench, CLASSROOM (Location #: 13)

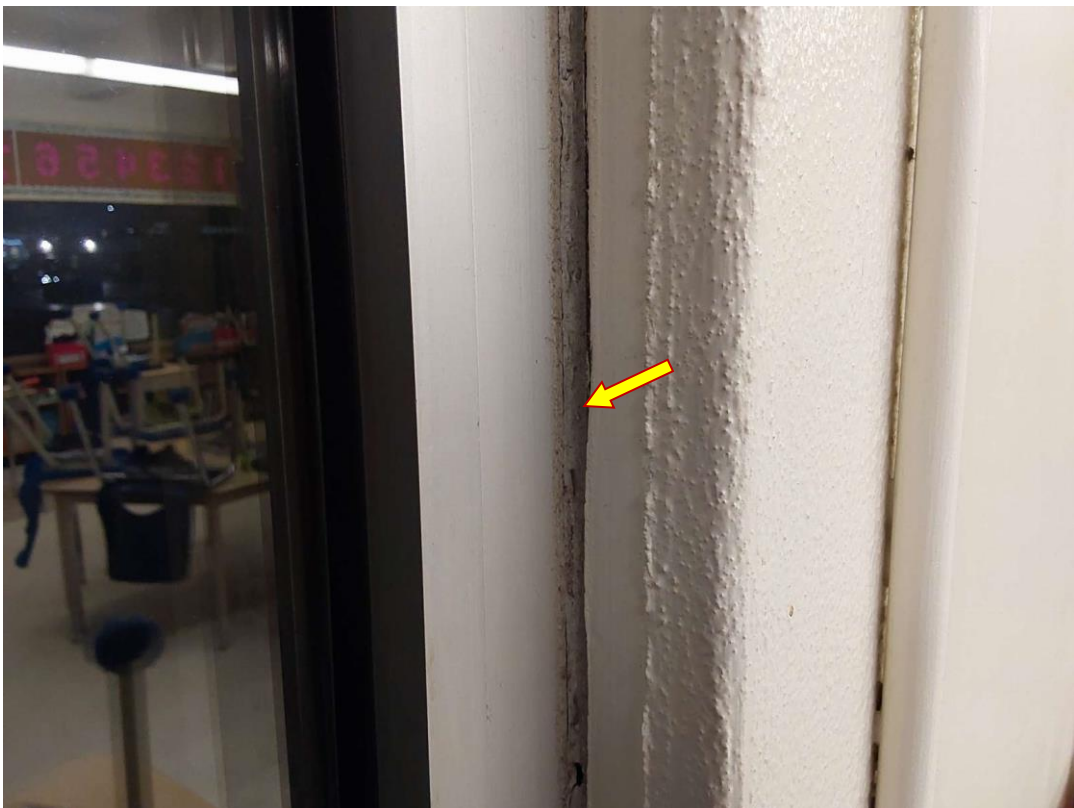
Sample Number	Material Description	Concentration	Confirmed Hazard	Total Quantity Present	Notes
P0002	Grey Caulking Along Windows	<0.2mg/kg	No	150 LF	
V0000	Light Ballasts	N/A	No	56 EA	T8 ballasts will not contain PCB

PCB, P0002(No), CAULKING, Grey caulking along windows, CLASSROOM (Location #: 26)
