Westview Elementary School

Window and Door Replacement

Designated Substance Audit Report

February 27, 2024

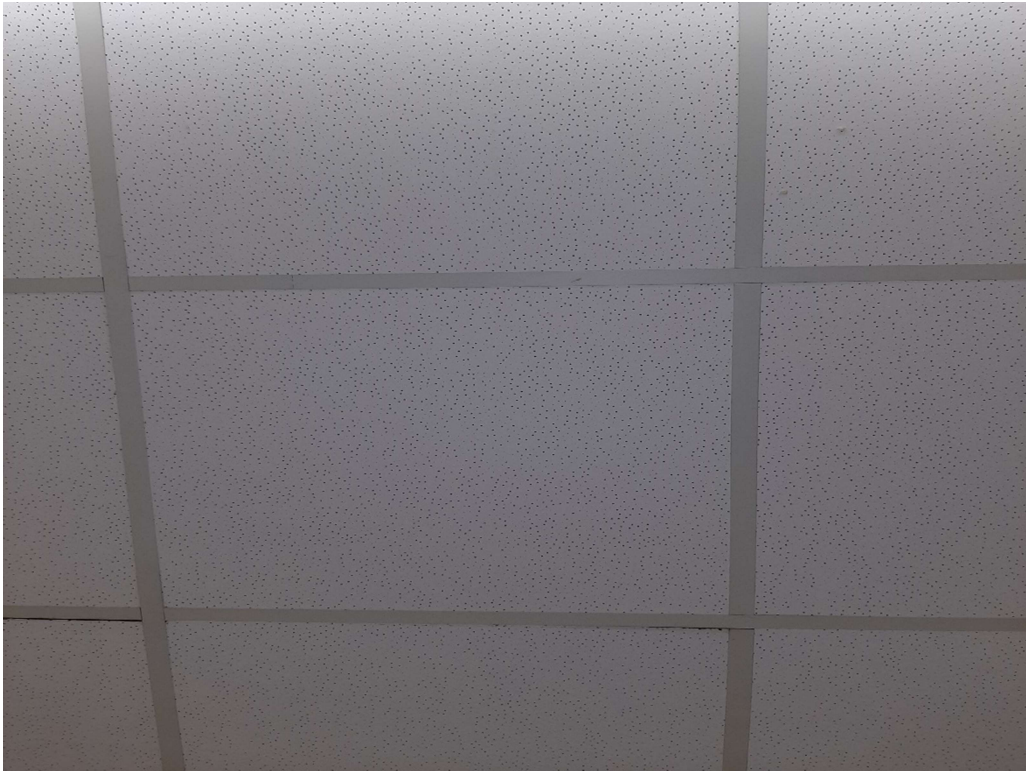
Photograph No. 1 – 2’x4’ pinhole pattern ceiling tiles are non-asbestos.

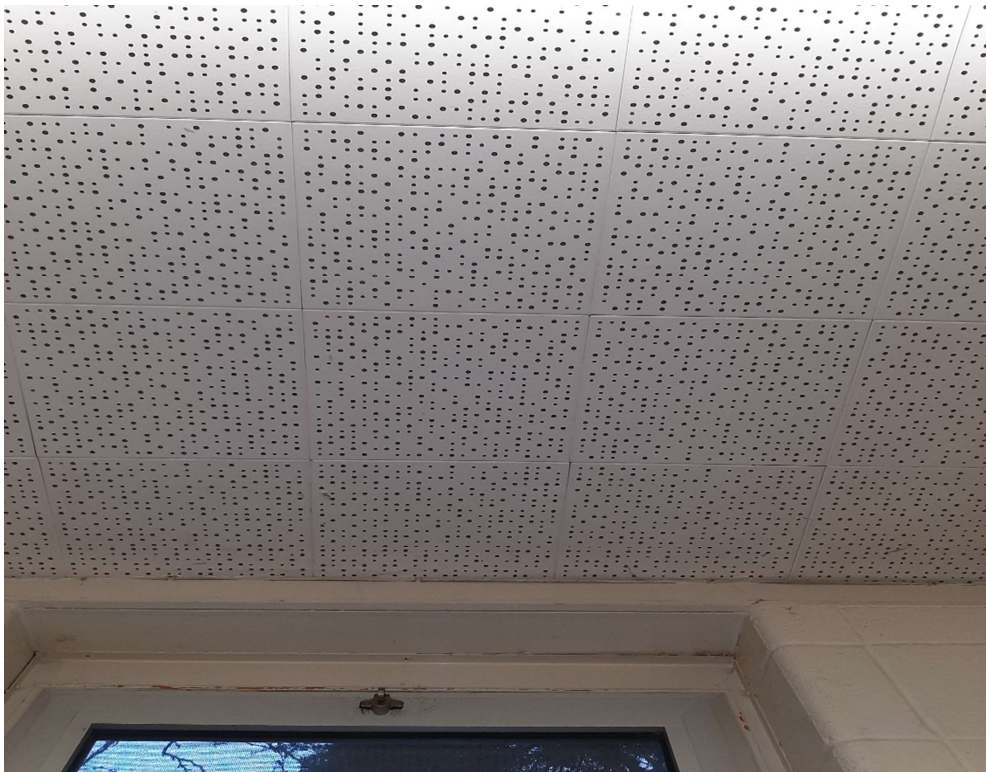
Photograph No. 2 – 1’x1’ pinhole pattern ceiling tiles in classroom 123 are non-asbestos, however suspect asbestos containing mastic may be concealed underneath.

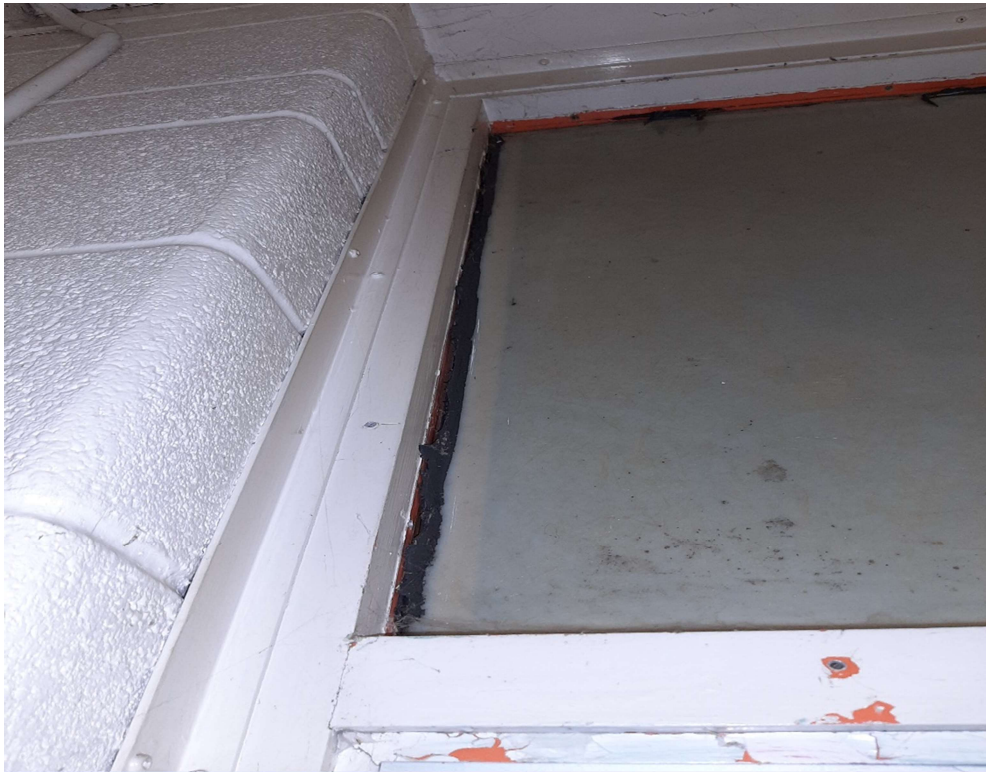
Photograph No. 3 – Black sealant on the door inside classroom 123 contains asbestos.

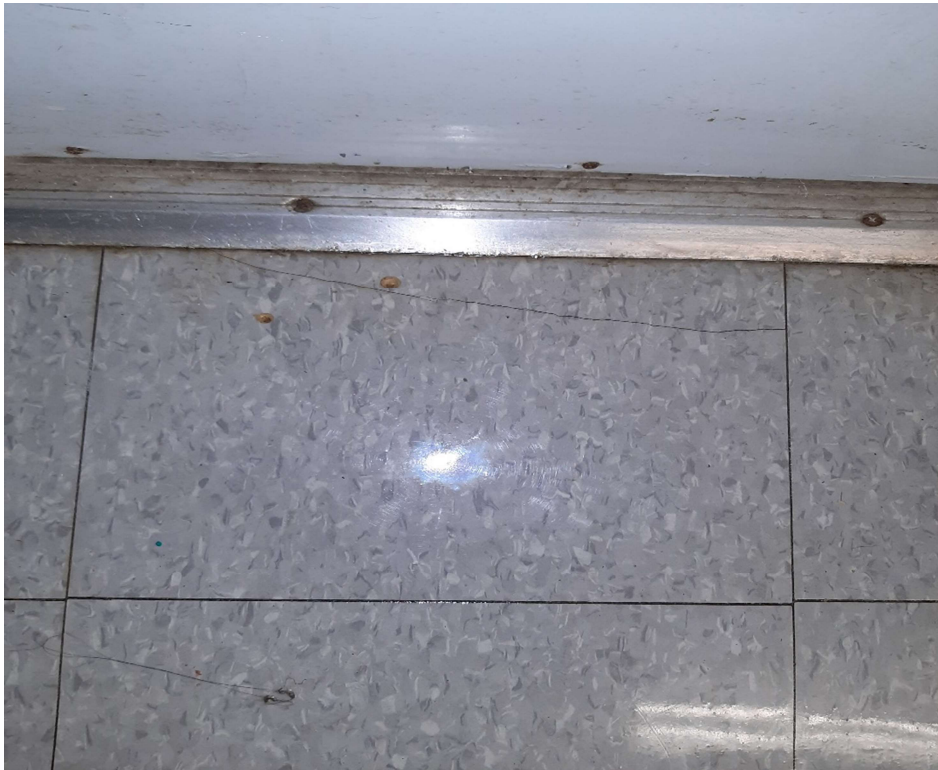
Photograph No. 4 – Black mastic under 12"x12" gray fleck pattern vinyl floor tiles in classroom 123 contains asbestos.

Asbestos Non-Friable	Classroom 123	Black Mastic Associated with 12"x12" Gray Fleck Pattern Vinyl Floor Tile	In place management in accordance with O. Reg. 278/05	Removal in accordance with O. Reg. 278/05 as a Type 1 Operation

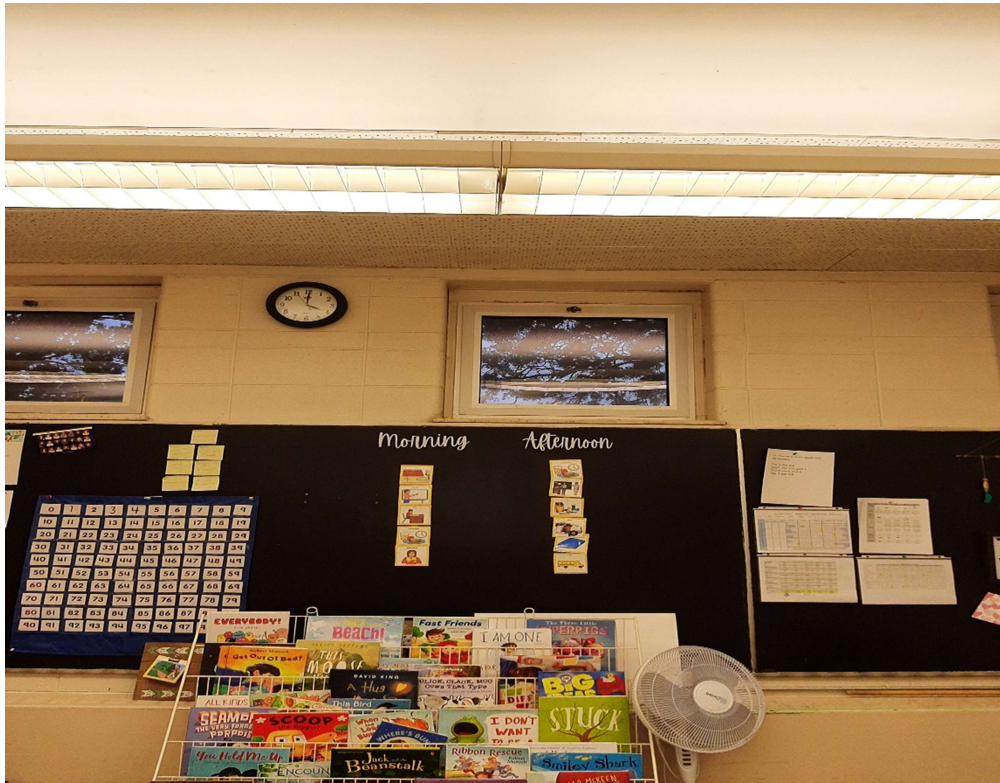
Photograph No. 5 – Drywall joint compound on the ceiling in classroom 123 contains asbestos.

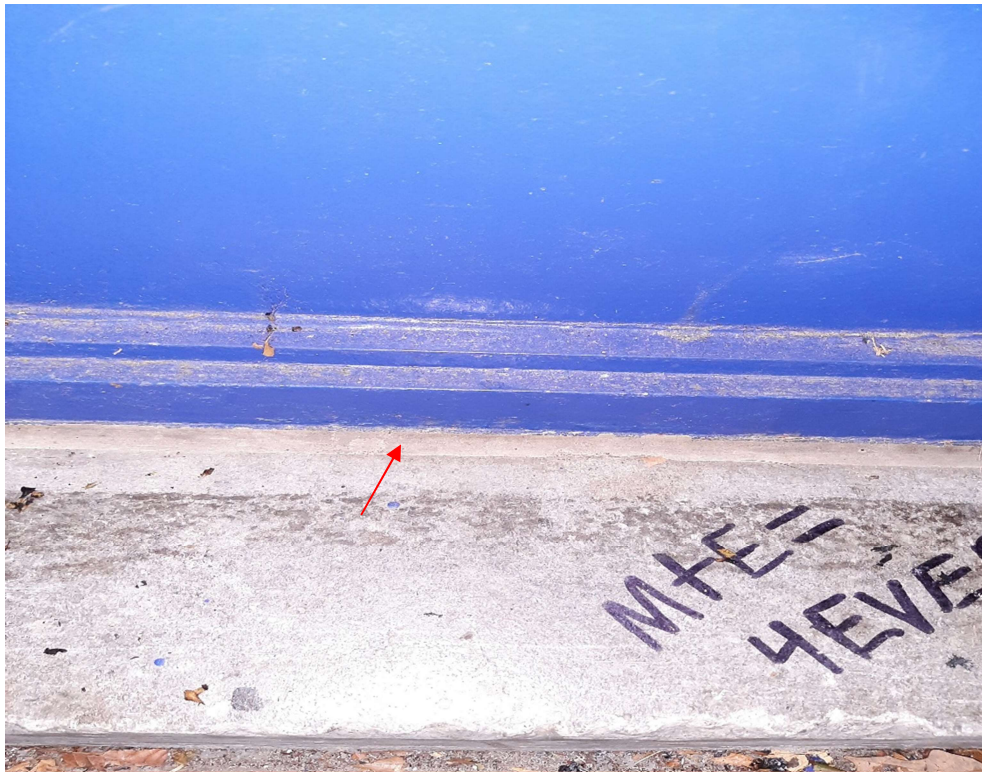
Photograph No. 6 – Gray exterior sealant around exterior doors and panels contains PCBs.

PCB-containing sealant was identified within the Subject Areas; therefore, special management, handling and disposal requirements apply to the proposed work.

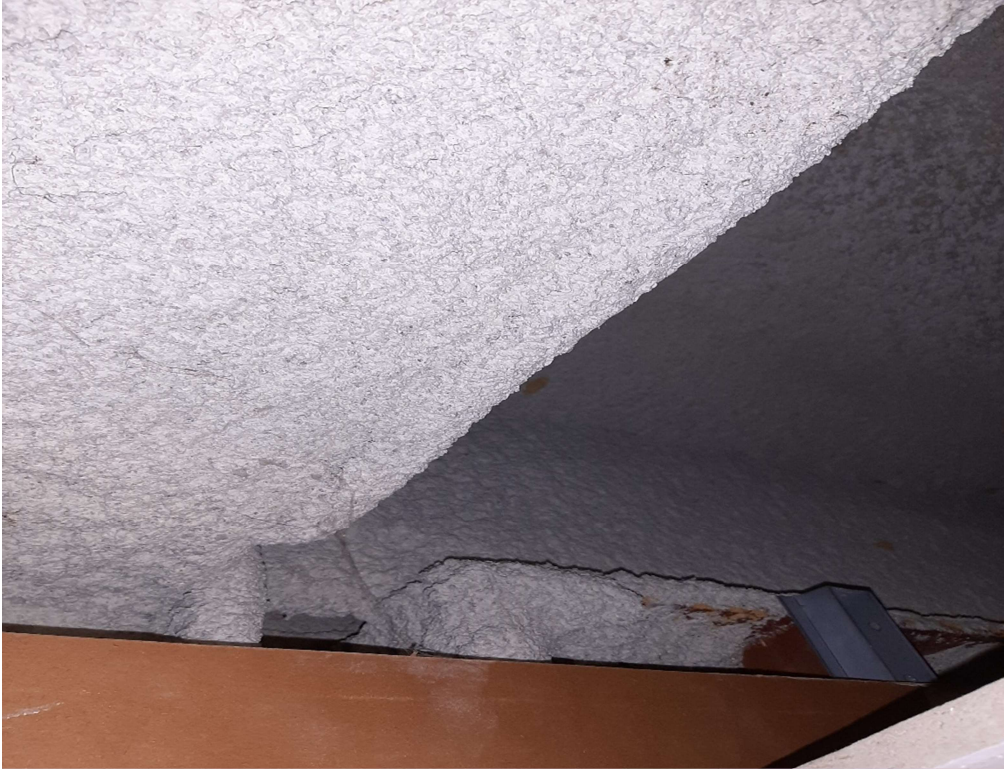
Photograph No. 7 – Fireproofing present within ceiling cavities throughout contains asbestos.

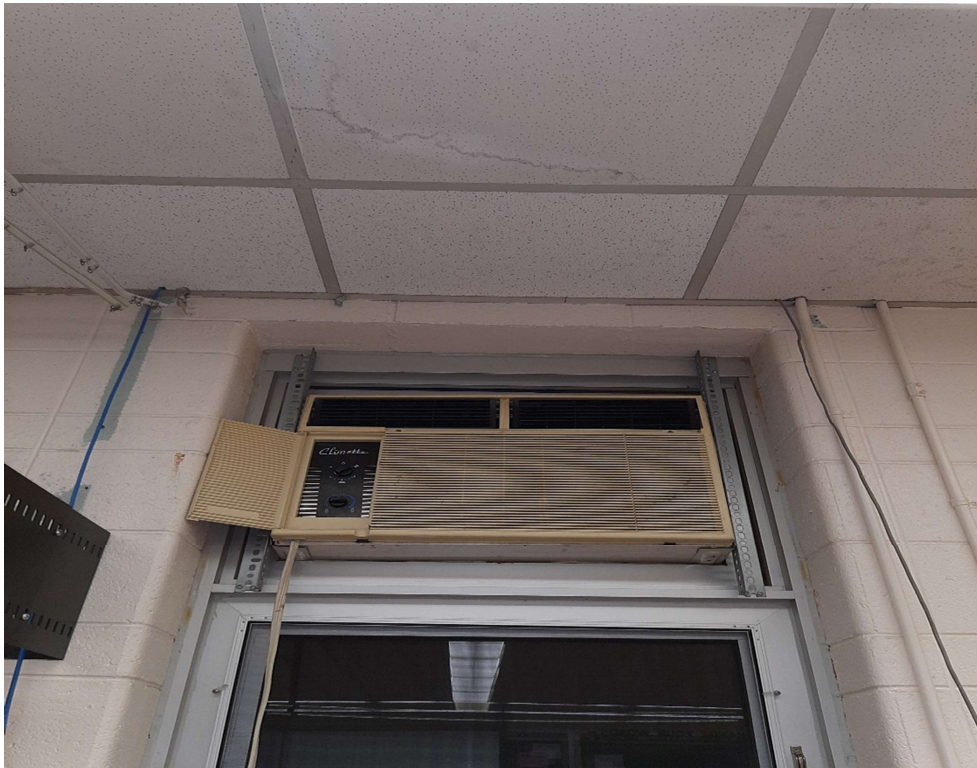
Photograph No. 8 – Window mounted air-conditioners may contain ODSs.

ODS	2nd Level Classrooms	Window Mounted Air Conditioning Unit(s)	None	Prior to the removal and disposal of equipment suspected of containing ODS, a licensed technician should be retained to drain and tag the equipment in a manner authorized under O. Reg. 463/10
