Re: Hazardous Building Materials Assessment (Pre-Construction)
Hampton Junior Public School, 43 Ormiston Street, Hampton, Ontario
Pinchin File: 335324.001

Kawartha Pine Ridge District School Board (KPRDSB) (Client) retained Pinchin Ltd. (Pinchin) to conduct a hazardous building materials assessment at Hampton Junior Public School located at 43 Ormiston Street, Hampton, Ontario.

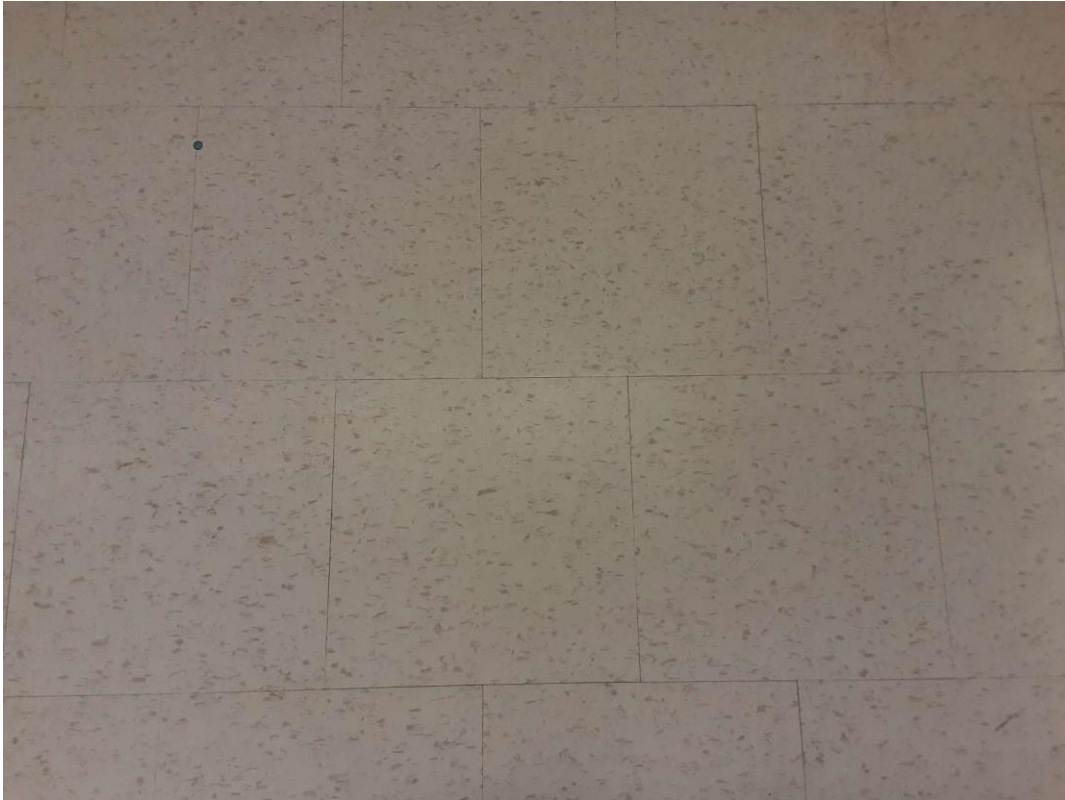
V0003 (None), 12" by 12" Vinyl Floor Tile and Mastic in Location #: 7

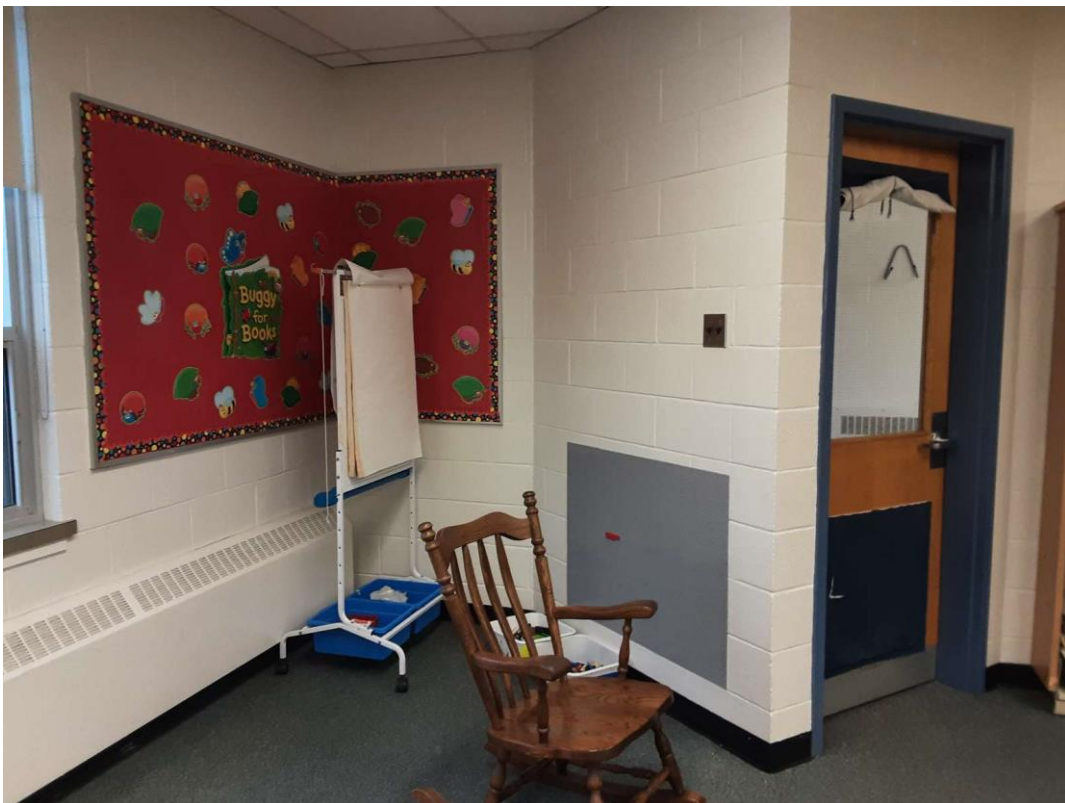
S0029C (None), White paint on block wall in the Library (Location #: 37)

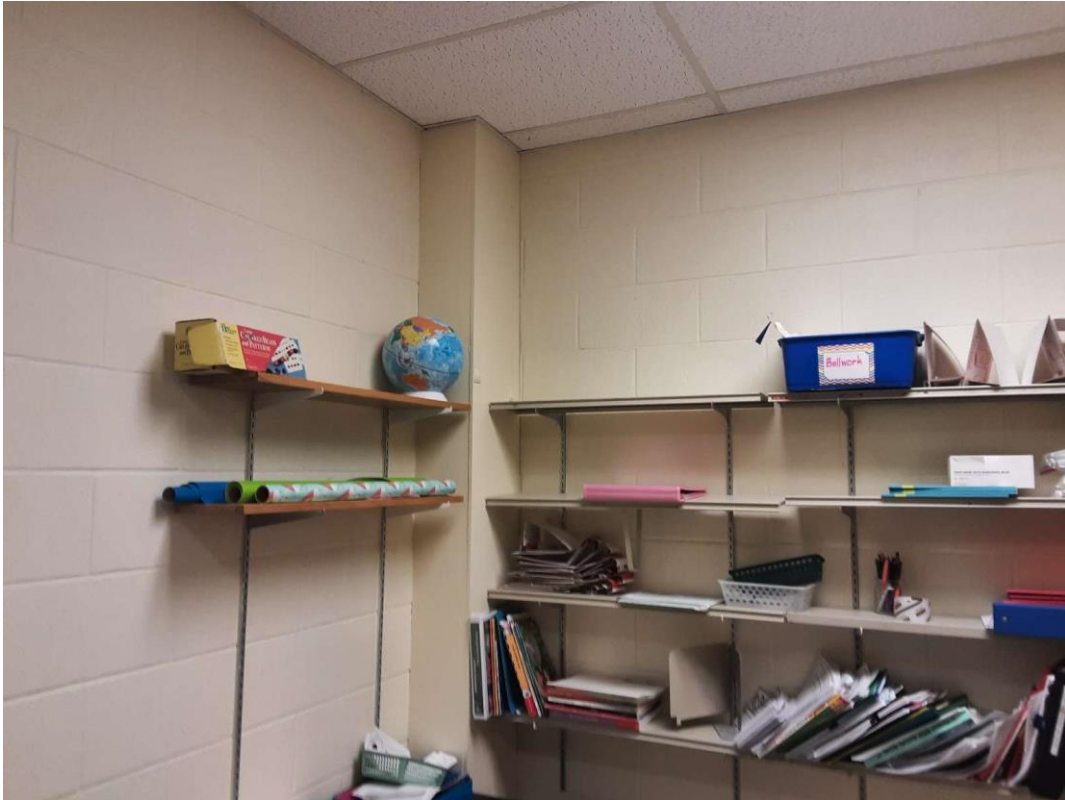
S0030C (None), Beige paint on block wall in the Work Room (Location #: 38)

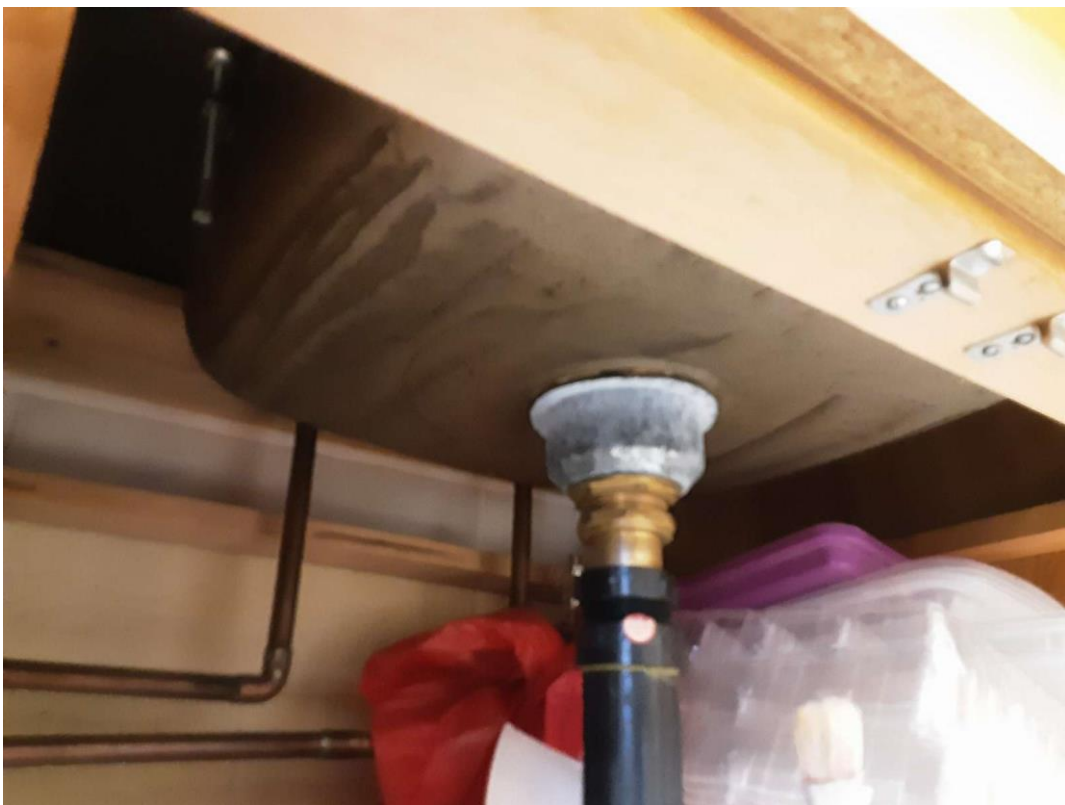
S0032C (Confirmed Asbestos), Sink mastic on sink bottom in Work Room (Location #: 38)
Located on the underside of the sink

Remove asbestos-containing materials (ACM) prior to renovation, alteration, or maintenance if ACM may be disturbed by the work.

Asbestos-containing materials must be disposed of at a landfill approved to accept asbestos waste.

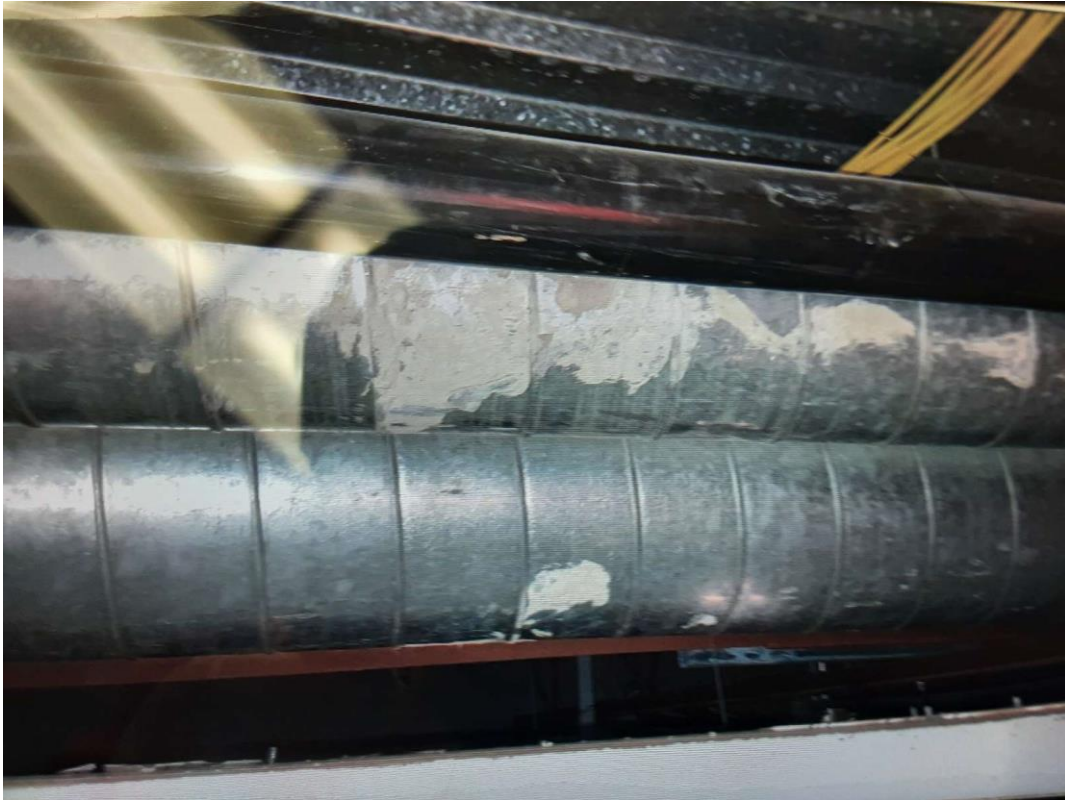
S0033C (None), Cementitious product on ducts in the Library (Location #: 37)

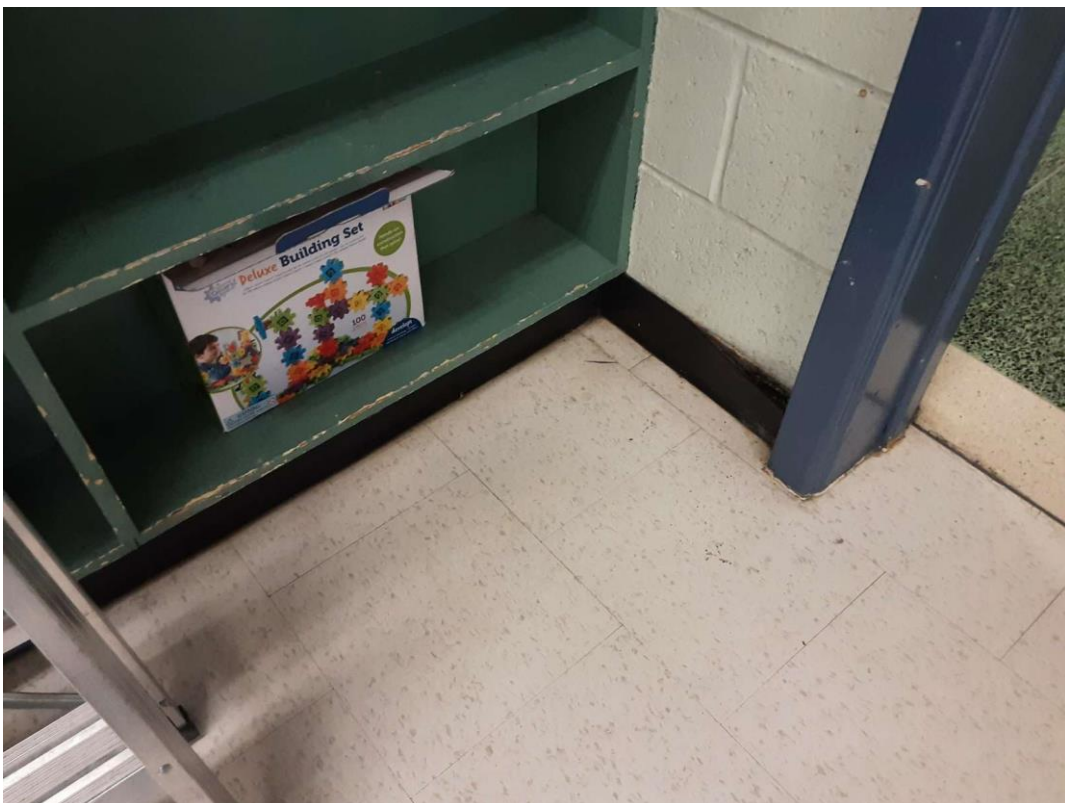
S0034C (None), Mastic behind vinyl baseboard in Location #: 7

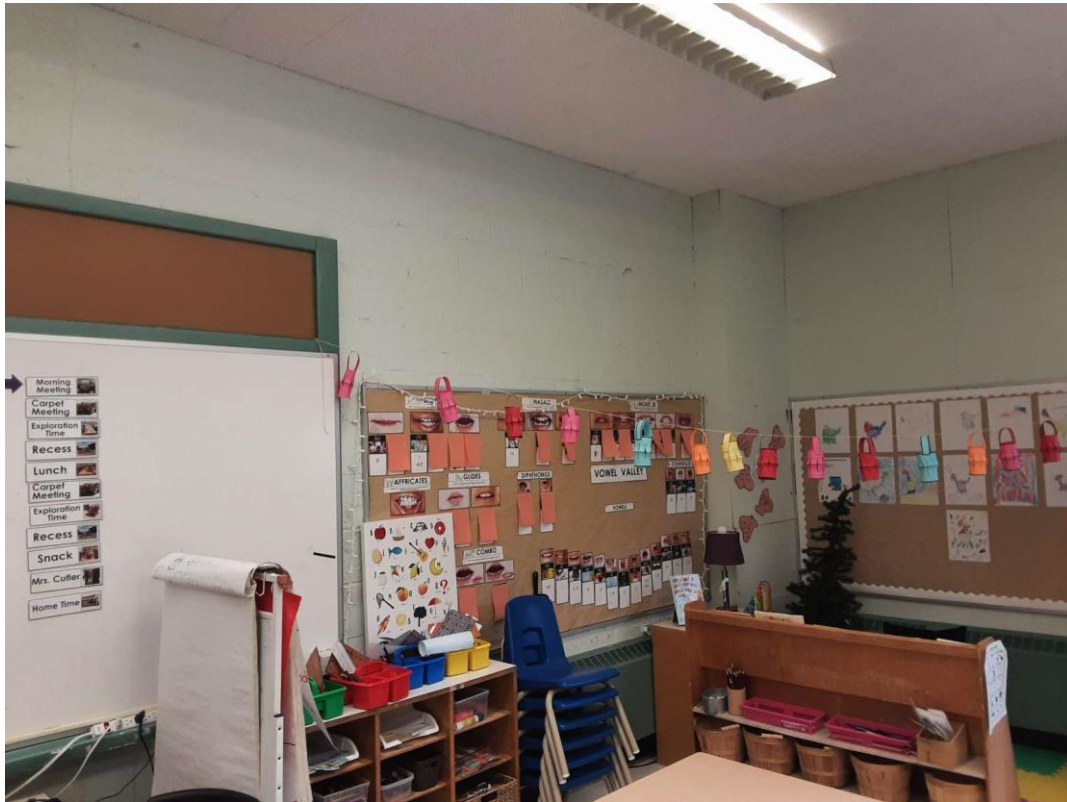
S0035C (None), Blue paint on block wall in Location #: 7

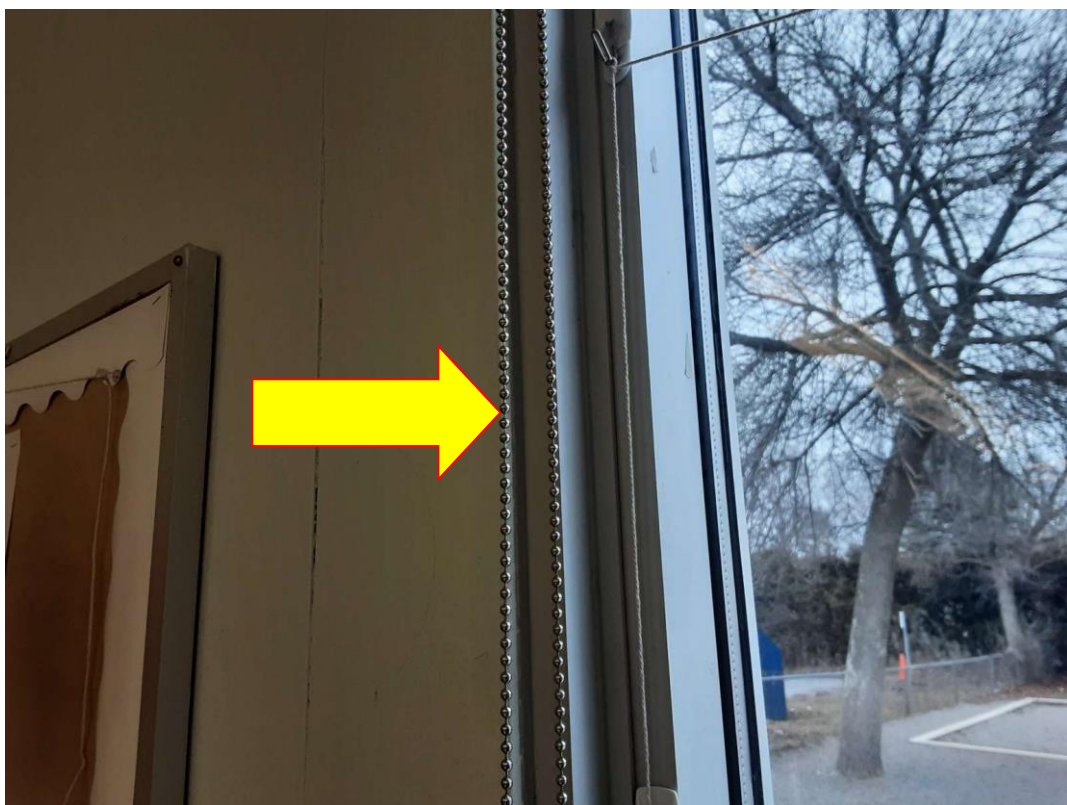
S0036C (None), Grey caulking around windows in Location #: 7

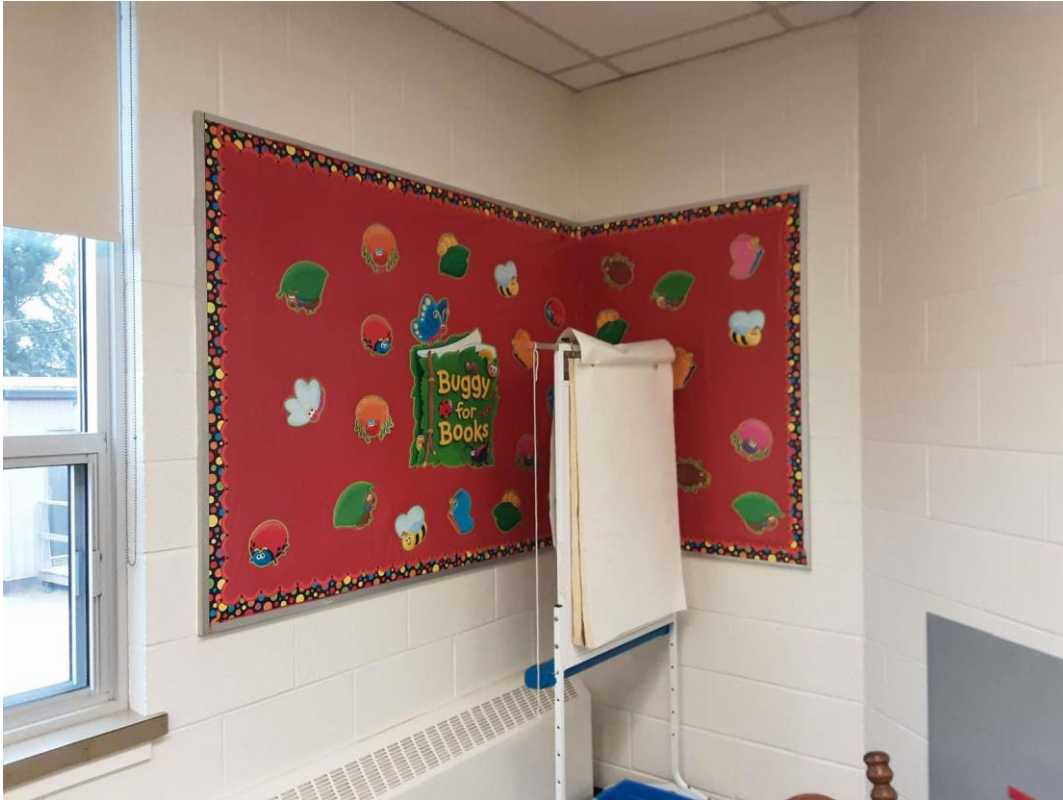
V9500 (Presumed Asbestos), Mastic behind corkboard in the Library (Location #: 37)

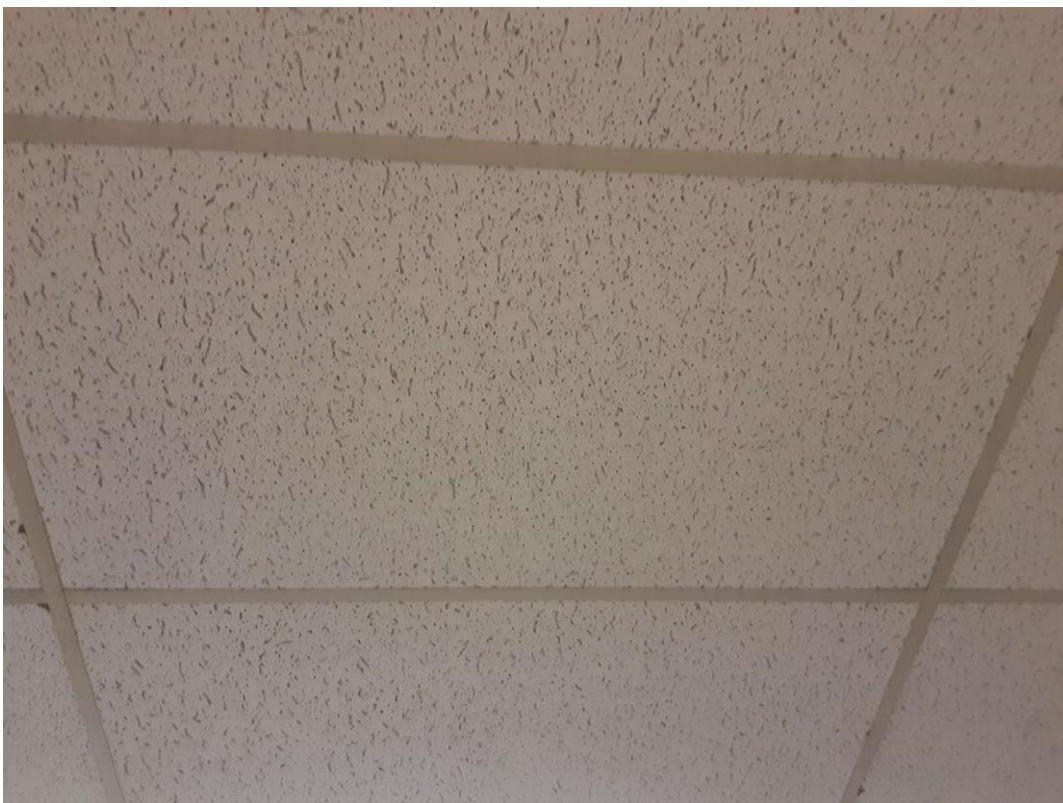
V0000 (None), 2ft by 4ft pinhole and fissure Ceiling Tiles (lay-in) in the Library (Location #: 37)
Date code 3183B

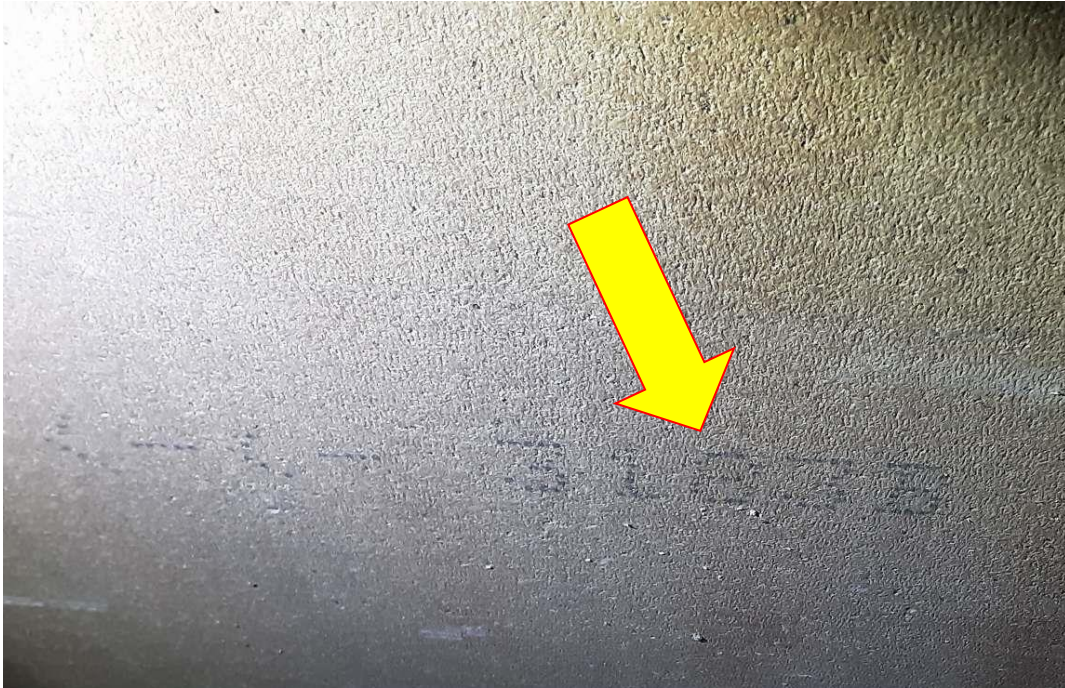
V0000 (None), 2ft by 4ft pinhole and fissure, Ceiling, Ceiling Tiles (lay-in), LIBRARY (Location #: 37)
Manufacturer code 3183B

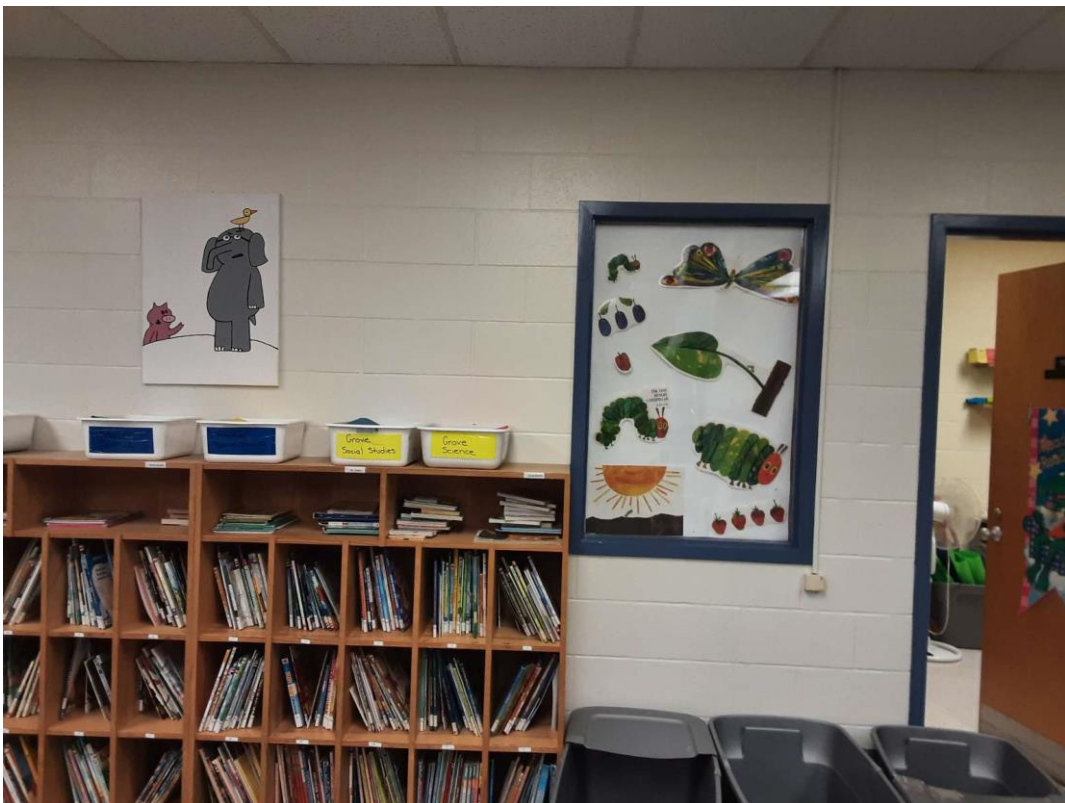
L0001(Lead, High), White paint on block wall in the Library (Location #: 37)

For lead-containing or lead-based paints (i.e., greater than the EACC guideline of 0.1% (1,000 mg/kg) for lead-containing paints, and 0.5% (5,000 mg/kg) for lead-based), construction disturbance may result in over-exposure to lead dust or fumes. The need for work procedures, engineering controls and personal protective equipment should be assessed on a site-specific basis to comply with Ministry of Labour, Training and Skills Development regulations and guidelines.

Dispose of painted materials exceeding the criteria for leachable lead as hazardous waste.

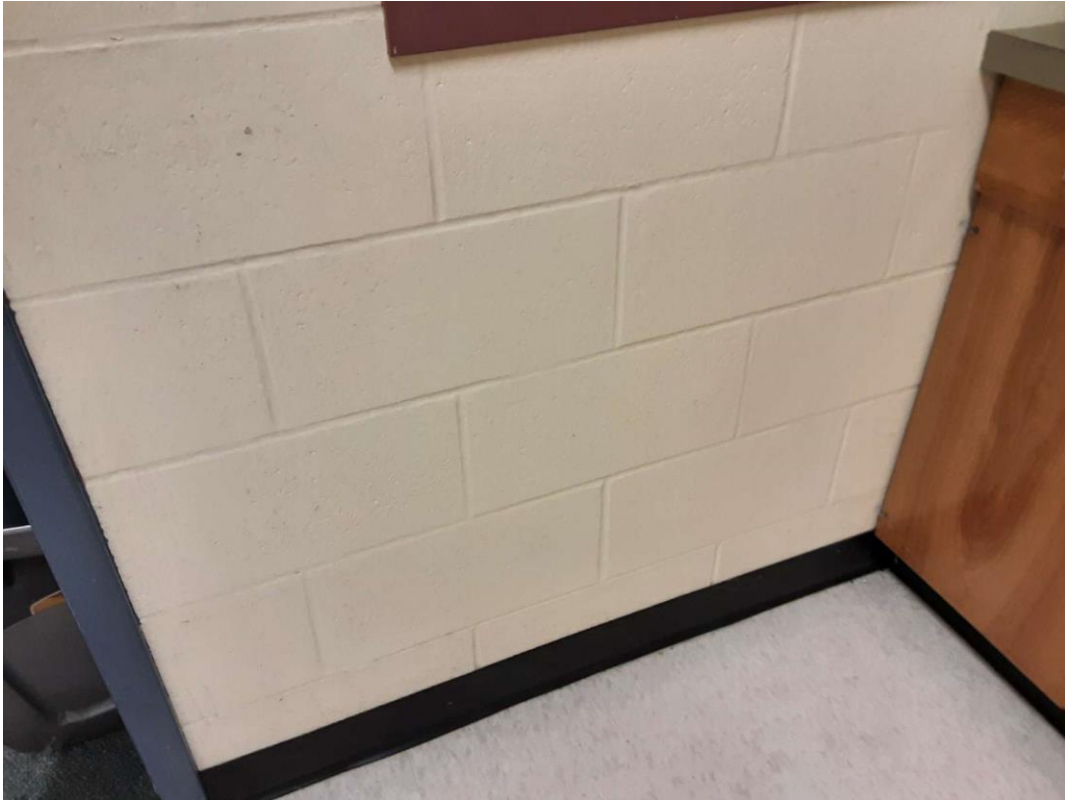
L0002(Lead, High), Beige paint on block wall in the Work Room (Location #: 38)

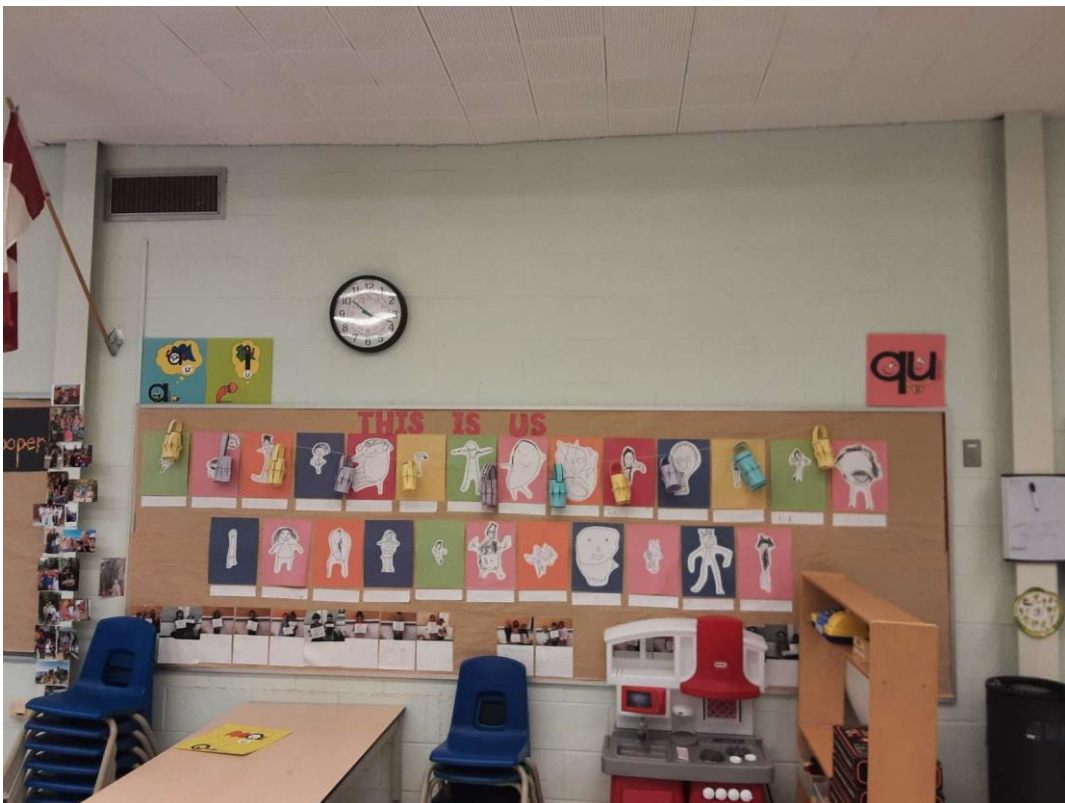
L0003(Lead, Low), Blue paint on block wall in Location #: 7

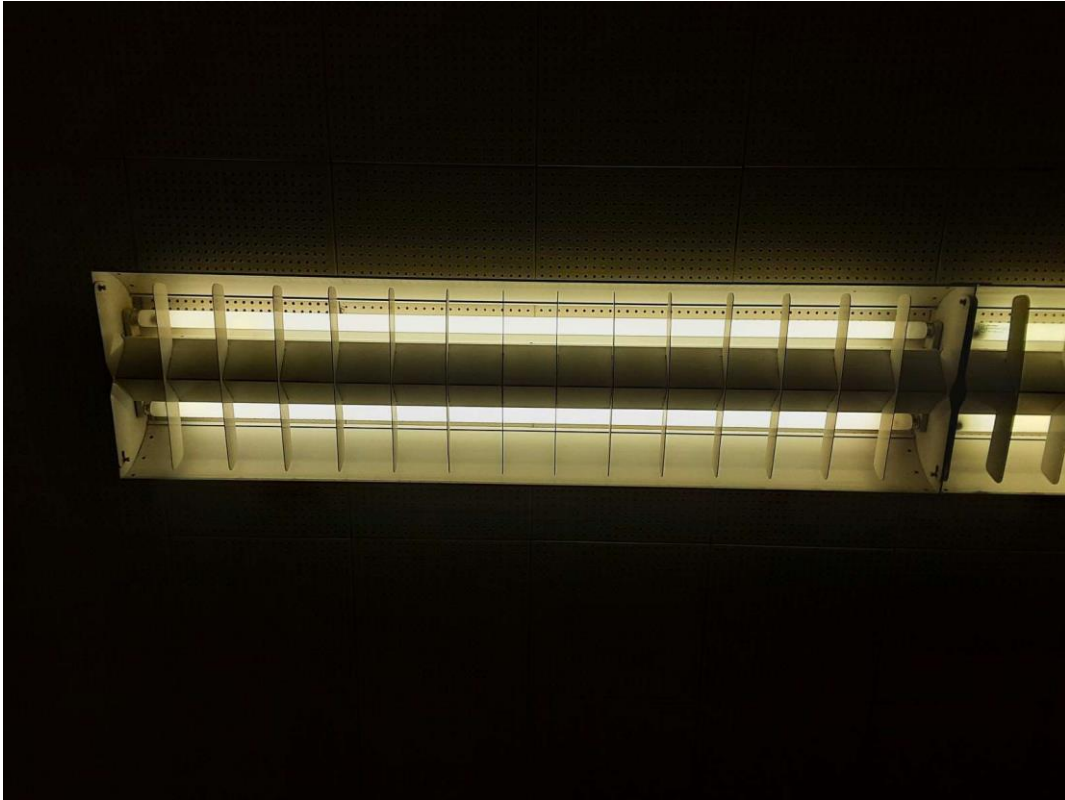
Mercury, V9000(Yes), Light Fixtures in Location #: 7

Do not break lamps. Recycle and reclaim mercury from fluorescent lamps when taken out of service. Mercury is classified as a hazardous waste and must be disposed of in accordance with applicable regulations.

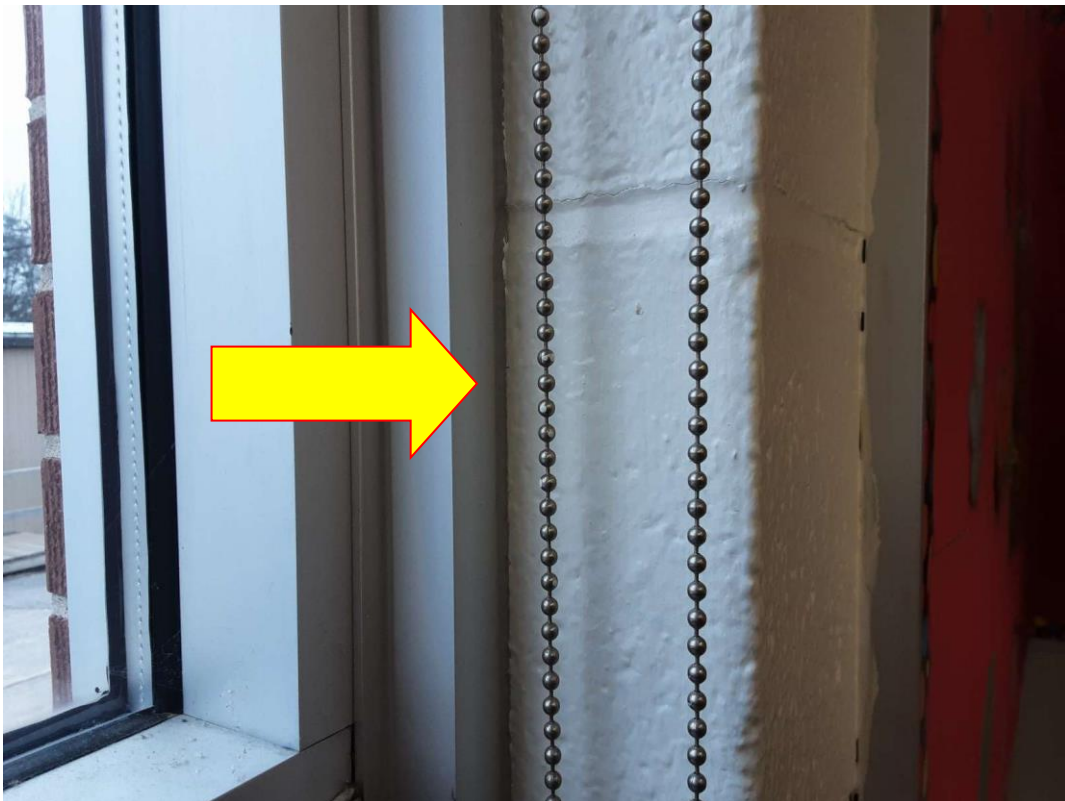
PCB, P0001(No), Grey caulking around windows in the Library (Location #: 37)
