Re: Hazardous Building Materials Assessment (Pre-Construction)
Clarke High School, 3425 Highway 35/115, R.R. # 8, Newcastle, Ontario
Pinchin File: 335495.030

Kawartha Pine Ridge District School Board (KPRDSB, Client) retained Pinchin Ltd. (Pinchin) to conduct a hazardous building materials assessment of Clarke High School located at 3425 Highway 35/115, R.R. #8, Newcastle, Ontario.

The objective of the assessment was to identify specified hazardous building materials in preparation for building renovations. The proposed work as identified by the Client includes alterations/upgrades to Classrooms on the North side of the building.

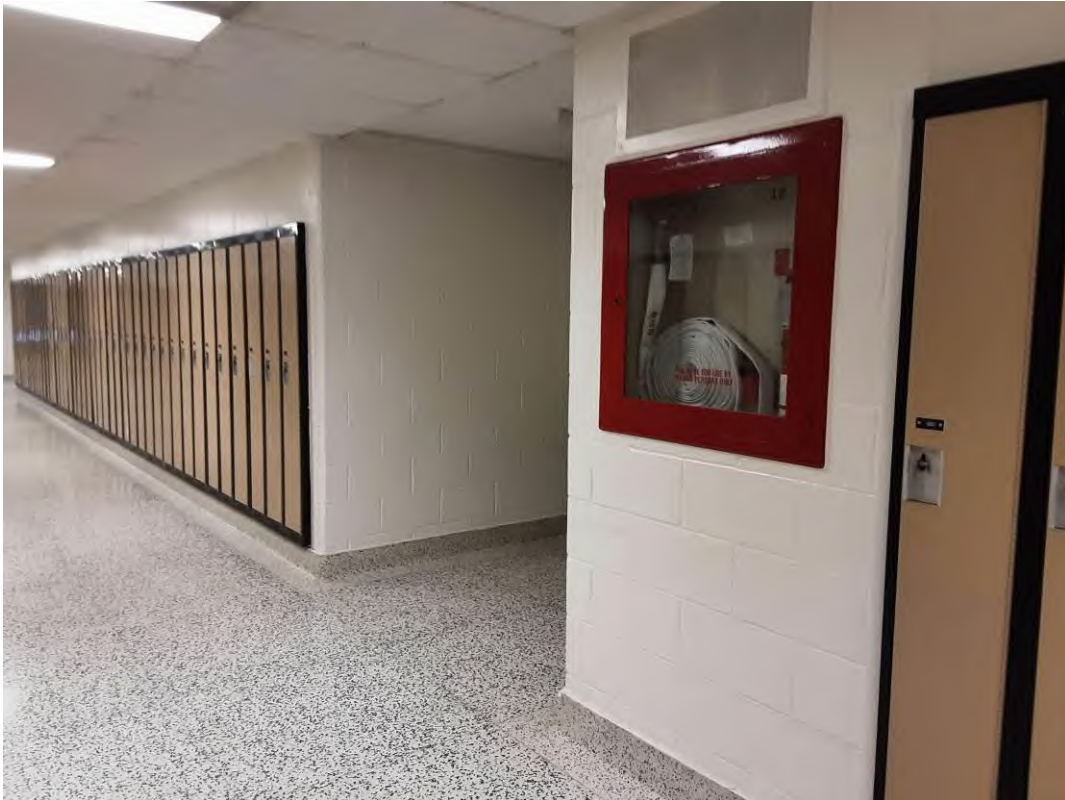
S0049F (None), White paint on block wall in the Corridor (Location #: 89)

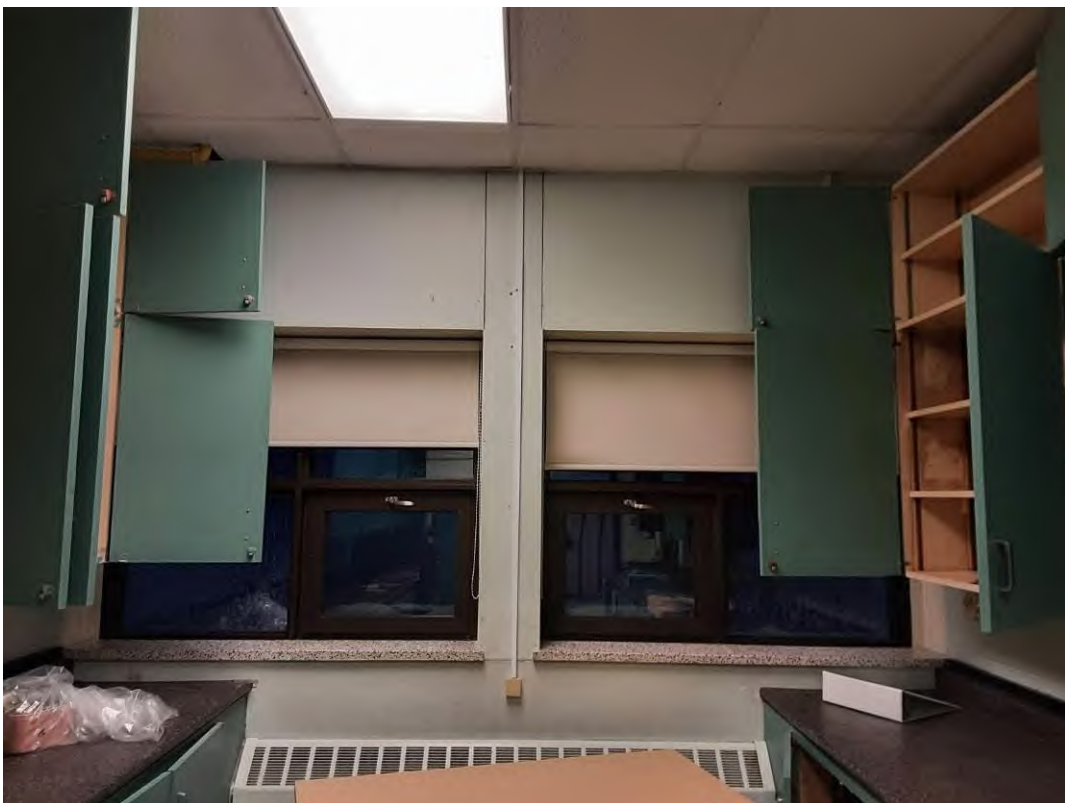
S0051C (None), Plaster on wall in the Prep Room (Location #: 21)

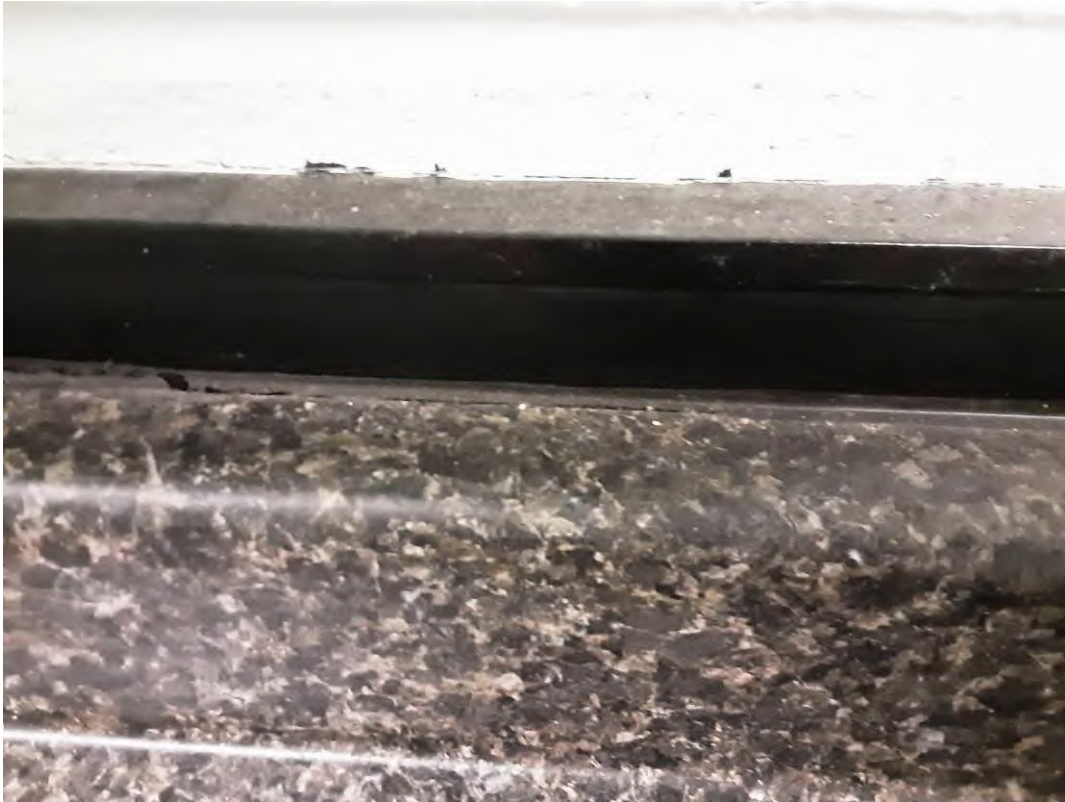
S0052C (None), Black caulking in the Prep Room (Location #: 21)

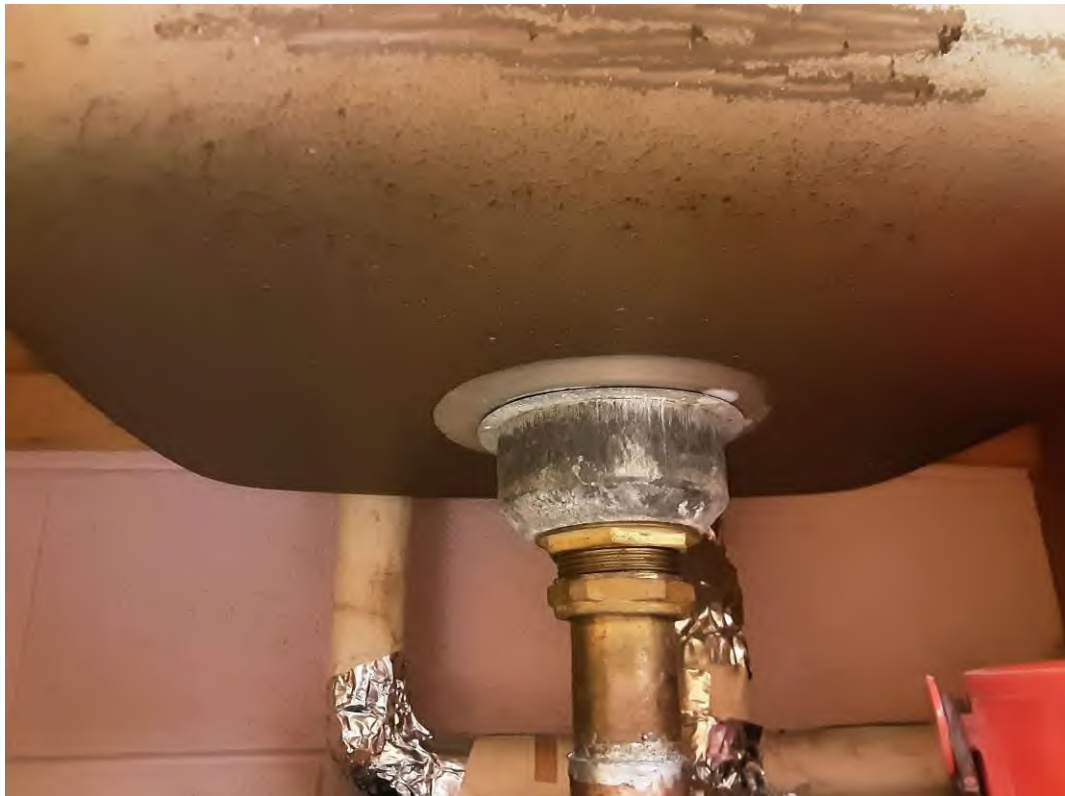
S0056C (Confirmed Asbestos), Sink mastic in the Study/Storage (Location #: 101)

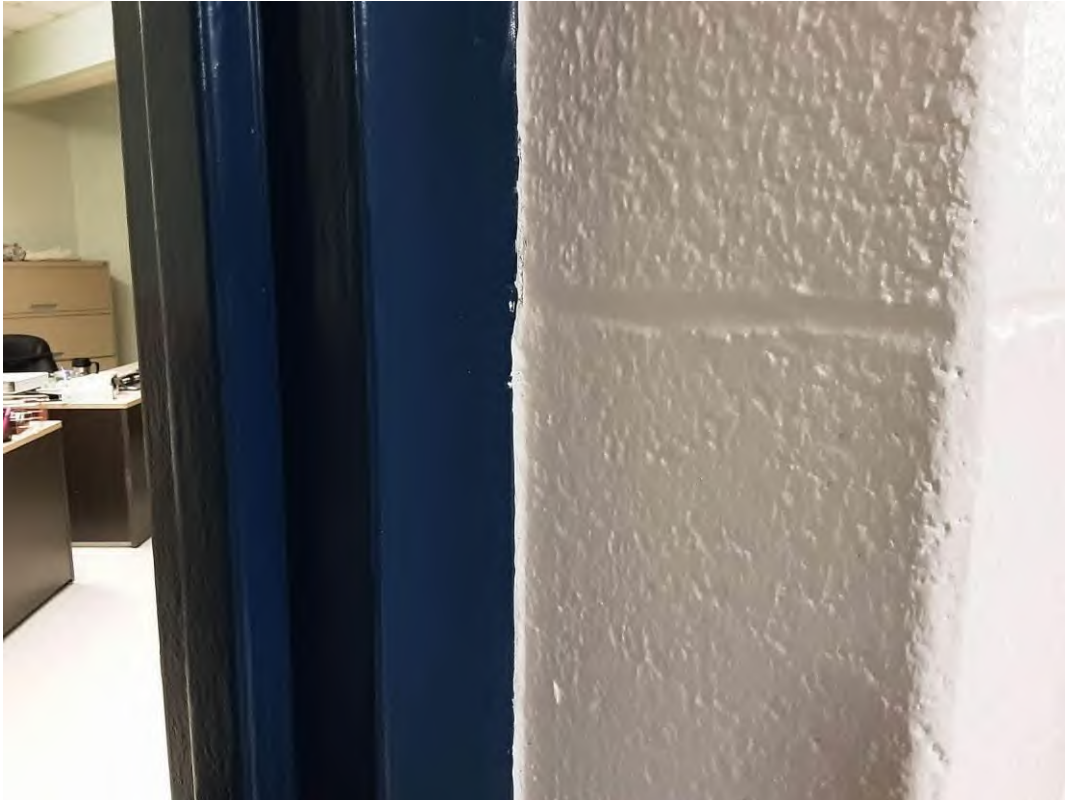
S0057C (None), Grey caulking around door frame in the Corridor (Location #: 125)

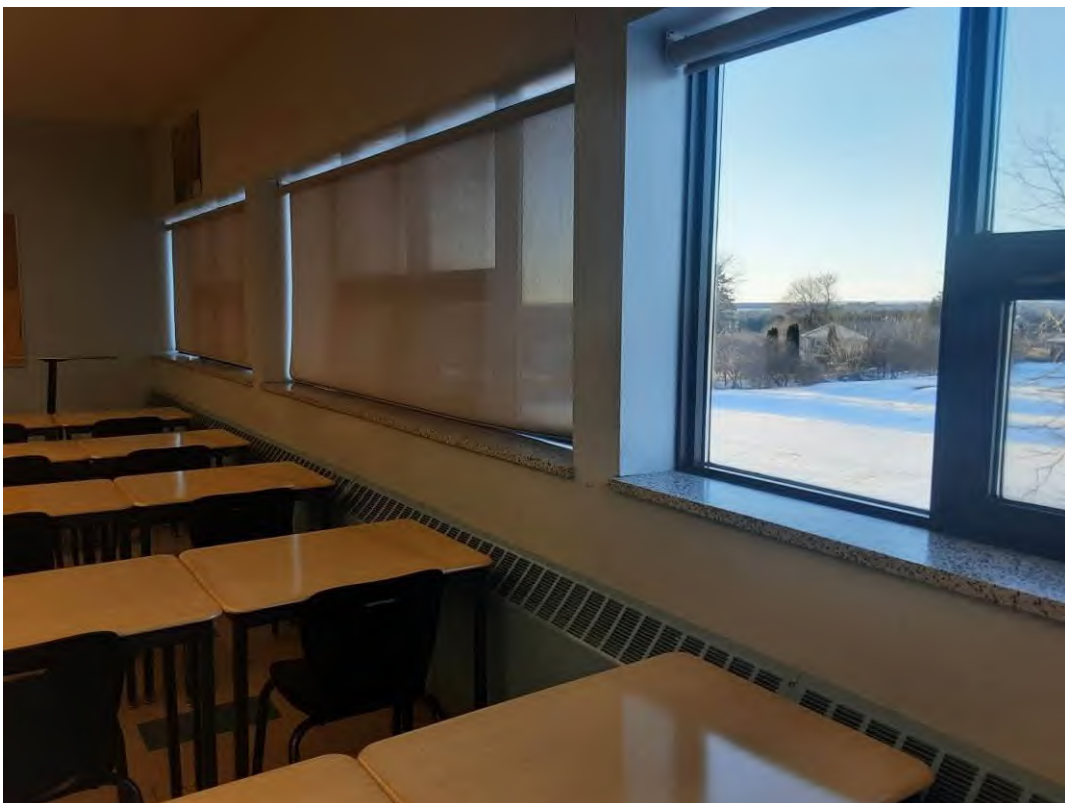
V9500 (Presumed Asbestos), Terrazzo window sills in Classroom (Location #: 105)

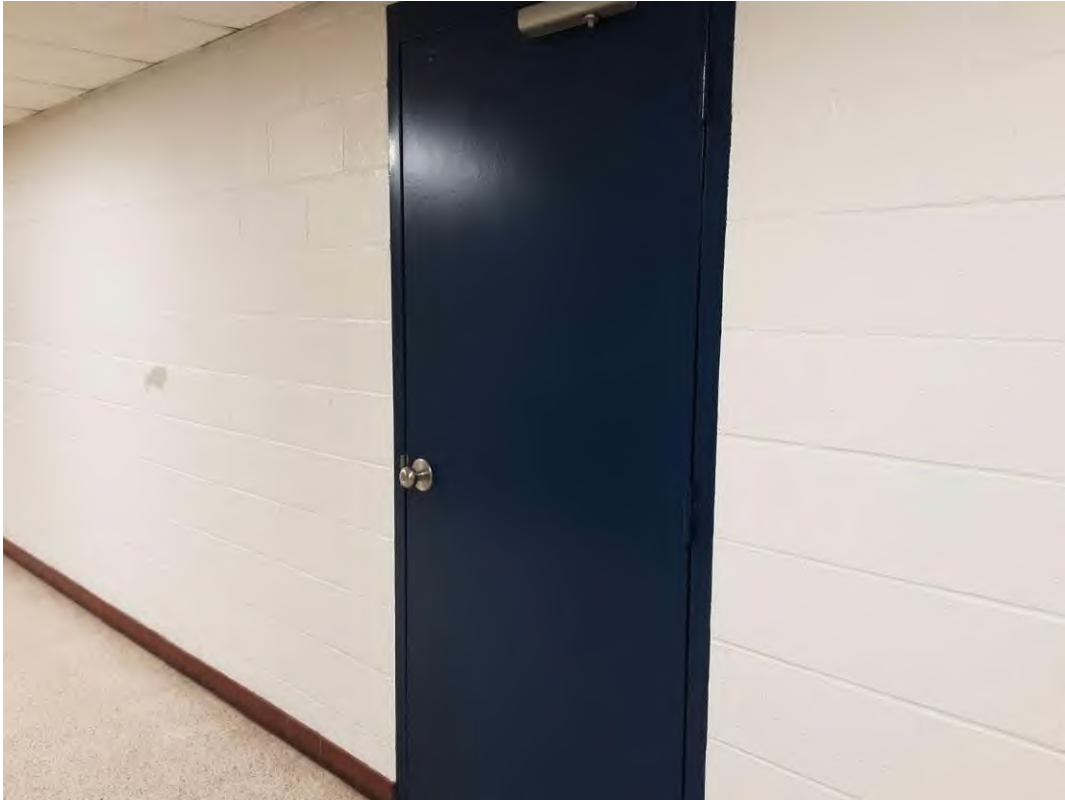
V0013(Lead, Low), Blue paint on doors and door frames in the Corridor (Location #: 125)

For paints identified as having low levels of lead (i.e., equal to or above 0.009% (90 mg/kg) but less than or equal to the EACC guideline of 0.1% (1,000 mg/kg) for lead-containing paints) special precautions are not recommended unless aggressive disturbance (grinding, blasting, torching) is planned.

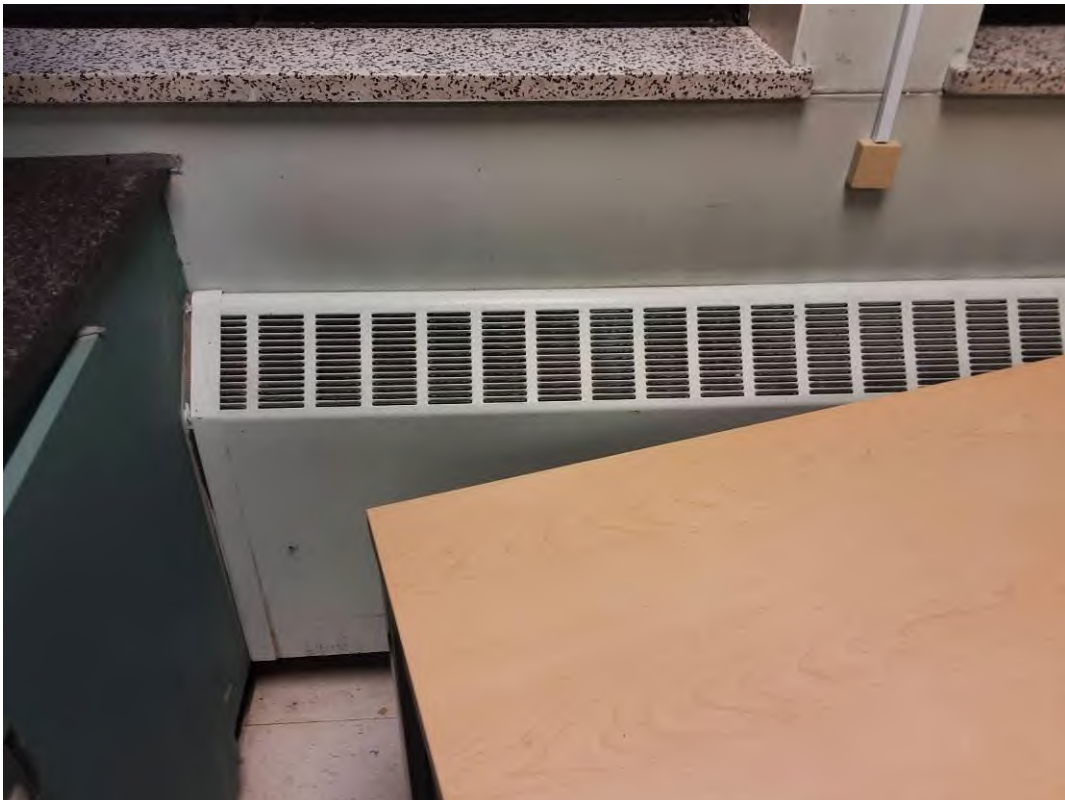
V0014(Lead, Low), Light blue paint on radiator vents in the Prep Room (Location #: 21)

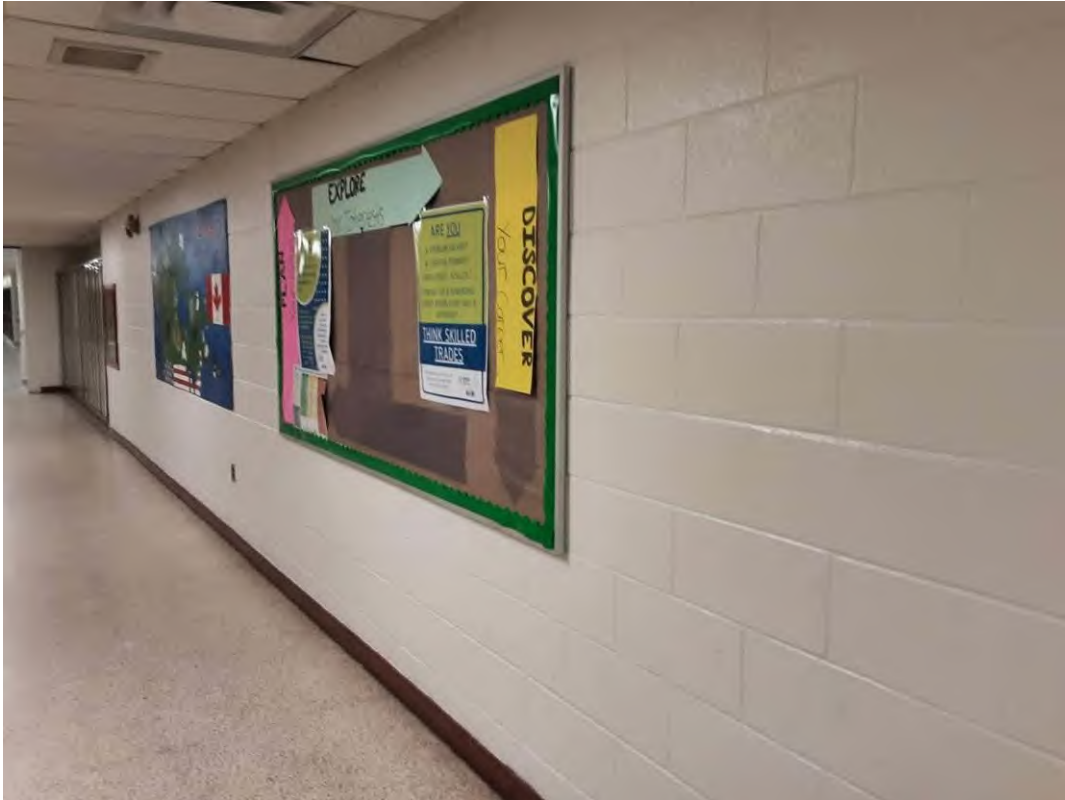
V0015(Lead, Low), White paint on masonry walls in the Corridor (Location #: 125)

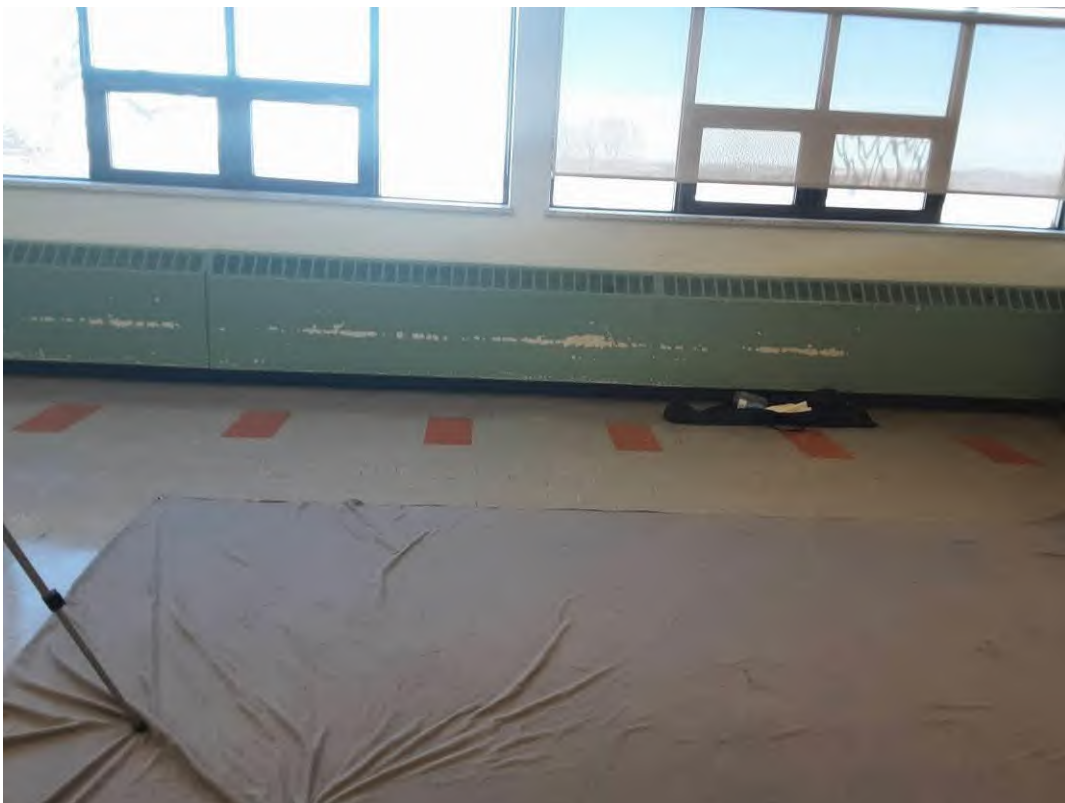
V0016(Lead, High), Green paint on radiators in the Classroom (Location #: 106)

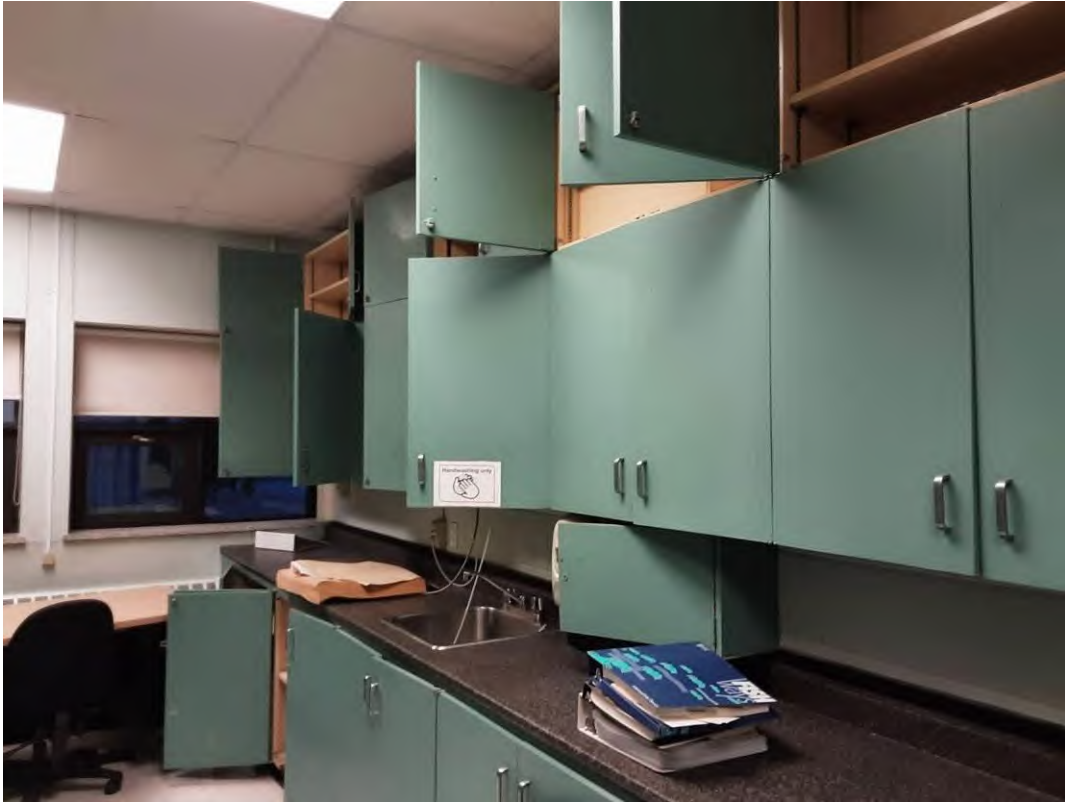
L0016(Lead, High), Green paint on cupboards in the Prep Room (Location #: 21)

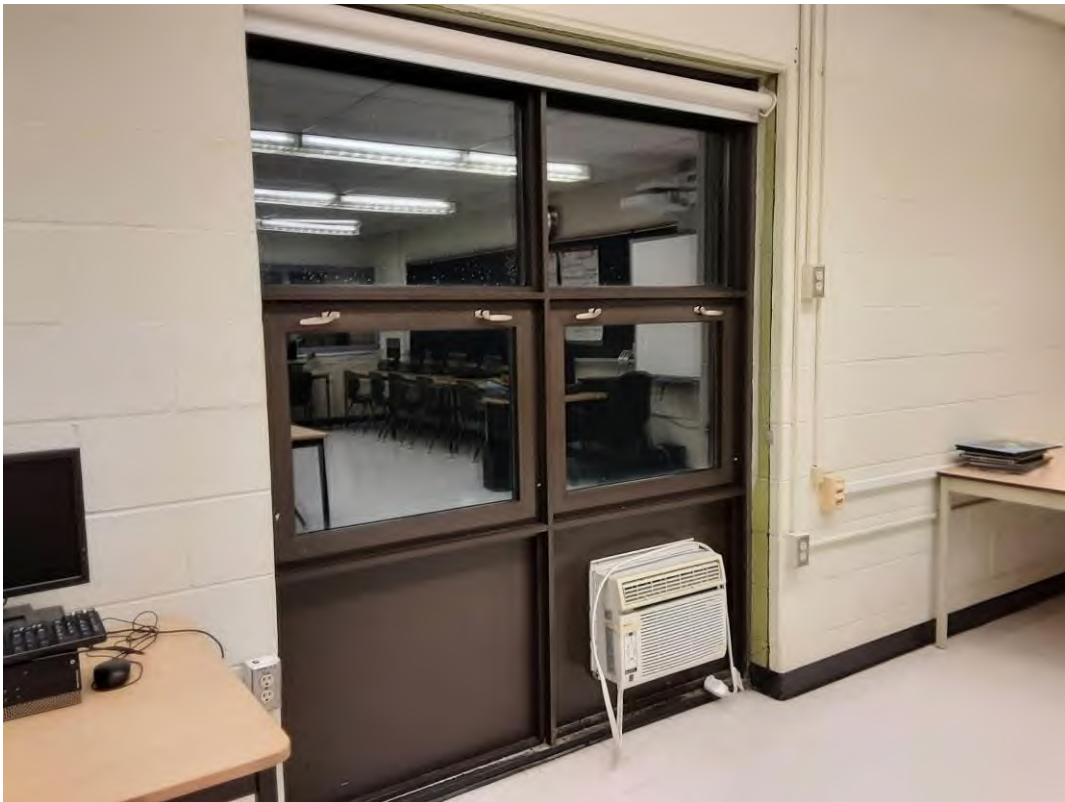
V9500(Presumed Lead), Black paint on windows frame in the Classroom (Location #: 100)

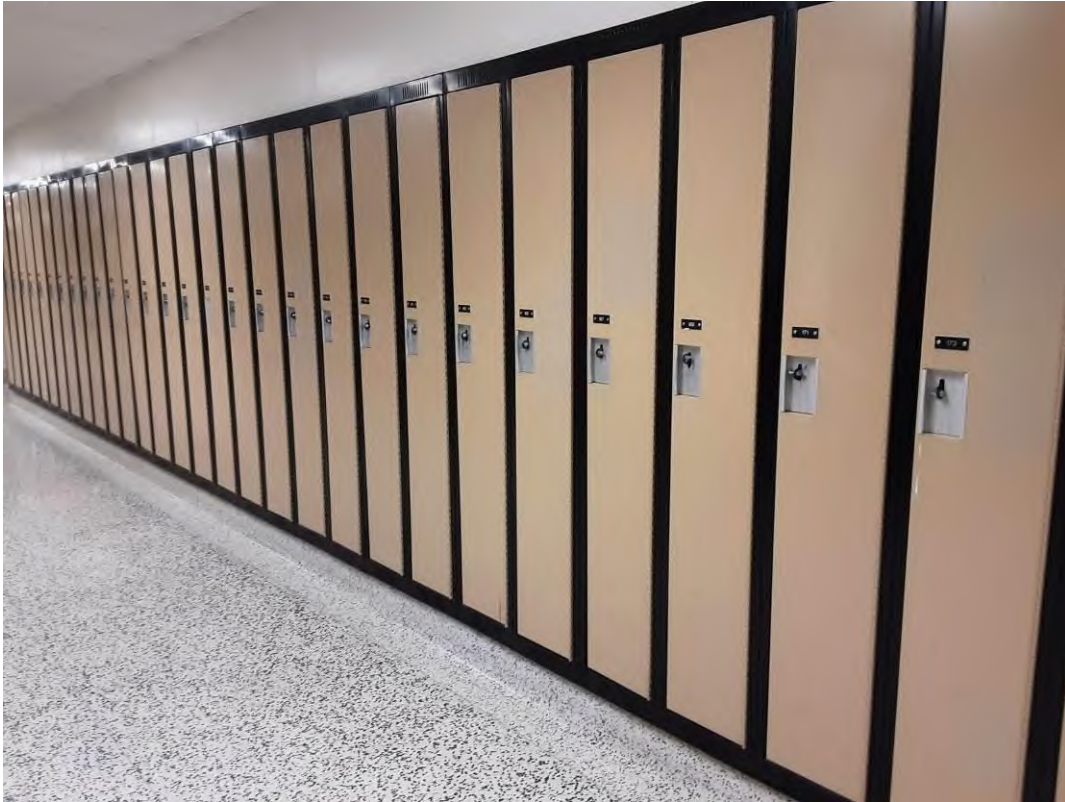
V9500(Presumed Lead), Beige paint on lockers in the Corridor (Location #: 89)

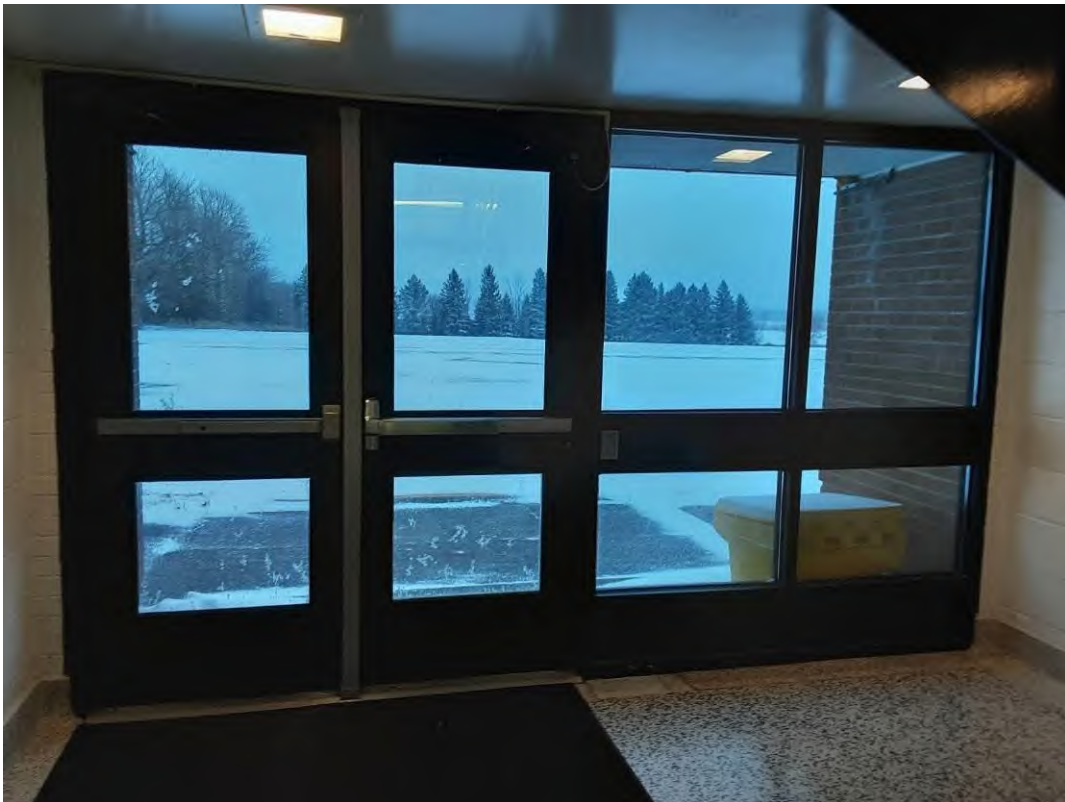
V9500(Presumed Lead), Black paint on doors and frames in the Stairs (Location #: 90)

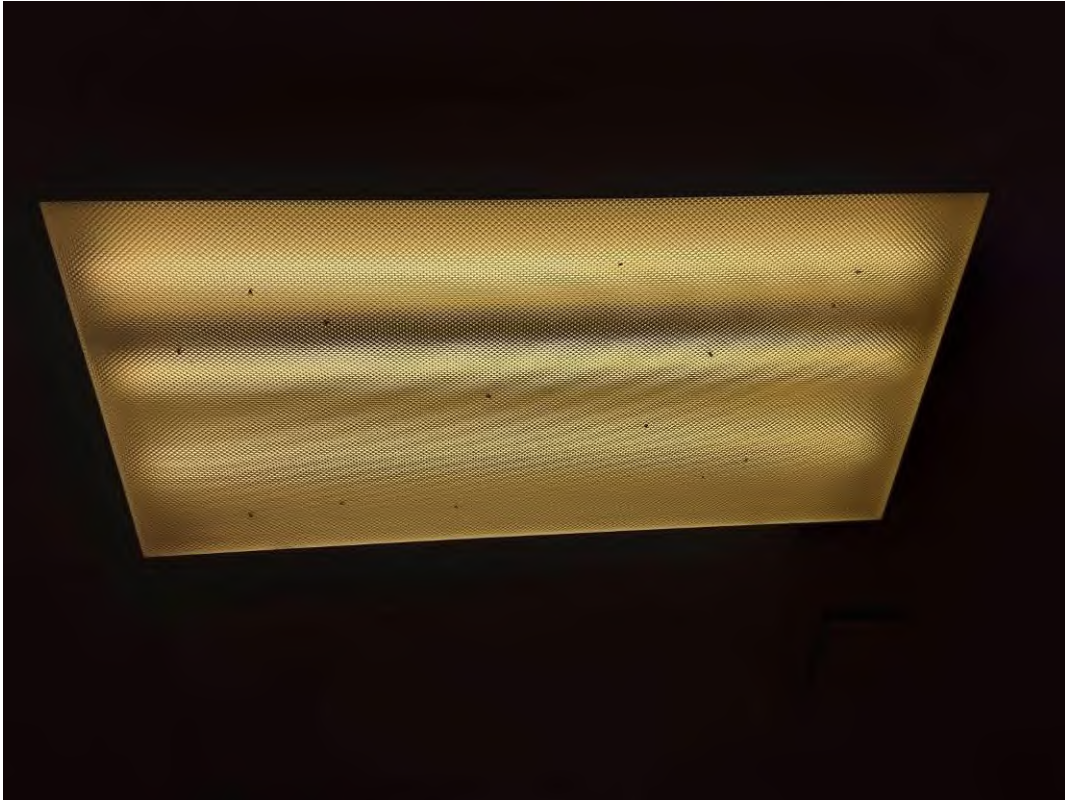
Mercury, V9000(Yes), Light Fixtures in the Classroom (Location #: 22)

Do not break lamps. Recycle and reclaim mercury from fluorescent lamps when taken out of service. Mercury is classified as a hazardous waste and must be disposed of in accordance with applicable regulations.

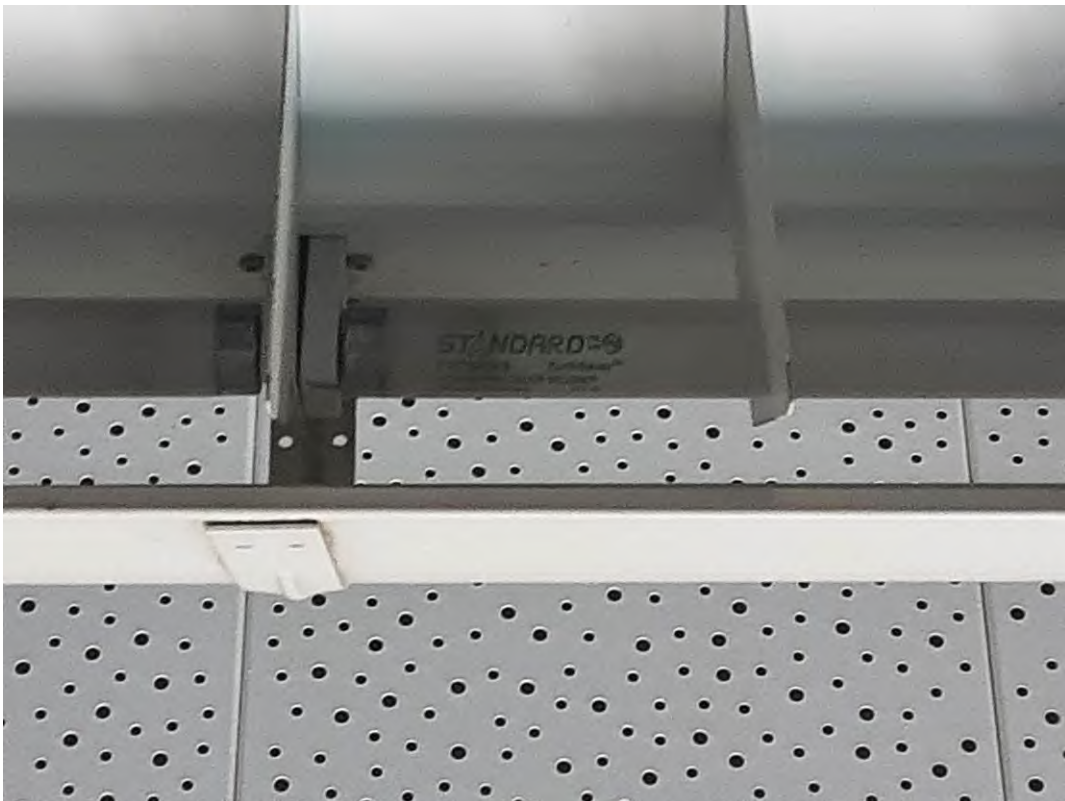
Mercury, V9000(Yes), Light Fixture in the Classroom (Location #: 105)

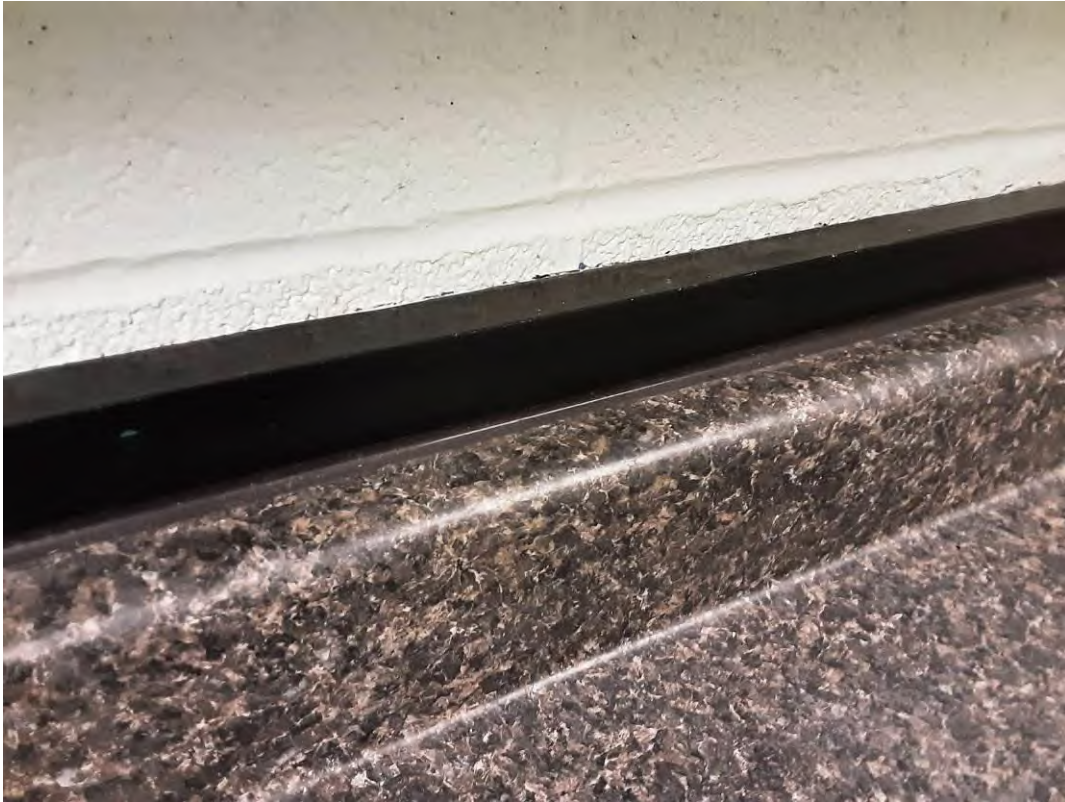
PCB, P0001(No), Black caulking in the Prep Room (Location #: 21)
