At the request of Tacoma Engineers (the Client), Durham EHS is pleased to provide this report on the designated substance survey (DSS) completed within select locations of the Erin Community Center, 14 Boland Drive, Erin, Ontario (the Site). The DSS was required prior to renovation and was conducted by Durham EHS on March 25th, 2024.

Erin Community Centre, 14 Boland Drive, Erin, ON

Job/Project Name: Erin Community Center

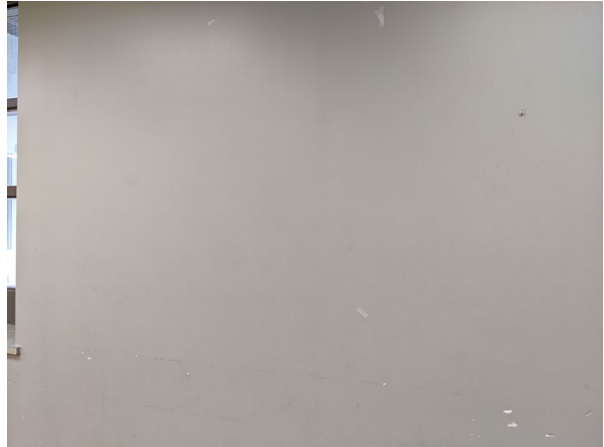
Samples 1A-G: non-asbestos drywall joint compound, throughout 1977 build

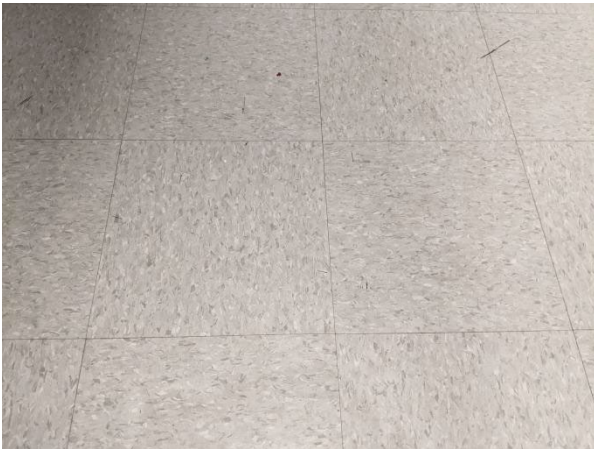
Samples 2A-C: non-asbestos grey flecked 12"x12" vinyl floor tile and mastic, Second Floor Servery, Second Floor Corridor, and OPP Office

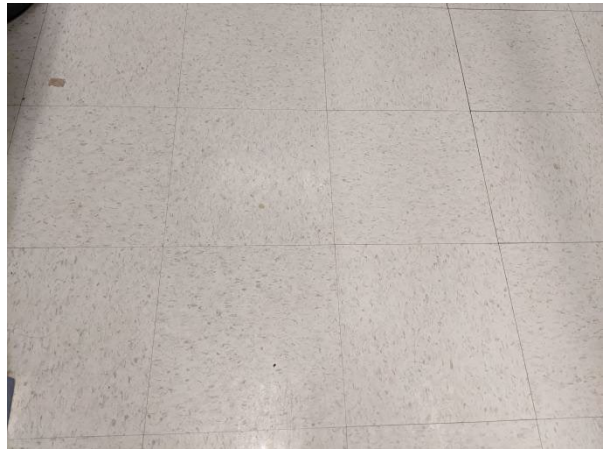
Samples 3A-C: non-asbestos white flecked 12"x12" vinyl floor tile and mastic; Second Floor Washrooms

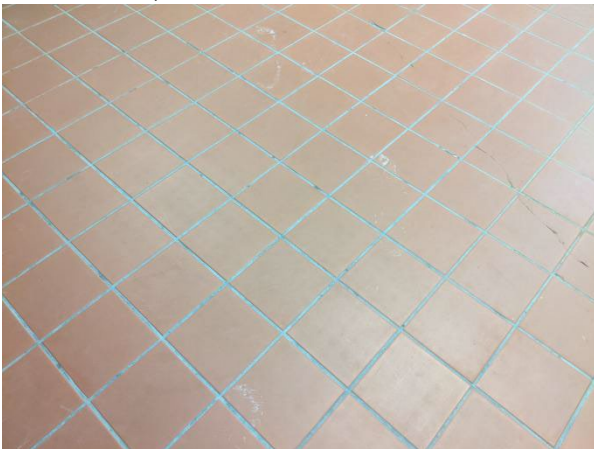
Samples 4A-C: non-asbestos terracotta tile grout, Stairwell/ Arena Vestibule

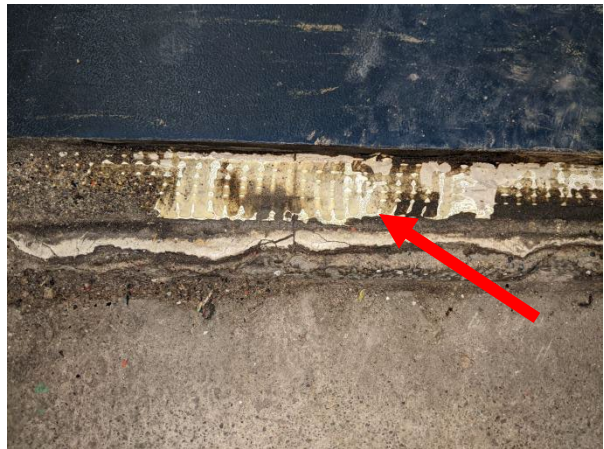
Samples 5A-C: non-asbestos concealed 12"x12" vinyl floor tile and mastic; Administration Office

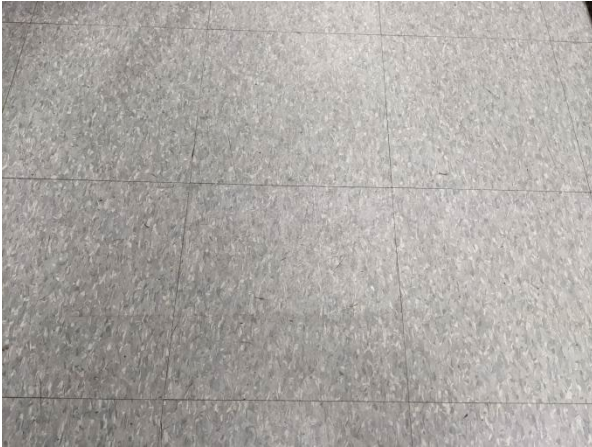
Samples 6A-C: non-asbestos dark grey flecked 12"x12" vinyl floor tile and mastic, Ground Floor Servery

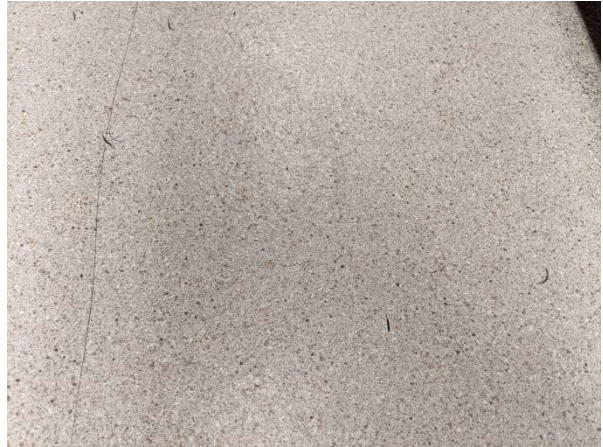
Samples 7A-C: non-asbestos brown pebbled vinyl sheet flooring, Ground Floor Kitchen

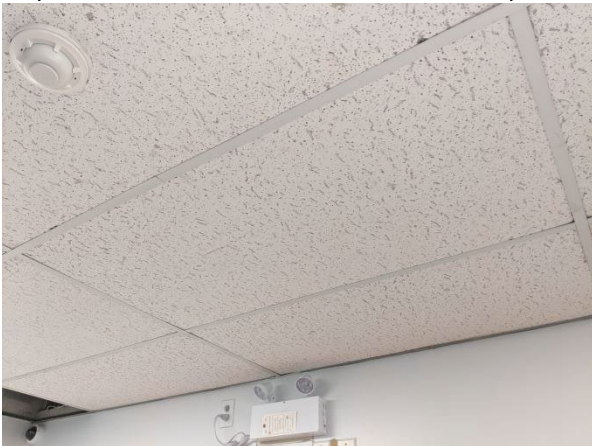
Samples 8A-C: non-asbestos acoustic ceiling tile, Second Floor Stairwell

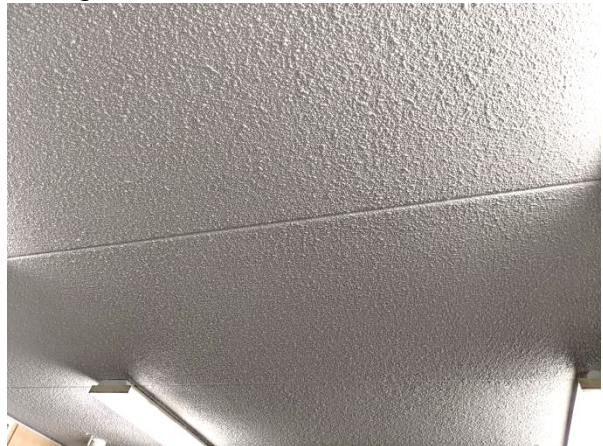
Samples 9A-E: non-asbestos ceiling texture coat, Ground Floor Main Corridor

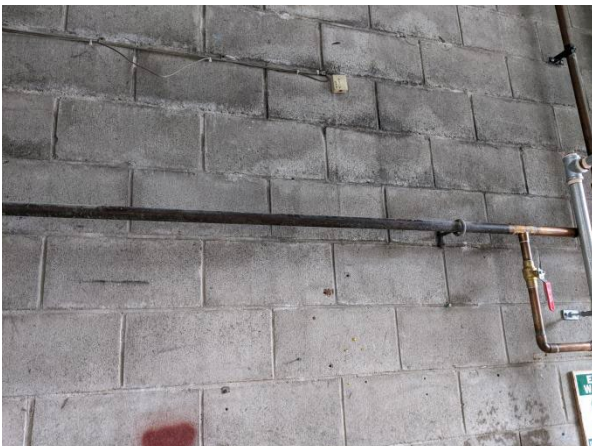
Samples 10A-C: non-asbestos concrete block mortar, 1977 build

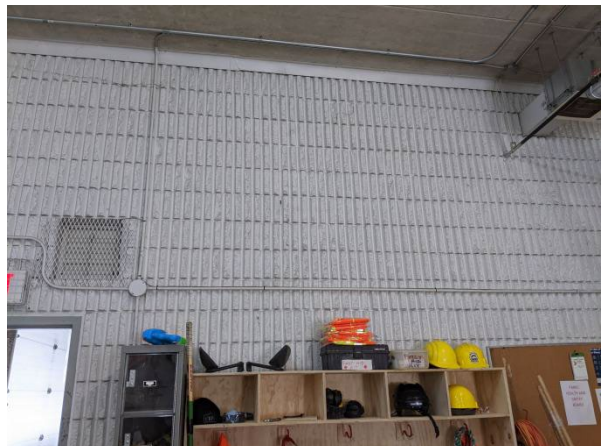
Samples 11A-C: non-asbestos brick mortar, Arena Storage Room

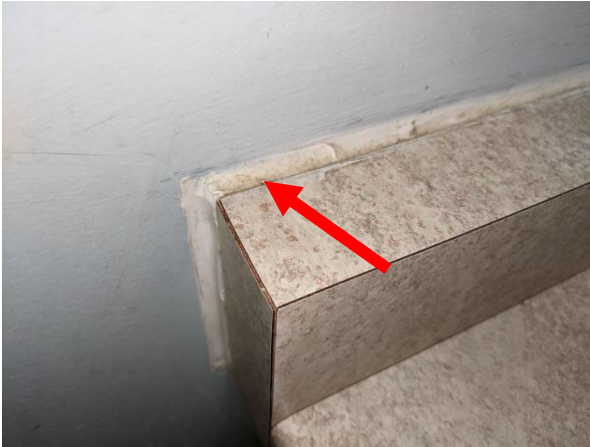
Samples 12A-C: non-asbestos white interior caulking, Second Floor Washrooms, Ground Floor Washrooms, and Ground Floor Kitchen

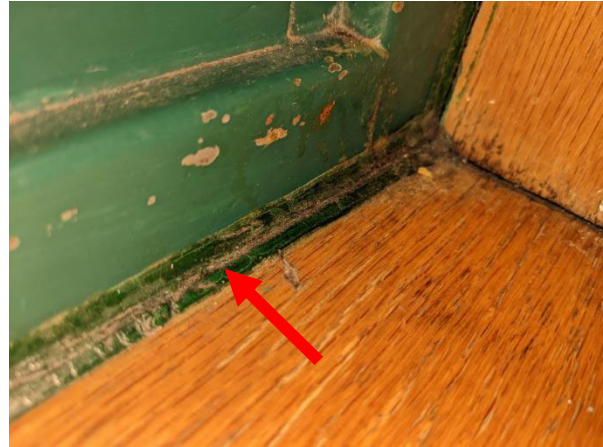
Samples 13A-C: non-asbestos green interior caulking, around wood window frames, Second Floor Multipurpose Room

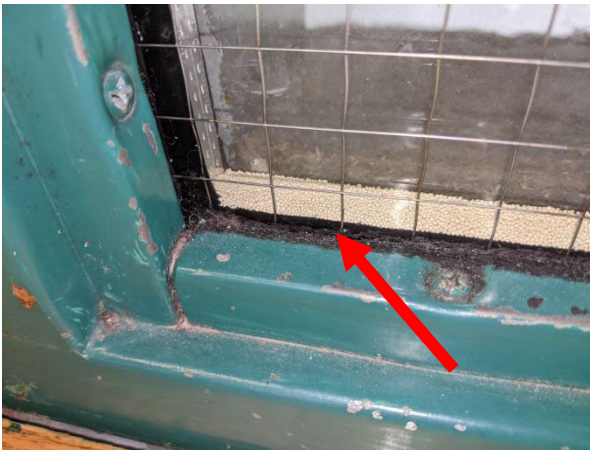
MATERIAL & LOCATION	RECOMMENDATIONS
<p><u>Black Glazing on Interior Windows; Second Floor Multipurpose Room, OPP Office, Ground Floor Main Corridor, 1977 build</u></p> <p>Samples 14A-C, approximately 95 linear meters of non-friable black interior window glazing, contains 2% chrysotile. The glazing was noted in good condition.</p>

Samples 14A-C: asbestos-containing black interior window glazing, Second Floor Multipurpose Room, OPP Office, Ground Floor Hall, 1977 build

<ul style="list-style-type: none"> • Manage in place. If there's potential for disturbance, remove the window glazing prior to renovation. • The window glazing can be removed following Type 1 procedures provided only non-powered hand-tools are used, and the material remains wetted during disturbance.

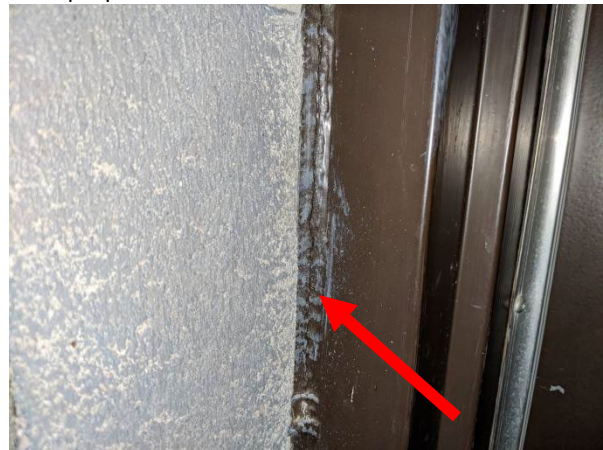
MATERIAL & LOCATION	RECOMMENDATIONS
<p><u>Grey Caulking Around Interior Window and Door Frames; Throughout The Ground Floor, 1977 build</u></p> <p>Samples 15A-C, approximately 50 linear meters of non-friable grey interior caulking around door frames and windows, contains 1% chrysotile. Some sections of the caulking are painted brown. The caulking was noted in good condition.</p>

Samples 15A-C: asbestos-containing grey caulking (some sections painted brown), Ground Floor interior door and window frames, 1977 build

<ul style="list-style-type: none"> • Manage in place. If there's potential for disturbance, remove the grey interior door and window caulking (some sections painted brown) prior to renovation. • The caulking can be removed following Type 1 procedures provided only non-powered hand-tools are used, and the material remains wetted during disturbance.
<p><u>White Caulking on Roof Flashing; East and West Roof, 1977 build</u></p> <p>Samples 18A-C, approximately 12 linear meters of non-friable white caulking on roof flashing contains 1% chrysotile. The caulking was noted in good condition.</p>

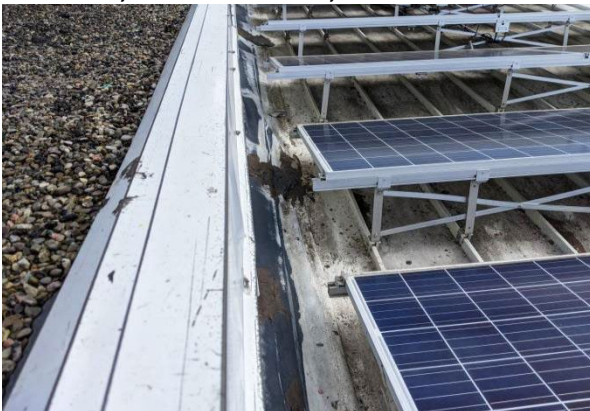
Samples 16A-C: non-asbestos roof seam membrane sealants, East Roof connection to Metal Roof

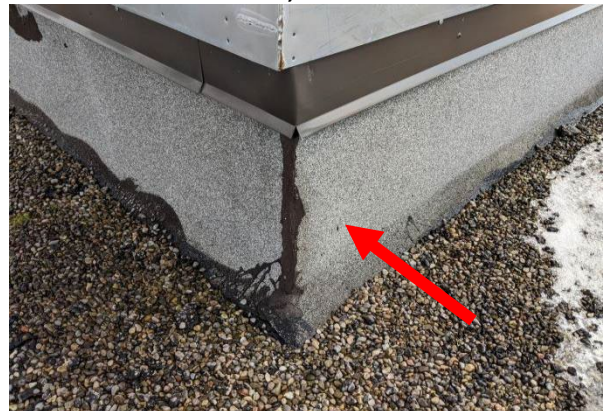
Samples 17A-C: non-asbestos asphalt sheeting, HVAC footings, East Roof

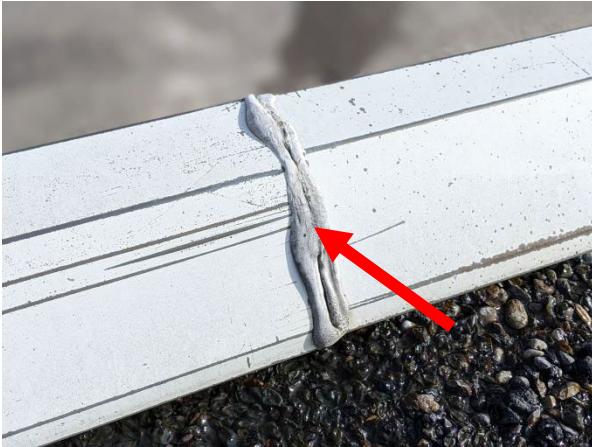
Samples 18A-C: asbestos-containing white caulking, roof flashing, East and West Roofs

<ul style="list-style-type: none"> • Manage in place. If there's potential for disturbance, remove the white caulking prior to renovation. • The caulking can be removed following Type 1 procedures provided only non-powered hand-tools are used, and the material remains wetted during disturbance.

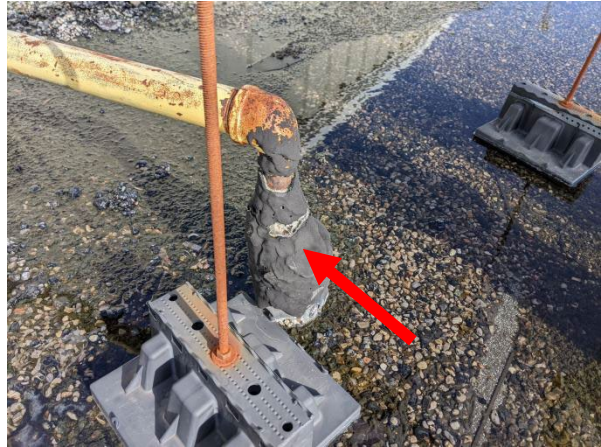
Samples 19A-C: non-asbestos tar sealant, roof penetrations, East and West Roofs

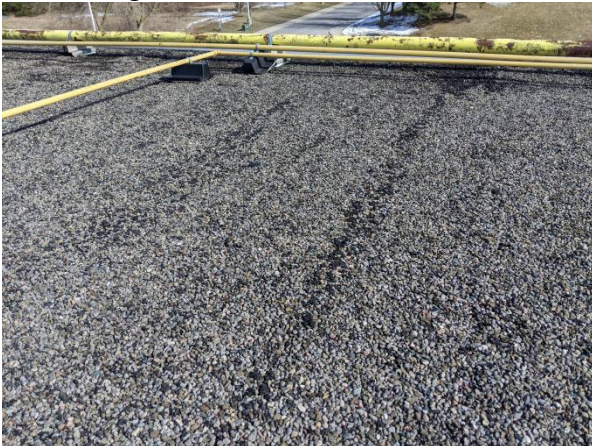
Samples 20A-C: non-asbestos built up roof matrix, East Roof

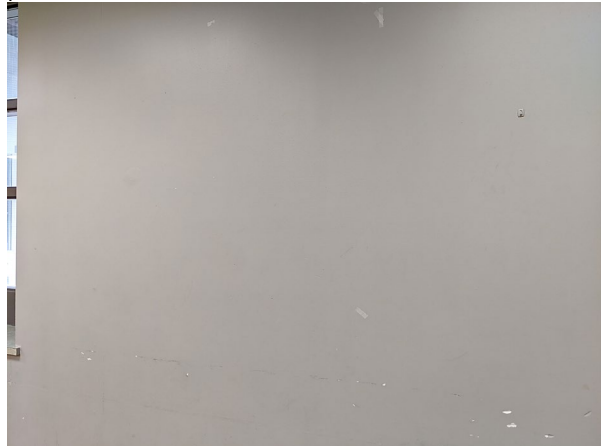
Sample LP1: non-lead dark blue-grey wall paint, throughout Second Floor

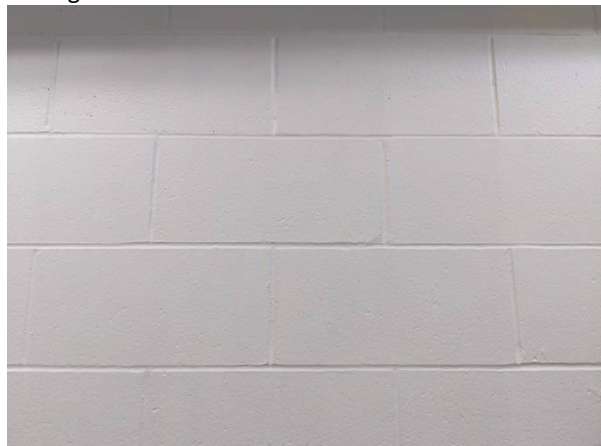
Sample LP3: non-lead white wall paint, throughout Ground Floor

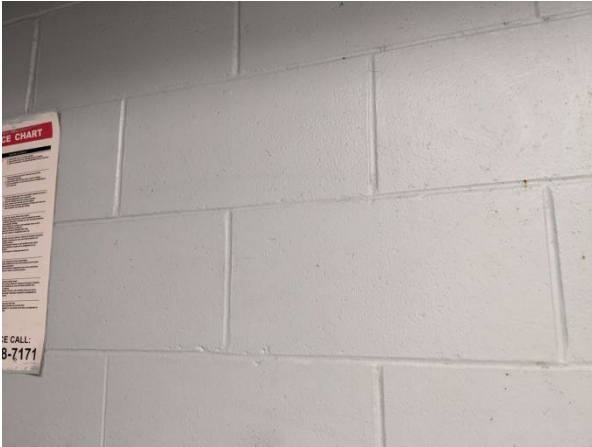
Sample LP4: non-lead light blue paint, Ground Floor Servery

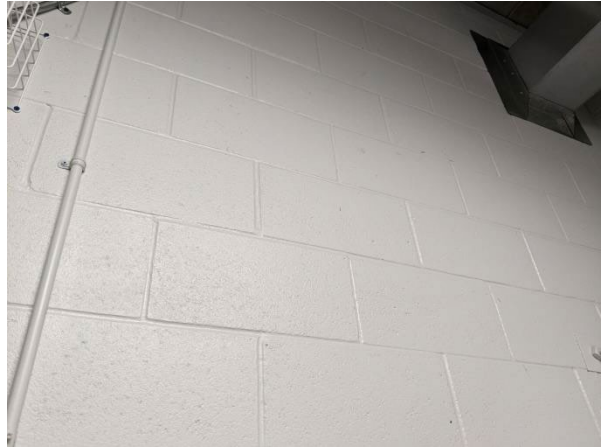
Sample LP5: non-lead light grey paint, Mechanical Room

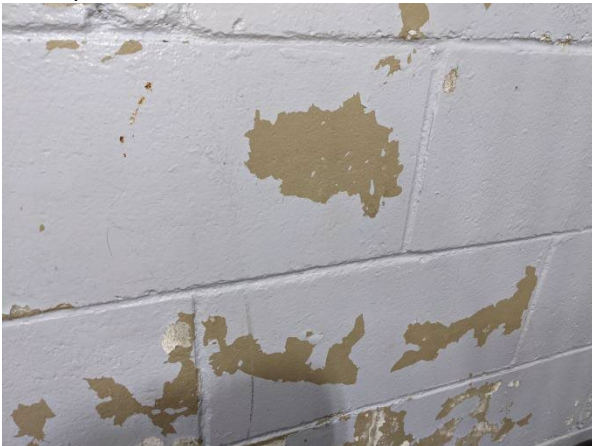
The six (6) most prominent paint colours were collected and analyzed for lead content. The light blue-grey multi-layered wall paint (Sample LP6) in the Arena was found to contain 641 µg/g or 0.0641% lead. The light blue-grey painted surfaces were noted generally in good to fair condition. Based on the laboratory results, all light blue-grey painted surfaces in the Arena should be treated as lead-containing. The MILTSD Guideline - Lead on Construction Projects, should be reviewed prior to disturbance to the painted surfaces at the Site, and the corresponding control measures (i.e., work area setup, PPE, training, etc.) implemented to reduce lead dust and exposure to the lowest concentration practicable. The specific remedial procedures required are dependent on the tools and methods used during disturbance.

Sample LP6: lead-containing multilayered light blue-grey paint, Arena

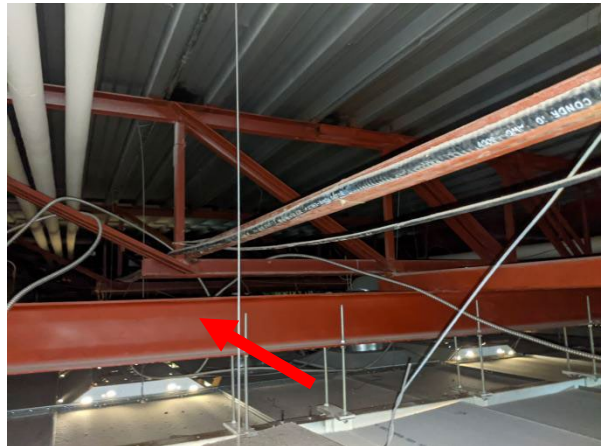
Lead is also presumed within anti-corrosion coatings applied to steel structural supports, lead-acid battery packs within emergency light fixtures, ceramic glazes, solder joints on copper pipe and wire connections, and as sub-surface layers to visible painted surfaces. Any paint colours not sampled should be treated as lead-containing until proven otherwise. It is also possible that concealed lead-containing materials (i.e., lead-sheeting, flashing, etc.) may be uncovered during renovation. If uncovered, prior to disturbance, the suspect lead-containing material should be assessed by an experienced Health and Safety Professional so that the appropriate control measures can be determined and implemented prior to disturbance. If encountered, bulk lead-containing materials should be recycled. If recycling is not practicable then remove and dispose of, prior to disturbance, in accordance with Ontario Regulation 347 - General Waste Management (O. Reg. 347).

Presumed lead-containing coatings on steel supports

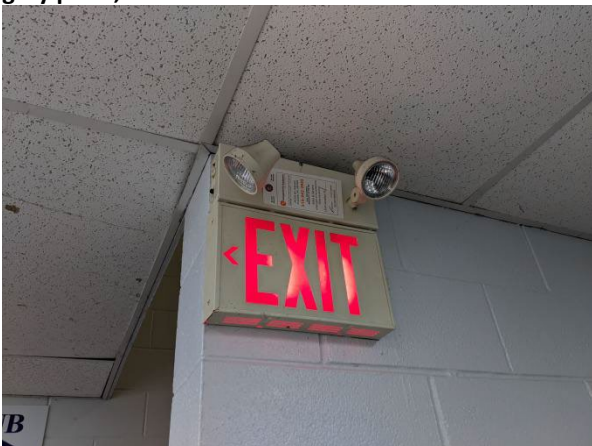
Presumed lead-containing batteries in emergency fixtures

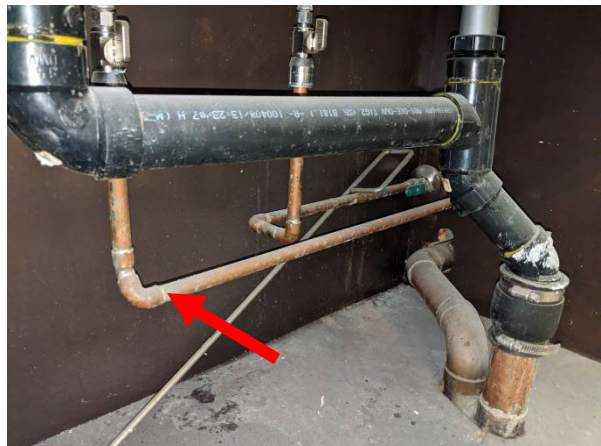
Presumed lead-containing solder in copper pipes

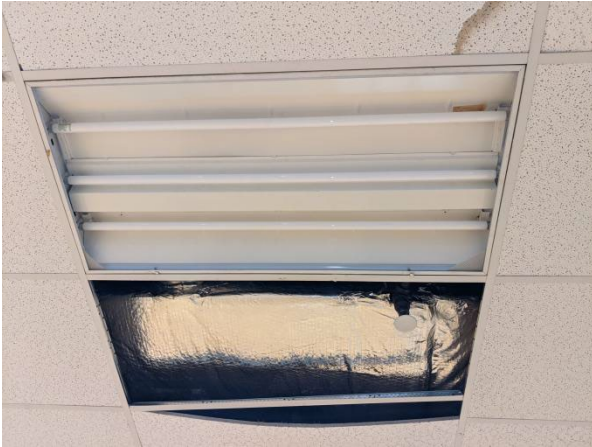
Mercury is presumed as vapour within the various fluorescent light tubes throughout the Site. To avoid accidental release, mercury-containing bulbs should be removed and stored in a safe and secure location prior to renovation. If the bulbs are to be disposed of, disposal must be conducted in accordance with O. Reg. 347.

Due to risk of electrical shock while handling active light fixtures, the ballasts present in the fluorescent light fixtures could not be safely examined. Therefore, light fixtures that contain fluorescent light tubes are presumed to be associated with PCB-containing lamp ballasts. Prior to disposal, all light ballasts must be inspected and compared to Environment Canada's Report EPS 2/CC/2 (revised) August 1991, Identification of Lamp Ballasts Containing PCBs. Disposal of PCB-containing lamp ballasts must be conducted in accordance with O. Reg. 347 and Ontario Regulation 362: Waste Management - PCB'S (O. Reg. 362/90).

Presumed mercury and PCBs associated with fluorescent light fixtures, interior

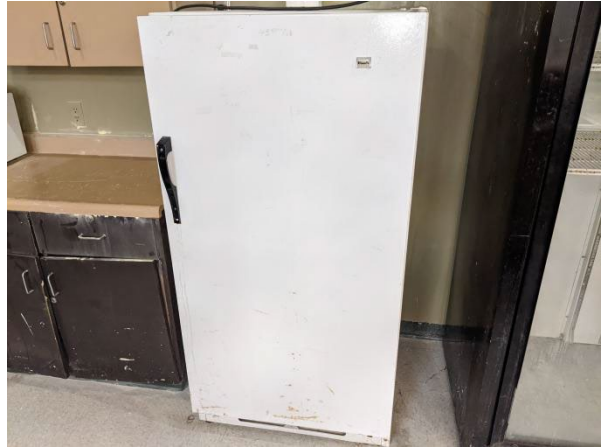
inaccessible. Therefore, the various refrigerators, coolers, vending machines, etc., throughout the areas surveyed are presumed to contain ODS refrigerants. The four (4) roof-mounted HVAC units on the East Roof of the 1977 build were noted to contain non-ODS refrigerant 410a. Prior to maintenance and/or disposal, the specific type of refrigerant gas within each refrigeration unit must be determined. Should any equipment be identified as containing ODS, their transfer and disposal must be managed as prescribed under Ontario Regulation 463/10 - Ozone Depleting Substances and other Halocarbons (O. Reg. 463/10), by a licensed technician.

Presumed ODS-containing refrigeration units

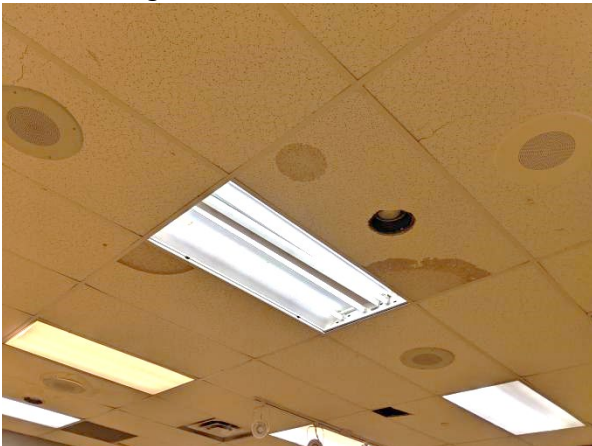
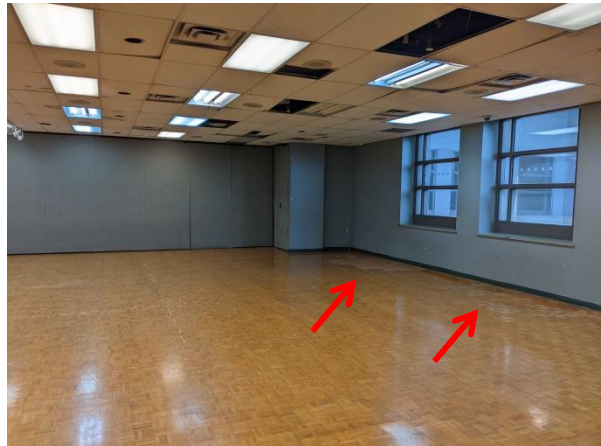
Approximately four (4) square meters of water-damaged parquet flooring, and ten (10) water-stained ceiling tiles were observed. The flooring appeared dry and noted to have been partially replaced. No visual evidence of mould contamination was observed. Reportedly, the water leak which caused the damage has been addressed. It is expected that the water-stained ceiling tiles can be removed following Level 1 mould procedures.

Water-stained ceiling tiles, Second Floor Multipurpose Room

Water-damaged floor, Second Floor Multipurpose Room

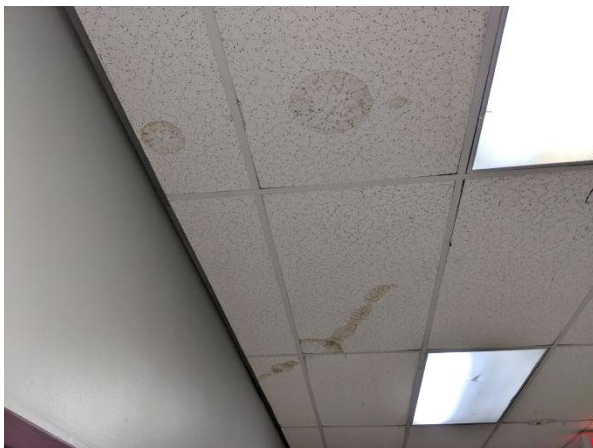
Five (5) water-stained ceiling tiles were observed throughout the Corridor. It is expected that the water-stained ceiling tiles can be removed following Level 1 mould procedures.

Water-stained ceiling tiles, Second Floor Corridor

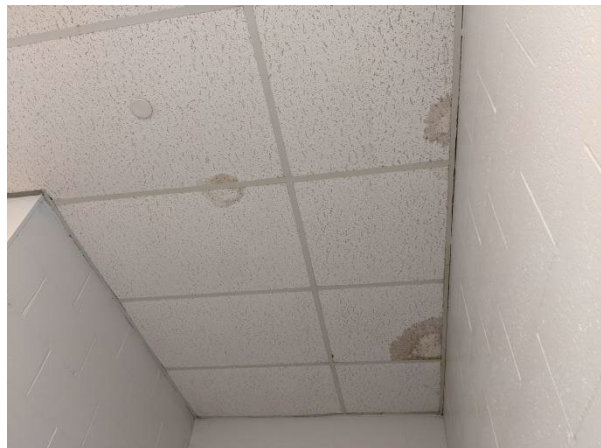
Eleven (11) water-stained ceiling tiles were observed. It is expected that the water-stained ceiling tiles can be removed following Level 1 mould procedures.

Water-stained ceiling tiles, Stairwell/Vestibule

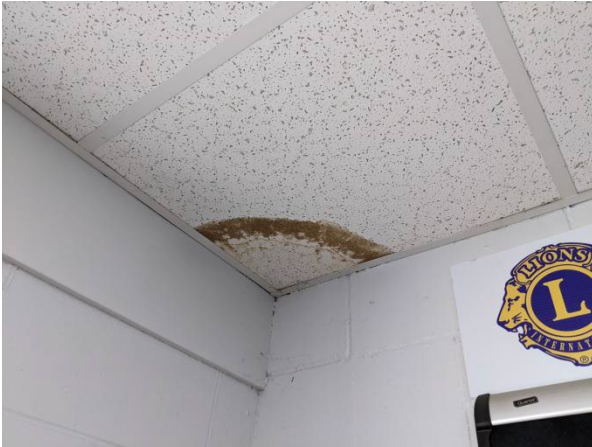
Ten (10) water-stained ceiling tiles were observed. It is expected that the water-stained ceiling tiles can be removed following Level 1 mould procedures.

Water-stained ceiling tiles, Administration Office

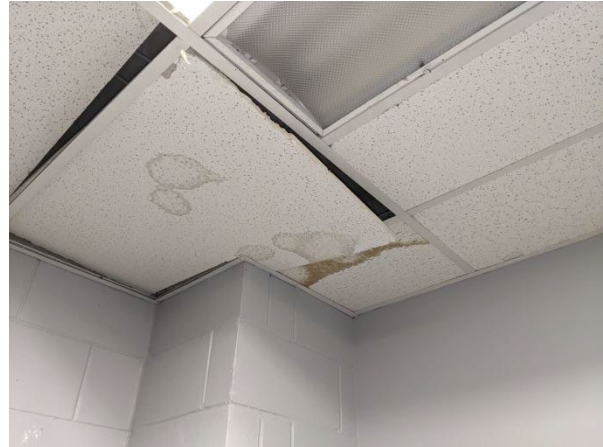
Five (5) water-stained ceiling tiles were observed. It is expected that the water-stained ceiling tiles can be removed following Level 1 mould procedures.

Water-stained ceiling tiles, OPP Office

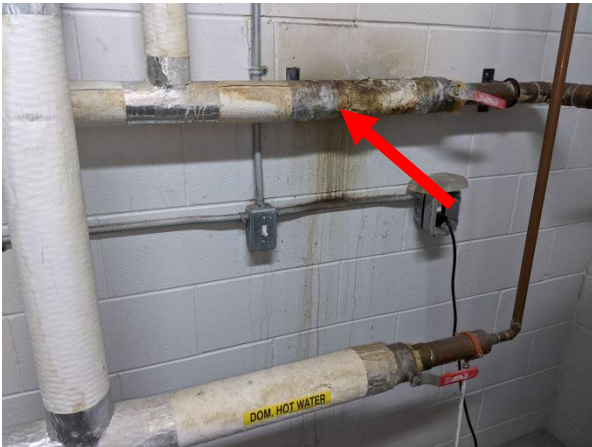
Approximately three (3) linear meters of water-stained fiberglass pipe insulation was observed along the north wall. It is expected that the water-stained insulation can be remediated following Level 1 mould procedures.

Water-stained pipe insulation, Arena Mechanical Room
