Hazardous Building Materials Assessment (Pre-Construction)

Gym Renovations
Rosedale Elementary School
25 Erindale Avenue, Hamilton,
Ontario

March 28, 2024

Pinchin File: 336572.005

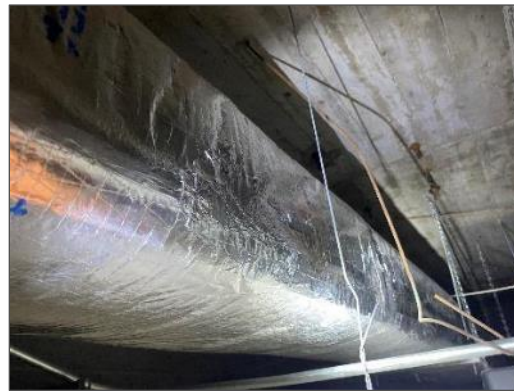
Photo 1

Ducts are either uninsulated or insulated with non-asbestos fibreglass (foil-faced or canvas jacketing) (photo 1).

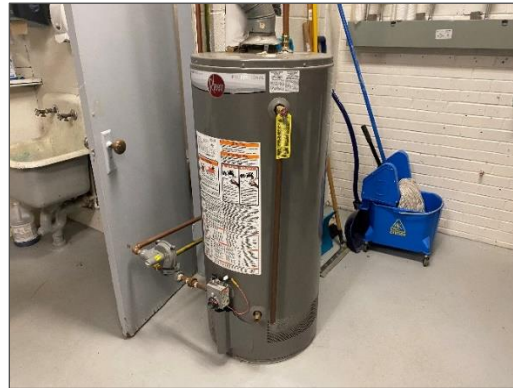
Photo 1

Mechanical equipment (, e.g., furnace and hot water tanks) is either uninsulated or insulated with non-asbestos fibreglass (photo 1).

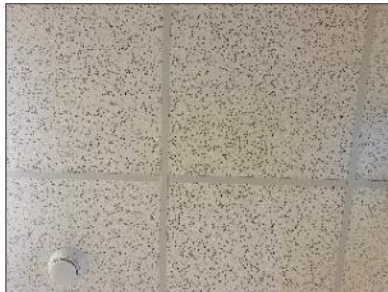
Description	Sample Location	Sample Number or Date Code	Asbestos	Photo
2'x4', lay-in ceiling tiles, irregular pinholes and small fissures	N/A	08/15/17	No

Ceiling tiles are presumed to be non-asbestos based on the date of manufacture determined from the date stamp applied to the top of the tiles. The tiles were manufactured after asbestos stopped being used in acoustic ceiling tiles.

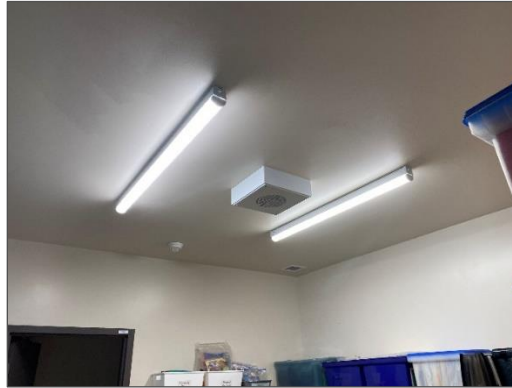
Photo 1

Asbestos in drywall joint compound was banned in Canada in 1980. Drywall joint compound in the assessed area was installed on or after 2020 and is presumed to contain no asbestos (photo 1).

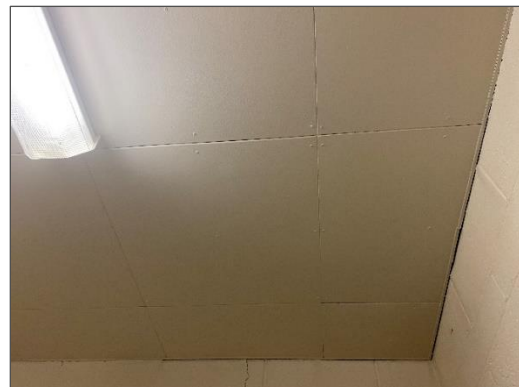
Photo 2

Cement board panels (24" x 48") with a smooth surface (e.g. Transite), containing asbestos, is present throughout the assessed area (samples S0037A-C, photo 2).

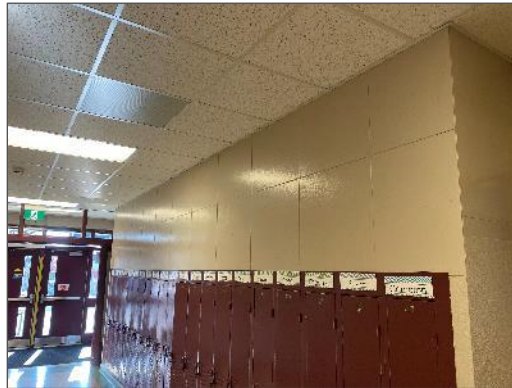
Photo 3

Cement board panels (24" x 48") with a smooth surface (e.g. Transite), containing asbestos, is present on wall panels throughout the assessed area (samples S0037A-C, photo 3).

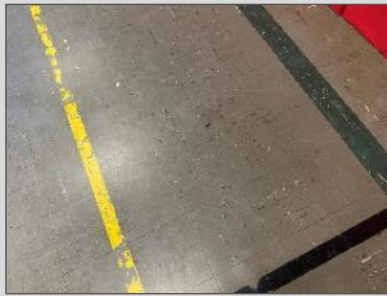
Description	Sample Location (Location #)	Sample Number	Asbestos (Tile / Adhesive)	Photo
12"x12", grey with black streaks	Stage (Location 8324) Gym (Location 8325)	S0030A-C	Yes / No

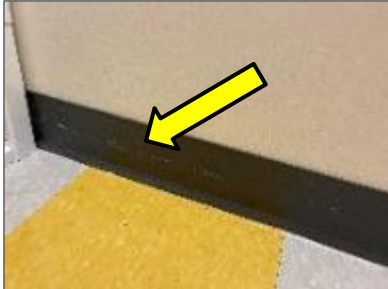
Description	Sample Location (Location #)	Sample Number	Asbestos (Tile / Adhesive)	Photo
Clear mastic on black rubber baseboards	N/A	V0000	No*

*Vinyl floor tiles were presumed to be non-asbestos based on historical knowledge of the date of installation (2020).

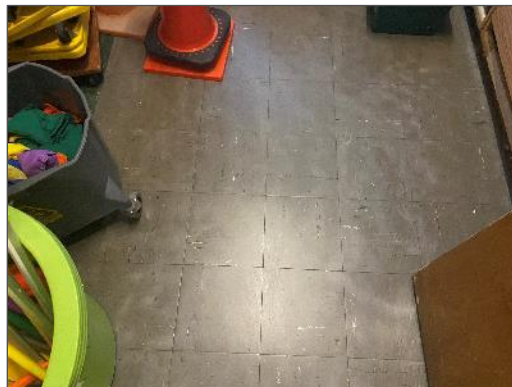
Photo 1

The beige levelling compound associated with the asbestos-containing 12"x12", grey with black streaks, vinyl floor tiles does not contain asbestos (samples S0030A-C; phase c, photo 1).

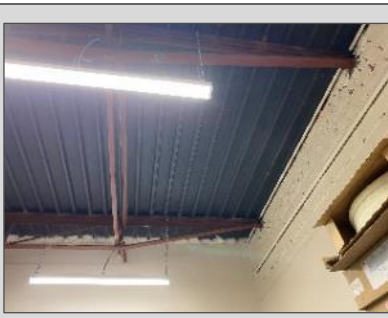
Sample Number	Colour, Substrate Description	Sample Location	Lead (%)	Photo
L0001; lab reference 71965710_PBP	Yellow on gas line	Roof (Location 1)	<0.0062	
L0005; lab reference 71965710_PBP	Red on structural steel	Gym (Location 8325)	5.3

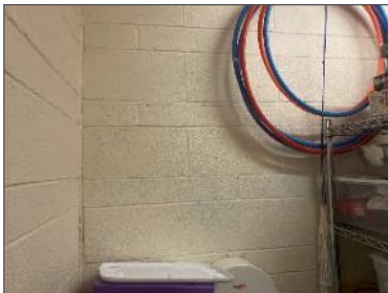
L0010	White on concrete block walls	Gym (Location 8325)	0.034

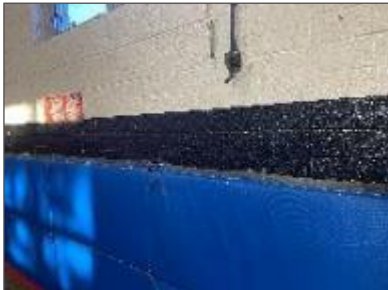
Sample Number	Colour, Substrate Description	Sample Location	Lead (%)	Photo
L0011	Red on concrete block walls	Gym (Location 8325)	0.039	 
L0012	Black on concrete block walls	Gym (Location 8325)	0.039

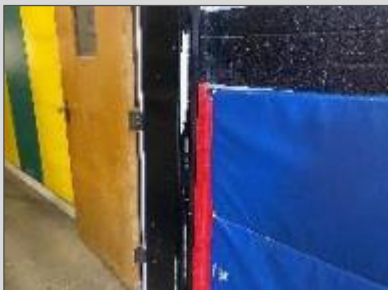
L0013	Black/white on metal trim	Stage (Location 8324)	<0.50

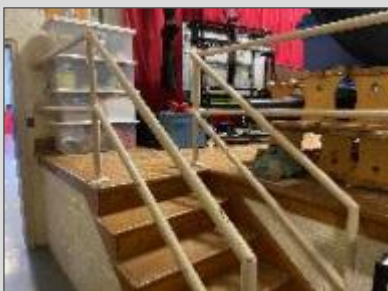
L0014	White on metal rails	Stage (Location 8324)	0.24

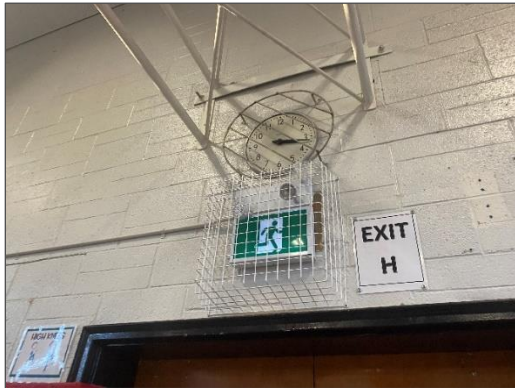
Photo 1

Lead-containing batteries are present in emergency lighting (photo 1) and fire control panels (photo 2).

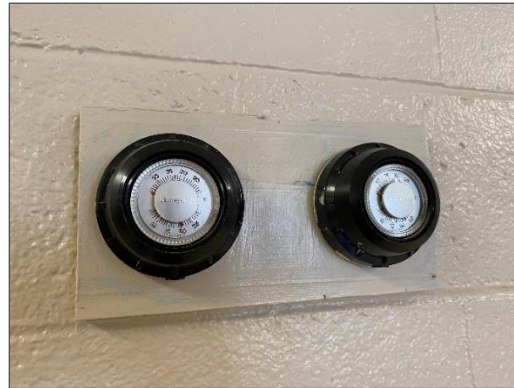
Photo 1

Mercury is present as a liquid in thermostats ampules (photo 1).

Do not break lamps. Recycle and reclaim mercury from fluorescent lamps when taken out of service. Mercury is classified as a hazardous waste and must be disposed of in accordance with applicable regulations.

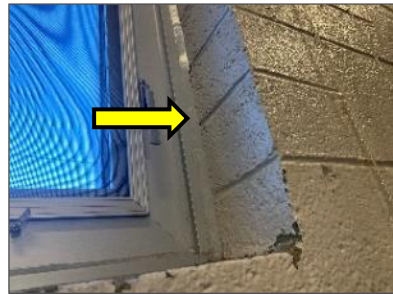
Material, Colour, Application	Sample Location (Location #)	Sample Number	PCB (mg/kg)	Photo
Grey caulking on interior windows	Gym (Location 8325)	P0005	<0.2

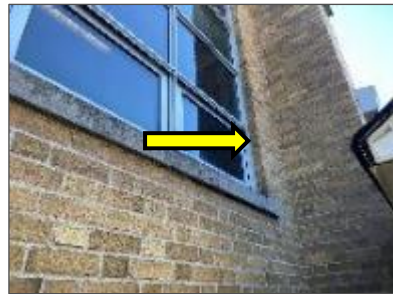
Grey caulking on exterior windows	Exterior (Location 0)	P0006	<0.2

The material is a non-PCB solid based on the threshold (50 mg/kg).

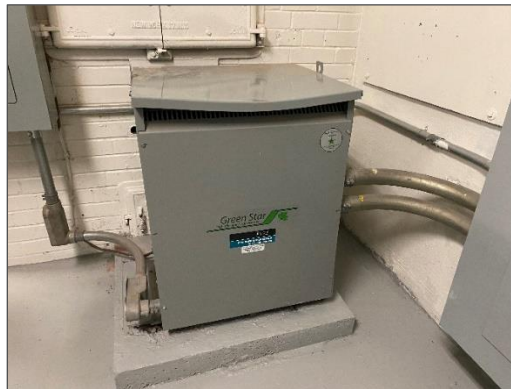
Photo 1

All transformers in the building are dry type transformers and do not contain PCB-containing dielectric fluids; however, may contain capacitors, which could not be assessed for PCBs as the equipment was in service (photo 1).
