# DESIGNATED SUBSTANCE SURVEY

**Birchmount Community Centre and Pool**

**93 Birchmount Road**

**CCI Project No: 135121**

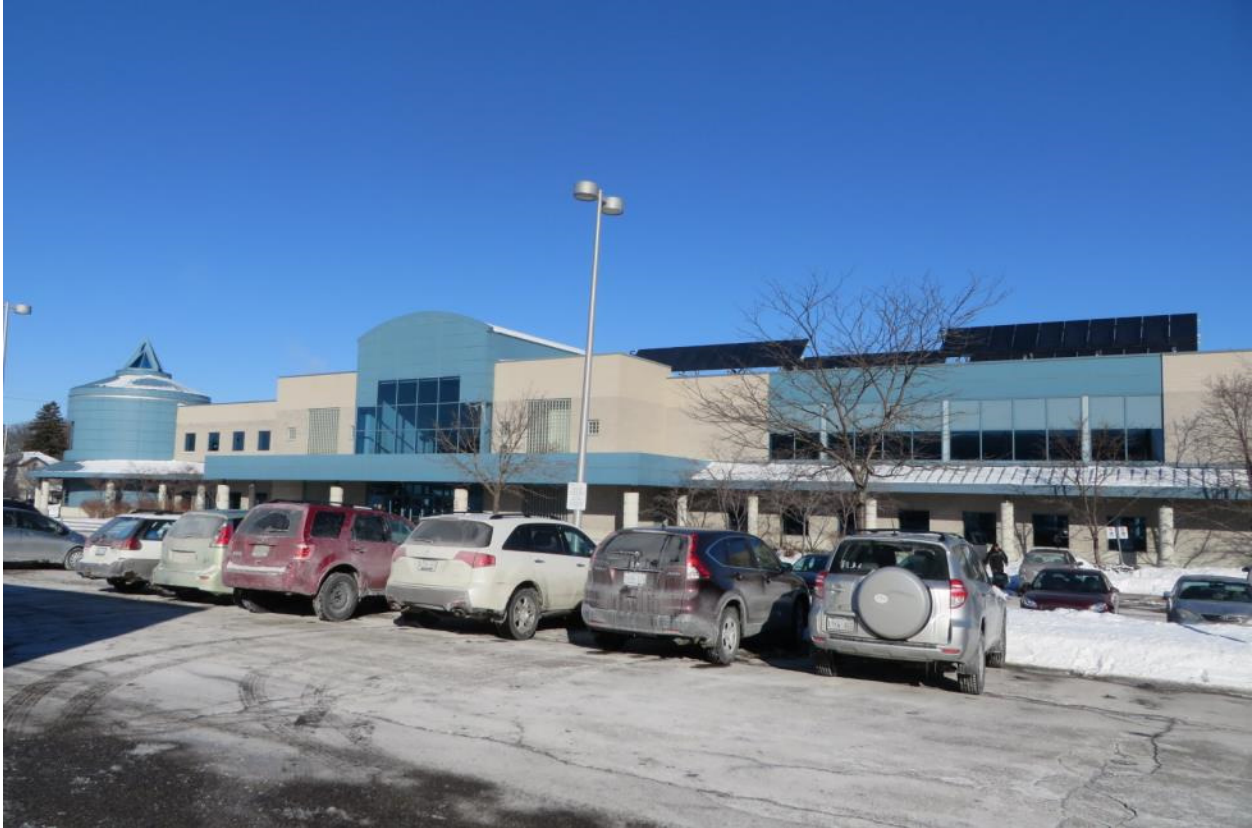
### *Property Description*

The Survey Area consisted of a two (2) storey Community Recreation Centre with a Pool, which was constructed in 1993. Floor finishes throughout the building include vinyl tiles, ceramic tile, carpet and exposed concrete. Wall finishes include painted concrete block, ceramic tiles and gypsum board. Ceiling finishes include gypsum board, lay-in ceiling tiles and steel roof deck structure. All domestic hot and cold water lines throughout the Survey Area appeared to be insulated copper or PVC, or wrapped with fibreglass insulation.

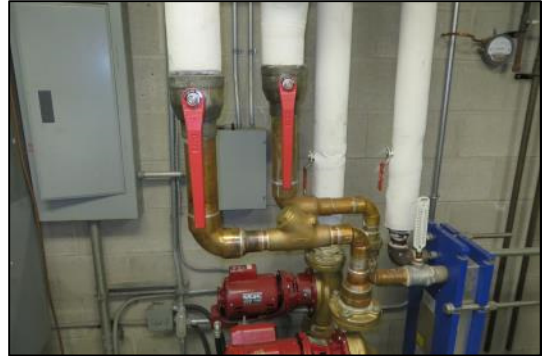
- Mechanical Piping Insulation

Pipe insulation was observed throughout the Survey Area and was observed to contain newer and older fiberglass insulation material with canvas wrapping. Fiberglass insulation is not expected to contain asbestos.

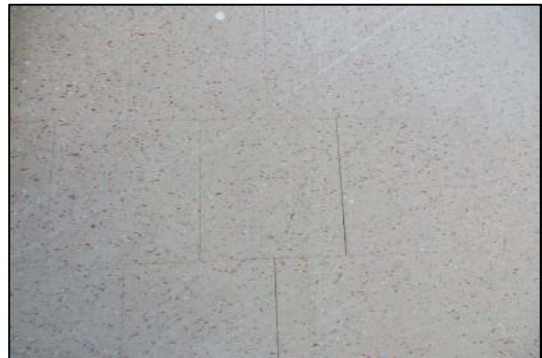
- Vinyl Floor Tiles

Vinyl tiles installed in the Bluffs Room were tested in the previous report and found not to contain asbestos. Other vinyl tiles installed are not expected to contain asbestos.

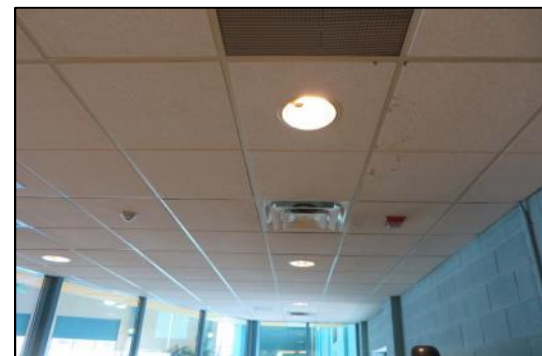
- Lay-in Ceiling Tiles

Lay-in ceiling tiles in the second floor's Main Hallway were tested in the previous report and found not to contain asbestos. Other ceiling tiles installed are not expected to contain asbestos.

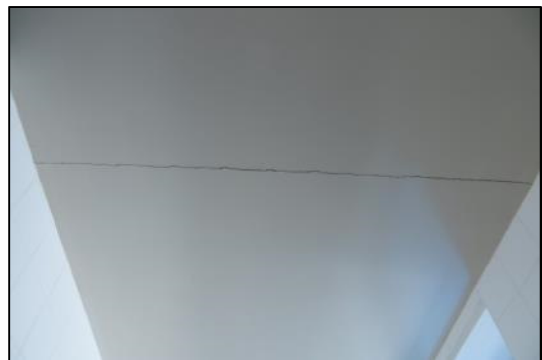
- Building Material

White joint compounds were tested in the previous report and found not to contain asbestos.

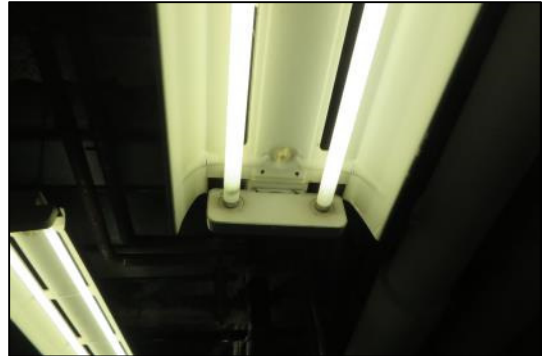
- Light Ballasts/Transformers

The building is illuminated using newer T-8 fluorescent and compact fluorescent bulbs. The ballasts are not expected to contain PCBs. The transformers are non-PCB type ballasts.
