ADDENDUM NO. 1

T-675-24 Allendale Long Term Care Home Site Rehabilitation, Milton, Ontario

Arborist Report

Tree Preservation Plan

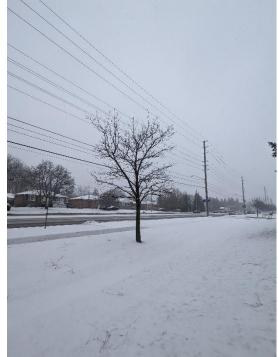
Trees #11-13

- Trees to be injured are specified with "Injured" in the "Action" column in the TPAK.
 - 8 trees (#1-4 and 10-13) have proposed construction activity within their drip lines and are likely to be injured.

- Trees #1-4 and 10-13 are expected to be impacted by replacement of an existing retaining wall and sidewalk. Replacement of an existing retaining wall and sidewalk is recommended to be performed with hand-tools within the drip lines of these trees. If root pruning is required, root pruning is recommended to be performed by a Certified Arborist. The retaining wall and sidewalk is to be replaced with topsoil, and all disturbed areas shall be graded and seeded to the satisfaction of the Town of Milton. The impact of injury is low for all trees, and we would expect all trees to maintain their current condition following minor drip line disturbance.
