# Site Review Report

Date: July 5, 2023	Pinchin Representative: Andres Gimenez	Report Number: 01 Pinchin File: 233190.003
Project Name: Type 1 and 2 Asbestos Abatement	Site Address: 13 & 23 Barberrry Place, Toronto, Ontario	
Client: City of Toronto	Client File Number: N/A	
Contractor: The BearStar Group Inc.	Arrival on Site: 9:30 AM Number of Workers: 3

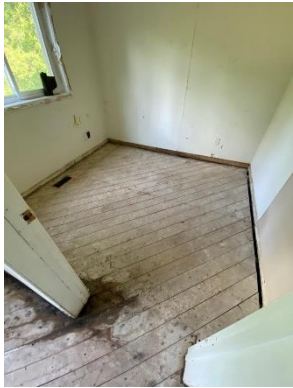
Post abatement (abated VFT) view, Location 10.

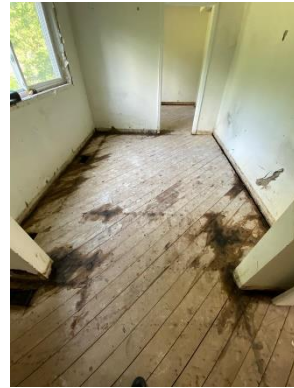
Post abatement (abated VFT) view, Location 9.

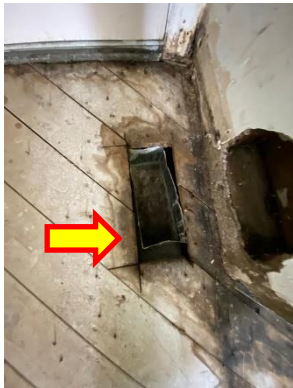
Post abatement (abated fiberboard insulation) view, Location 9.

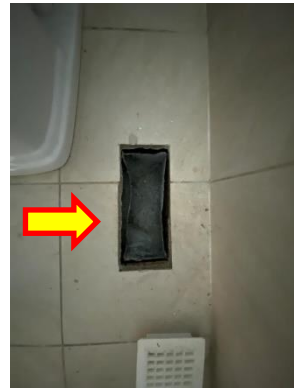
Post abatement (abated fiberboard insulation) view, Location 8.

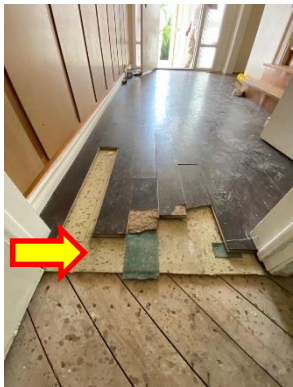
Asbestos-containing VFT concealed under wood flooring, Location 4.

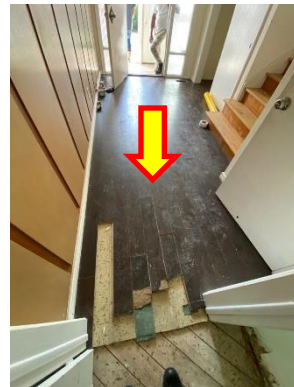
Asbestos-containing VFT concealed under wood flooring, Location 4.

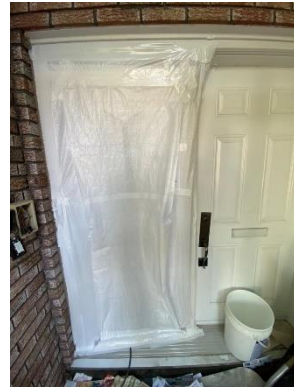
Enclosure entrance, Location 8

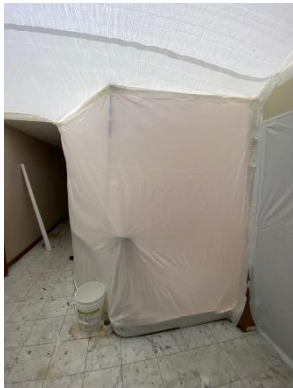
General view within enclosure, Location 8.

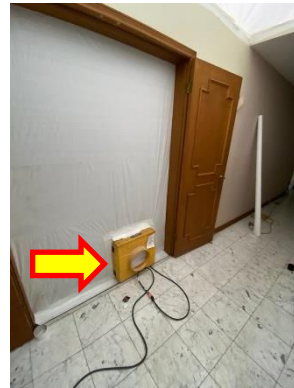
View of one D air unit exhausting air out of the enclosure, Location 8.

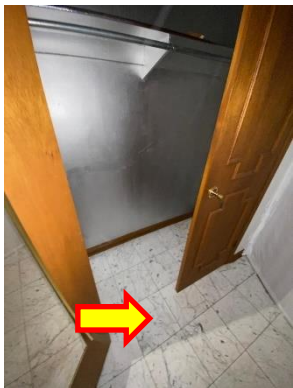
Ceramic floor tile and concealed asbestos-containing levelling compound to be abated, Location 8.

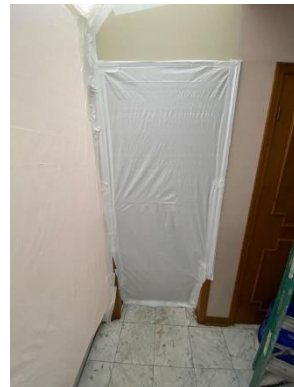
General view within enclosure, Location 8.
