Site Review Report

Date: August 15, 2023	Pinchin Representative: Andres Gimenez	Report Number: 04 Pinchin File: 233190.004
Project Name: Type 3 Asbestos Abatement	Site Address: 23 Barberry Place, Toronto, Ontario	
Client: City of Toronto	Client File Number: N/A	
Contractor: The BearStar Group Inc.	Arrival on Site: 8:30 AM Number of Workers: 4

Material	Work Area	Work in Progress	Type of Review	Status
Asbestos	Work Area 1: 23 Barberry Place	O.Reg. 278/05 Type 3 removal of hardwood flooring and concealed asbestos-containing white paper insulation.	Clean Site Preparation	Acceptable

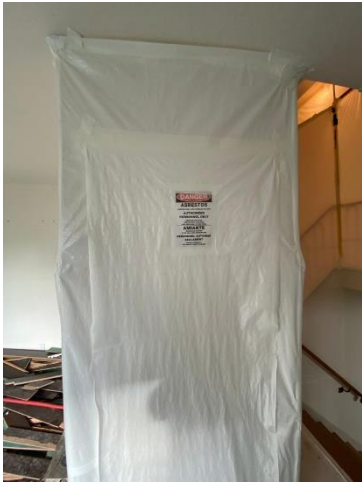
Asbestos warning sign posted on the entrance to the enclosure

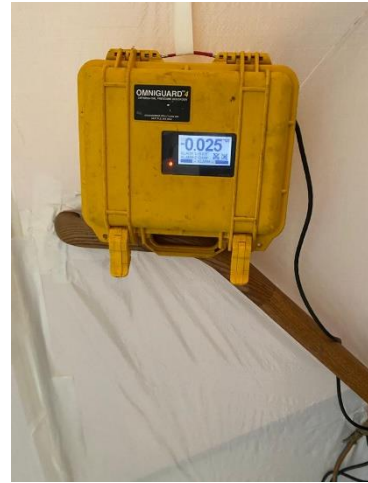
Sufficient negative air pressure displayed on manometer.

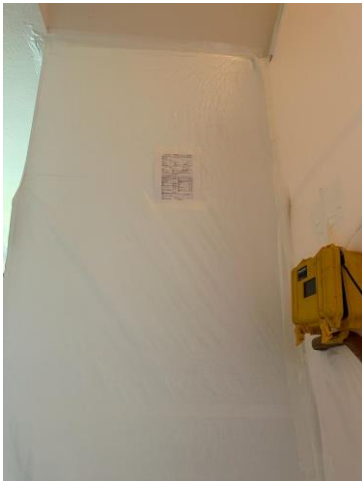
Notice of Project posted on the entrance to the enclosure

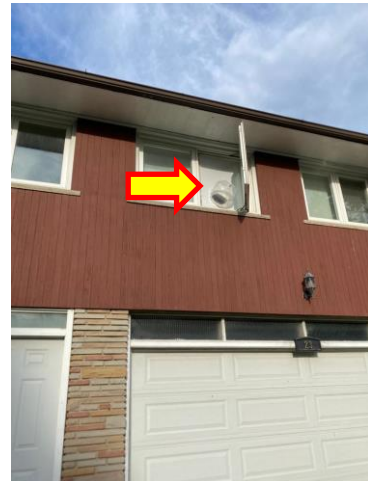
View of negative air unit venting outside of the building.

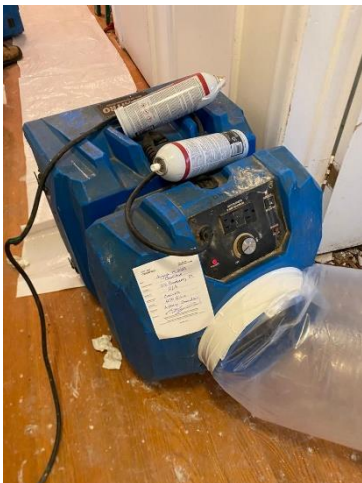
View of negative air.

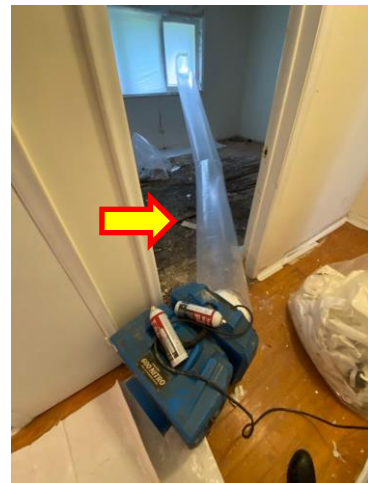
View of negative air unit venting outside of the building.

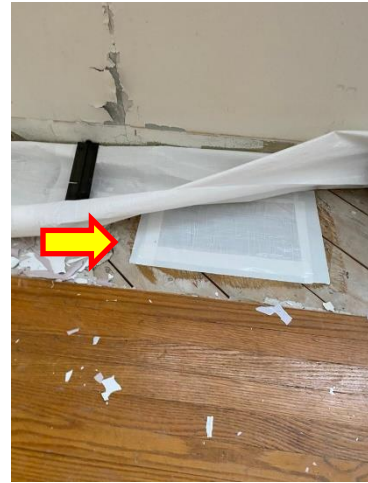
View of floor registers covered with poly.

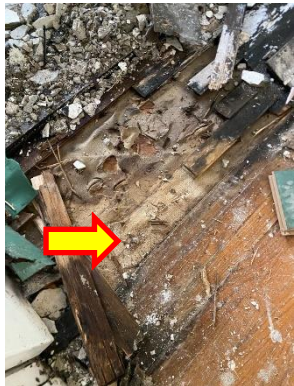
Asbestos-containing white paper insulation under original hardwood flooring to be abated, Bedroom, 2nd Floor, Location 13

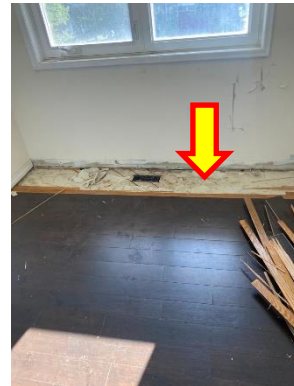
Asbestos-containing white paper insulation found under original hardwood flooring to be abated, Bedroom, 2nd Floor, Location 14.
