# Site Review Report

Date: August 16, 2023	Pinchin Representative: Andres Gimenez	Report Number: 05 Pinchin File: 233190.004
Project Name: Type 3 Asbestos Abatement	Site Address: 23 Barberry Place, Toronto, Ontario	
Client: City of Toronto	Client File Number: N/A	
Contractor: The BearStar Group Inc.	Arrival on Site: 3:00 PM Number of Workers: 4

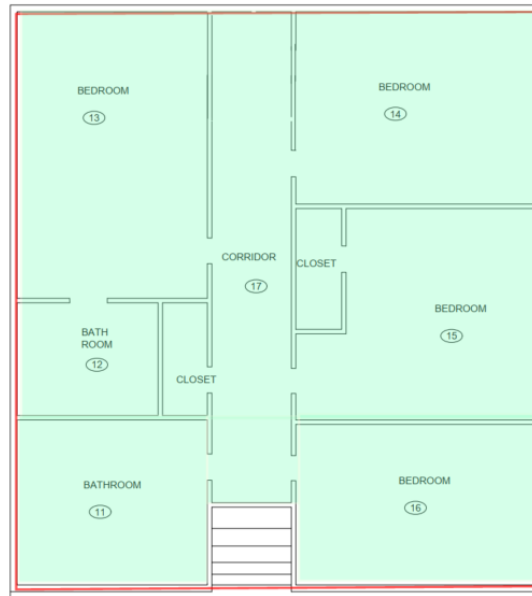
Abated Area, 2<sup>nd</sup> Floor Abatement Work Area, Highlighted in Red

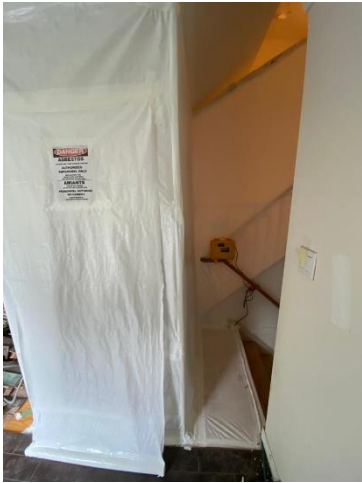
Asbestos warning sign posted on the entrance to the enclosure and manometer.

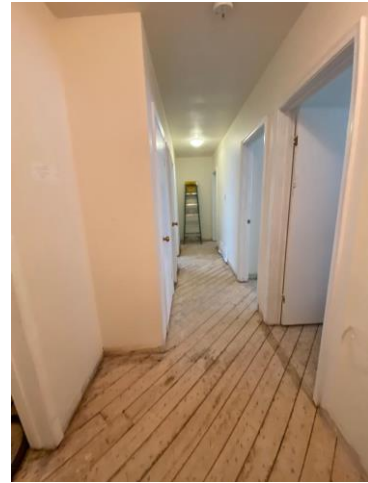
Abated asbestos-containing paper insulation and original hardwood flooring, Corridor, Location 17.

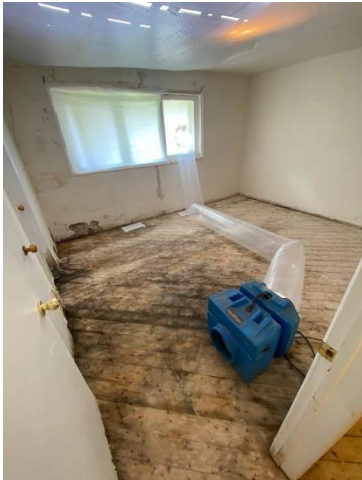
Abated asbestos-containing paper insulation and original hardwood flooring, Bedroom, Location 13.

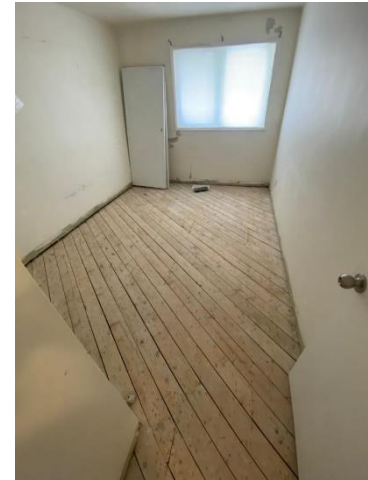
Abated asbestos-containing paper insulation and original hardwood flooring, Bedroom, Location 14.

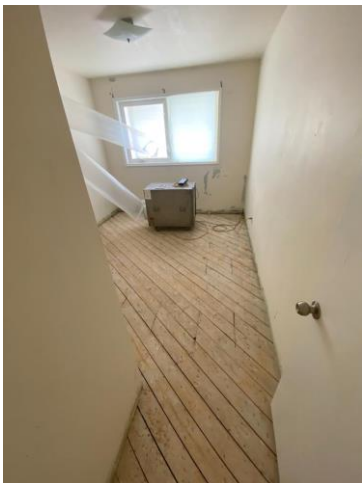
Abated asbestos-containing paper insulation and original hardwood flooring, Bedroom, Location 15.

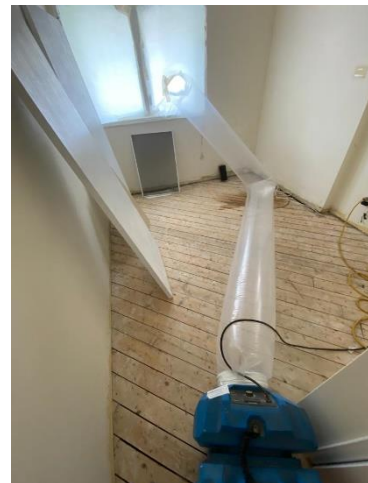
Abated asbestos-containing paper insulation and original hardwood flooring, Bedroom, Location 16.

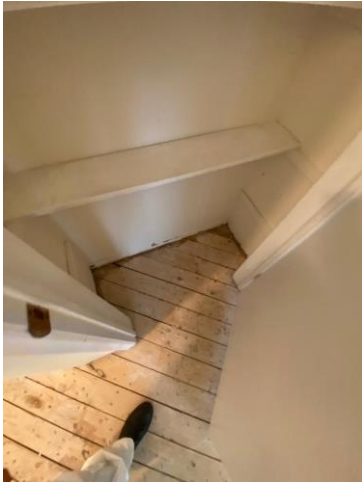
Abated asbestos-containing paper insulation and original hardwood flooring, Corridor's Closet, Location 17.

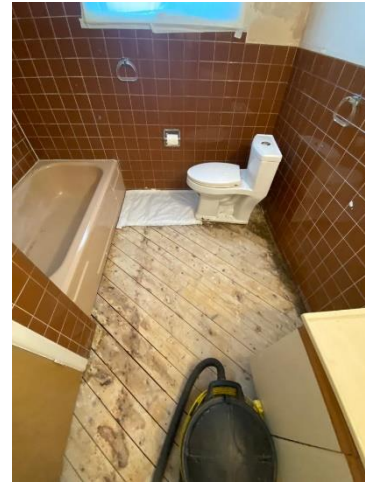
Abated asbestos-containing paper insulation and original hardwood flooring, Bathroom, Location 11.

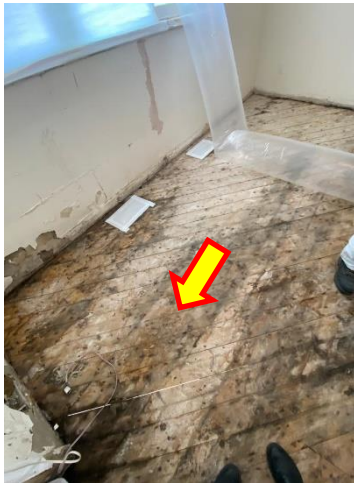
Visible mould growth was observed on plywood floor, Bedroom, Location 13.
