Site Review Report

Date: July 7, 2023	Pinchin Representative: Andres Gimenez	Report Number: 02 Pinchin File: 233190.003
Project Name: Type 1 and 2 Asbestos Abatement	Site Address: 13 & 23 Barberrry Place, Toronto, Ontario	
Client: City of Toronto	Client File Number: N/A	
Contractor: The BearStar Group Inc.	Arrival on Site: 4:30 PM Number of Workers: 4

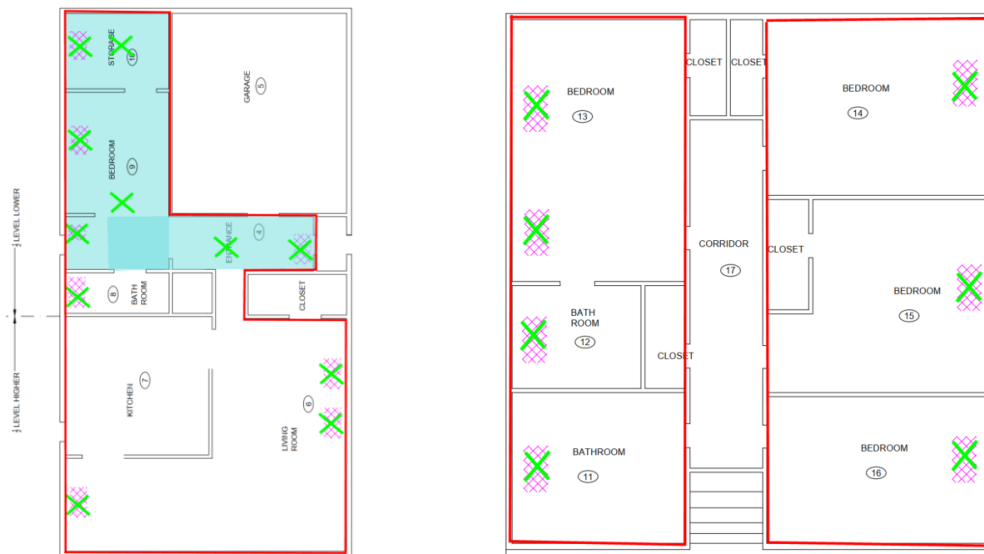
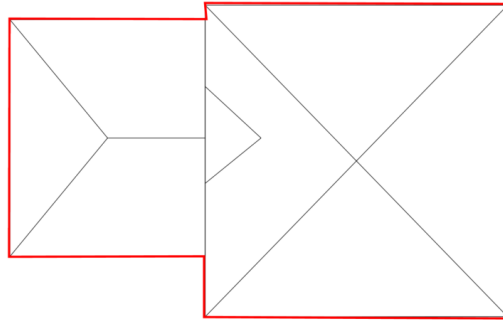
Abatement Work Area, Highlighted in Red

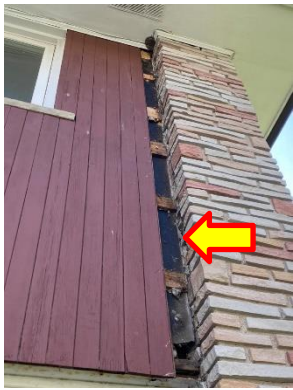
Post abatement (abated caulking) view, Wood Siding, Exterior.

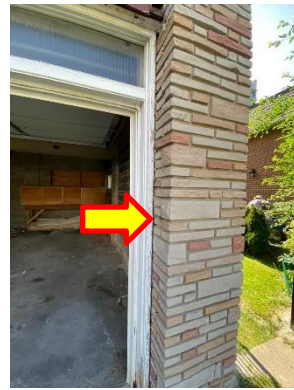
Post abatement (abated caulking) view, Garage Door, Exterior.

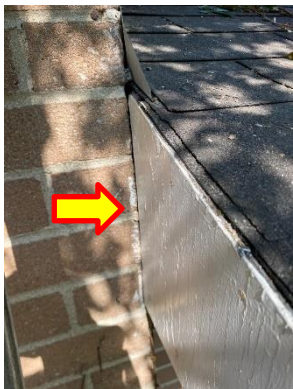
Post abatement (abated caulking) view, Roof Flashing, Exterior.

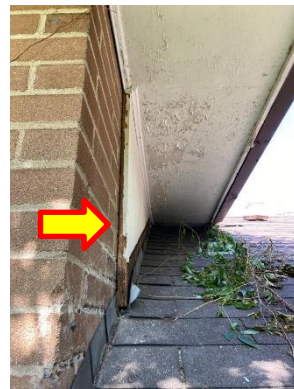
Post abatement (abated caulking) view, Roof Flashing, Exterior.

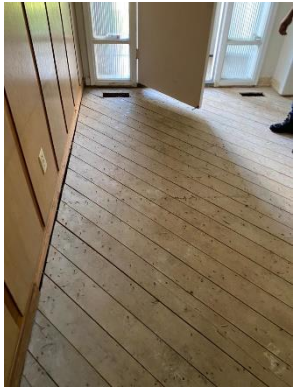
Post abatement (abated VFT) view, Location 4.

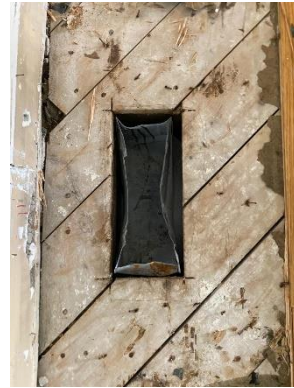
Post abatement (abated fiberboard insulation) view, Floor Register.

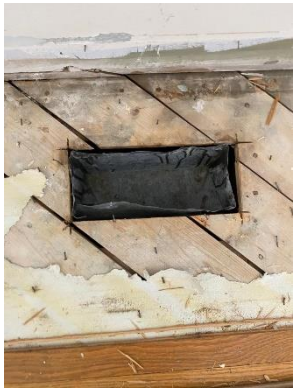
Post abatement (abated fiberboard insulation) view, Floor Register.

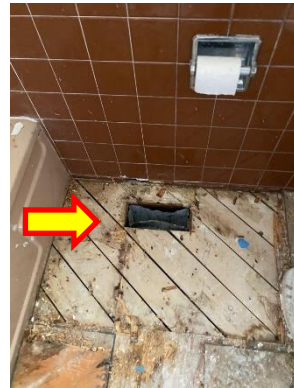
Post abatement (abated fiberboard insulation) view, Floor Register.

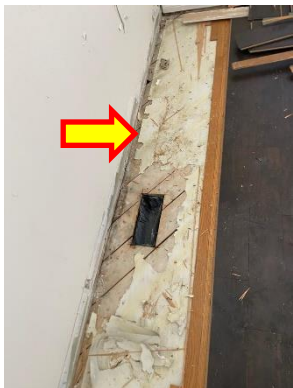
<p>Rush TAT as authorized by the City of Toronto.</p> <ul style="list-style-type: none"> - White paper insulation was found concealed under a second layer of wood flooring (original hardwood flooring) during the removal of the heating registers within Locations 14 and 15 on the 2nd Floor. This material was not observed during the original assessment. Three (3) samples were collected and submitted to be analysed for asbestos content based on a Rush TAT as authorized by the City of Toronto. <p>Work Area 2: 13 Barberry Place:</p> <ul style="list-style-type: none"> - Visual clearance for the removal of non-asbestos ceramic floor tiles and associated asbestos-containing levelling compound was acceptable. Flooring finishes were removed down to the plywood layer.
--	--

White paper insulation found under original hardwood flooring, Location 14.

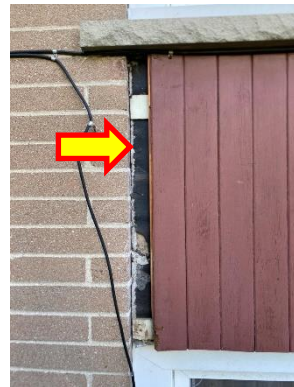
- Black paper insulation was found concealed behind wood siding present at the front of the building. This material was not observed during the original assessment. Three (3) samples were collected and submitted to the lab to be analysed for asbestos content, based on a

Black paper insulation behind wood siding, Exterior.

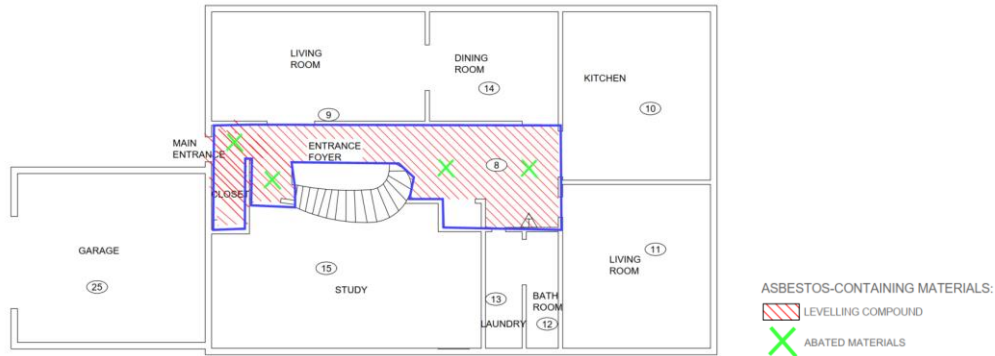
Abatement Work Area, Highlighted in Blue

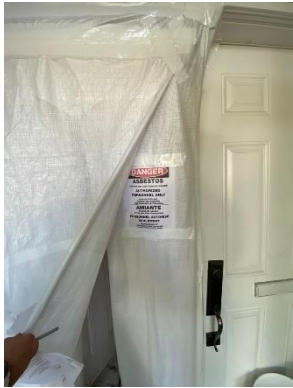
Enclosure entrance with posted asbestos warning sign, Location 8.

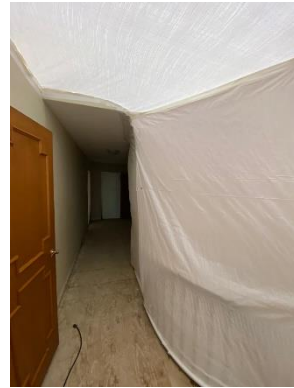
General view within enclosure, Location 8.

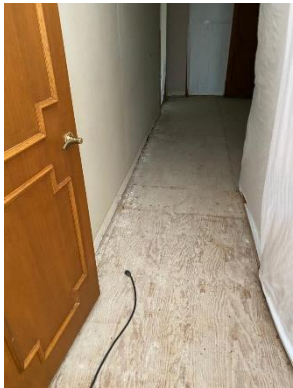
Post abatement view, Location 8

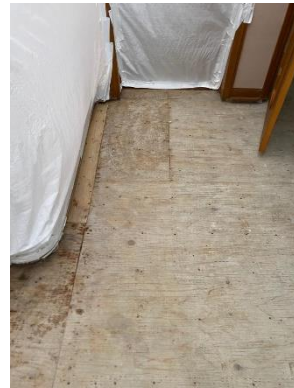
Post abatement view, Location 8
