Asbestos Assessment

Allendale
185 Ontario Street South, Milton,
ON, L9T 2M4

Halton Region
1151 Bronte Road
Oakville, Ontario, L6M 3L1

September 25, 2023

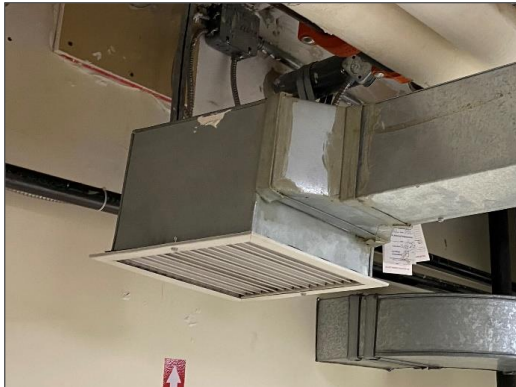
Photo 1

Grey duct mastic present on seams / joints on ducts throughout the assessed area does not contain asbestos (samples S0010A-C, photo 1).

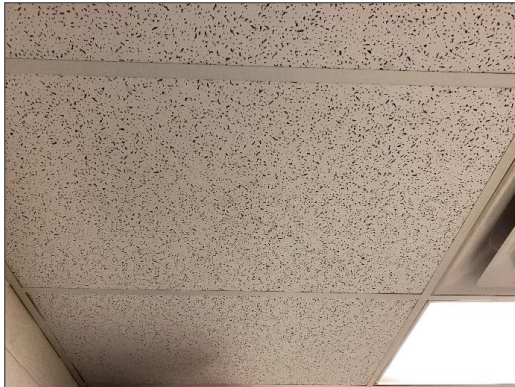
Photo 1

Size, Type, Pattern	Sample Number or Date Code	Asbestos Type
24"x48", pinhole with fleck, photo 1	03/07/22	Non-asbestos
24"x48", pinhole with width wise fissure, photo 2	08/16/08	Non-asbestos
24"x48", gypsum tiles, photo 3	Not sampled	Non-asbestos
Mechanically fastened wood fibre	Not sampled	Non-asbestos

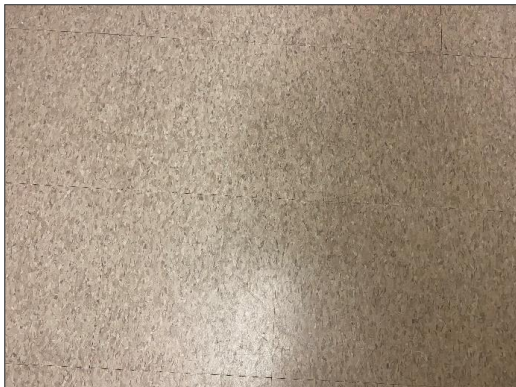
Photo 1

Pattern, and Number	Colour Photo	Sample Locations	Sample Number	Asbestos Type	Asbestos Type (Adhesive)
Beige with sparkles, photo 1		Preparation Kitchen, Laundry Room / Office (Locations 8 and 15)	S0008A-C	None detected	None detected
Multi-colour wave pattern, photo 2		Storage (Location 21)	S0016A-C	None detected	N/A
Green wave pattern, photo 3		Storage (Location 22)	S0017A-C	None detected	None detected
Wood style, photo 4		Reception and Corridors, Cafeteria (Locations 26 and 27)	S0021A-C	None detected	None detected

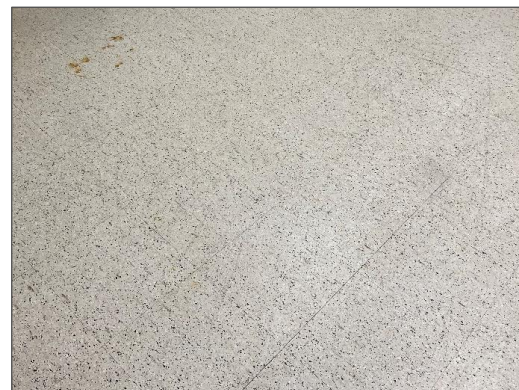
Photo 6

12"x12", grey with dark grey and white fleck, photo 6	Bronte House and Trafalgar House (Location 29 and 32)	S0033A-C	None detected	None detected

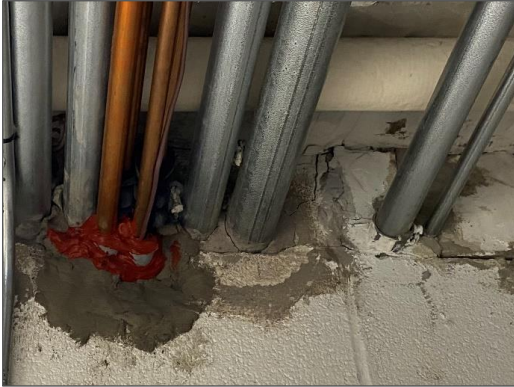
Photo 1

Red, maroon and blue/grey firestopping (sealant) present at pipe and conduit penetrations in the Generator / Electrical / Sprinkler / Workshop, Corridor, Storage and Garbage / Elevator Room (Locations 1, 2, 3 and 11) does not contain asbestos (samples S0002A-C, S0003A-C and S0004A-C, photo 1).

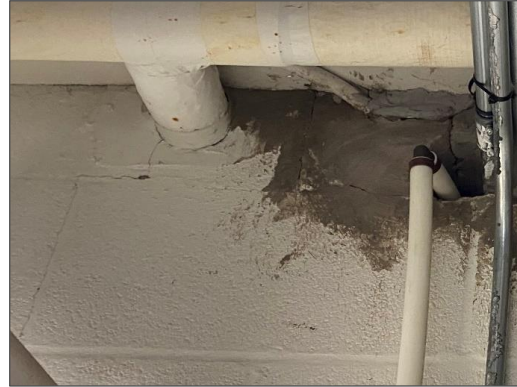
Photo 2

Firestopping (cementitious) is present at pipe and conduit penetrations in the Generator / Electrical / Sprinkler / Workshop (Location 1) does not contain asbestos (samples S0005A-C, photo 2).

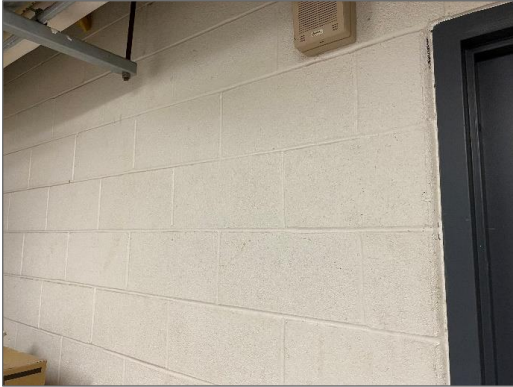
Photo 1

Description	Sample Location (Location #)	Sample Number	Asbestos
Paint on concrete block walls, photo 1	Generator / Electrical / Sprinkler / Workshop, Corridor, Corridor and Staff Washrooms and Changerooms (Location 1, 2, 10 and 19)	S0001A-G	No
Tectum wall covering, photo 2	Cafeteria and Auditorium (Location 27 and 28)	S0022A-C	No
Blue wave pattern epoxy, photo 3	Courtyard Vestibule (Location 33)	S0034A-C	No
