Limited Designated Substance Survey Report

Brock High School

1590 Concession Road 12, Cannington, Ontario

April 17, 2024
Parasol Project No: 13210

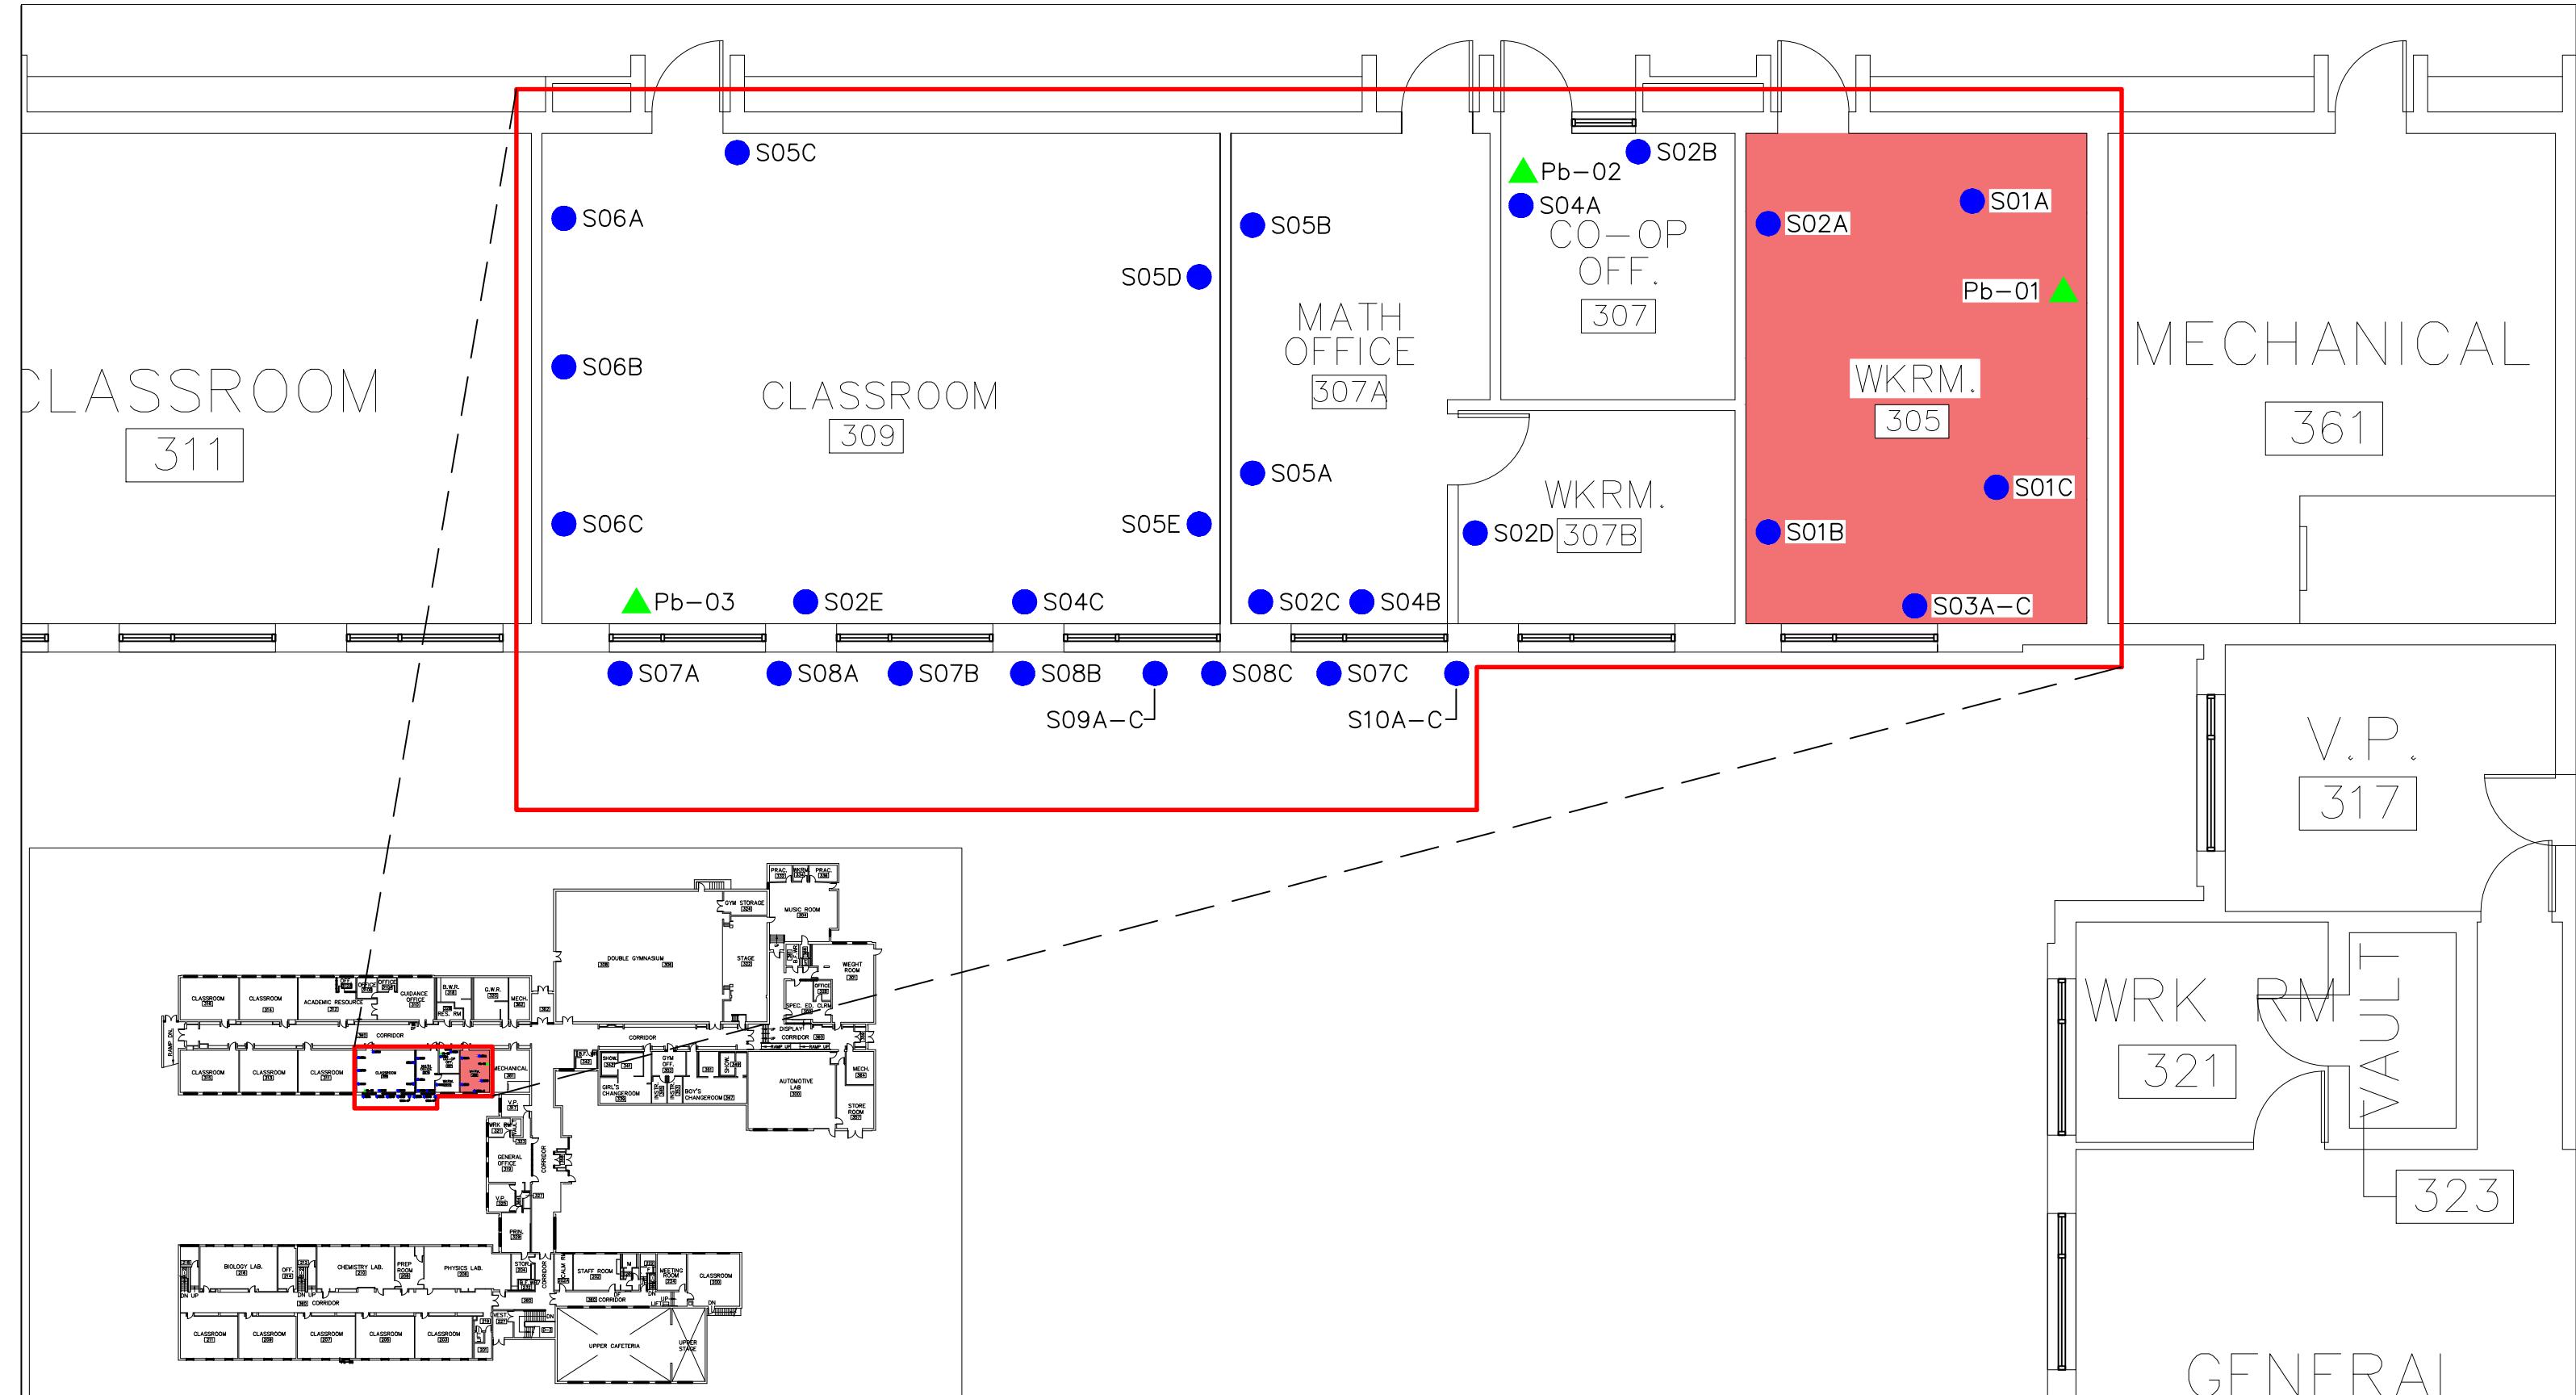
Site Drawing

The survey was limited to Location #305, 307, 307A, 307B, 309 and the immediate building exterior as illustrated on the attached drawing (DSR-01). The scope of the assessment was carried out in all accessible areas on a non-intrusive basis. Areas that were inaccessible at the time of the survey are listed in Section 3.11.
