Limited Designated Substance Survey Report

Brock High School

1590 Concession Road 12, Cannington, Ontario

May 28, 2024
Parasol Project No: 13220

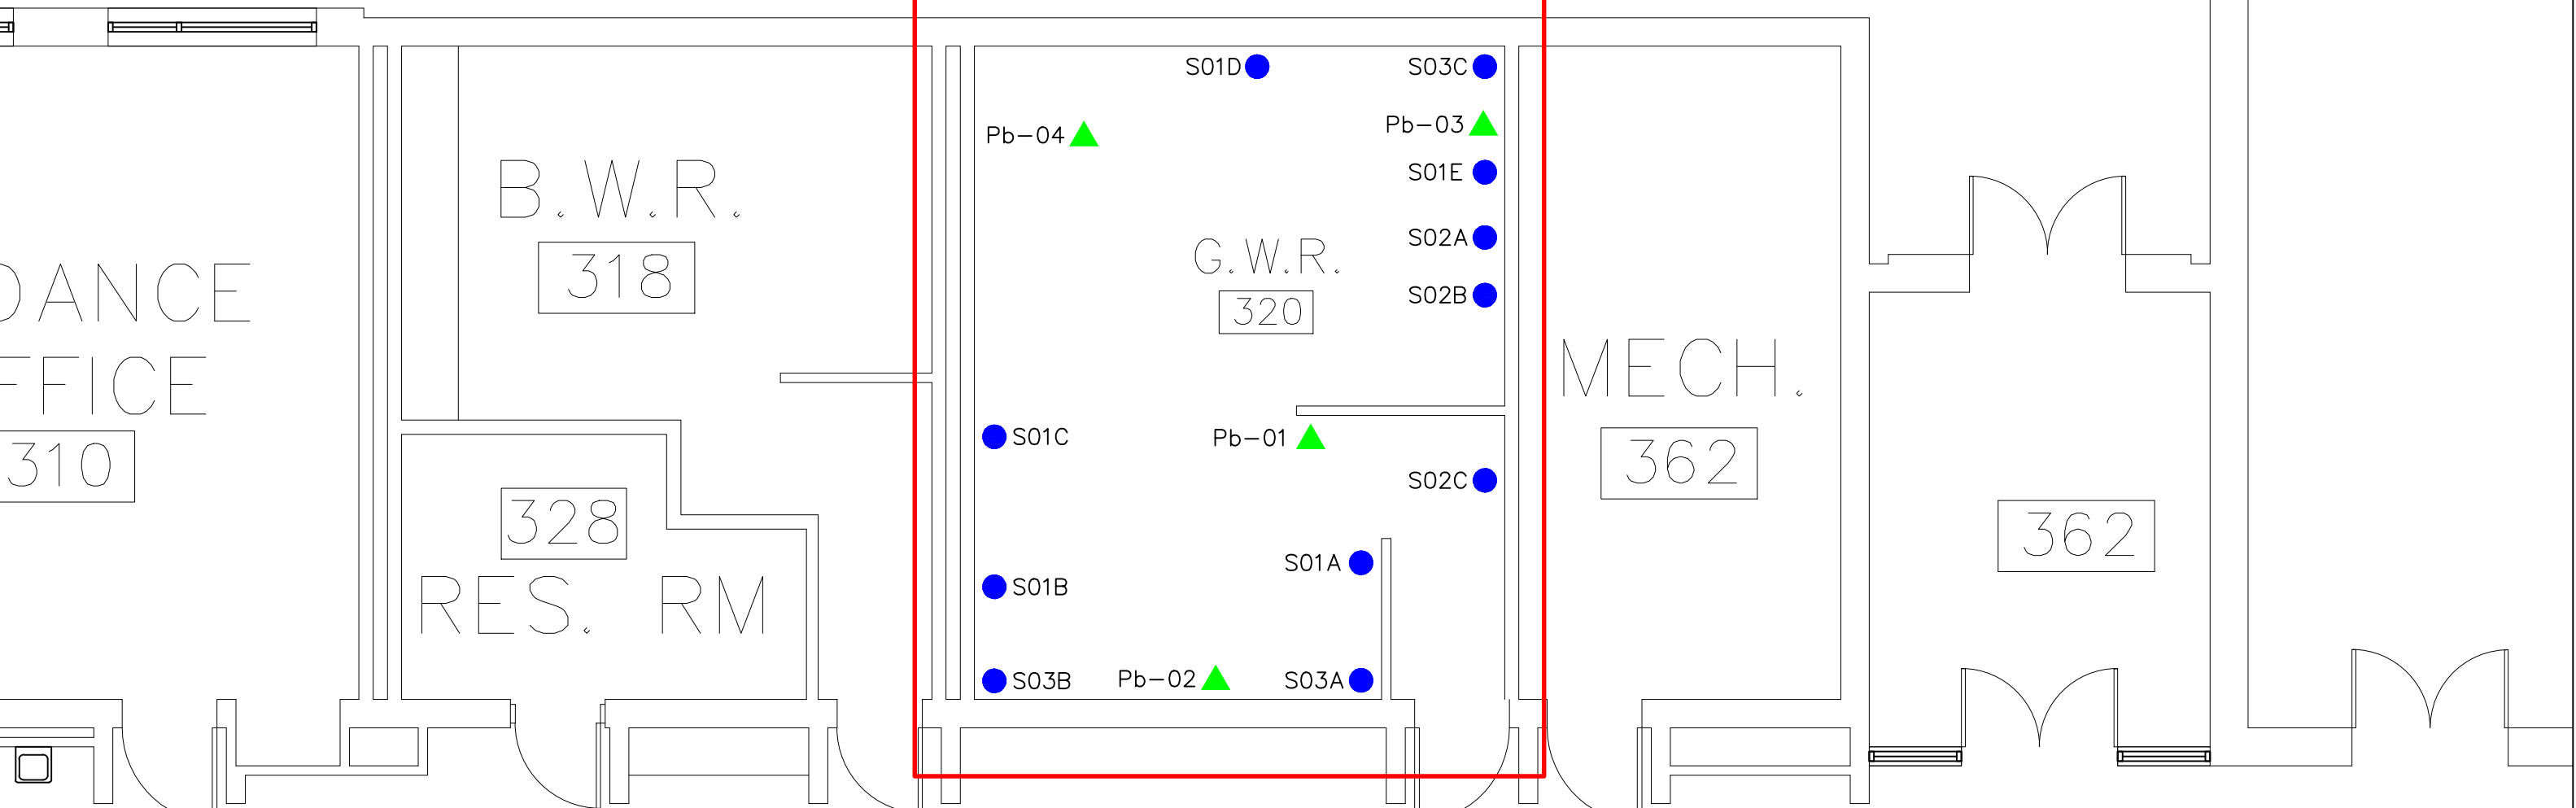
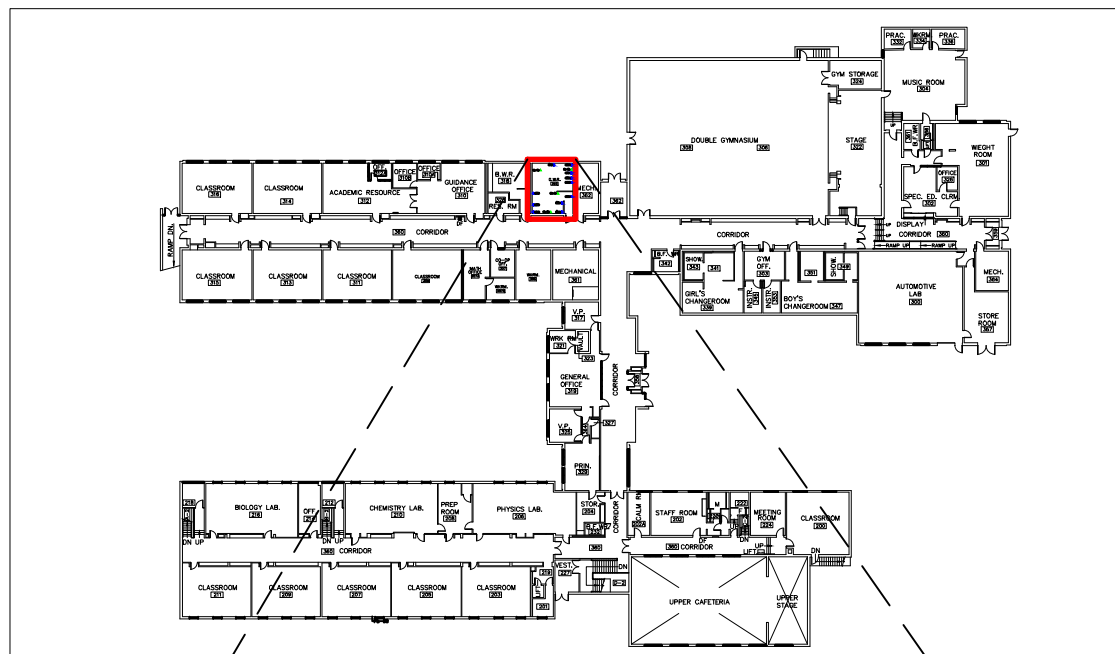
1) Suspect asbestos-containing transite pipe collars are present within the surveyed area. Specific locations of transite pipe collars are not illustrated.
