Project Manual
VOLUME I OF II
BIDDING AND CONTRACTING REQUIREMENTS
O'Connor Child Care Centre
Interior Renovations
1386 Victoria Park Avenue
Toronto, Ontario. M4A 2L8

DESIGNATED SUBSTANCES AND HAZARDOUS MATERIALS REASSESSMENT REPORT

**O'Connor Early Learning and Child Care Centre
1368 Victoria Park Avenue
North York, Ontario
M4A 1A5**

Safetech Project # 1-3230266

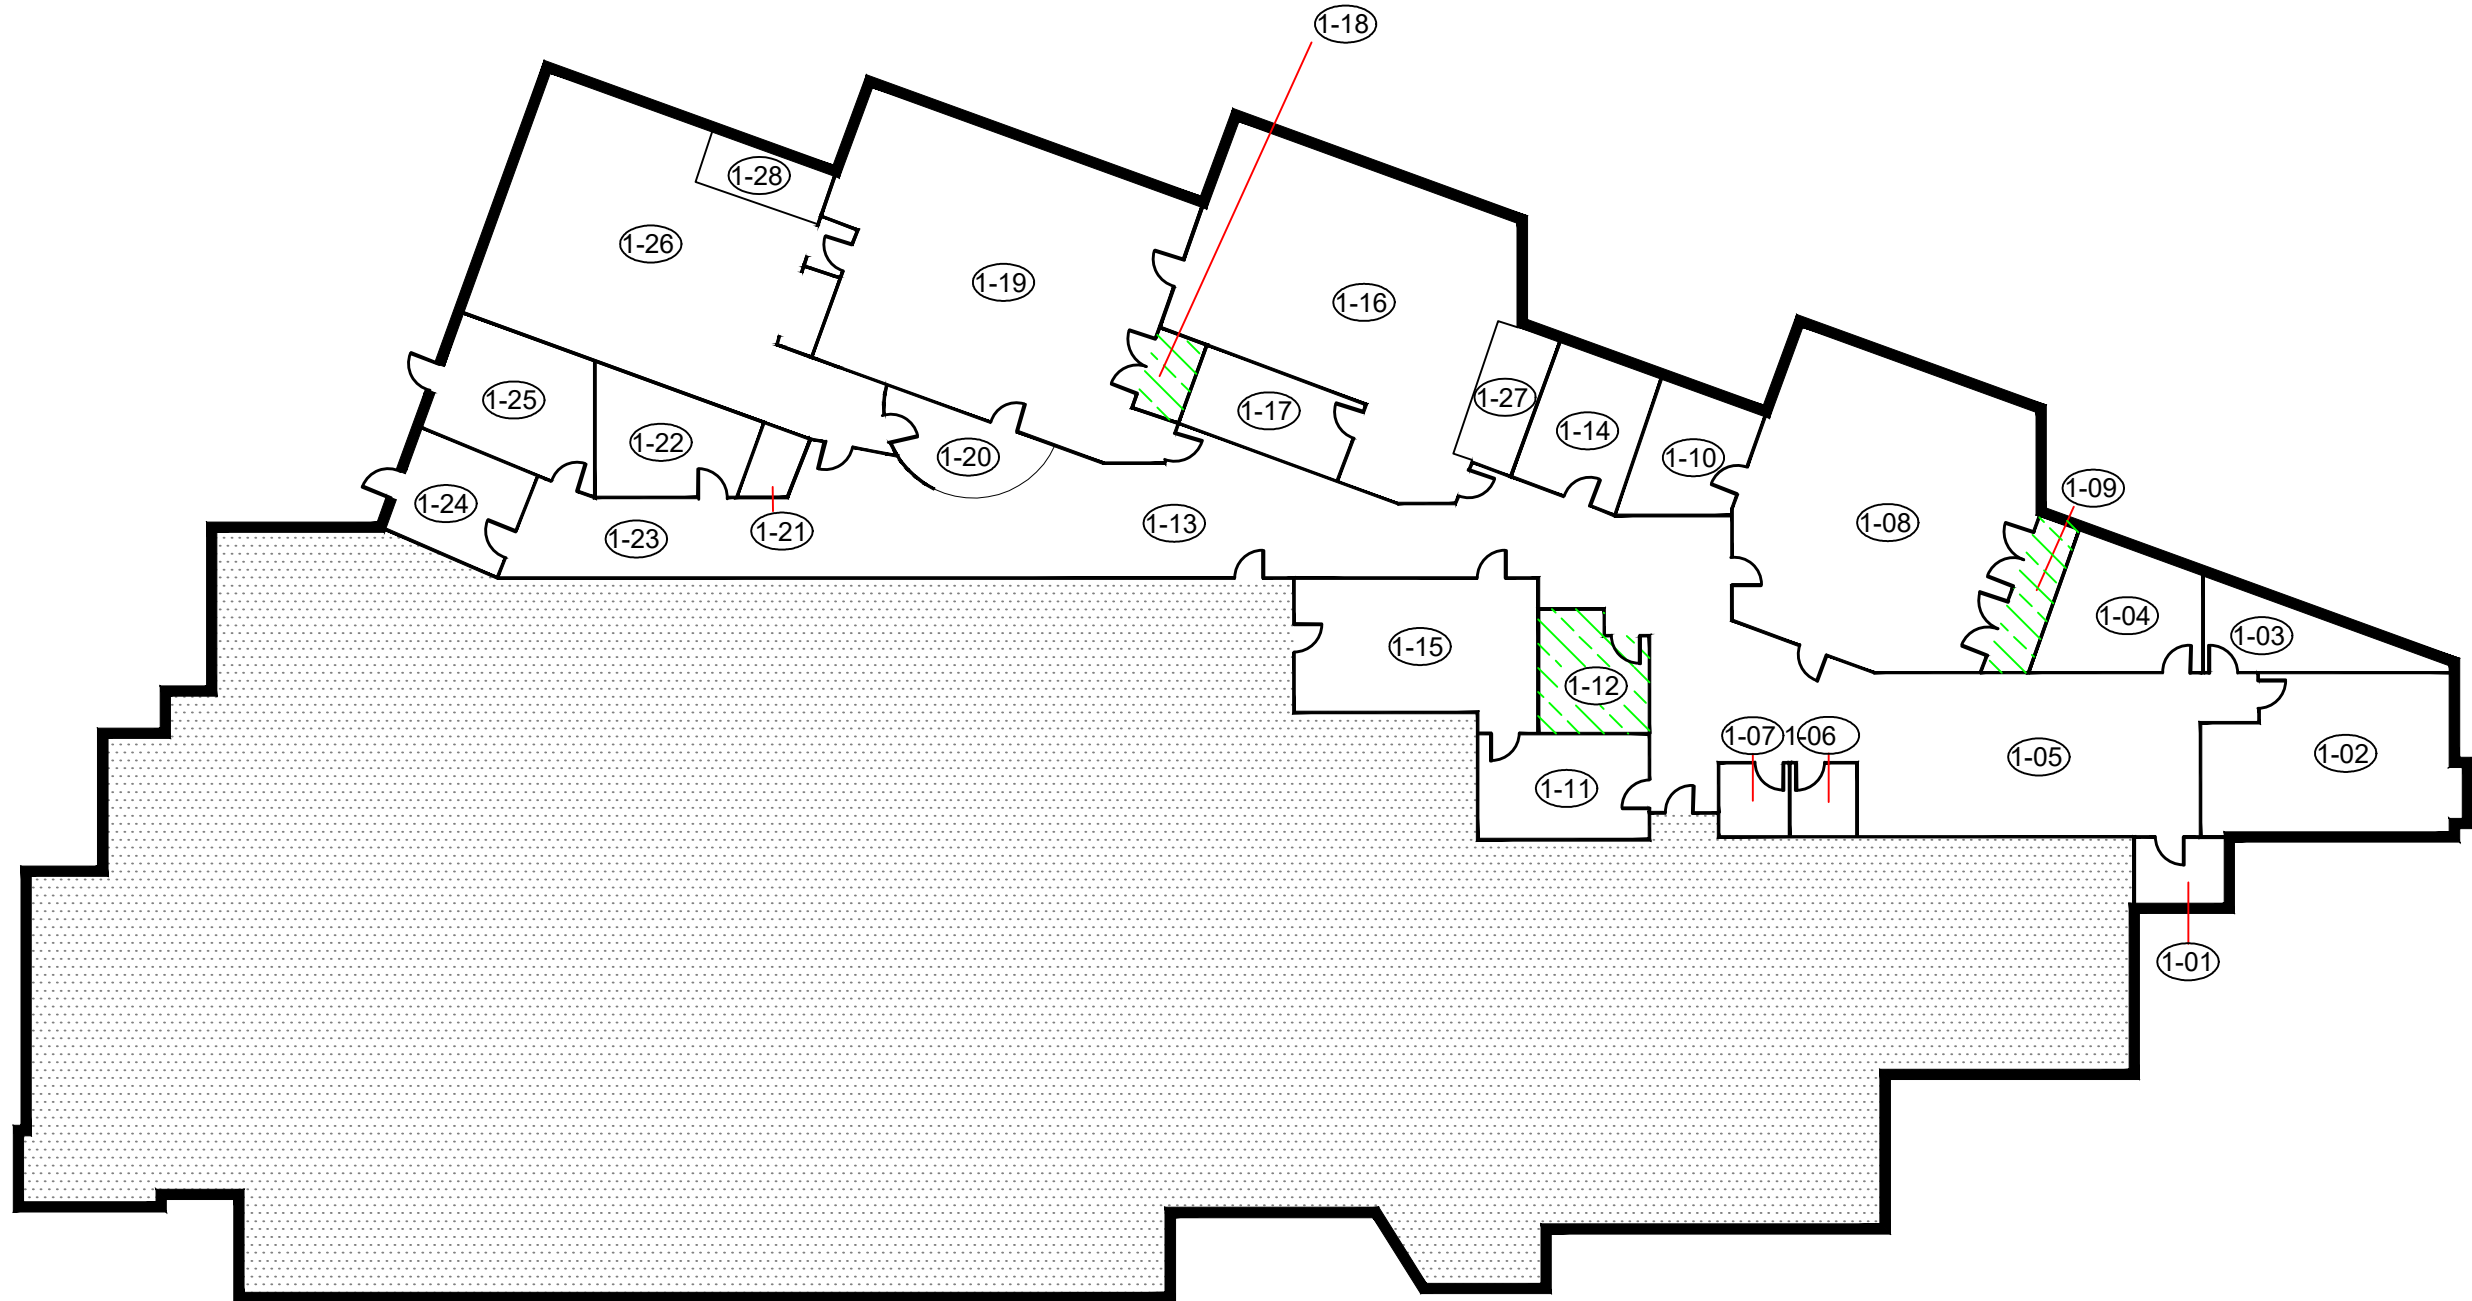
GROUND FLOOR

Assumed/Confirmed ACM
