**DESIGNATED SUBSTANCES and HAZARDOUS
MATERIALS SURVEY**

**LONG TERM CARE HOMES & SERVICES
Bendale Acres
2920 Lawrence Avenue East
Toronto, Ontario**

Project Number: FE 23-12800

SEPTEMBER 1, 2023

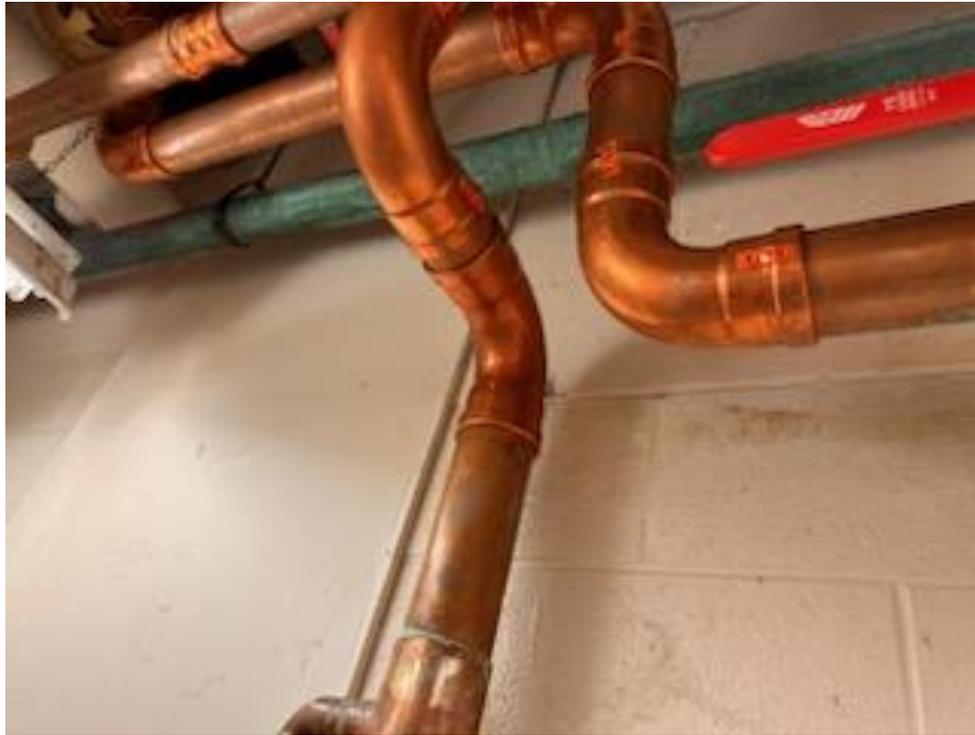
During the visual inspection of the surveyed areas, visible mould growth was observed on (non-ACM) insulation on five pipes in the Valve Room B-051.

Photo 1: View of the pipes after abatement work.

Fisher Engineering Limited communicated the reported deficiencies and recommendations for corrective actions to the City of Toronto. These activities have been completed and an Addendum was made to this report to confirm completion of the corrective actions. Details of the abatement work can be found in the Corrective Actions Inspection Report (Project No. FE 23-13254), which are provided in Appendix V.

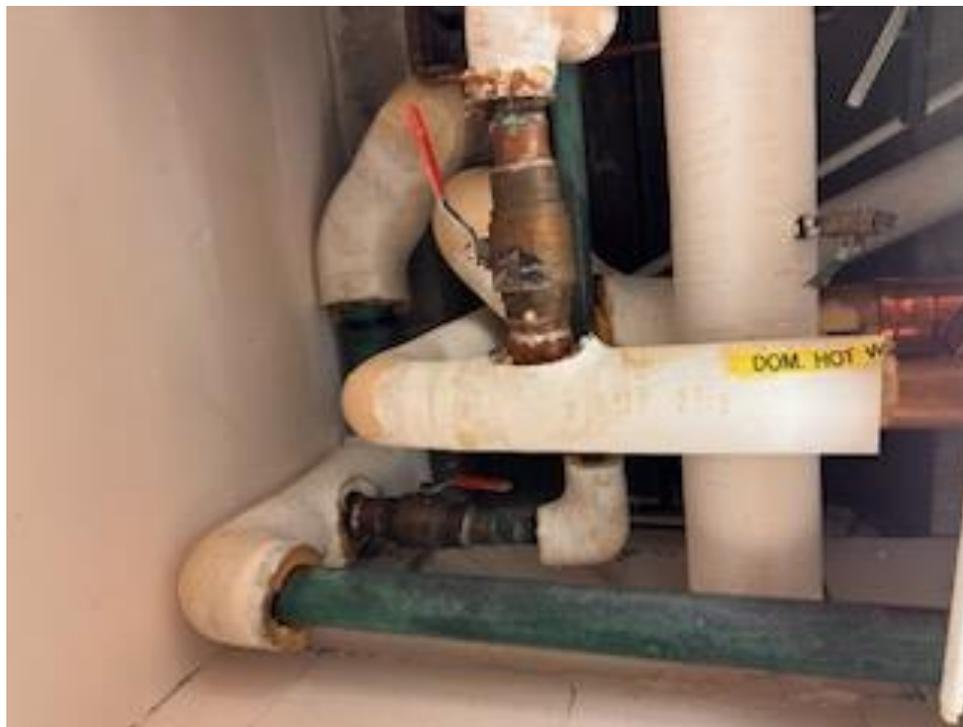
Photo 2: View of the pipes after abatement work.

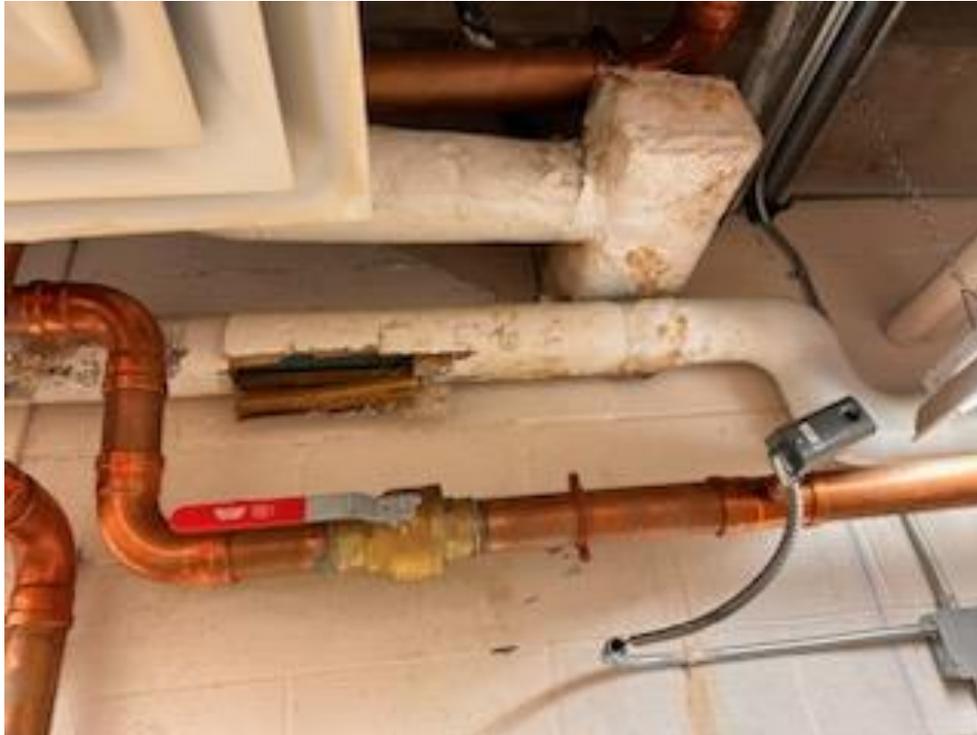
Photo 3: View of mould impacted pipe Insulation.

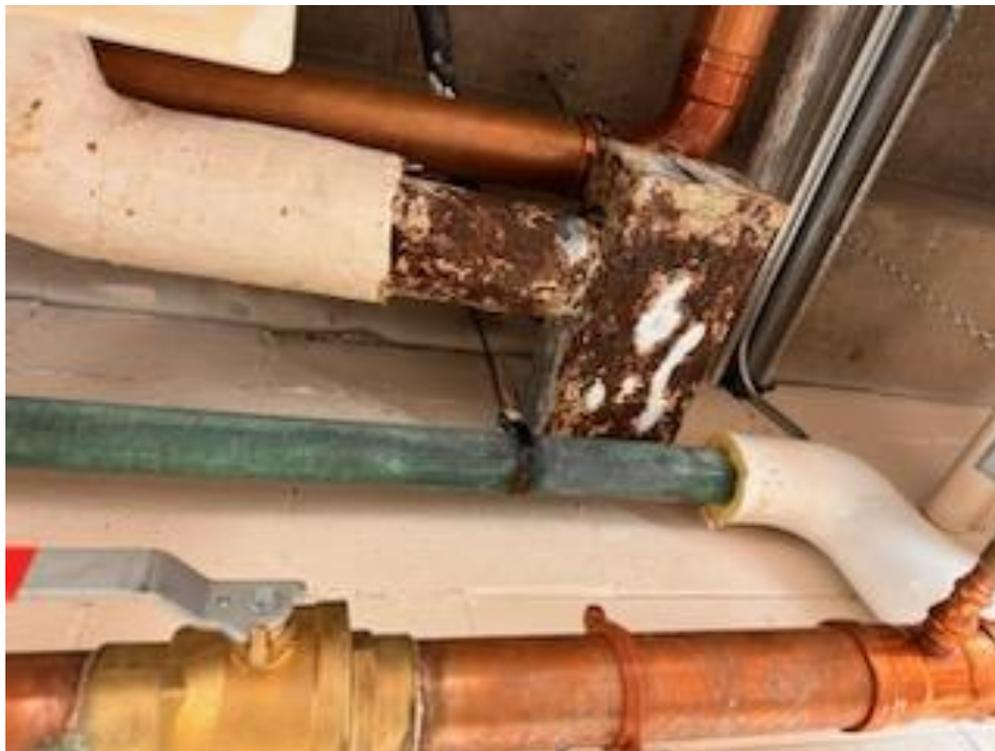
Photo 4: View of the pipes after abatement work.
