PRE-RENOVATION DESIGNATED SUBSTANCES AND HAZARDOUS MATERIALS SURVEY

**REXDALE COMMUNITY HUB
21 PANORAMA COURT
ETOBICOKE, ON**

ECOH Project No.: 28129

October 31, 2023

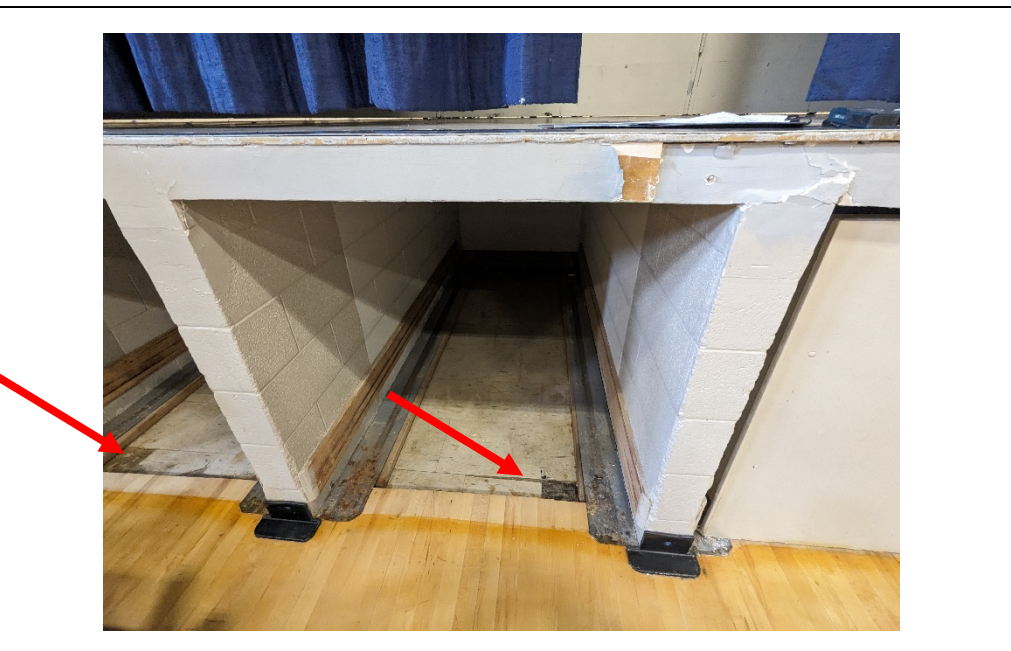
Photo No. 2.

- Approximately thirty-five (35) square feet of VFT1 were observed to be in POOR condition in the Back Stage (Loc. 1067).
- Three (3) samples of Vinyl Floor Tile 2 (VFT2 – 12"x12" Beige with Black Streaks) were collected (28129-ASB-09A-09C) and determined by laboratory analysis to contain **2% Chrysotile asbestos**.

- Approximately fifty (50) square feet of VFT2 was observed to be in POOR condition in the storage spaces under the Front Stage (Loc. 1067).

Date: October 11, 2023	
Location: Storage Areas under Stage (Loc. 1067)	
Description: Representative photo of POOR condition Vinyl Floor Tile 2 - 12"x12" Beige with Black Streaks, asbestos-containing 2% Chrysotile.

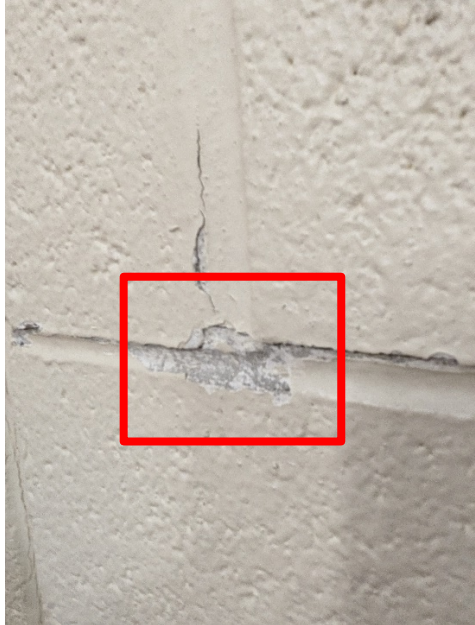
Photo No. 3.

Date: October 11, 2023	
Location: Throughout Project Area	
Description: Concrete Block Fill is asbestos-containing 1% Chrysotile.

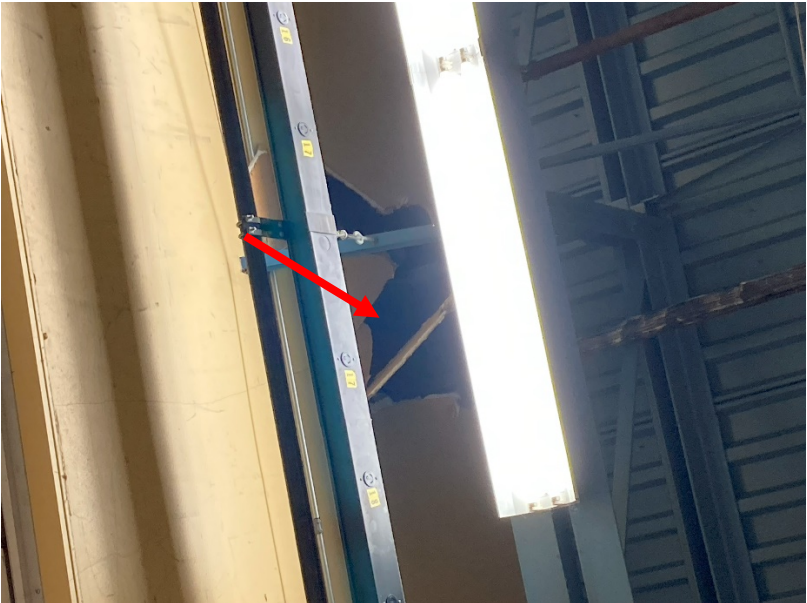
Photo No. 4.

Drywall with joint compound were observed to be present on bulkheads in the Back Stage (Loc. 1067). These areas were out of reach with a standard 6-foot ladder and therefore not sampled. These materials are **presumed to be asbestos-containing** until sampling determines otherwise.

- Approximately fifteen (15) square feet of drywall with joint compound on horizontal bulkhead were observed to be in POOR condition in the Back Stage (Loc. 1067).

Date: October 11, 2023	
Location: Stage (Loc. 1067)	
Description: Representative photo of POOR drywall joint compound bulkhead, presumed asbestos-containing.

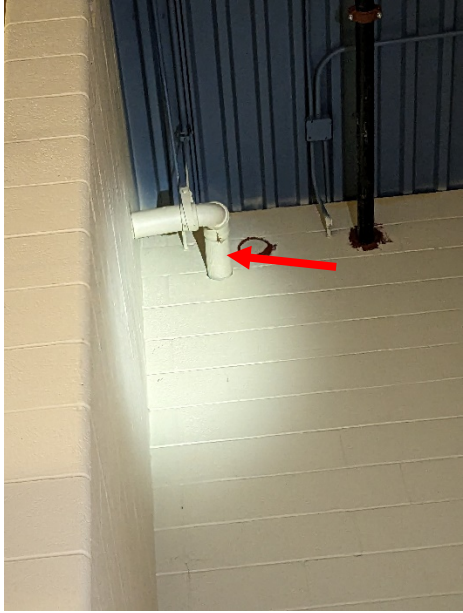
Photo No. 5.

Transite Pipe was observed above the east stairs in the Back Stage (Loc. 1067). This material is **visually confirmed to be asbestos-containing**.

Date: October 11, 2023	
Location: Stage (Loc. 1067)	
Description: Transite pipe visually confirmed to be asbestos-containing .

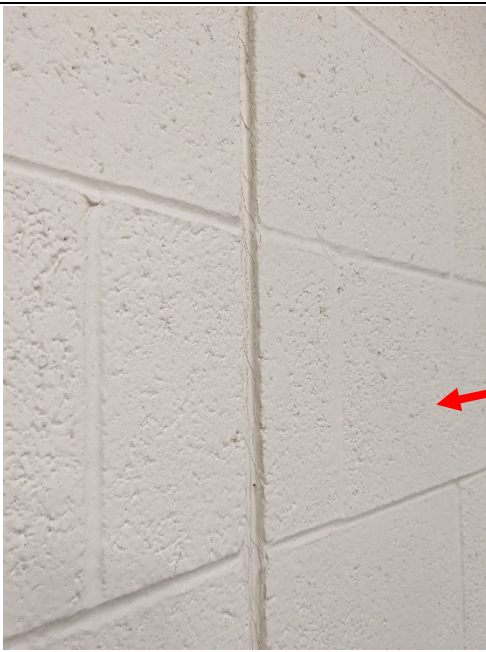
Photo No. 6.

Vermiculite insulation was previously sampled within the facility and determined to contain **0.5-5% Actinolite asbestos** (*Survey for Designated Substances and Hazardous Materials*, Nov. 27, 2020). This material may be present within concrete block walls in the Project Area, but its presence could not be verified as intrusive investigations were not conducted.

Date: October 11, 2023	
Location: Throughout Project Area	
Description: Representative photo of concrete blocks that may have asbestos-containing (0.5-5% Actinolite) vermiculite insulation within.

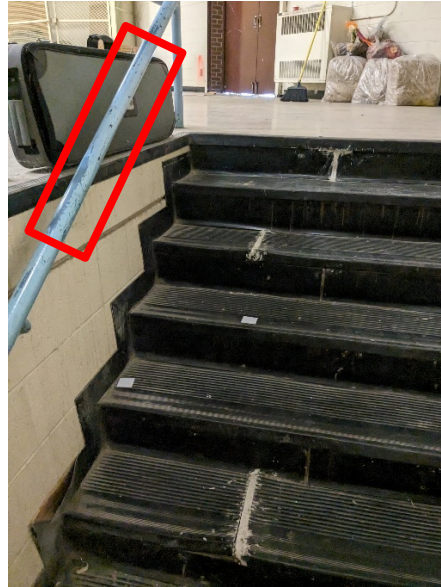
Blue paint on stairs railing,
lead-containing 1500 ppm.

Any work involving the disturbance of building materials confirmed to be lead-based or lead-containing (Blue Paint on Stairs Railing-1500 ppm) should be conducted following recommendations detailed within the Ministry of Labour document *Guideline - Lead on Construction Projects*, dated April 2011, and the Environmental Abatement Council of Canada (EACC) *Lead Guideline*, dated October 2014.
