PRE-RENOVATION DESIGNATED SUBSTANCES AND HAZARDOUS MATERIALS SURVEY

**DAVENPORT SHELTER
348 DAVENPORT ROAD
TORONTO, ON**

ECOH Project No.: 28698

August 8, 2024

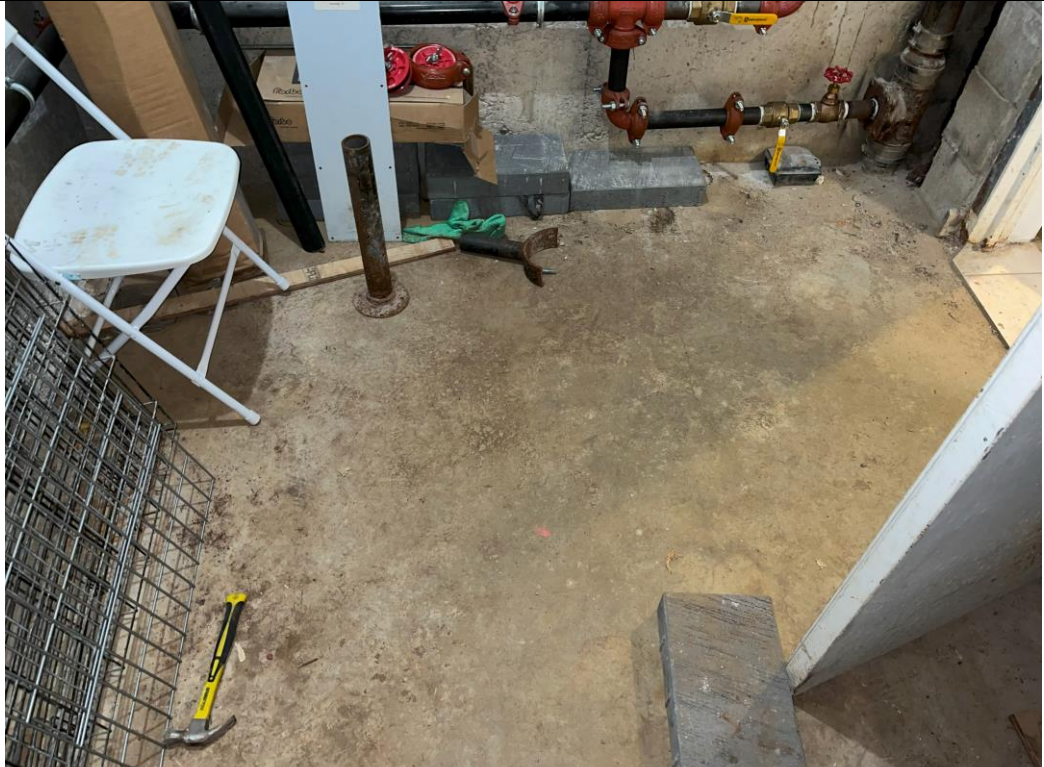
Non-asbestos
concrete slab.

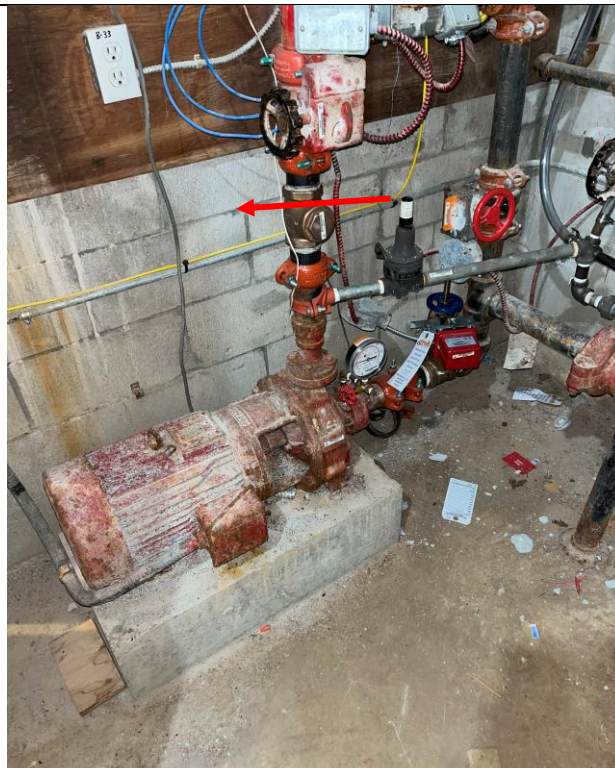
Photo No. 2.

Mortar was observed on concrete block walls within the Project Area. Three (3) representative samples of the mortar were collected (28698-ASB-02A-C) and determined by laboratory analysis to be non-asbestos.

Non-asbestos
concrete block
mortar.

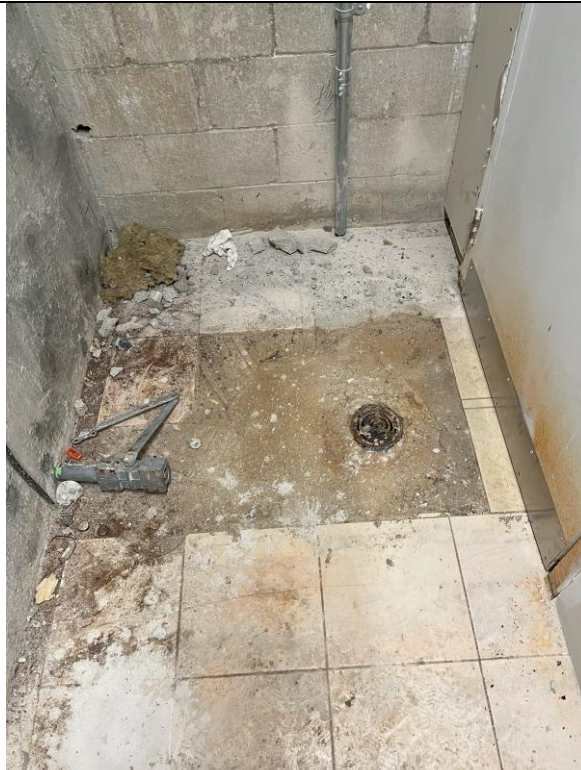
Grout was observed on ceramic tile floors within the Project Area. Three (3) representative samples of the grout were collected (28698-ASB-02A-C) and determined by laboratory analysis to be non-asbestos.

Non-asbestos
ceramic tile grout.

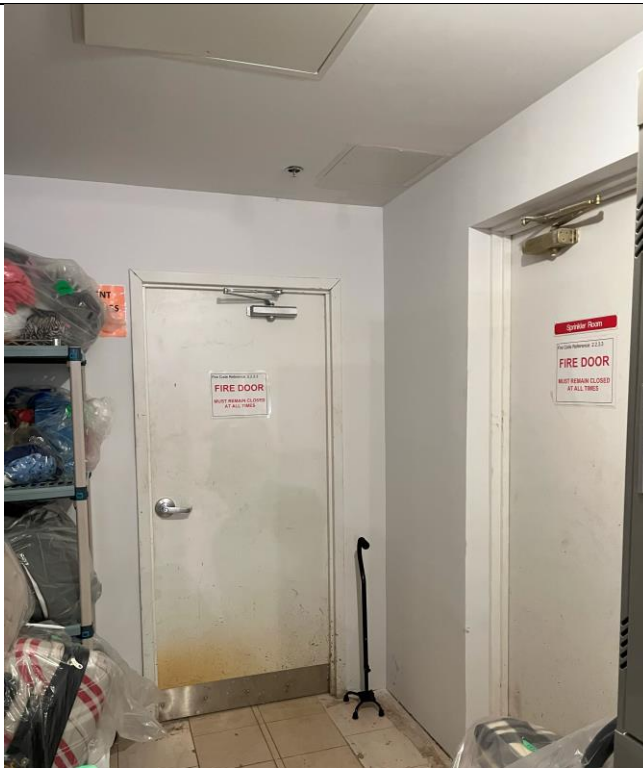
Photo No. 4.

Drywall with joint compound was observed on ceilings within the Project Area. The joint compound was previously sampled (18501-ASB-01A-E, 18501-ASB-03A-E, 18501-ASB-06A-E, 18501-ASB-08A-E, 18501-ASB-10A-E, 20586-PR2-ASB-01A-E, 20586-PR2-ASB-03A-C, 20586-PR2-ASB-05A-C, & 20586-PR2-ASB-07A-C) and determined by laboratory analysis to be non-asbestos.

Drywall with joint compound was observed on walls within the Project Area. The joint compound was previously sampled (18501-ASB-02A-E, 18501-ASB-04A-E, 18501-ASB-05A-E, 18501-ASB-07A-E, 18501-ASB-09A-E, 18501-ASB-11A-E, 20586-PR2-ASB-02A-C, 20586-PR2-ASB-04A-C, & 20586-PR2-ASB-06A-C) and determined by laboratory analysis to be non-asbestos.

Non-asbestos joint
compound on
drywall wall and
ceilings.

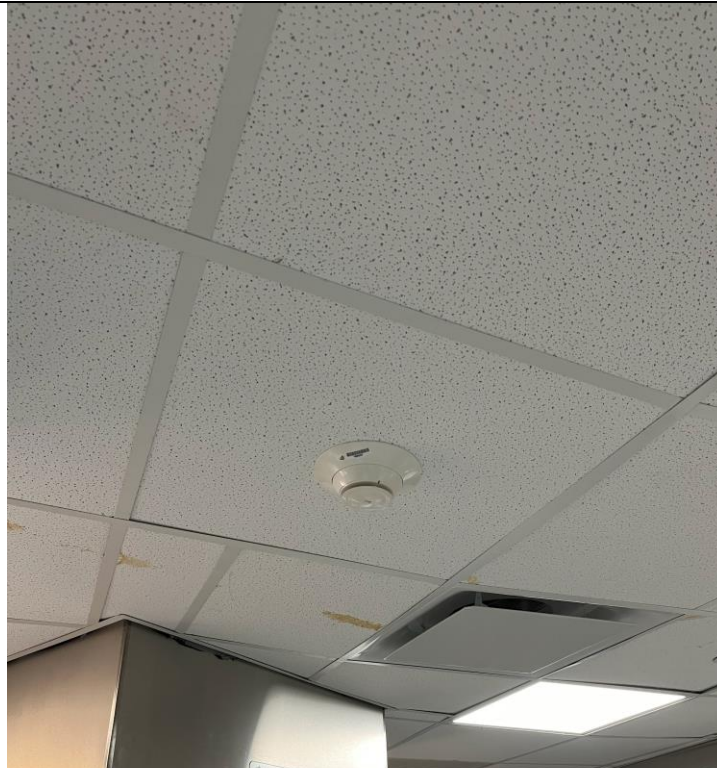
Ceiling tile 1 – 2'x2' small pinholes and small fissure was observed within the Project Area. This material was previously sampled (20586-PR2-ASB-08A-C) and determined by laboratory analysis to be non-asbestos.

Non-asbestos
ceiling tile 2'x2'
small pinholes and
small fissures.
