THE REGIONAL MUNICIPALITY OF NIAGARA

PROJECT-SPECIFIC DESIGNATED SUBSTANCES AND HAZARDOUS MATERIALS SURVEY

5853 PEER STREET, NIAGARA FALLS, ON - INTERIOR
RENOVATION PROJECT

JULY 26, 2019

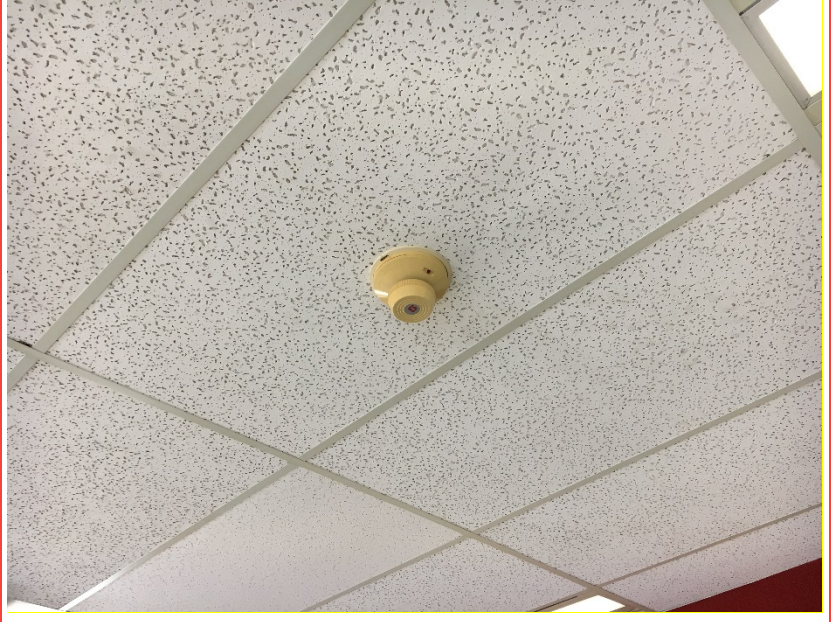
| PHOTO NO. | MATERIAL DESCRIPTION & LOCATION | PHOTO |
|---|---|--|
| 2 | <p>Smoke detector observed in the proposed work area on the 1st floor of the building may contain radioactive materials (Americium-241).</p> | |

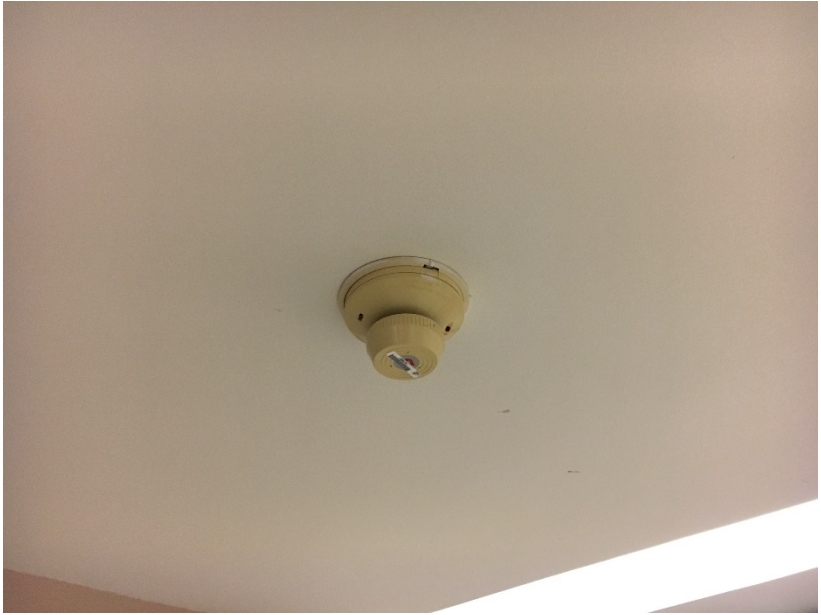
| PHOTO NO. | MATERIAL DESCRIPTION & LOCATION | PHOTO |
|---|--|--|
| 3 | Smoke detector observed in the proposed work area on the basement level of the building may contain radioactive materials (Americium-241). | |

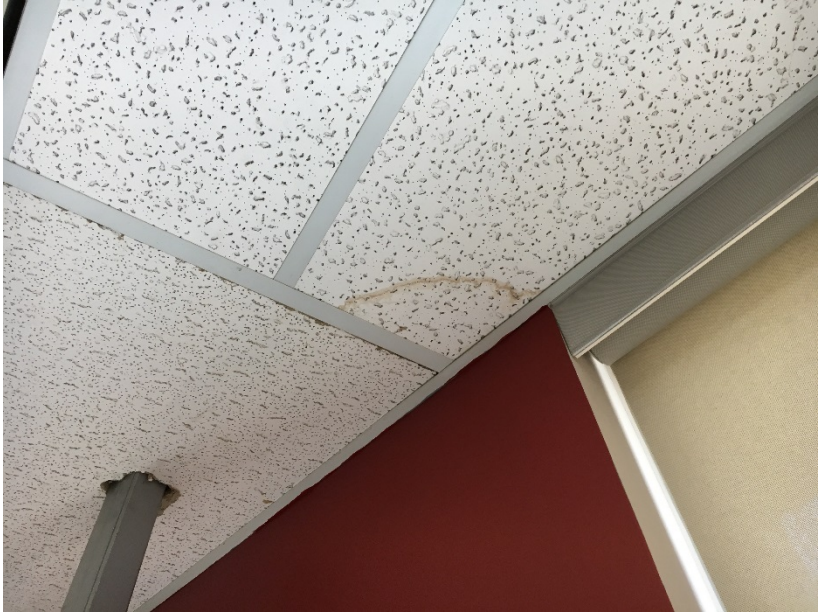
| MATERIAL | SURVEY FINDINGS |
|---|---|
| Mould | Water-stained ceiling tiles were observed on the 1 st floor of the building. No other water-damaged or mould-affected materials were observed within the proposed work areas. |

| PHOTO NO. | MATERIAL DESCRIPTION & LOCATION | PHOTO |
|---|--|--|
| 4 | Water-stained ceiling tile observed in the proposed work area on the 1 st floor of the building. | |
