2022 ASBESTOS REASSESSMENT

CS - NIAGARA FALLS COMMUNITY SERVICES, 5853 PEER STREET, NIAGARA FALLS, ON

PROJECT NO.: 221-06405-00
DATE: AUGUST 12, 2022

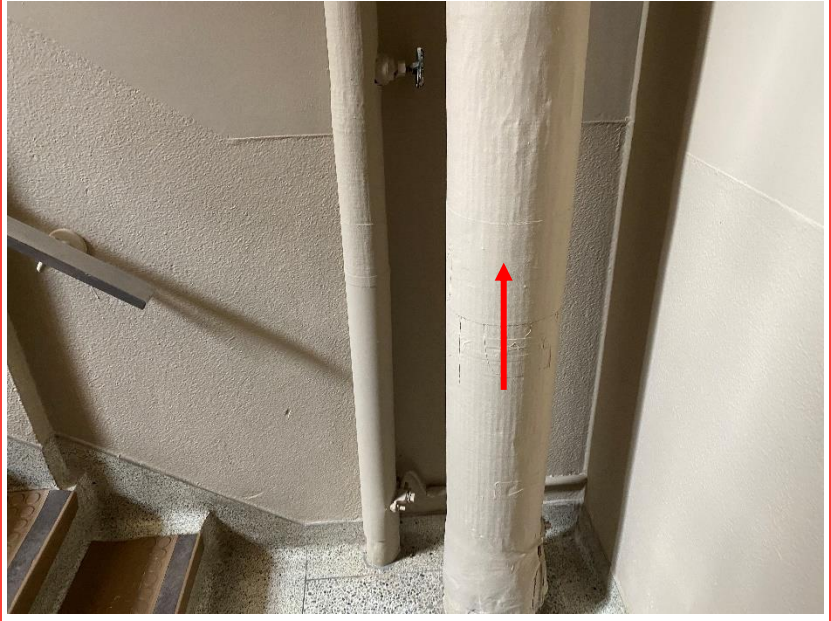
PHOTO NO.	MATERIAL DESCRIPTION & LOCATION	PHOTO
1	<p>Representative photo of asbestos-containing pipe insulation identified on pipe straights within various areas in the basement of the subject building observed in good condition.</p>

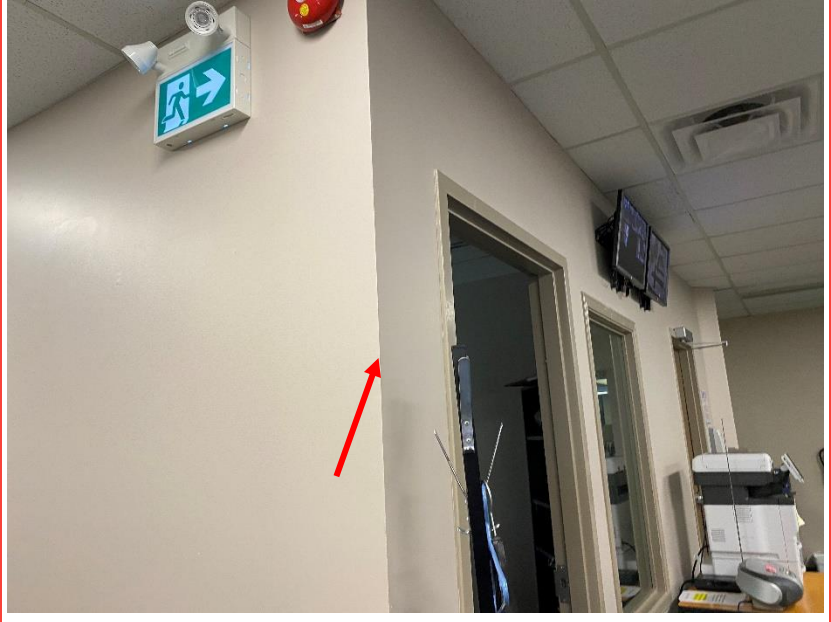
2	<p>Representative photo of asbestos-containing drywall joint compound identified on walls and ceilings throughout the subject building observed in good condition.</p>

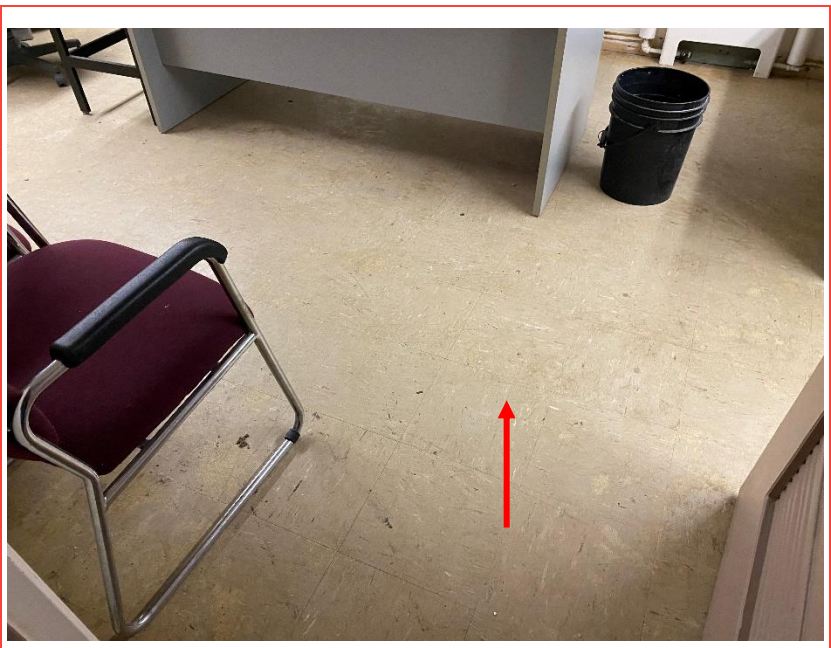
PHOTO NO.	MATERIAL DESCRIPTION & LOCATION	PHOTO
3	<p>Representative photo of asbestos-containing vinyl floor tiles (12"x12"beige with grey streaks) and associated black mastic identified in B104 (room #8) in the basement observed in good condition.</p>

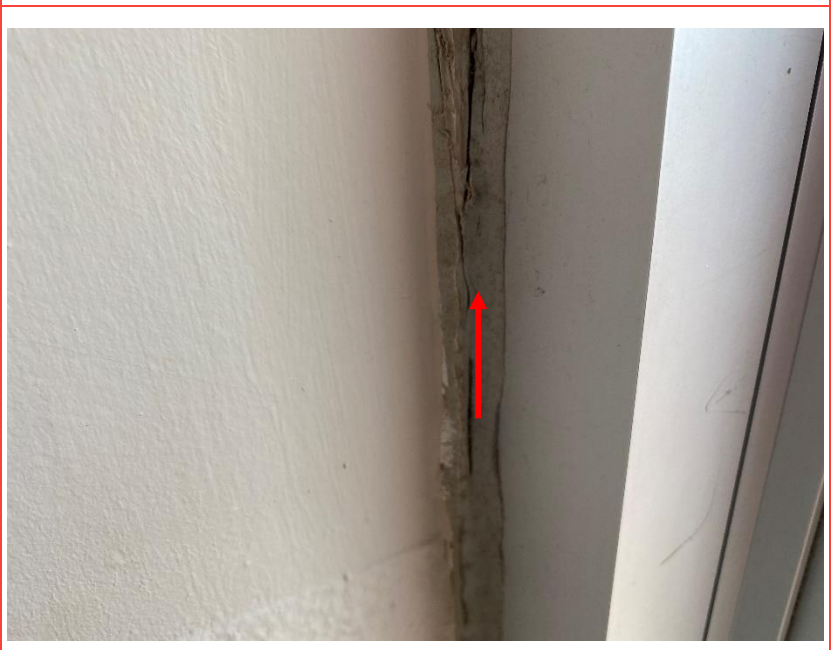
4	<p>Representative photo of asbestos-containing tan glazing/caulking identified on door frames throughout the subject building observed in good condition.</p>
