**DESIGNATED SUBSTANCES & HAZARDOUS MATERIALS SURVEY  
PEEL REGIONAL POLICE - 11 DIVISION  
3030 ERIN MILLS PARKWAY  
MISSISSAUGA, ONTARIO**

**PEEL REGIONAL POLICE**

**Project: 1732-230  
July 31, 2013**

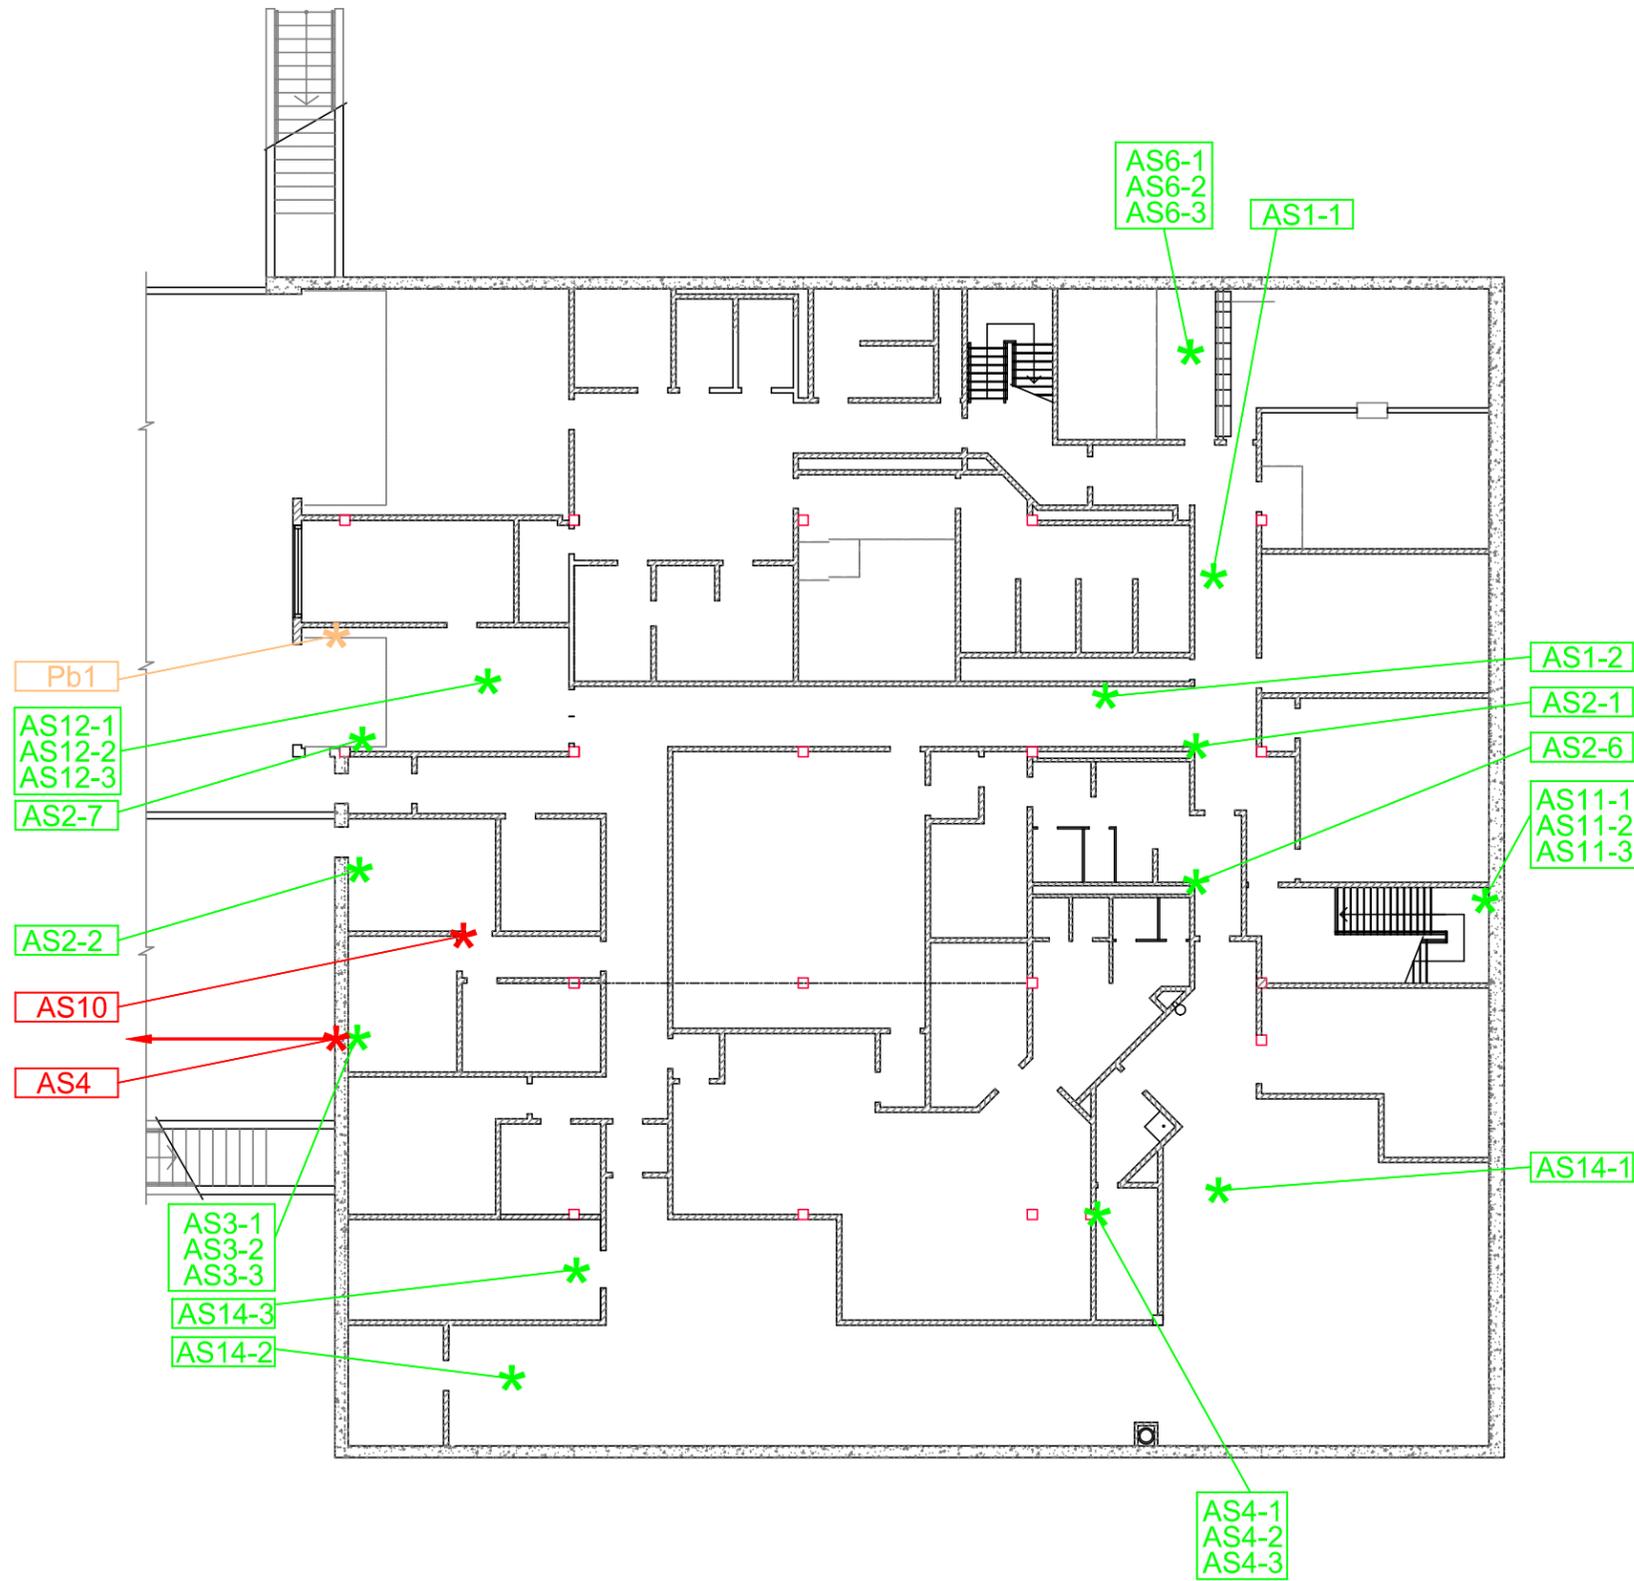
- Note:
1. This drawing must be read in conjunction with associated report
  2. Drawings provided to SPL by client
  3. Asbestos containing materials may be present in inaccessible areas throughout the building
  4. Asbestos containing window caulking was observed around door frames in basement of building
  5. Asbestos containing sealant was observed on roof flashing and facade

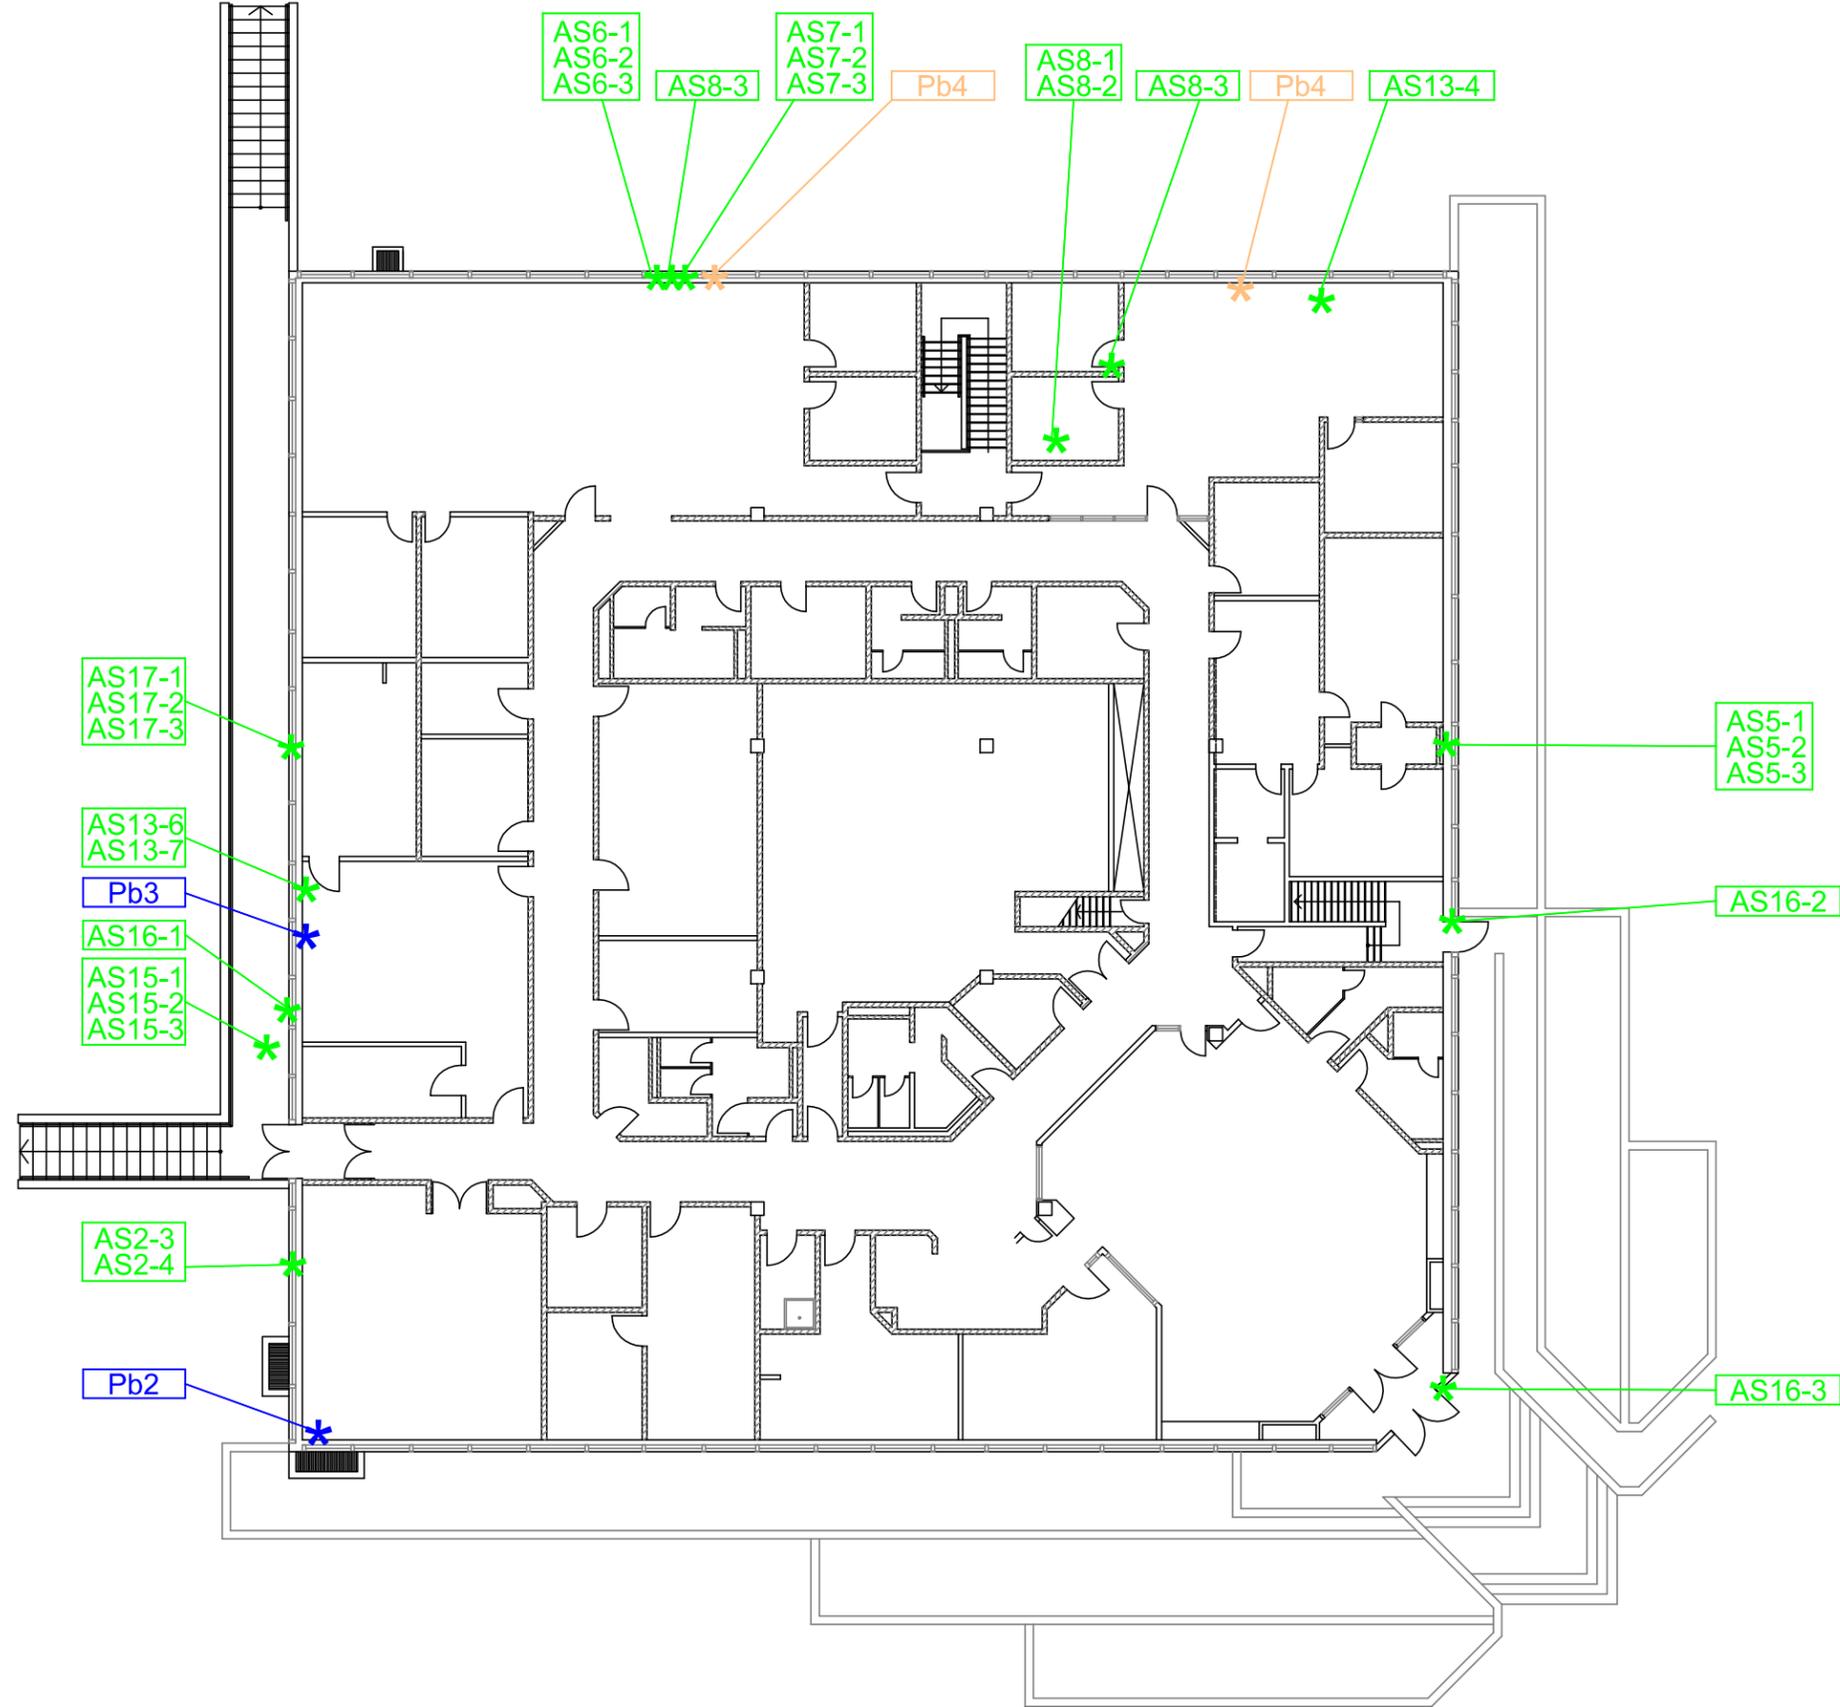
- Note:
1. This drawing must be read in conjunction with associated report
  2. Drawings provided to SPL by client
  3. Asbestos containing materials may be present in inaccessible areas throughout the building
  4. Asbestos containing window caulking was observed around door frames in basement of building
  5. Asbestos containing sealant was observed on roof flashing and facade

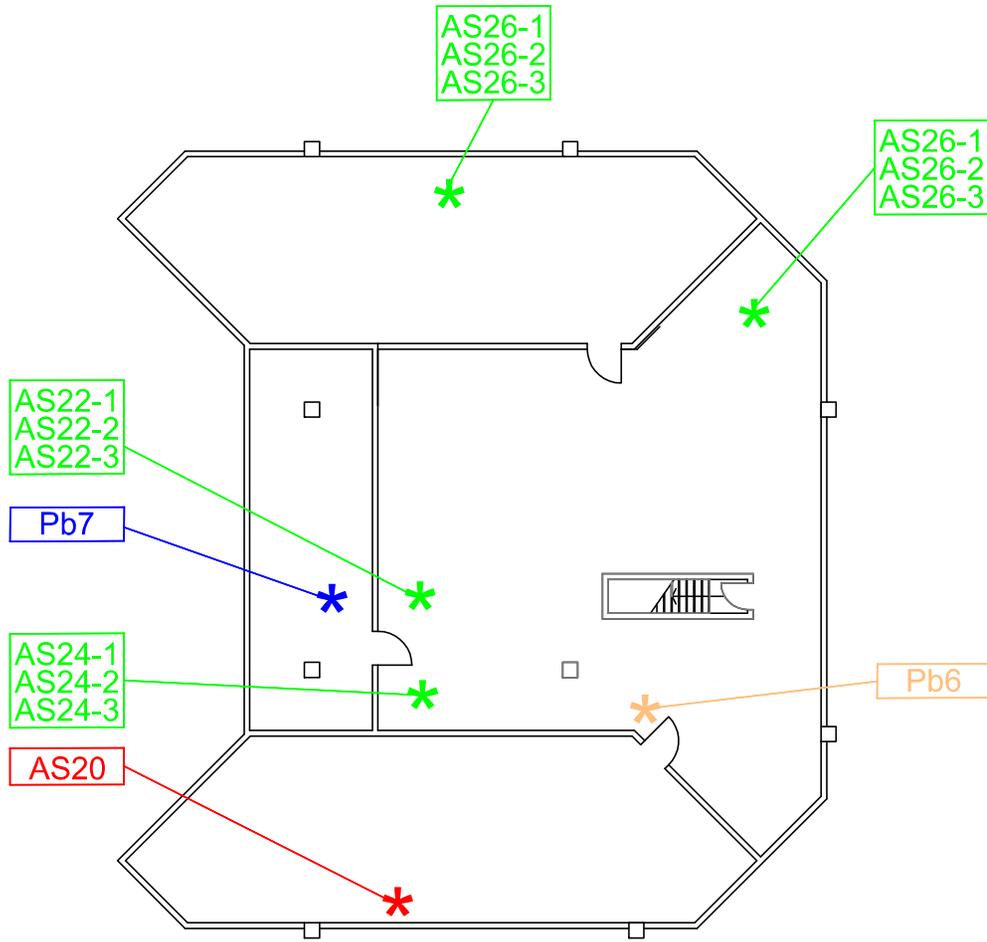
1. This drawing must be read in conjunction with associated report
2. Drawings provided to SPL by client
3. Asbestos containing materials may be present in inaccessible areas throughout the building
4. Asbestos containing window caulking was observed around door frames in basement of building
5. Asbestos containing sealant was observed on roof flashing and facade

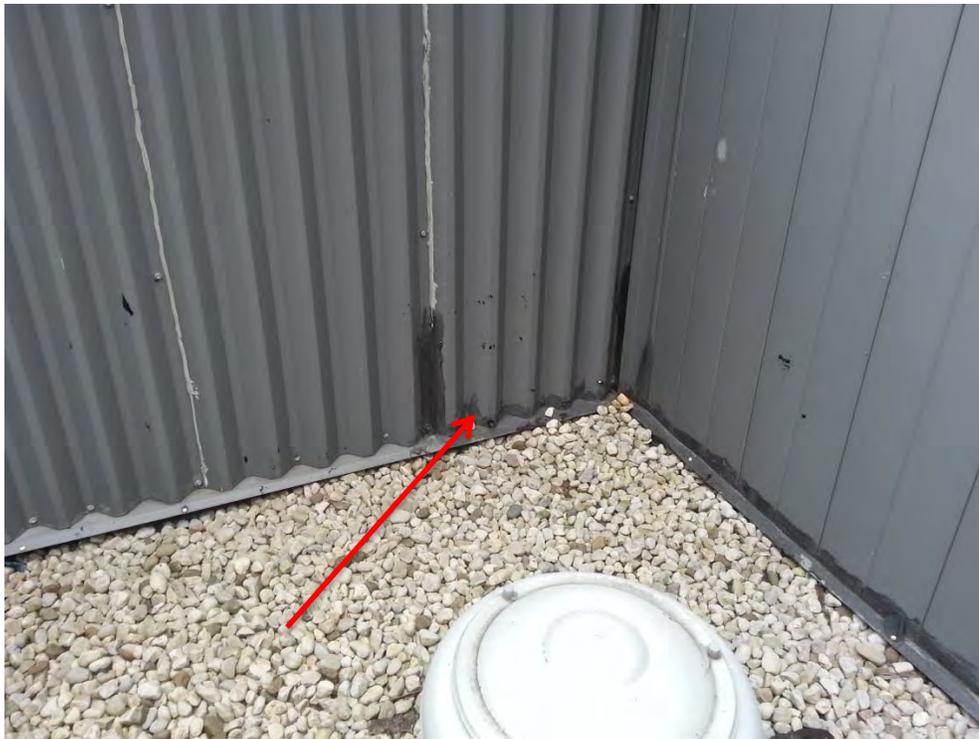
2 – View of asbestos black sealant on roof.

It is recommended that all identified asbestos containing materials be removed in accordance with O.Reg. 278/05. If any potential asbestos containing materials are encountered unexpectedly, SPL should be contacted to sample, monitor and/or document the removal of asbestos containing materials, and to ensure that appropriate procedures are being followed.
