**Re: Hazardous Building Materials Assessment (Pre-Construction)**

Murray Centennial, 654 County Road 40, Trenton, Ontario

Pinchin File: 335495.031

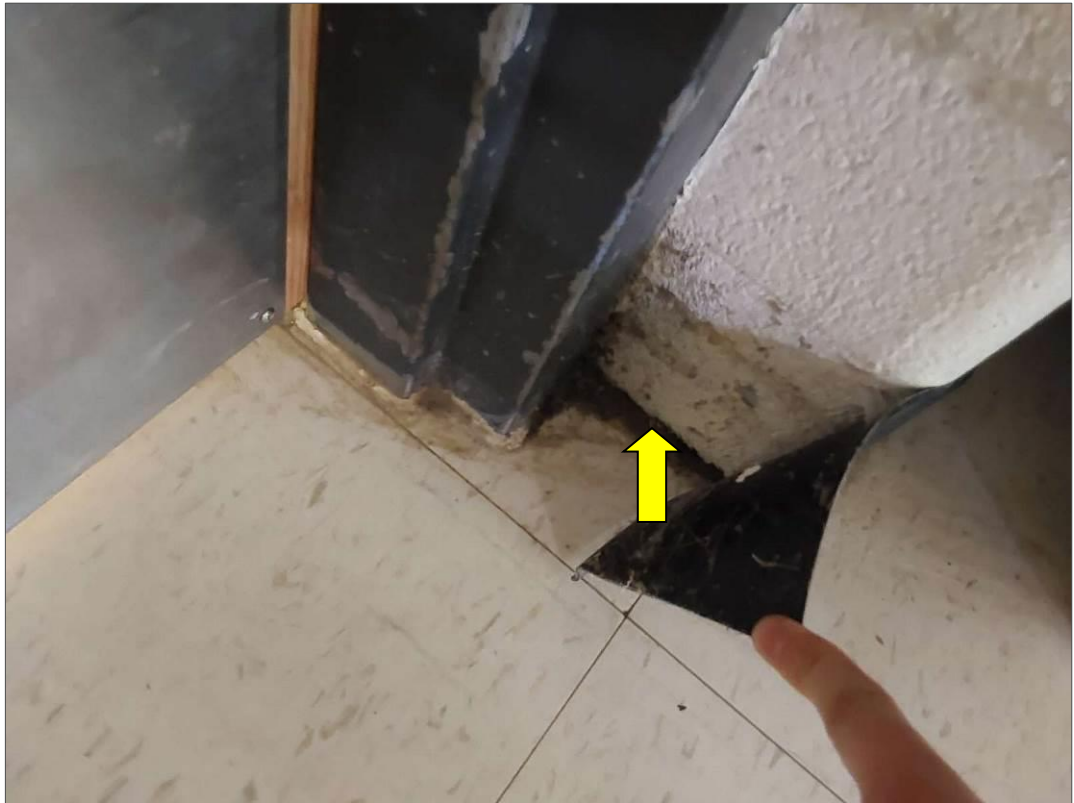
S0028 (None), Beige baseboard mastic, Other, Base, Adhesive/mastic, Kindergarten (Location #: 53)

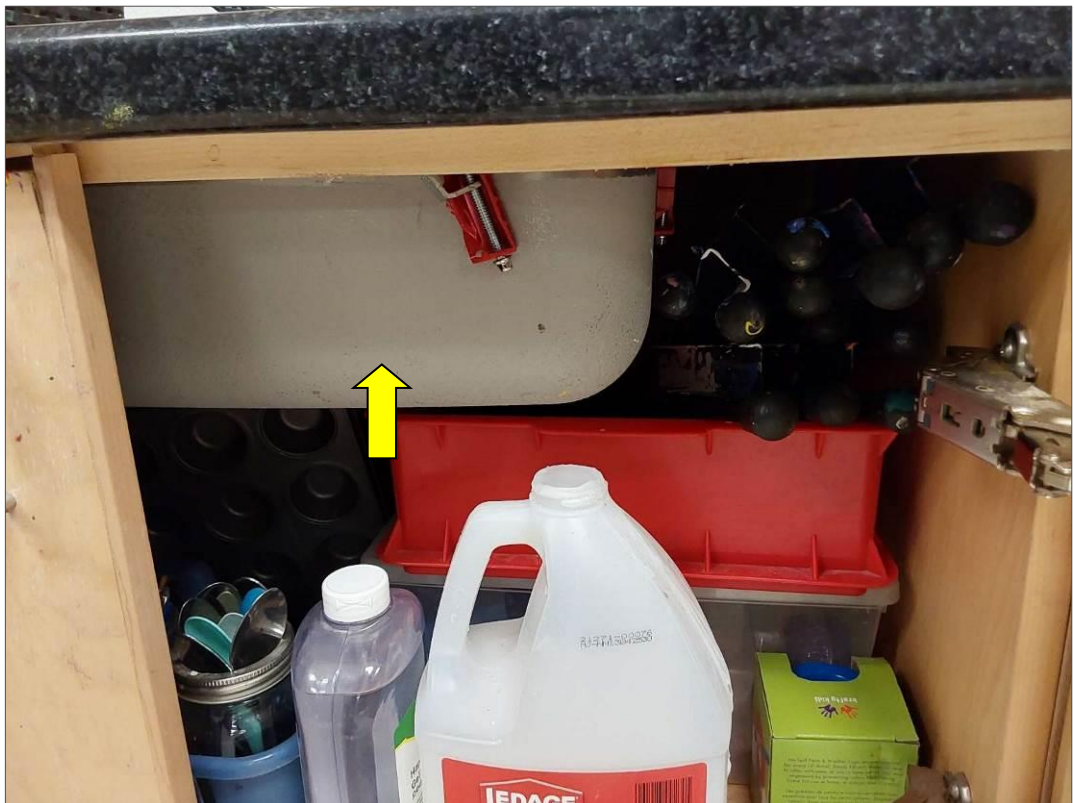
V0029 (None), Grey sink mastic, Other, Mastic, Kindergarten (Location #: 53)

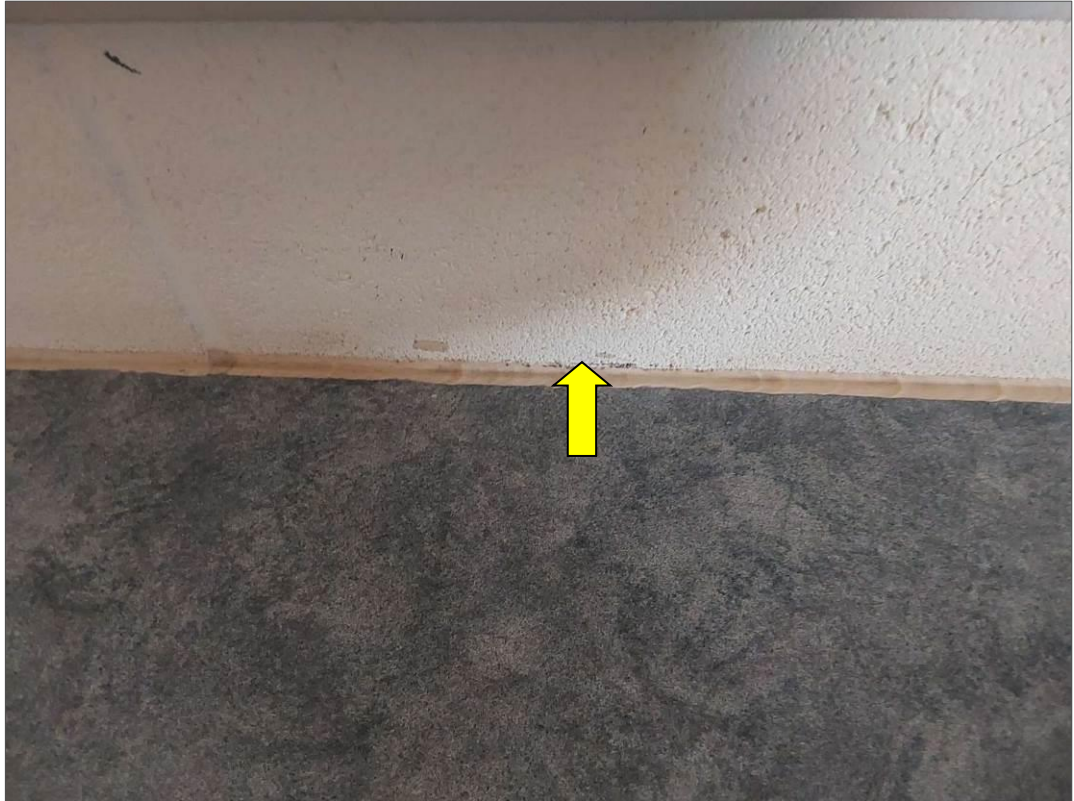
S0031 (None), Other, Caulking, Classroom (Location #: 50)

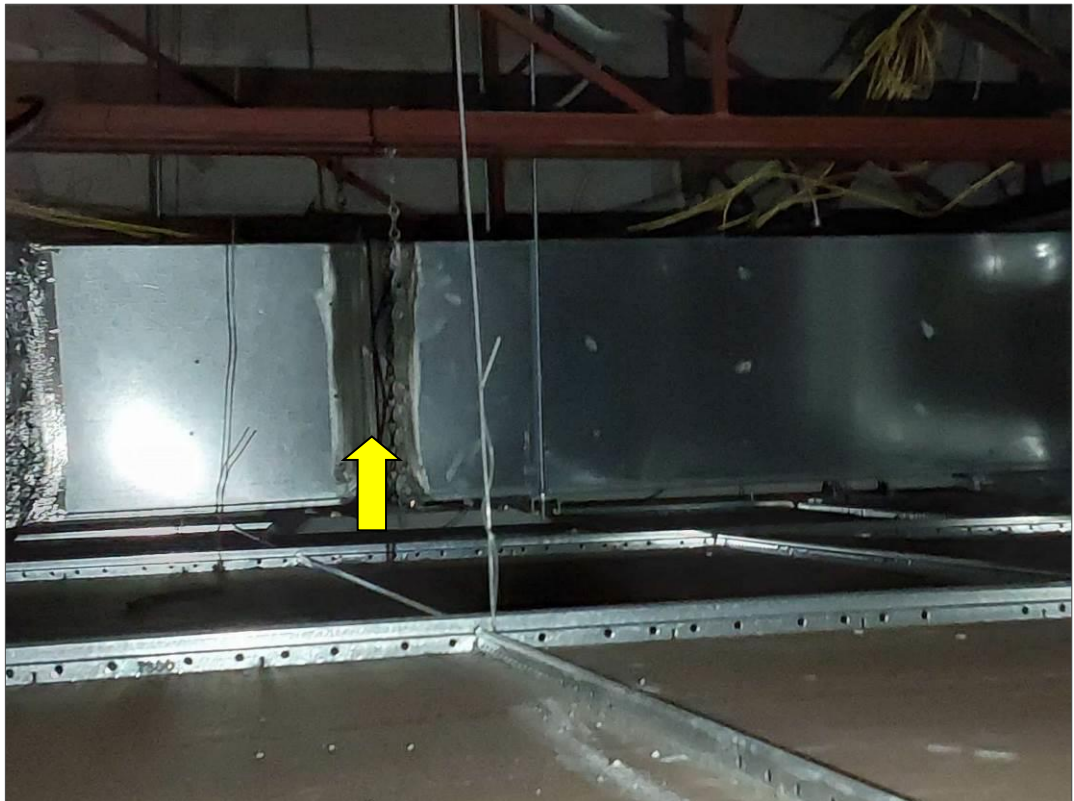
S0039A (None), Grey duct mastic, Duct, Mastic, Grey, Classroom (Location #: 40)

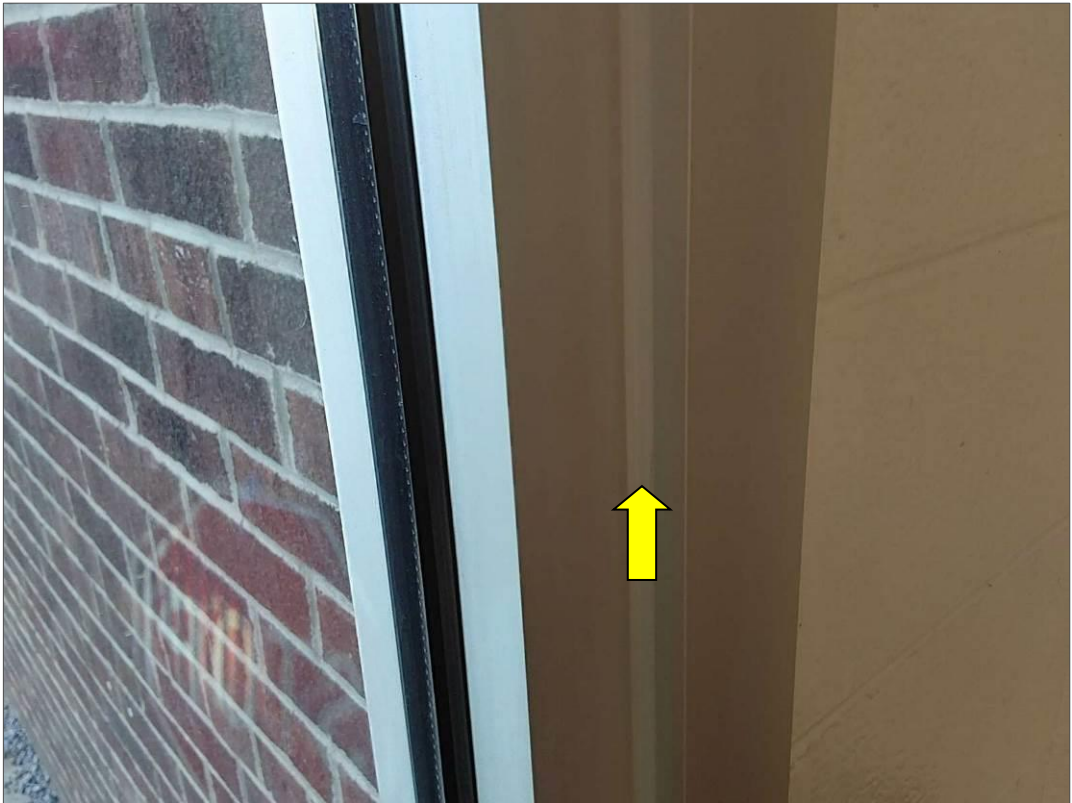
S0040A (None), Grey caulking on 2006 date stamped door, Other, Door, Caulking, Corridor (Location #: 48)

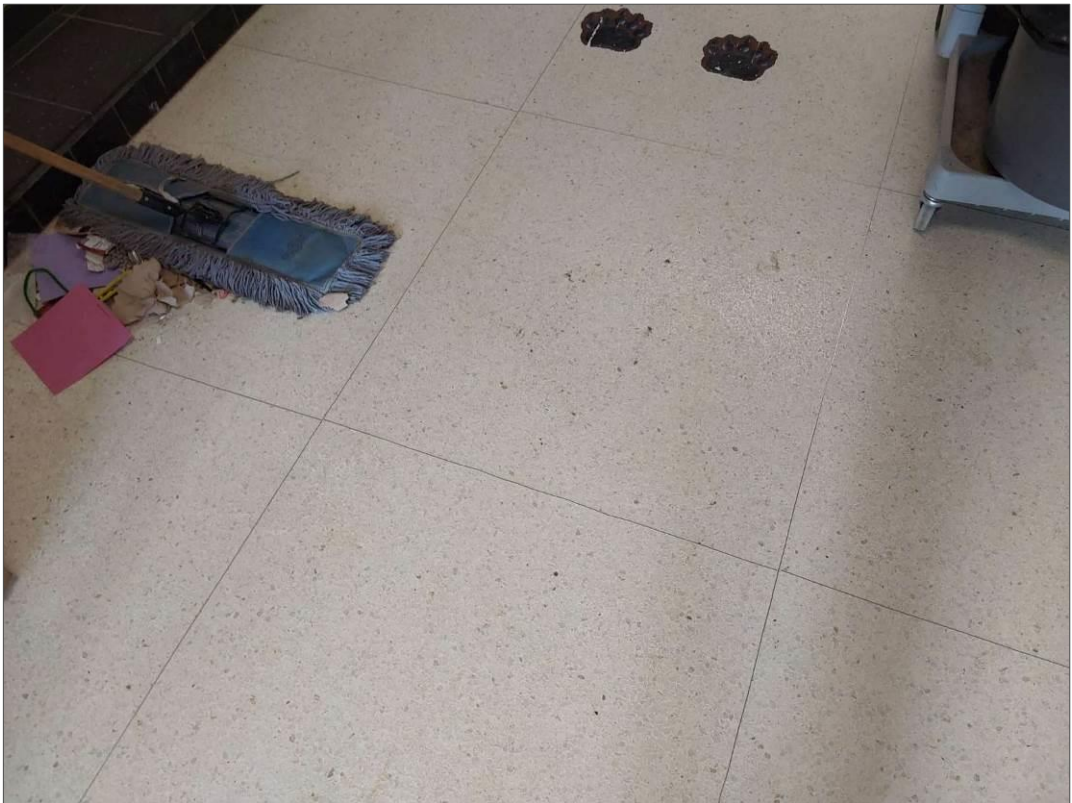
S0041A (None), Floor, Terrazzo, Corridor (Location #: 48)

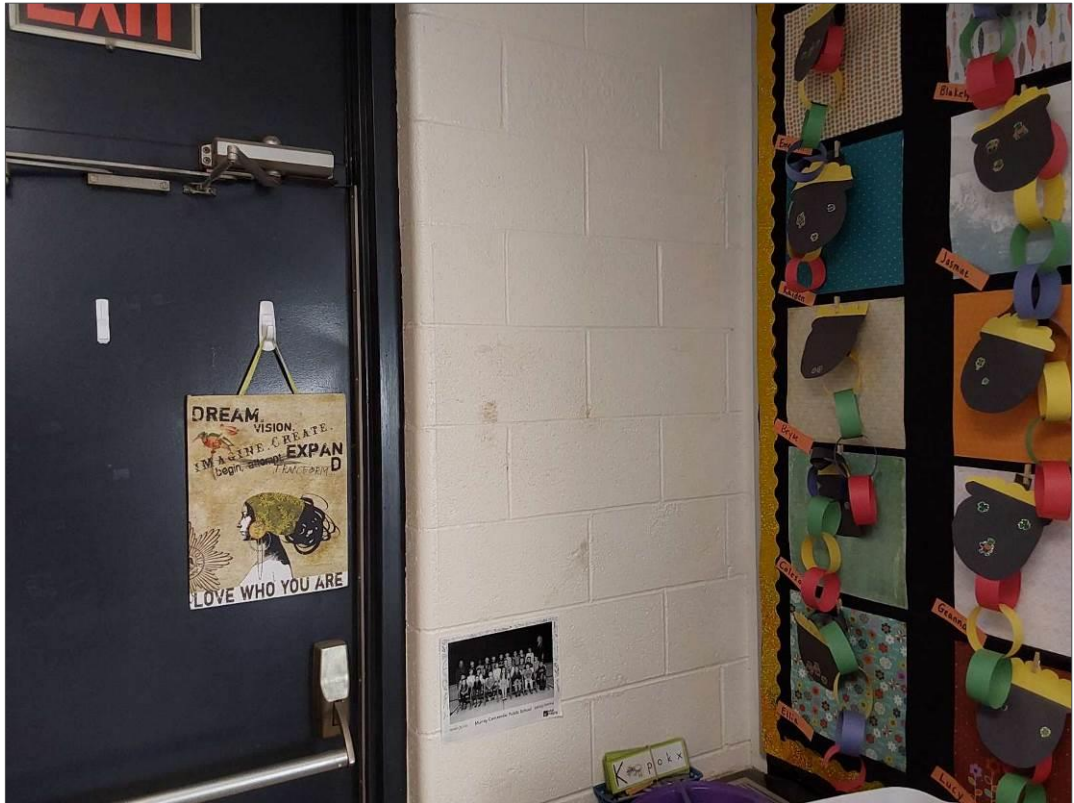
S0042C (None), White paint on concrete block walls, Wall, Paint, Kindergarten (Location #: 52)

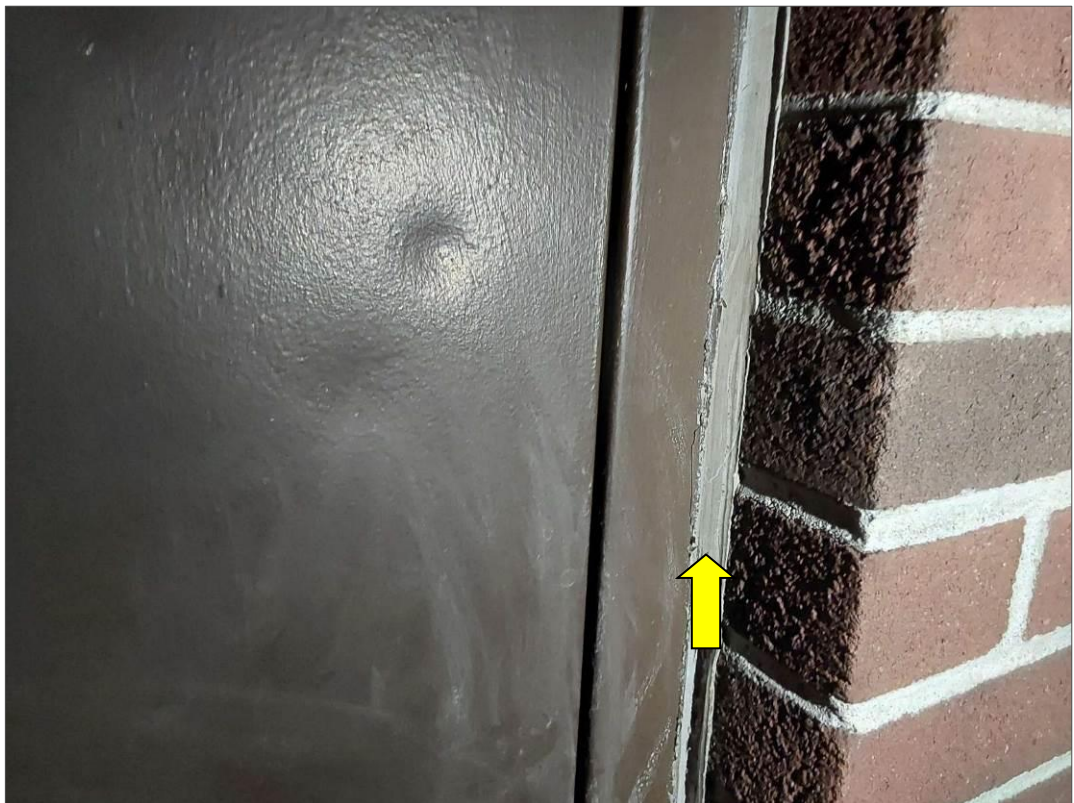
S0043C (None), Caulking on exterior of door, Other, Door, Caulking, Exterior Wall For Renovation (Location #: 81)

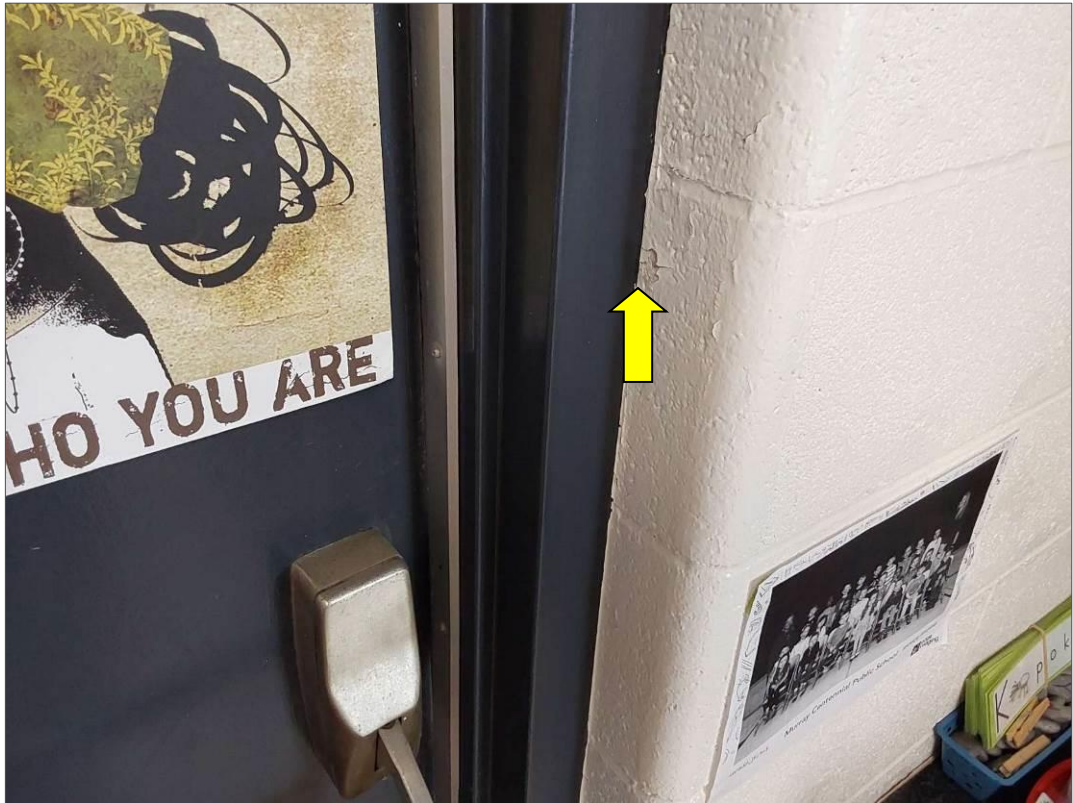
S0044A (None), White caulking on door frame interior side of exterior door, Other, Door, Caulking, Kindergarten (Location #: 52)

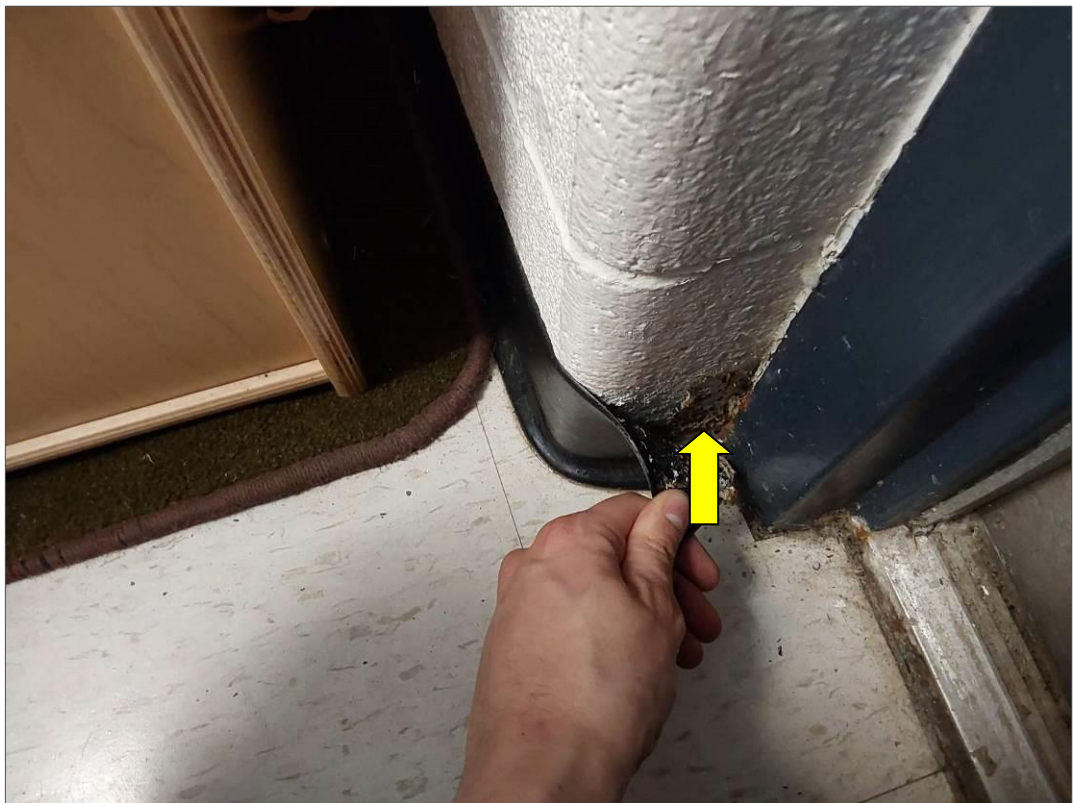
S0045A (None), Baseboard adhesive behind black rubber baseboards, Other, Base, Adhesive/mastic, Kindergarten (Location #: 52)

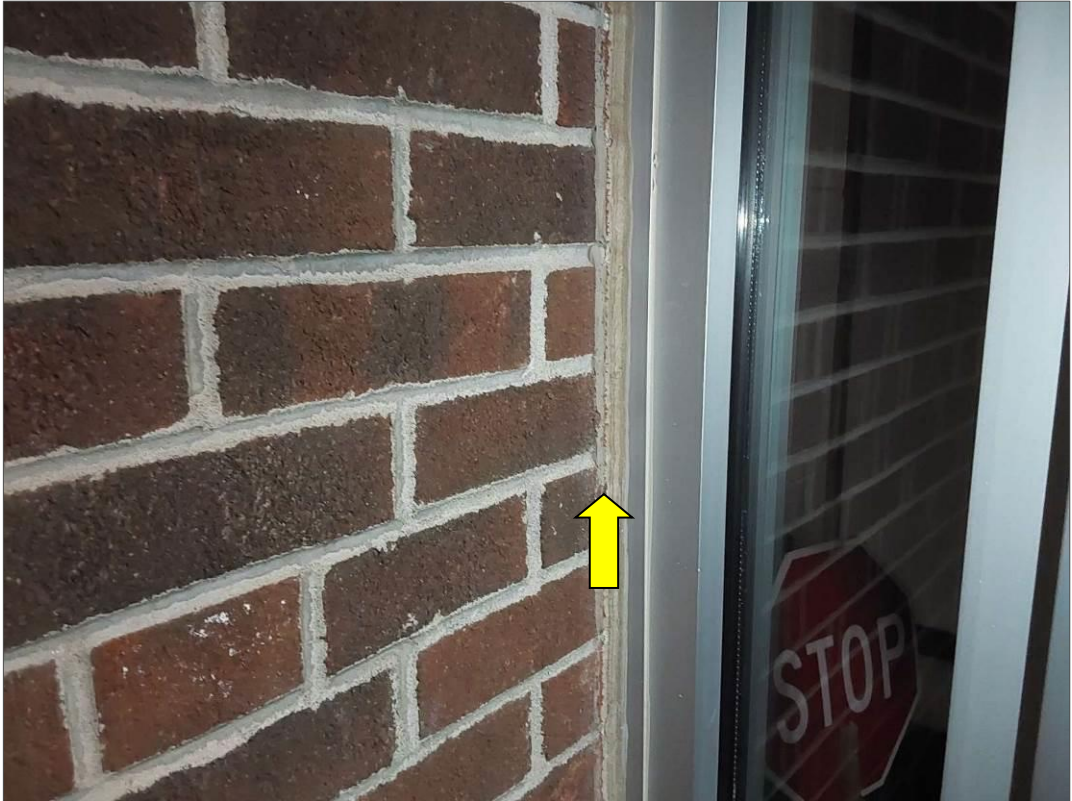
S0046C (None), Dark grey caulking on exterior door, Other, Door, Caulking, Exterior Wall For Renovation (Location #: 81)

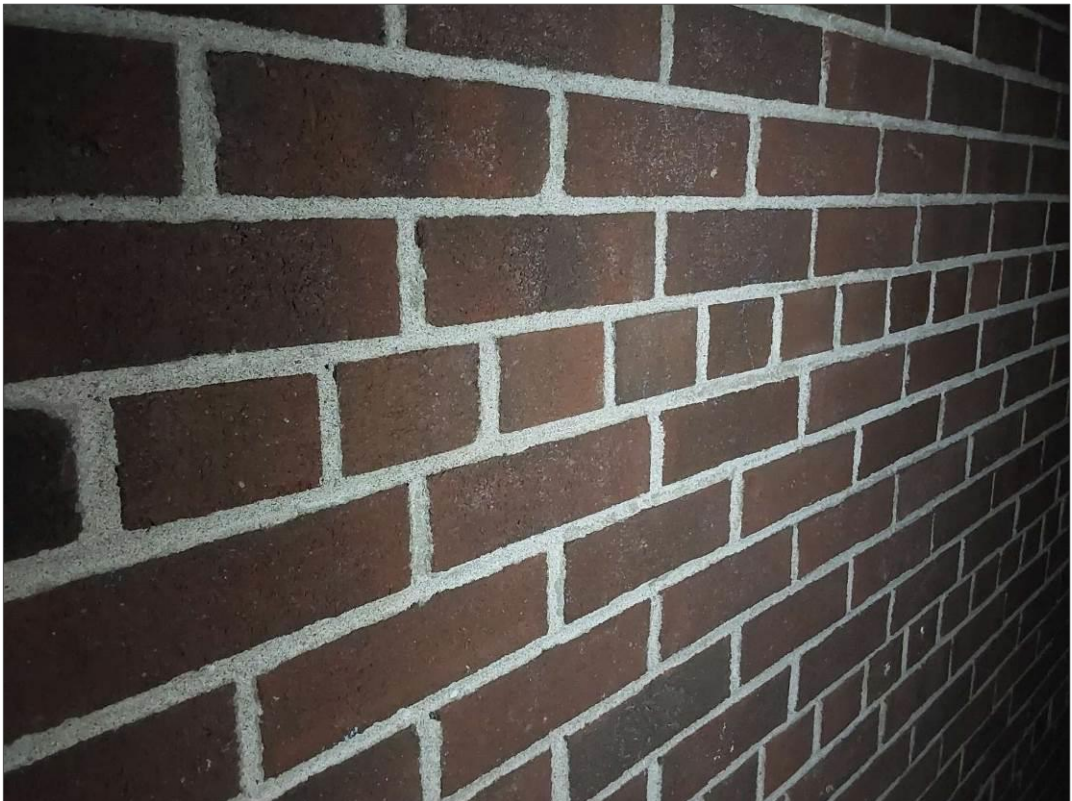
S0047C (None), Brick masonry mortar, Wall, Mortar, Exterior Wall For Renovation (Location #: 81)

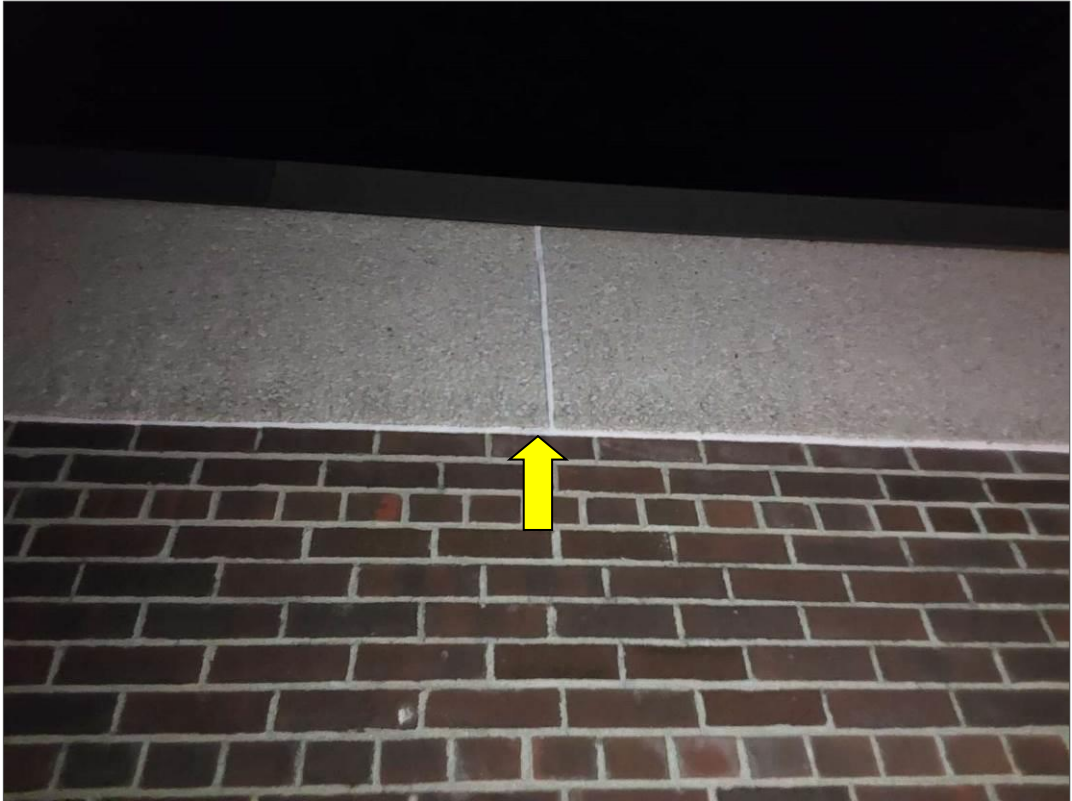
S0048C (Confirmed Asbestos), White caulking on fascia, Other, Fascia, Caulking, Exterior Wall For Renovation (Location #: 81)

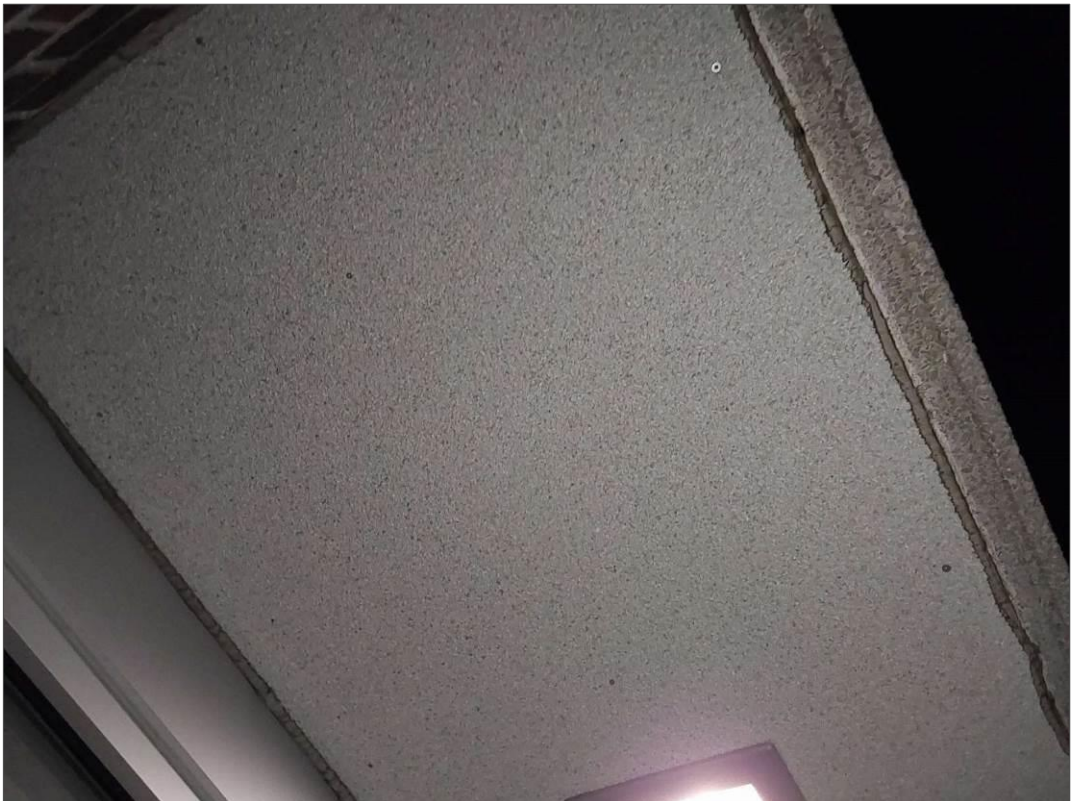
S0049C (None), white pebbled panels on soffit, Structure, Soffit, Unidentified Material, Exterior Wall For Renovation (Location #: 81)

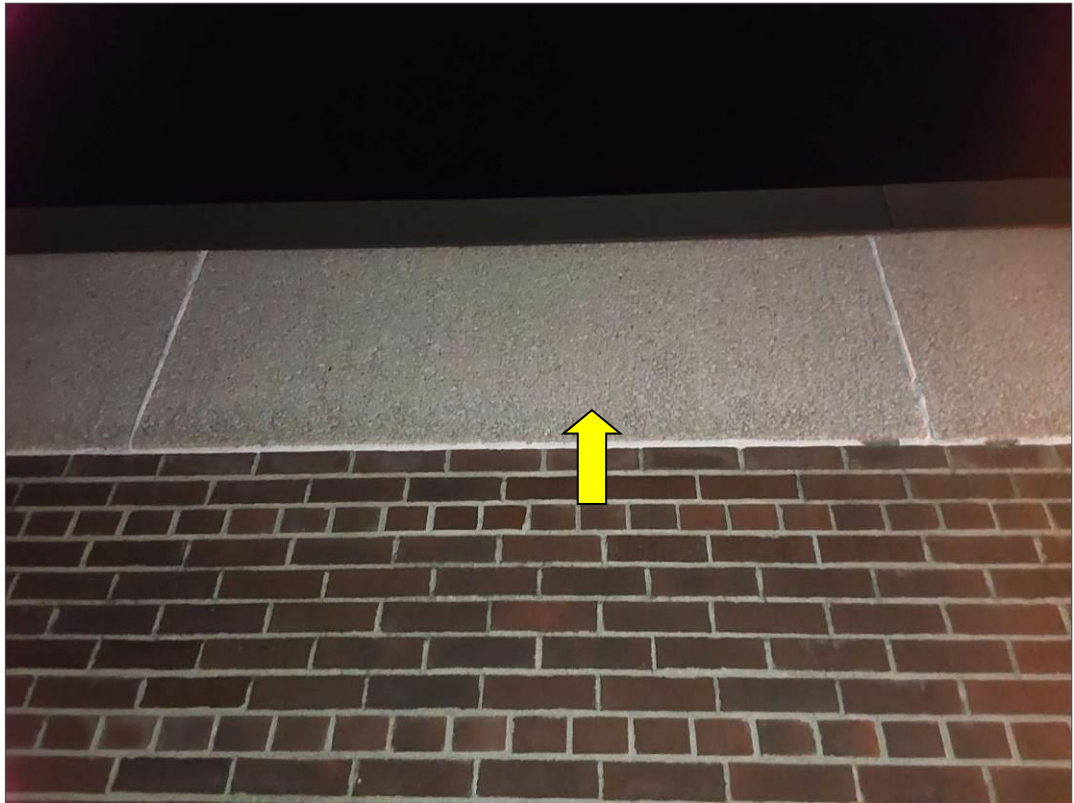
S0050C (None), clear pebbled rock fascia panels, Other, Fascia, Unidentified Material, Exterior Wall For Renovation (Location #: 81)

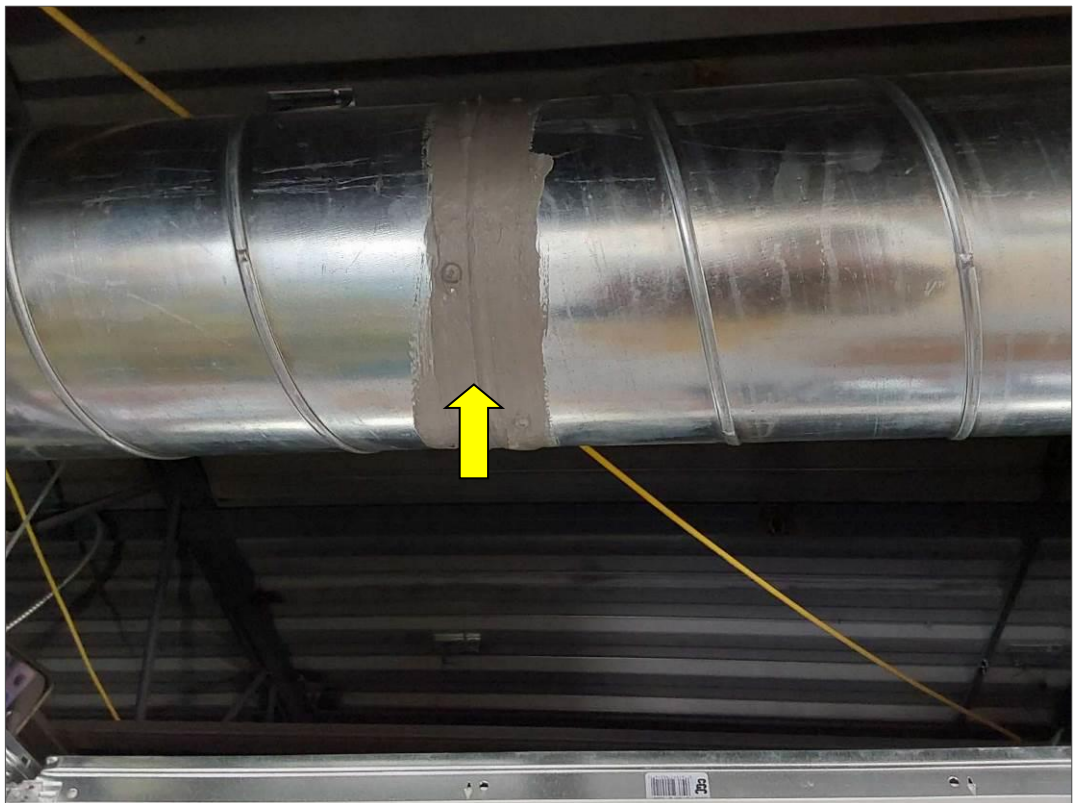
S0065C (None), Duct, Mastic, 2014 Phase Construction (Location #: 77)

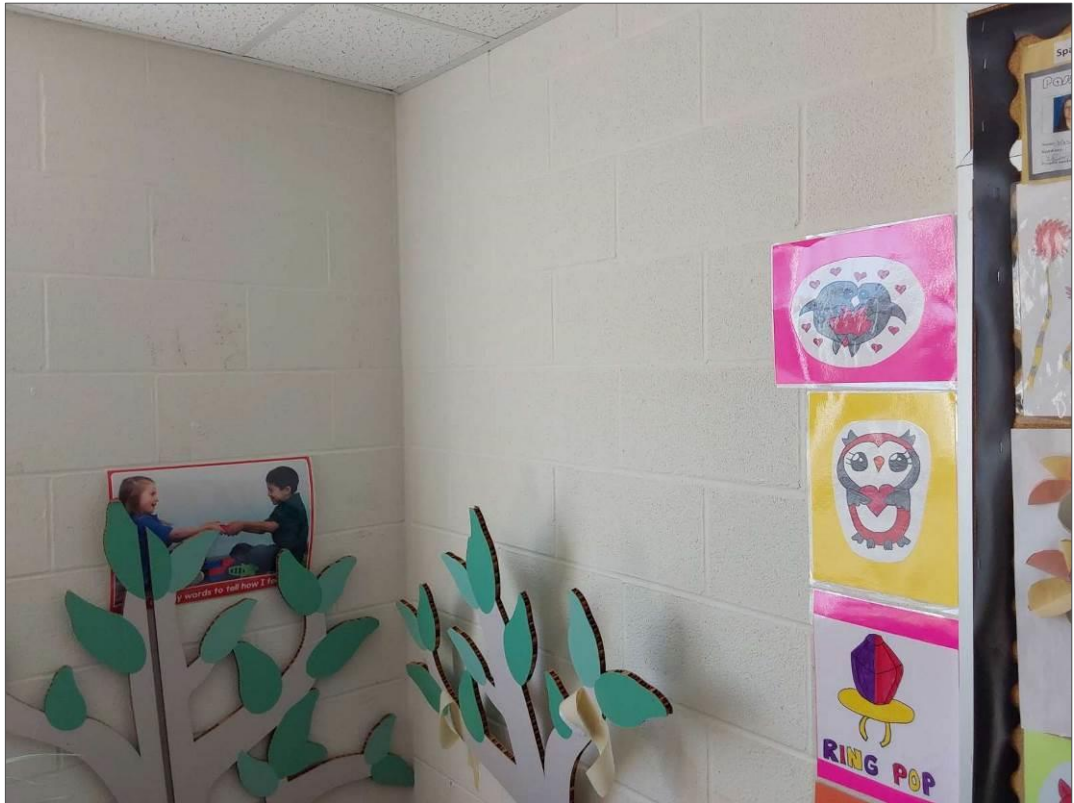
S0066E (None), Off-white paint on masonry wall, Other, Paint, 2014 Phase Construction (Location #: 77)  
Paint on masonry block

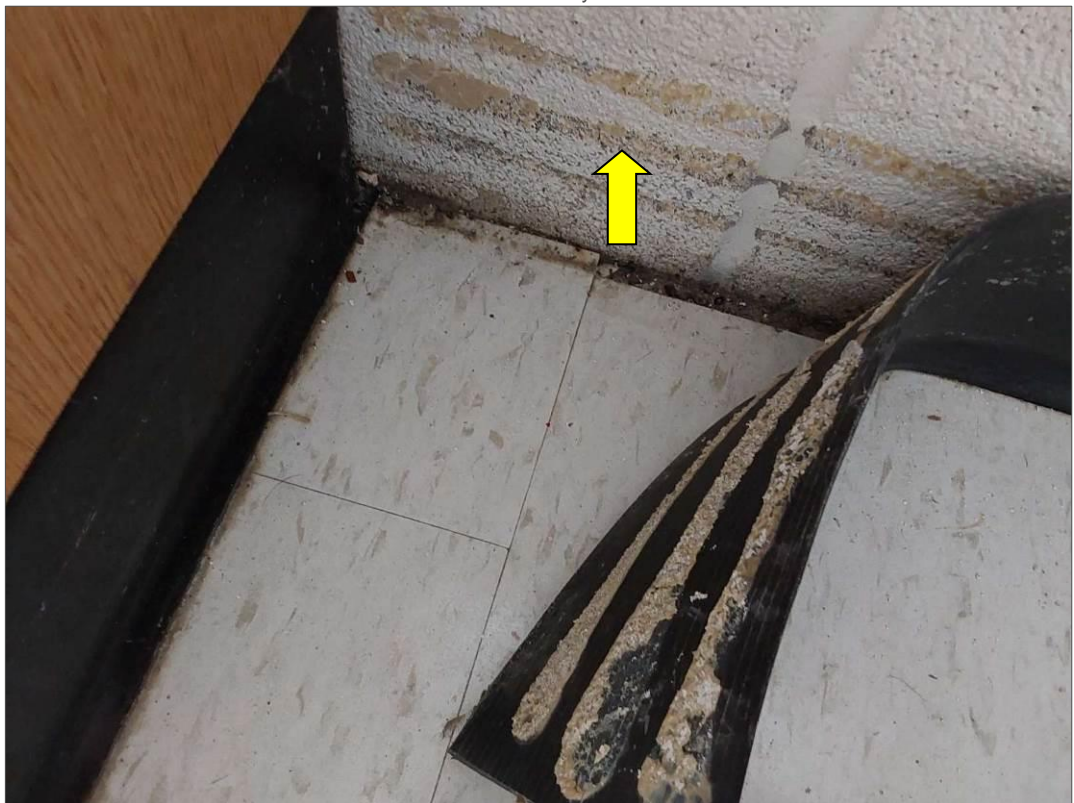
S0067A (None), Wall, Adhesive/mastic, 2014 Phase Construction (Location #: 77)  
Beige baseboard mastic

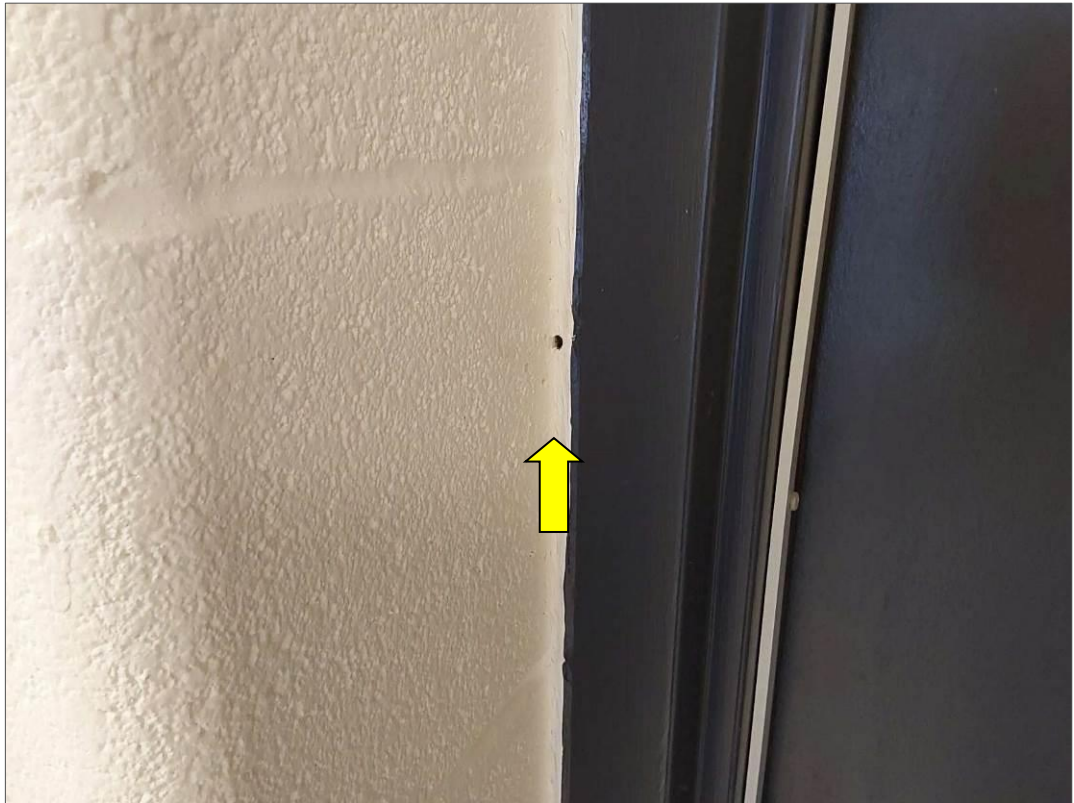
S0068A (None), White caulking around door frames, Other, Caulking, 2014 Phase Construction (Location #: 77)

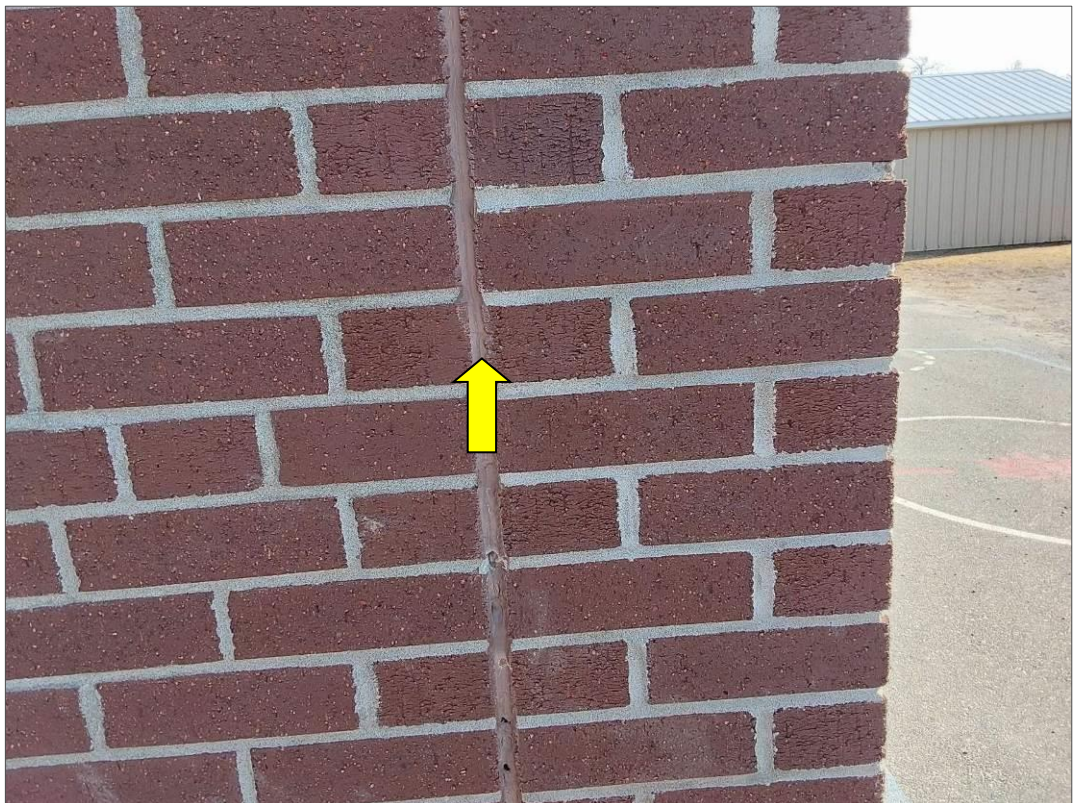
S0069C (None), Brown caulking on expansion joints and exterior door frame, Other, Caulking, Exterior Wall For Renovation (Location #: 81)

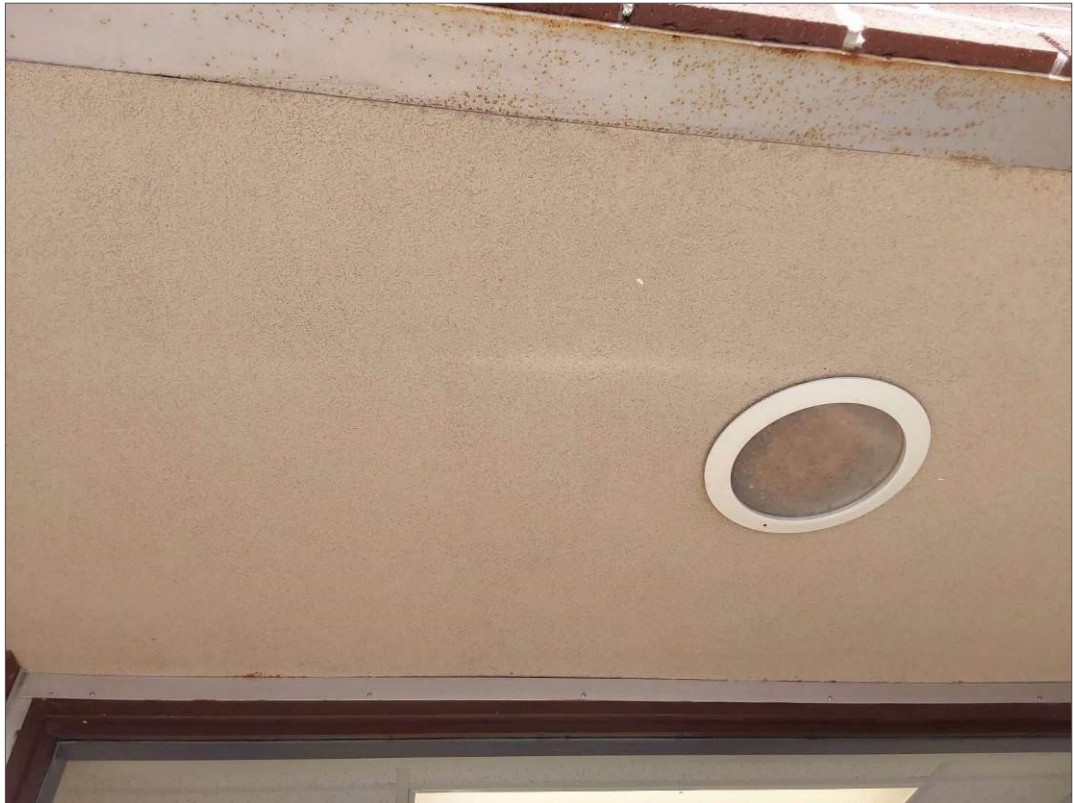
S0070C (None), Ceiling, Texture Coat, Exterior Wall For Renovation (Location #: 81)  
On soffit above door

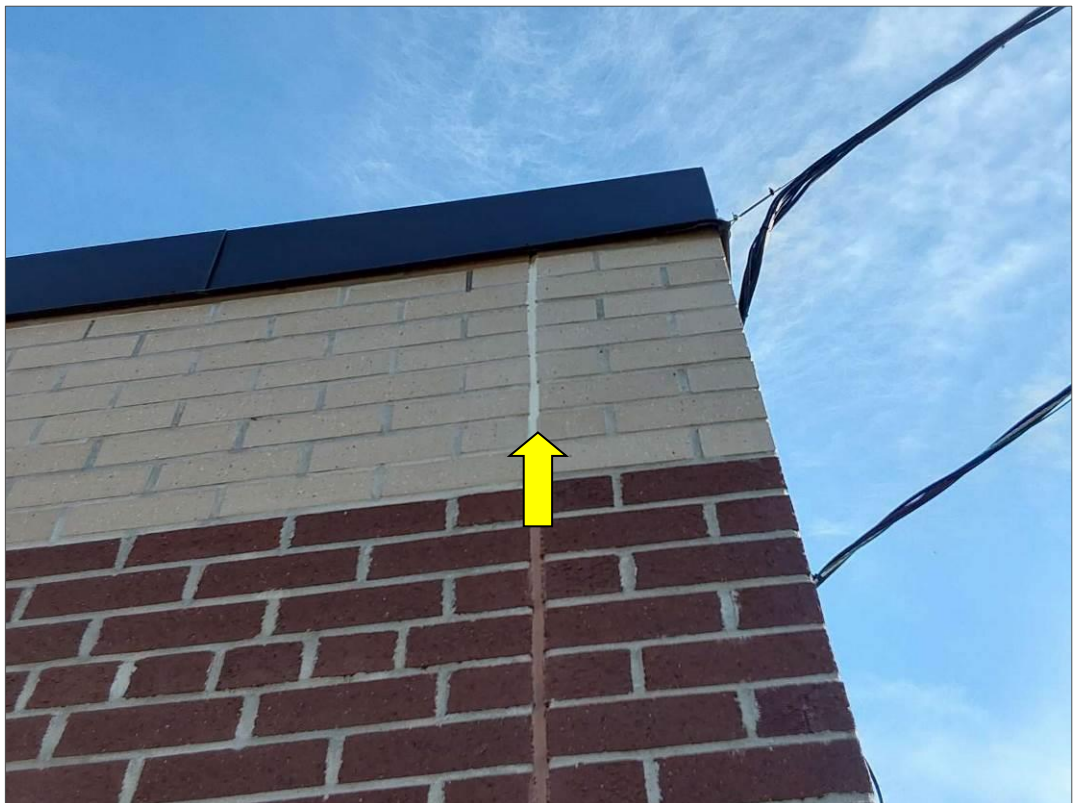
S0071C (None), White caulking on exterior brick, Other, Caulking, Exterior Wall For Renovation (Location #: 81)

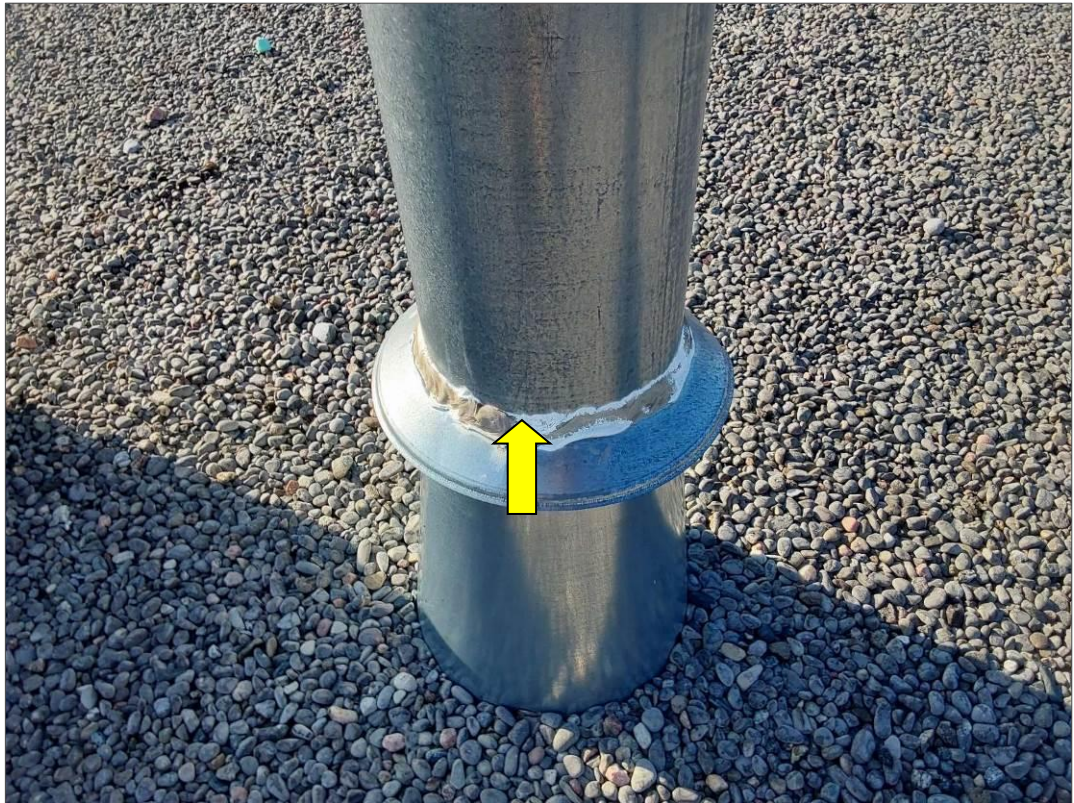
S0072C (None), White caulking on duct, Duct, Caulking, Roof H (Location #: 86)  
Grey duct mastic covering s0073

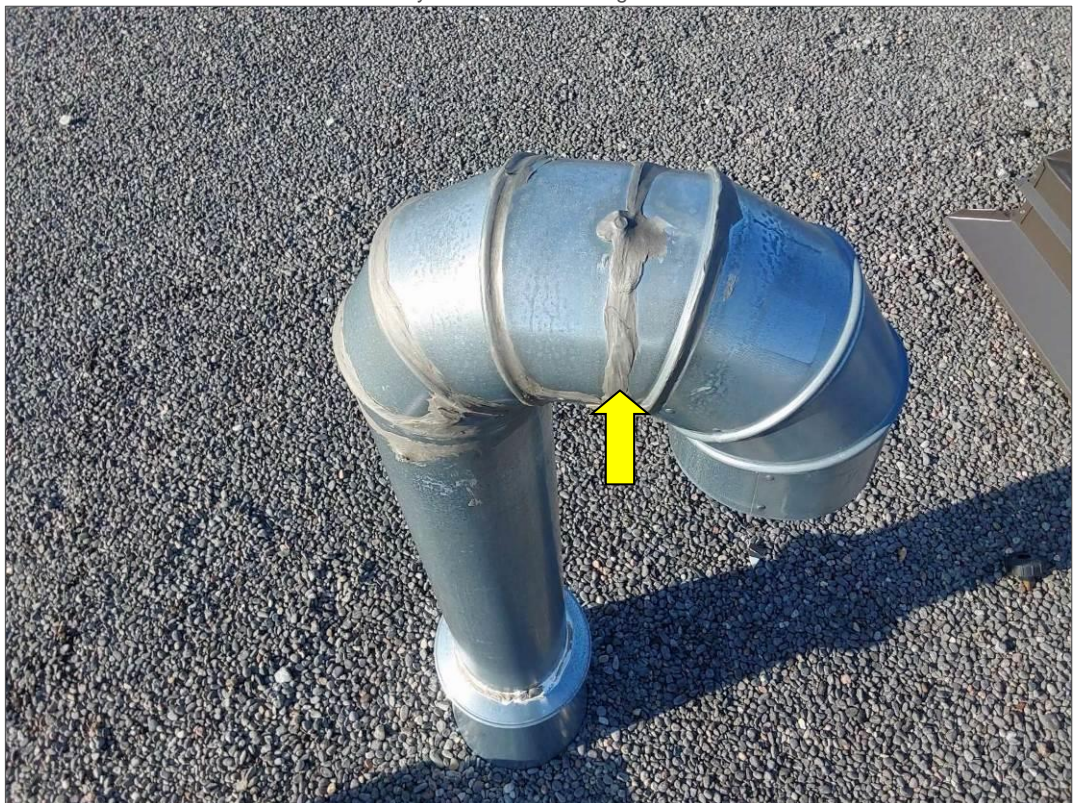
S0073C (None), Grey duct mastic, Duct, Mastic, Roof H (Location #: 86)

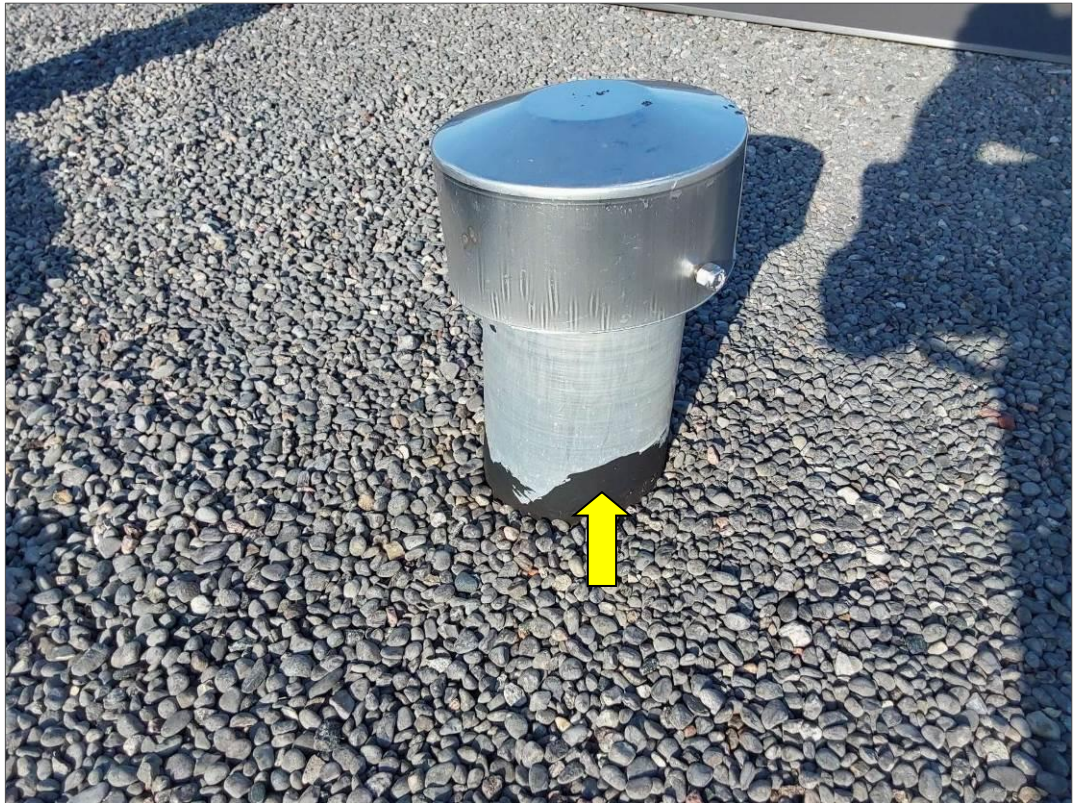
S0074C (None), Tar on vents, Other, Tar, Roof H (Location #: 86)

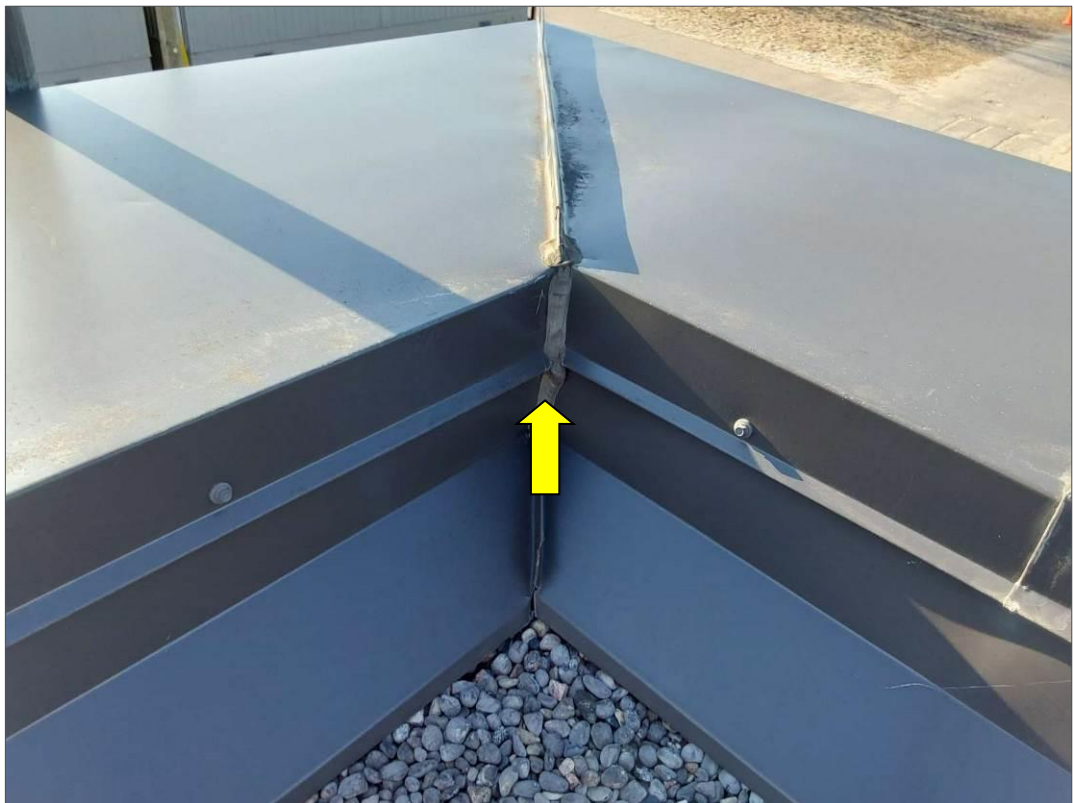
S0075C (None), Grey caulking on flashing, Other, Caulking, Roof H (Location #: 86)
