**Re: Hazardous Building Materials Assessment (Pre-Construction)**

Murray Centennial, 654 County Road 40, Trenton, Ontario

Pinchin File: 335495.031

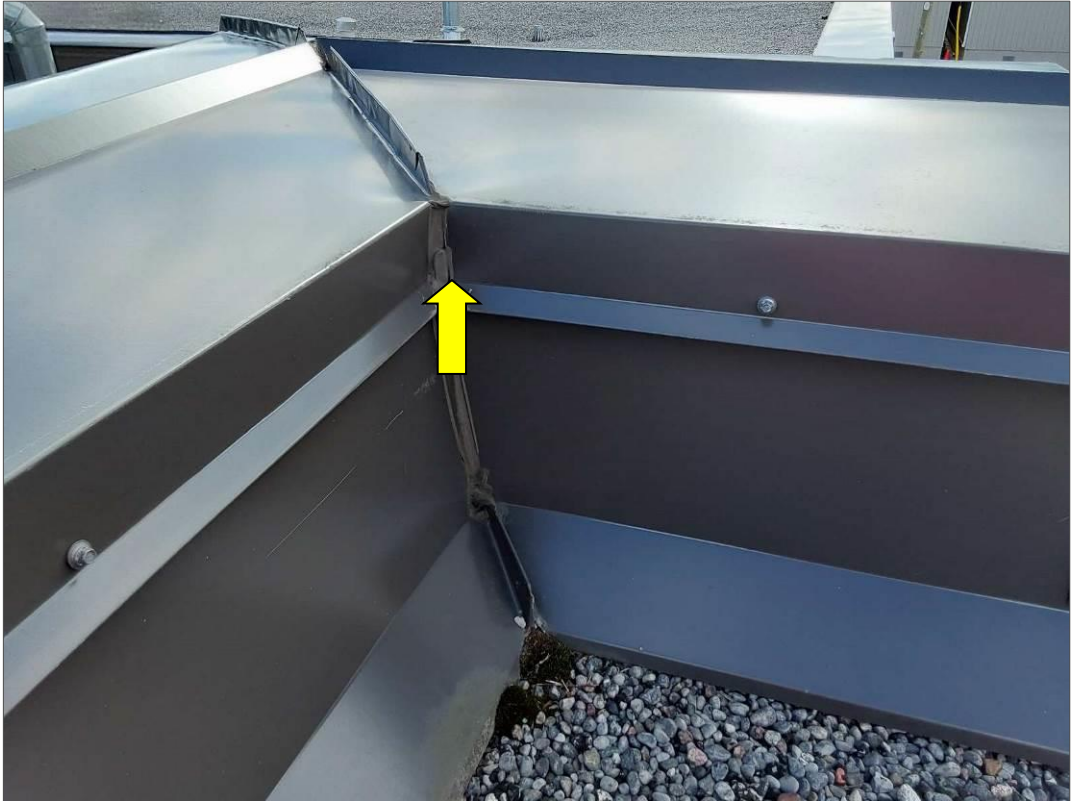
S0076A (None), Grey caulking on flashing, Other, Caulking, Roof G (Location #: 87)

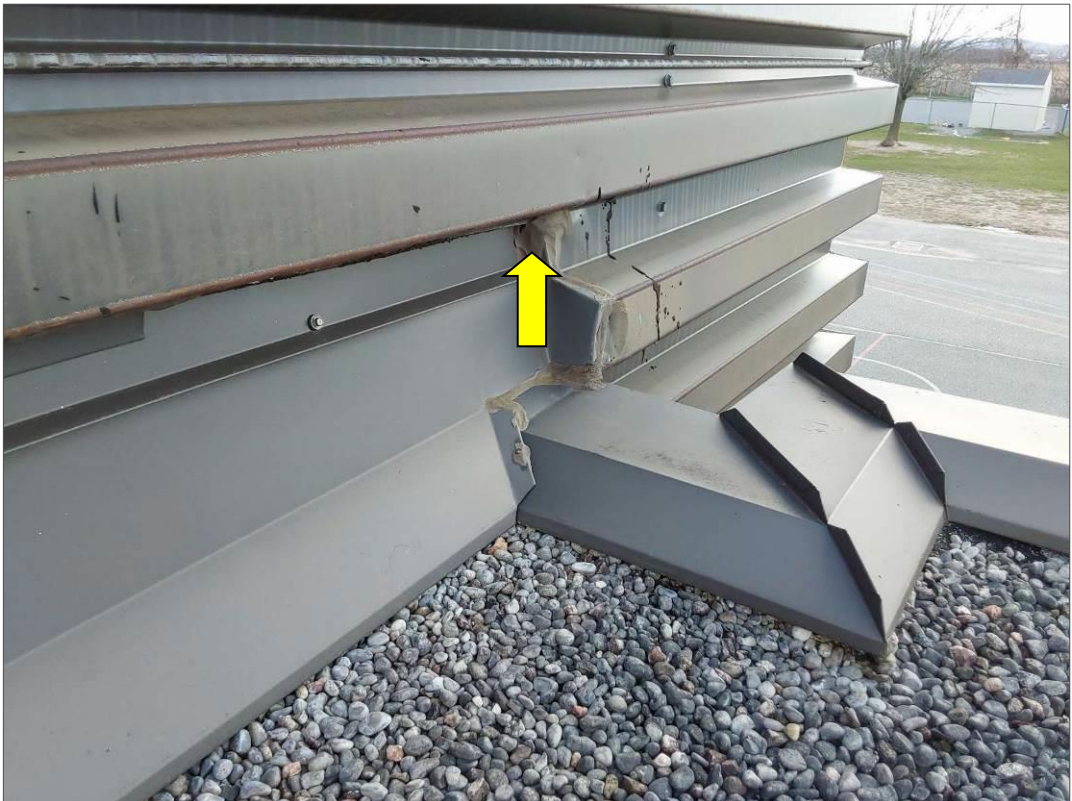
S0077A (None), Brown caulking on flashing, Other, Caulking, Roof F2 (Location #: 88)

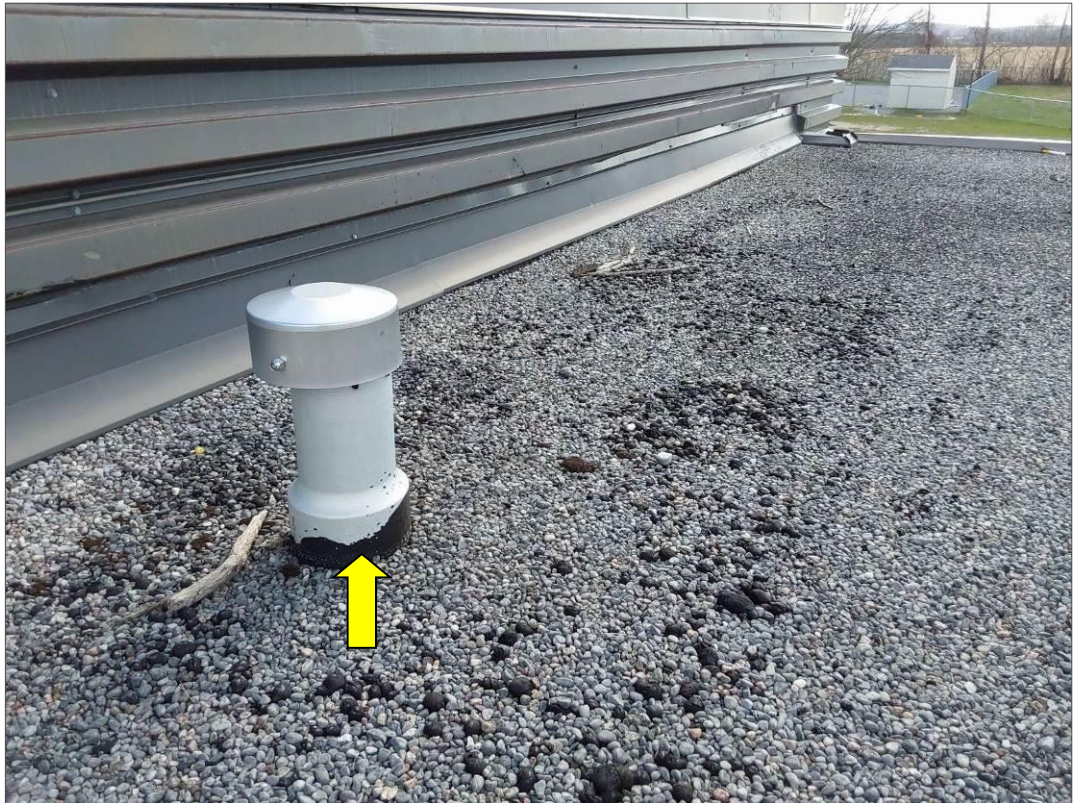
S0078A (None), Tar on vents, Other, Tar, Roof F2 (Location #: 88)

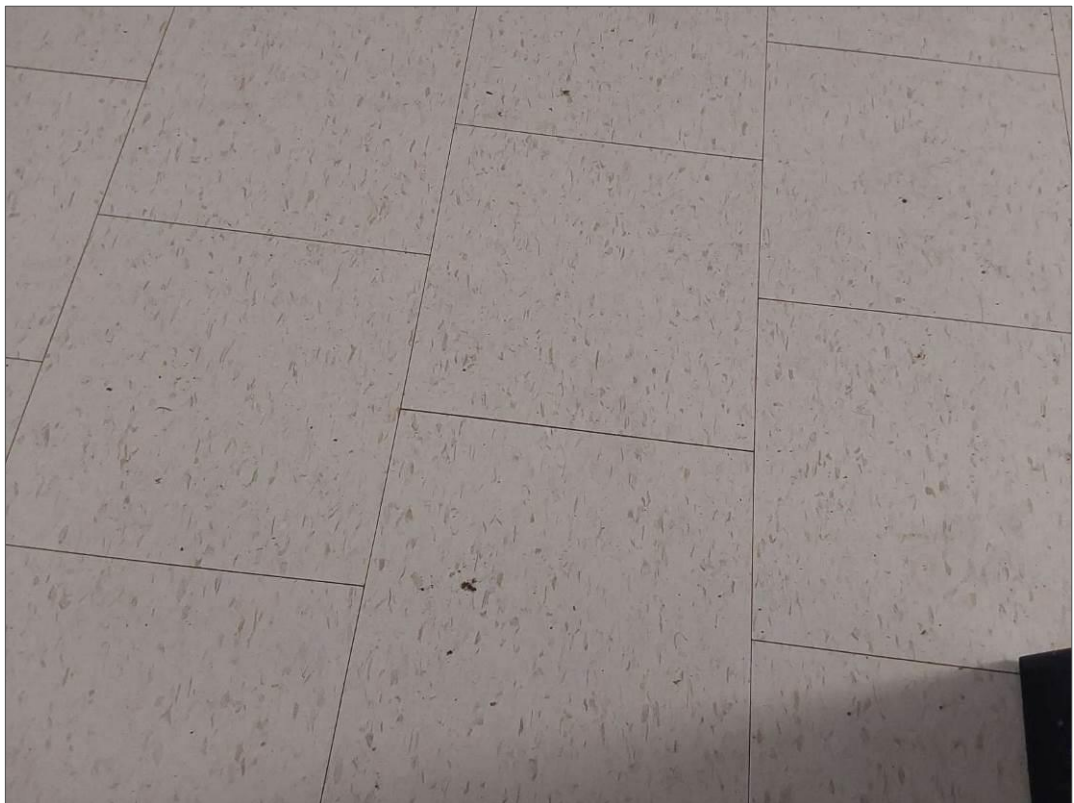
S0079C (None), 12" x 12" Off-white with brown specks, Floor, Vinyl Floor Tile and Mastic, Kindergarten (Location #: 52)

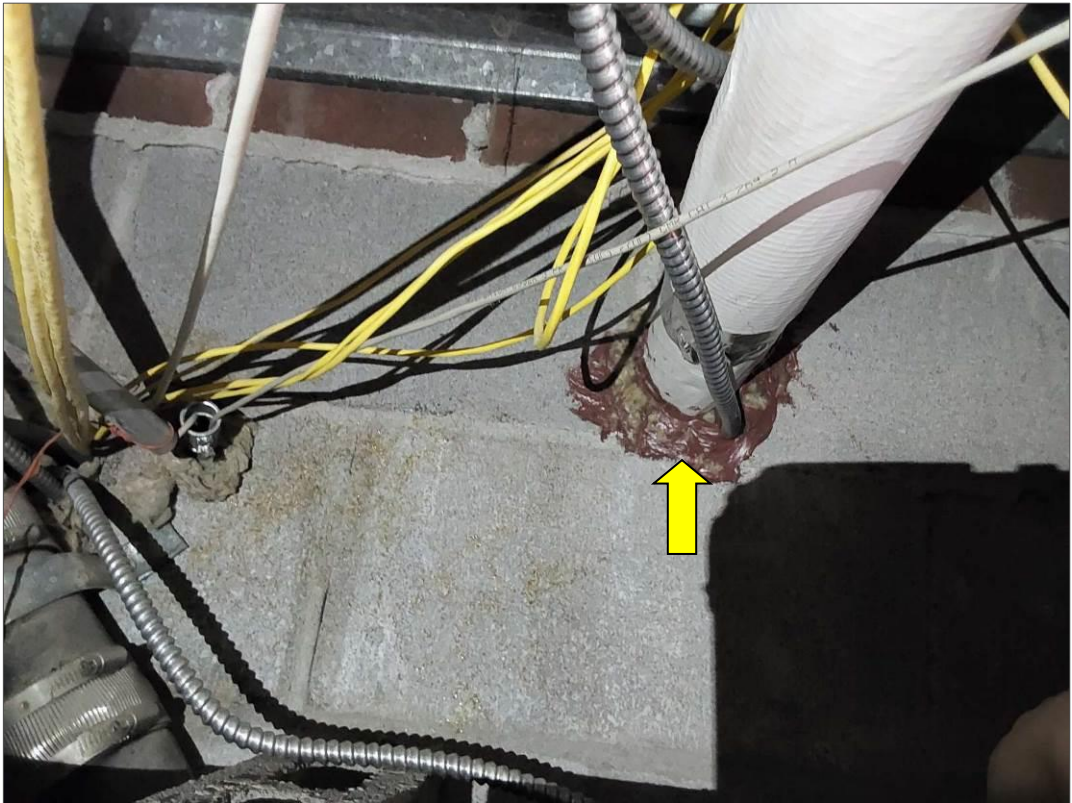
S0080C (None), Brown firestopping, Other, Firestopping (mastic), Corridor (Location #: 48)

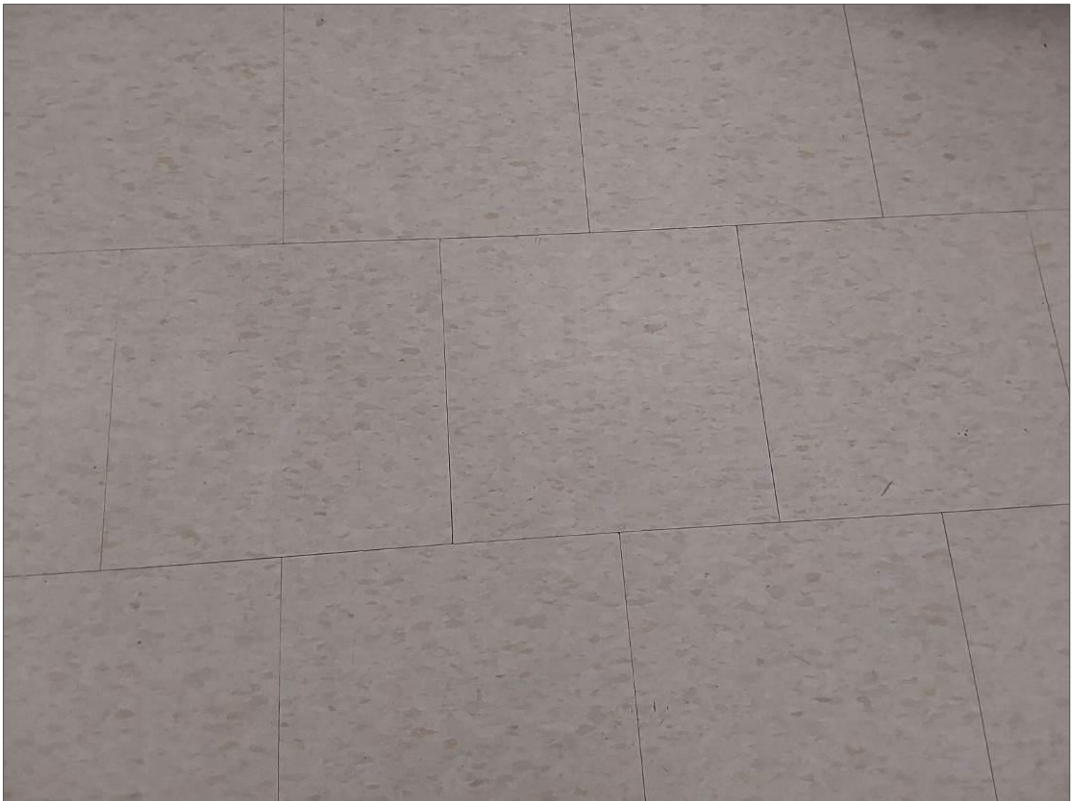
S0081C (None), 12" x 12" white with grey splotch, Floor, Vinyl Floor Tile and Mastic, Classroom (Location #: 40)

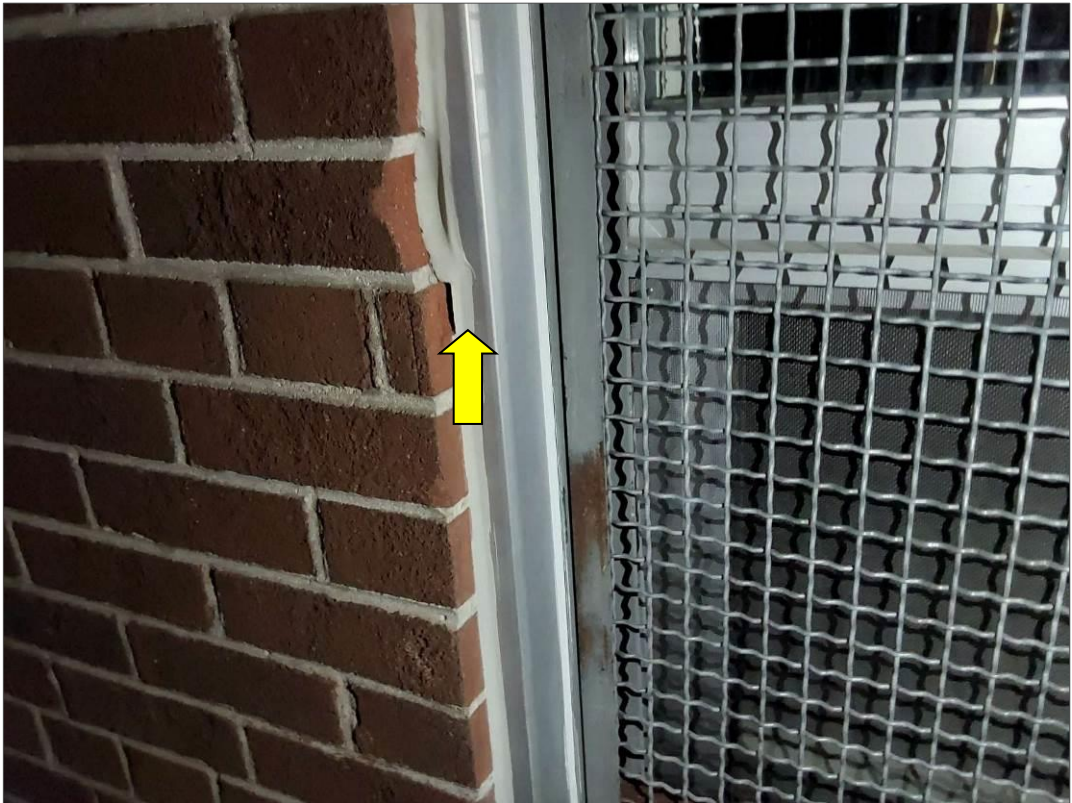
S0082C (None), Light grey caulking along window cages, Wall, Caulking, Exterior Wall For Renovation (Location #: 81)

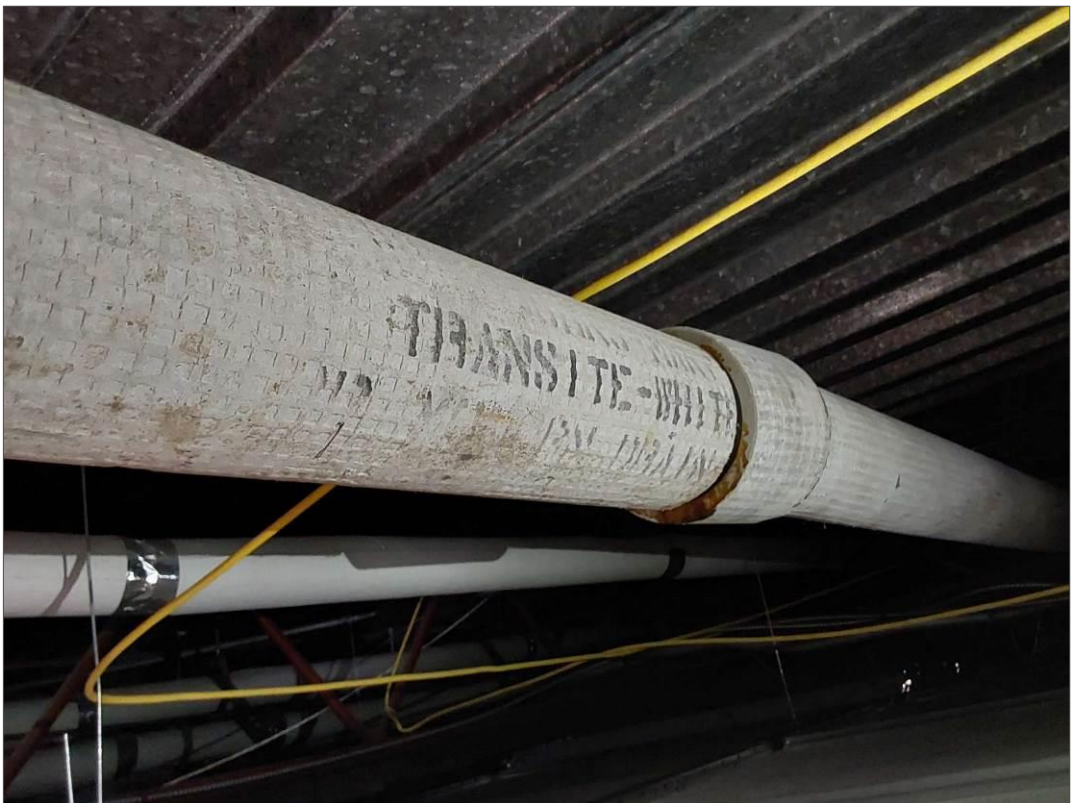
V9000 (Confirmed Asbestos), Piping, Cement Product, Kindergarten (Location #: 52)  
Transite pipe

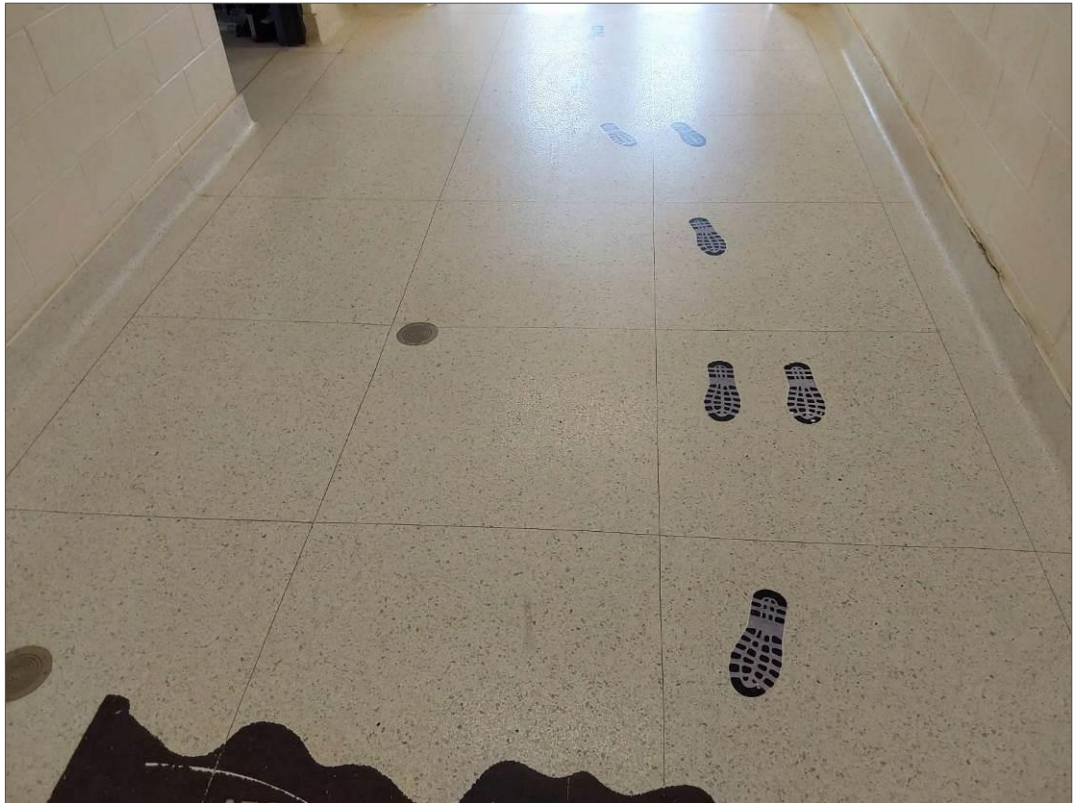
V9500 (Presumed Asbestos), Floor, Terrazzo, 2014 Phase Construction (Location #: 77)

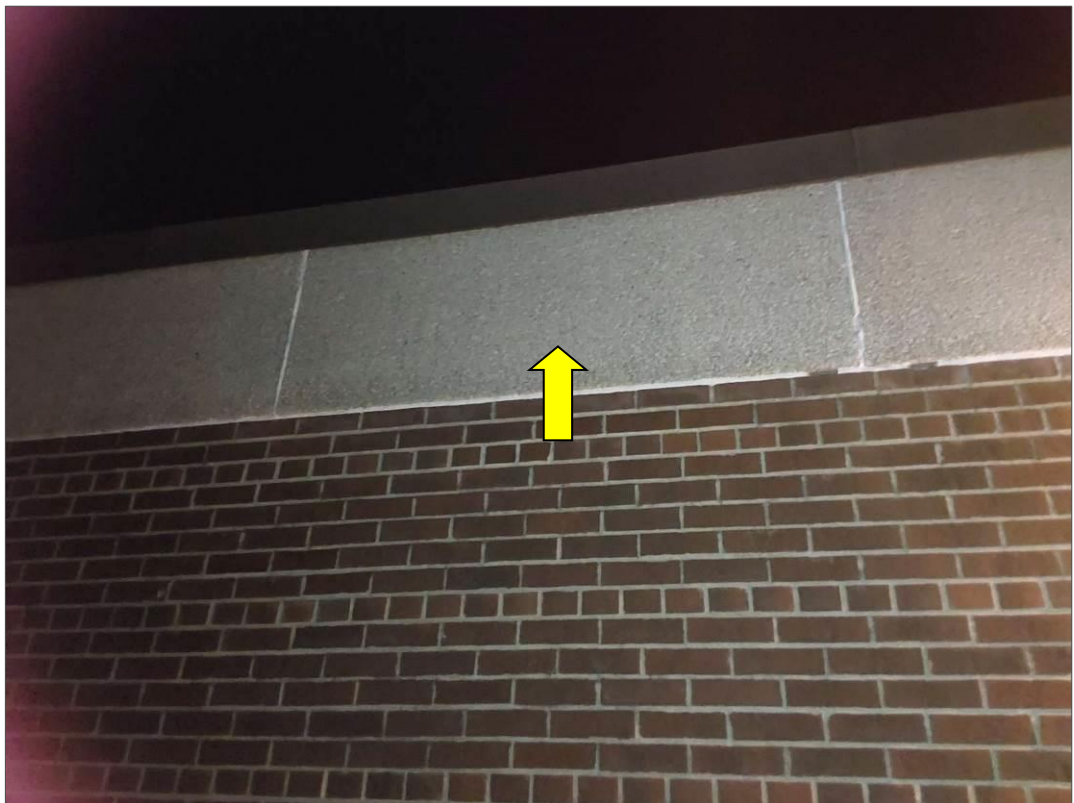
1. Materials identified as Sample Number V9500 were either observed to be present or based on the construction of the building/equipment are likely present in concealed locations. These materials have not been sampled and are presumed to contain asbestos based on historical known use of asbestos. Sampling of these materials may be completed prior to disturbance.
2. Materials identified as Sample Number V9000 were observed to be present and were determined to contain asbestos based on previous analytical results, or labelling (e.g., Transite clearly labelled by the manufacturer).
3. Materials identified as Sample Number V0000 were determined to be non-asbestos based on the manufacture date and known end of use of asbestos in these products.

V9500 (Presumed Asbestos), Other, Fascia, Cement Product, Exterior Wall For Renovation (Location #: 81)  
Transite presumed present behind decorative panel

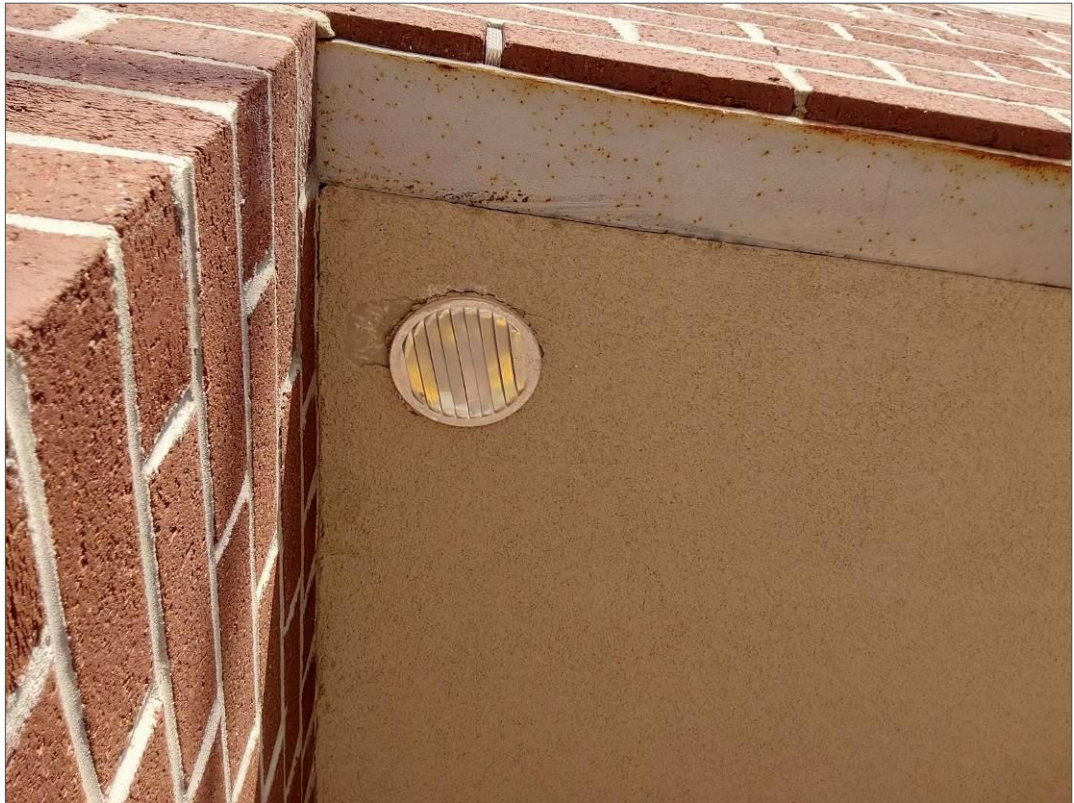
V9500 (Presumed Asbestos), Other, Soffit, Cement Product, Exterior Wall For Renovation (Location #: 81)  
Transite presumed present behind texture coat and decorative panel

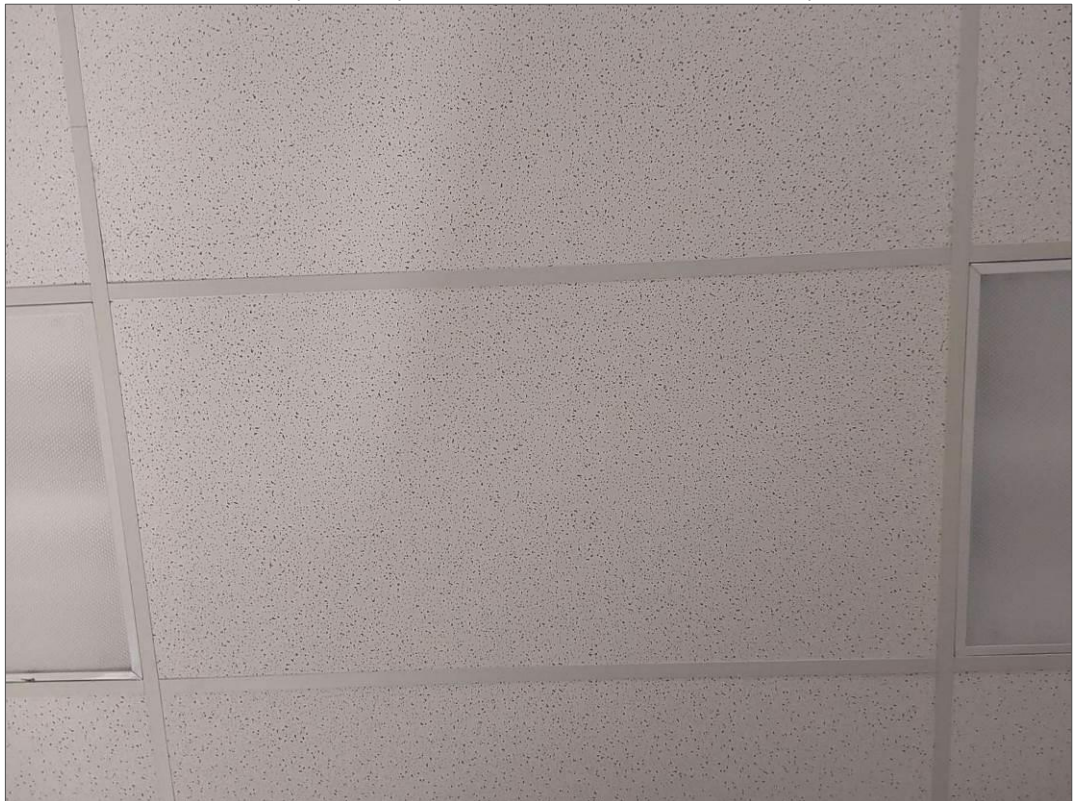
V0000 (None), 24x48 lay-in, fleck and pinhole, Ceiling, ACOUSTIC TILE, Ceiling Tiles (lay-in), Kindergarten (Location #: 52)  
Date stamp 08/09/18

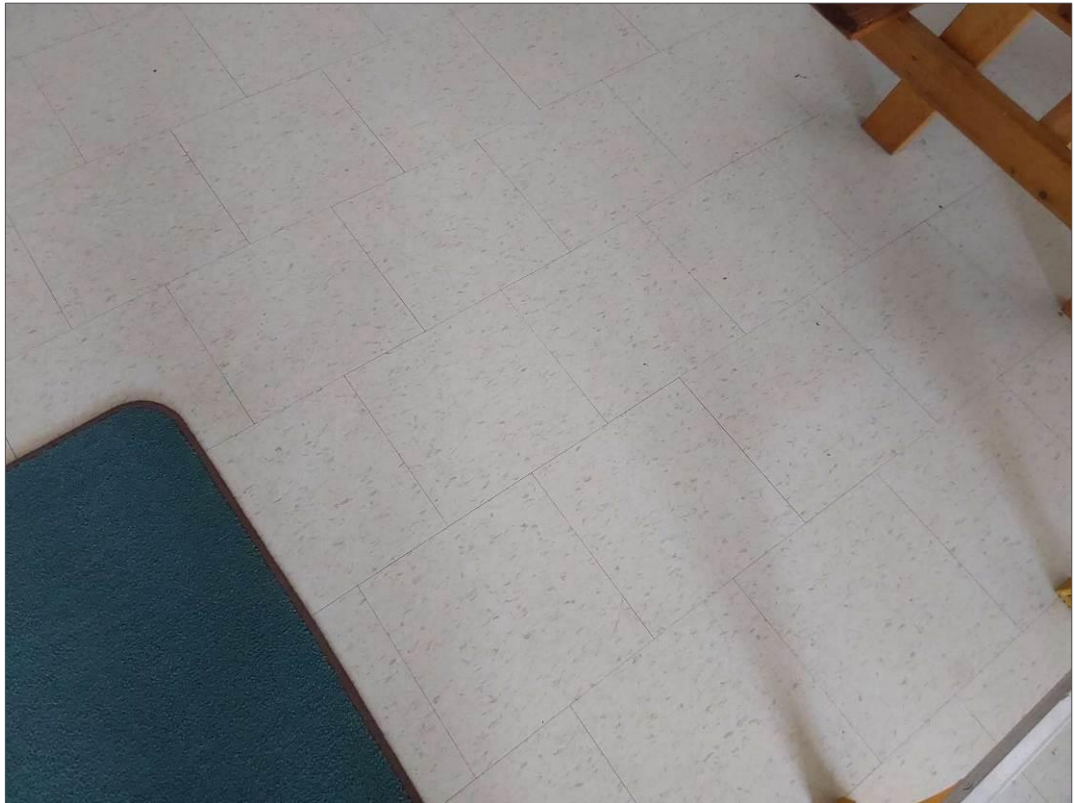
V0000 (None), 12" x 12" white with grey flecks, Floor, Vinyl Floor Tile and Mastic, 2014 Phase Construction (Location #: 77)  
Installed in 2014

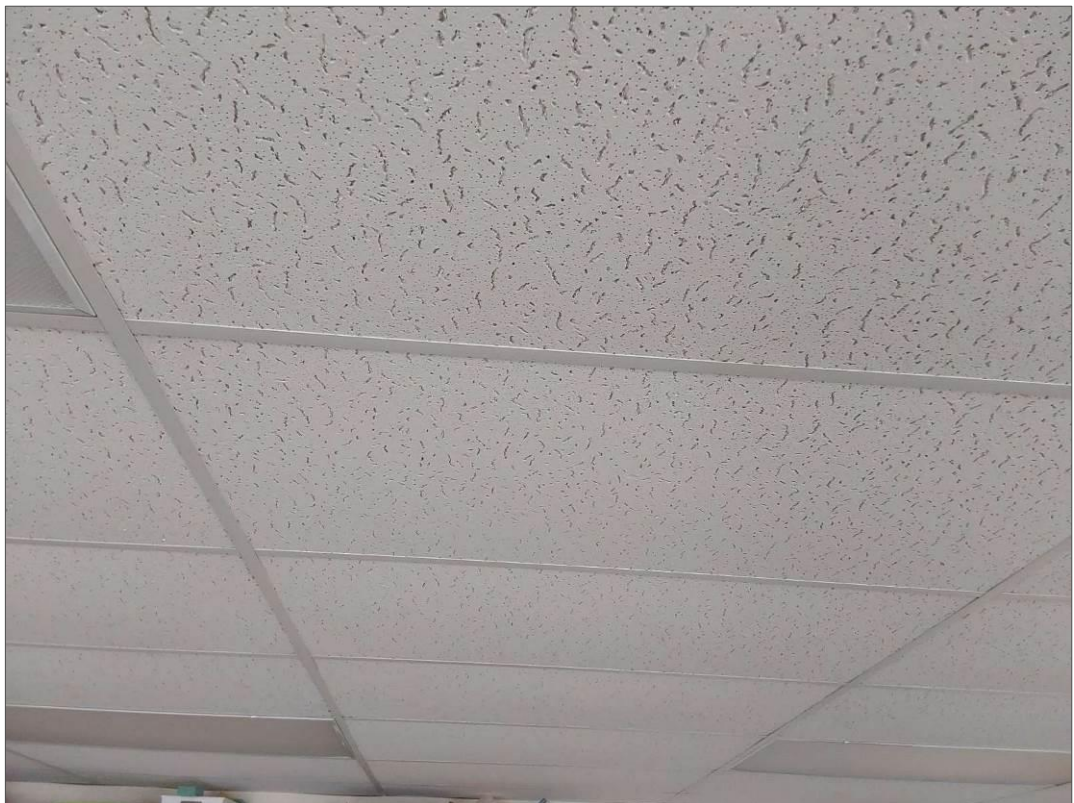
V0000 (None), 24"X48" large ridge with scattered pinhole, Ceiling, Ceiling Tiles (lay-in), 2014 Phase Construction (Location #: 77)  
Date stamped 08/14/13

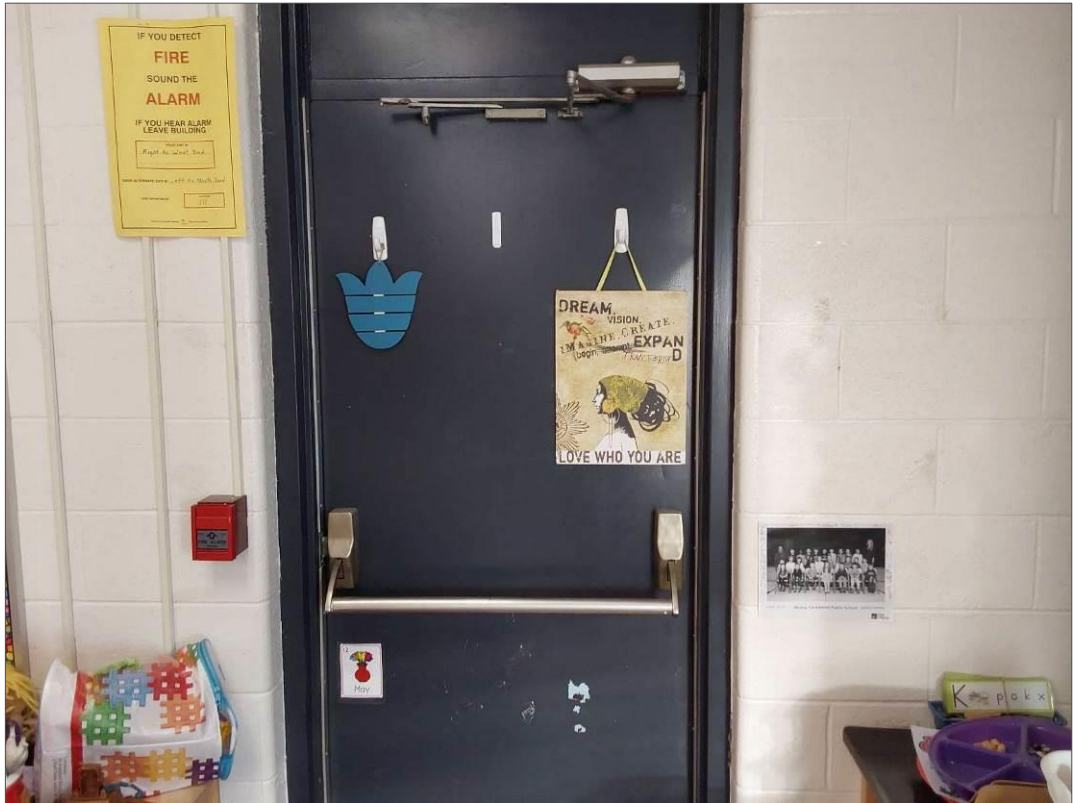
V0003(Lead, None), Dark blue on door, Other, Kindergarten (Location #: 52)

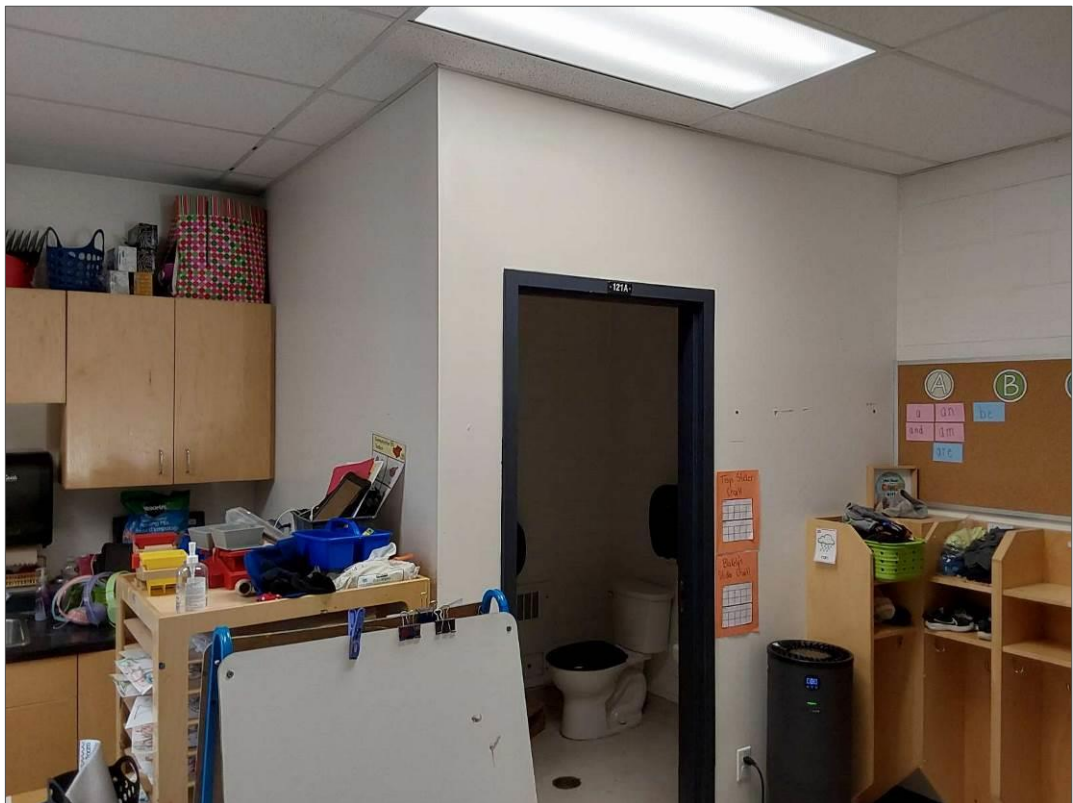
V0004(Lead, None), White paint on drywall, Wall, Kindergarten (Location #: 52)

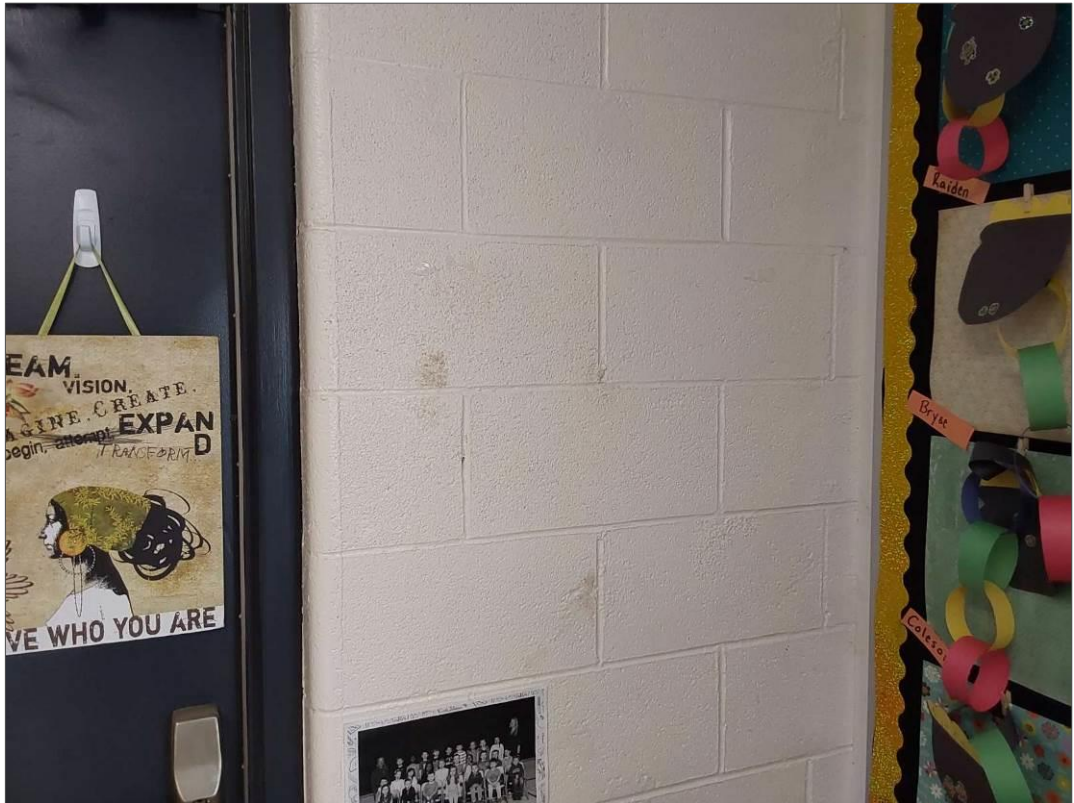
L0011(Lead, Low), White paint on concrete block wall, Wall, Kindergarten (Location #: 52)

For paints identified as having low levels of lead (i.e., equal to or above 0.009% (90 mg/kg) but less than or equal to the EACC guideline of 0.1% (1,000 mg/kg) for lead-containing paints) special precautions are not recommended unless aggressive disturbance (grinding, blasting, torching) is planned.

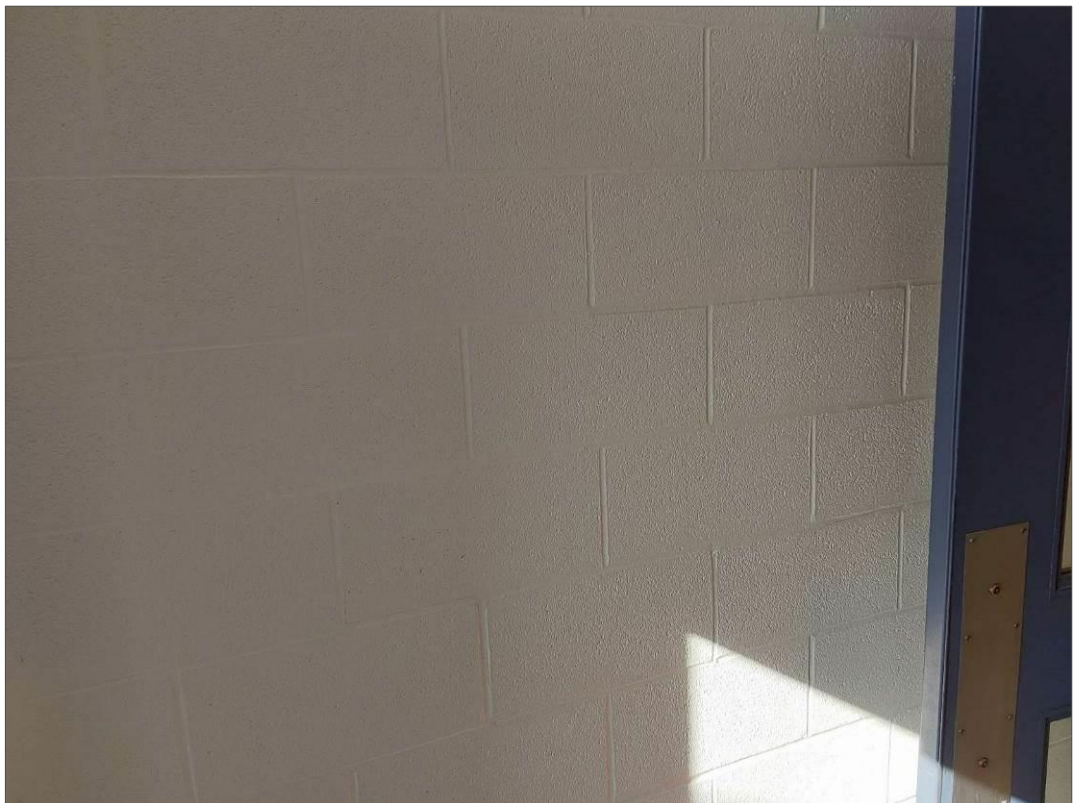
L0013(Lead, None), Off-white paint on masonry wall, Wall, 2014 Phase Construction (Location #: 77)

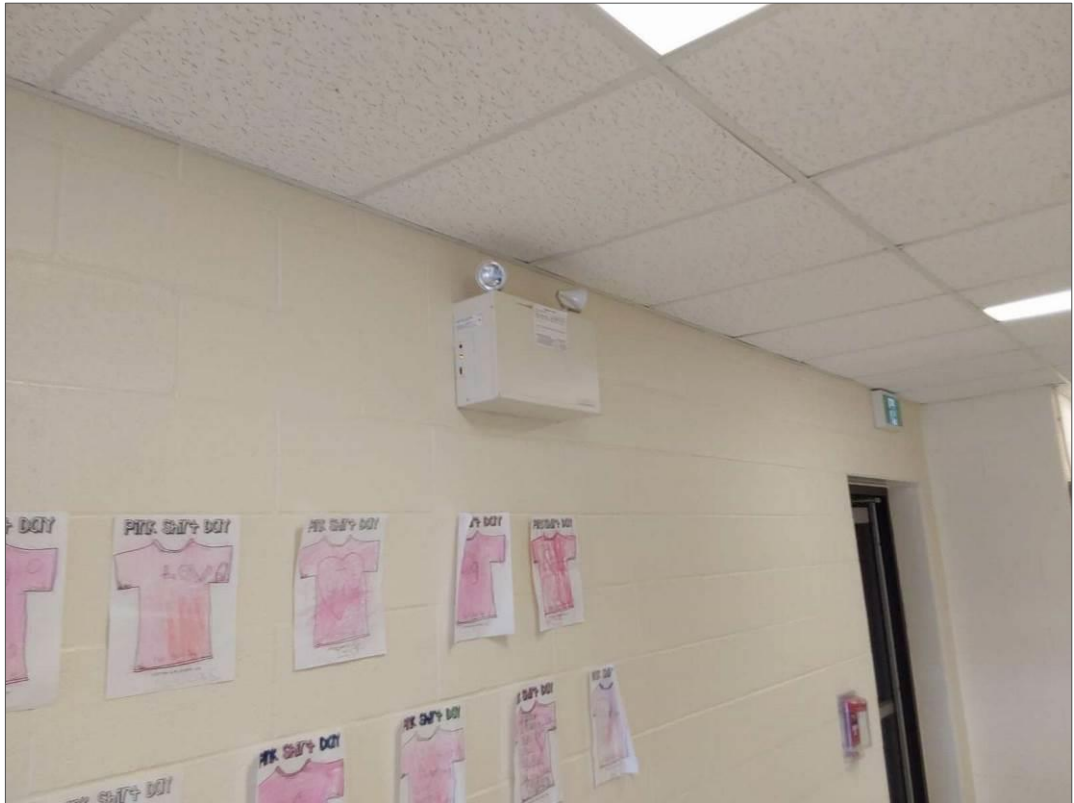
Pb Products, V9000(Yes), BATTERIES IN EMER. LIGHTS, 2014 Phase Construction (Location #: 77)

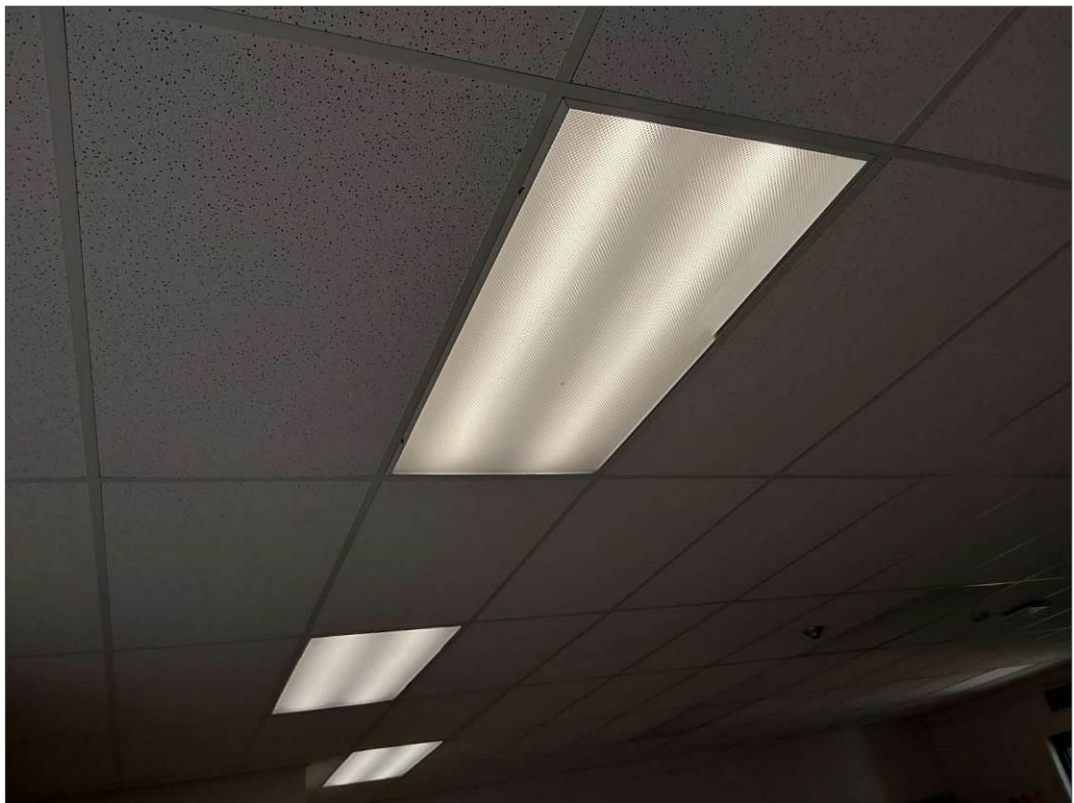
Mercury, V9000(Yes), LIGHT FIXTURE, Kindergarten (Location #: 52)

Do not break lamps. Recycle and reclaim mercury from fluorescent lamps when taken out of service. Mercury is classified as a hazardous waste and must be disposed of in accordance with applicable regulations.

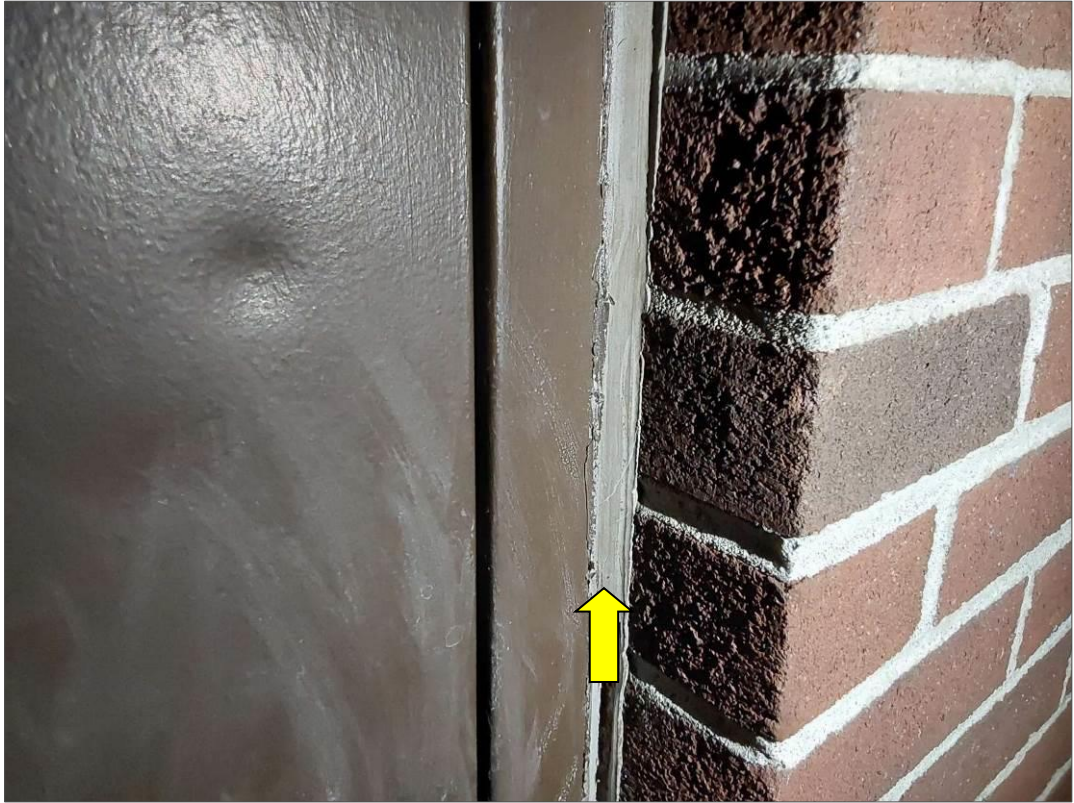
PCB, P0001(No), CAULKING, Grey caulking on exterior door, Exterior Wall For Renovation (Location #: 81)

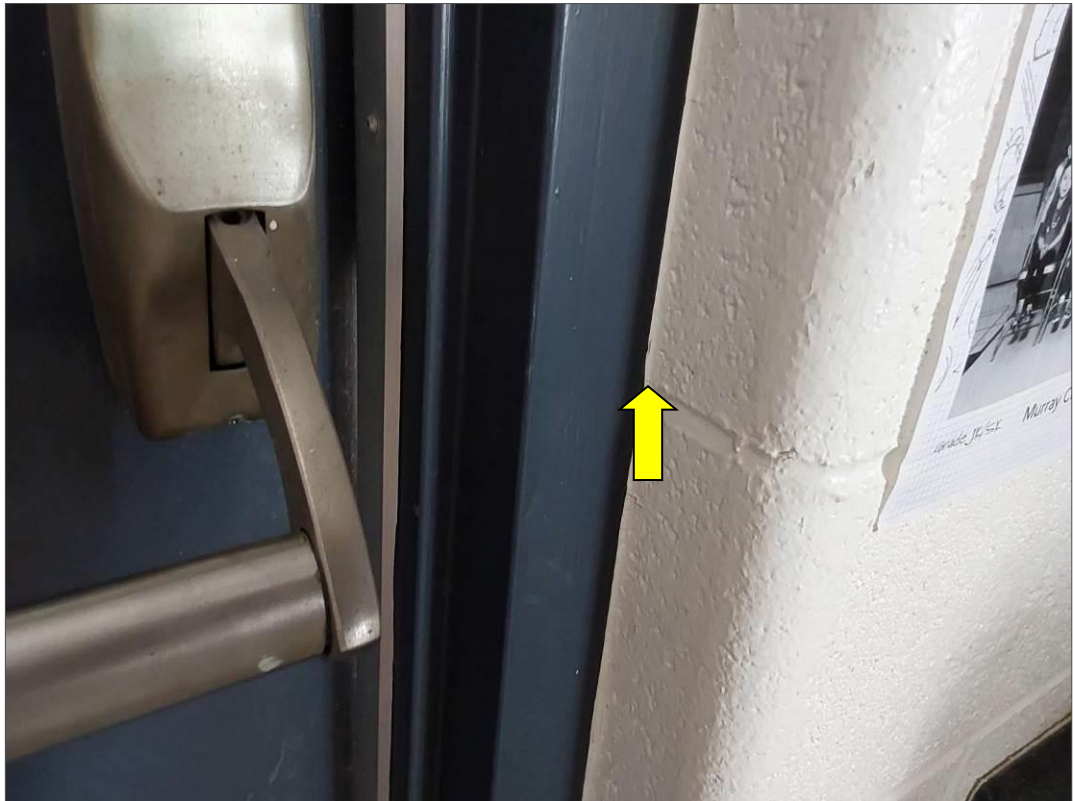
PCB, P0002(No), CAULKING, White caulking on interior side of door to exterior, Kindergarten (Location #: 52)

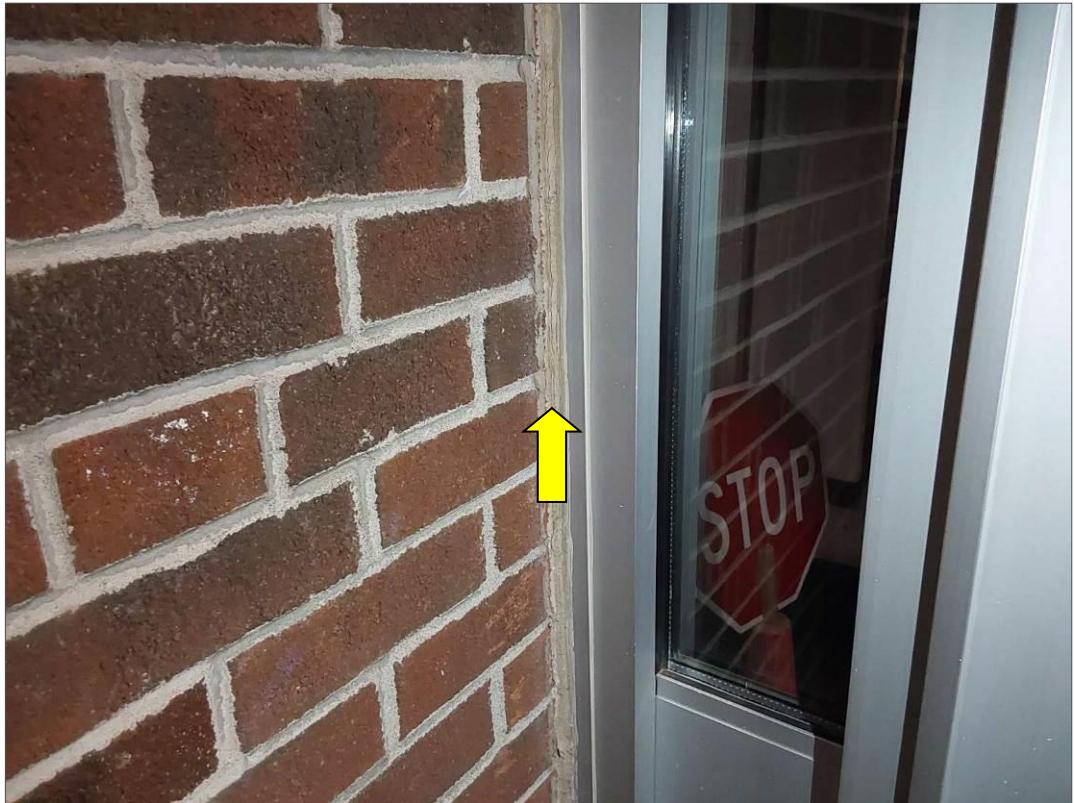
PCB, P0003(No), CAULKING, Dark grey caulking on exterior door, Exterior Wall For Renovation (Location #: 81)

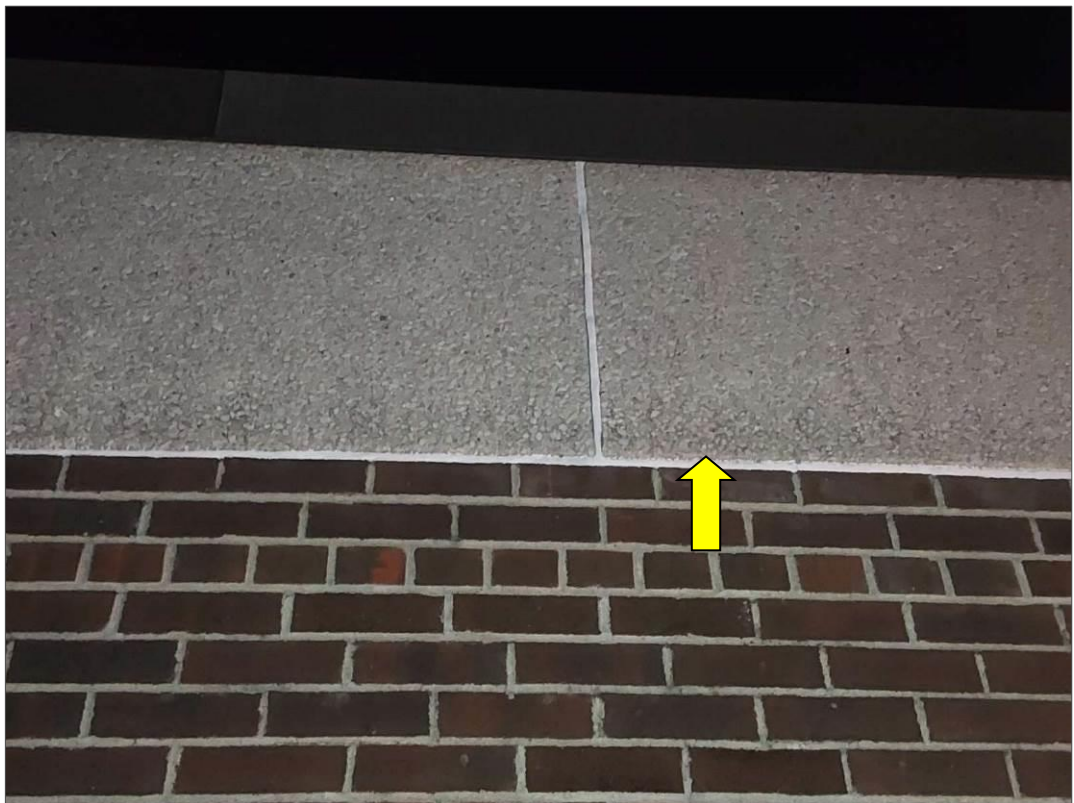
PCB, P0004(No), CAULKING, White caulking on fascia, Exterior Wall For Renovation (Location #: 81)

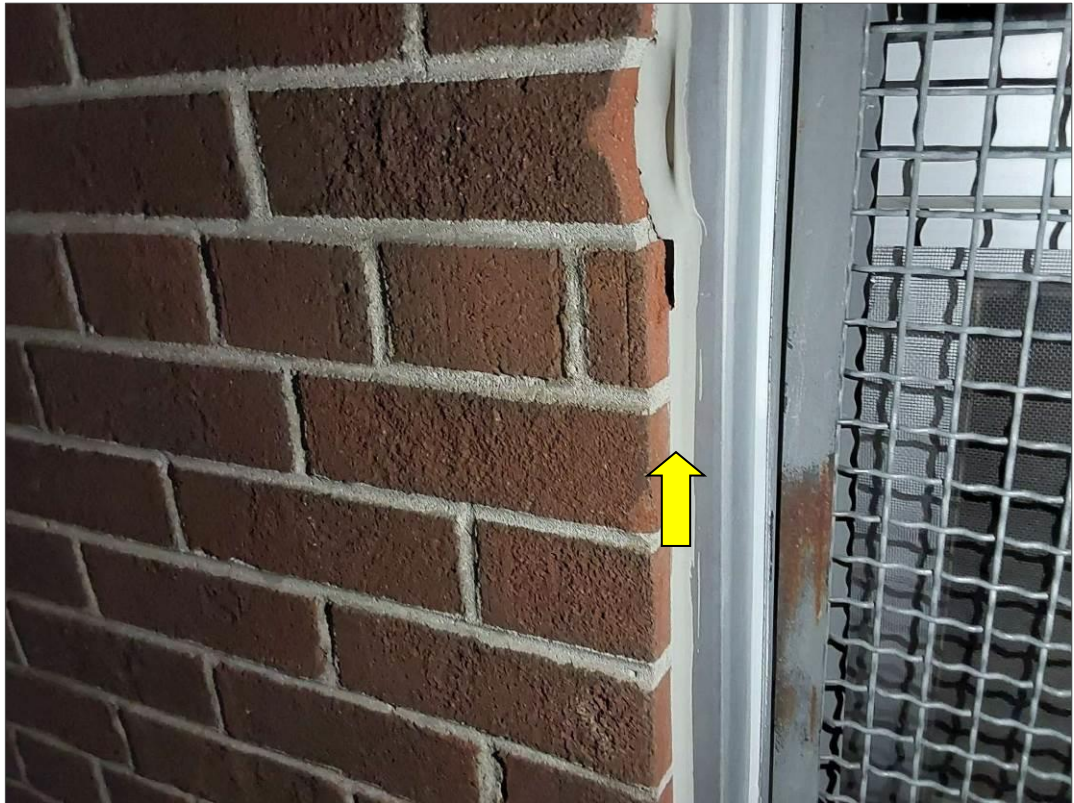
PCB, P0005(No), CAULKING, Light grey caulking along window cages, Exterior Wall For Renovation (Location #: 81)
