**Re: Hazardous Building Materials Assessment (Pre-Construction)**

Murray Centennial, 654 County Road 40, Trenton, Ontario

Pinchin File: 335495.031

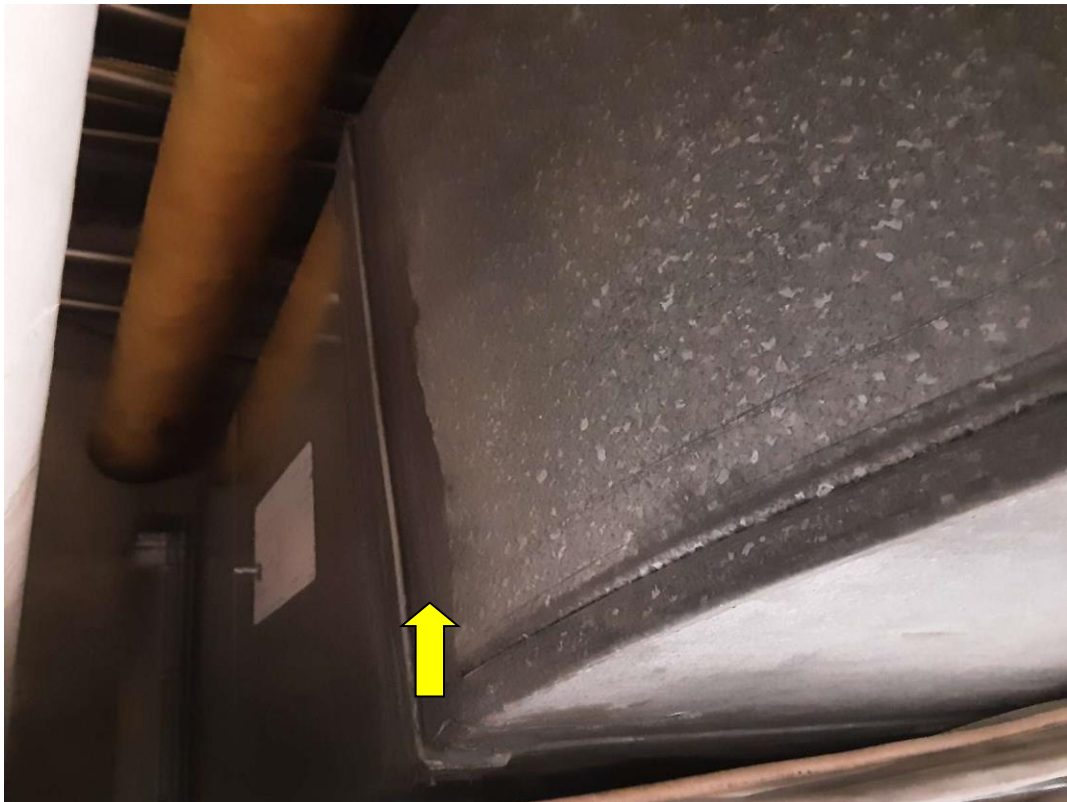
S0083C (None), Grey, Duct, Mastic, Grey, Corridor (Location #: 28)  
Duct mastic

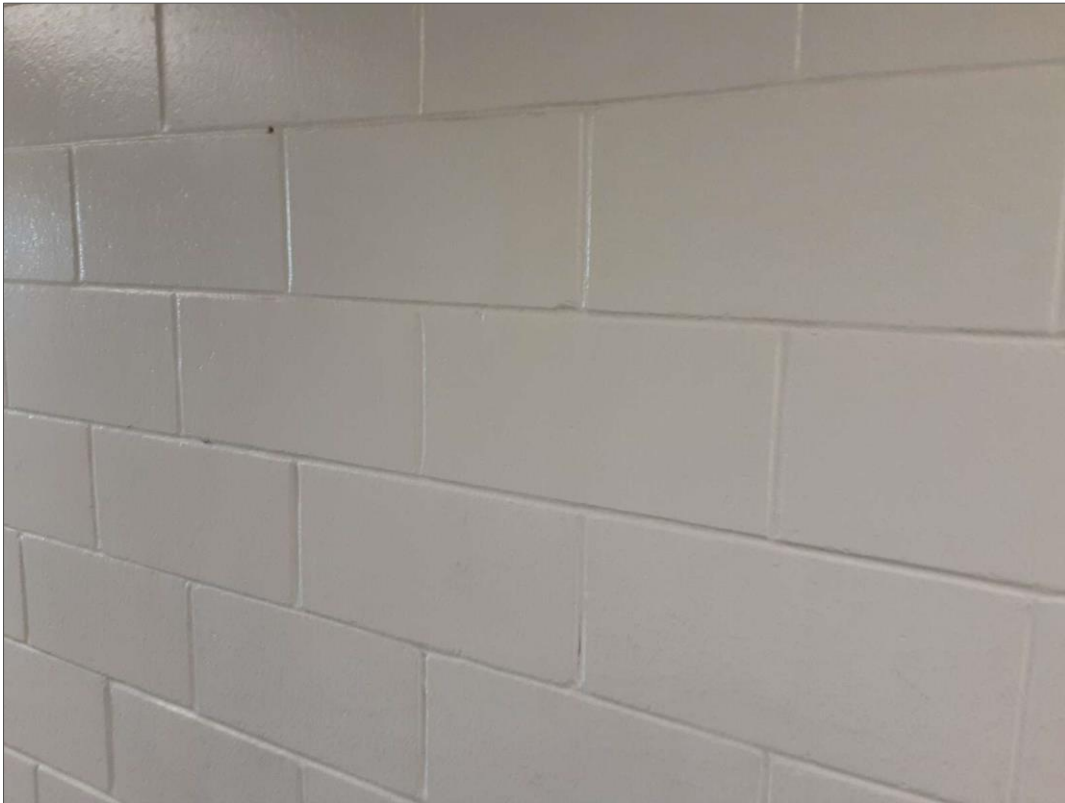
S0084A (None), Wall, Paint, Corridor (Location #: 28)

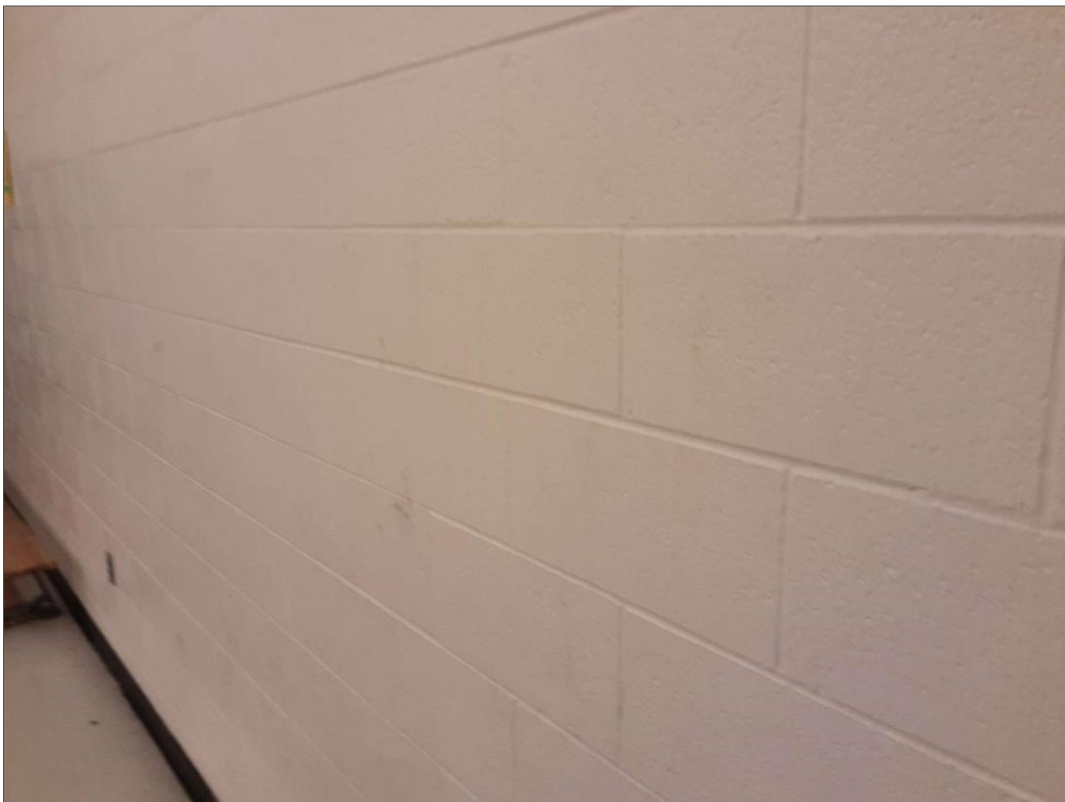
S0085C (None), Off white, Wall, Paint, Multi-Purpose Room (Location #: 12)  
On concrete block

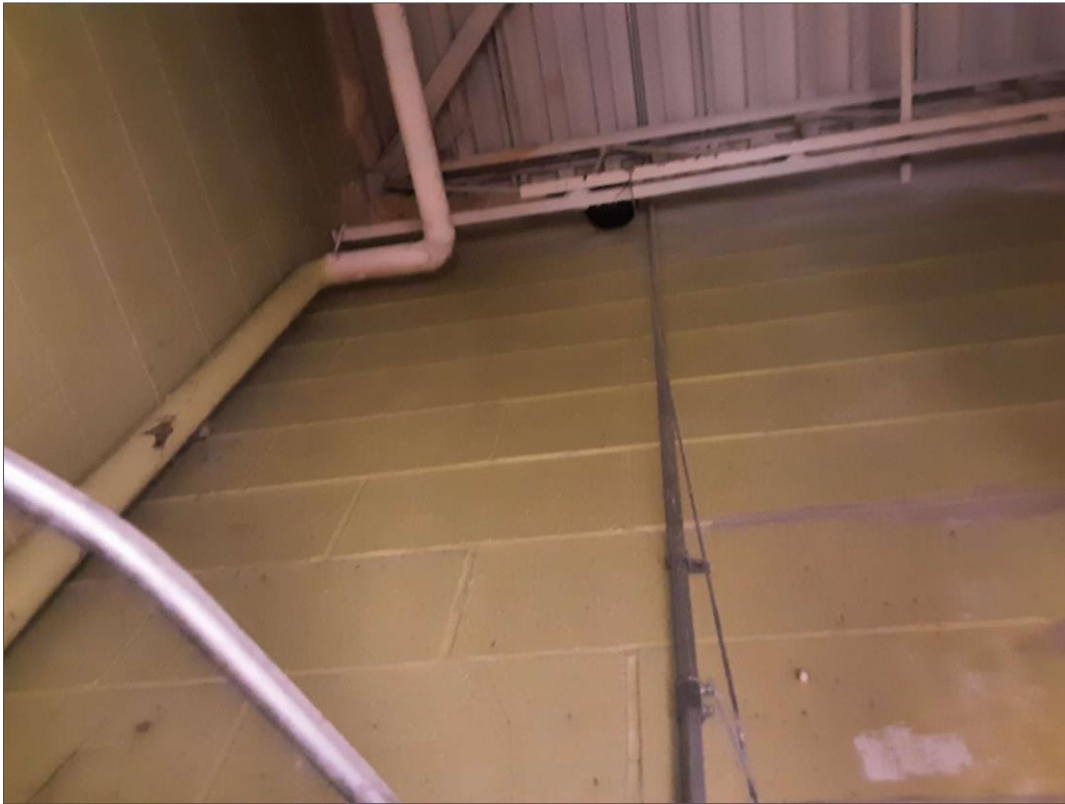
S0086C (Confirmed Asbestos), Light green, Wall, Paint, Storage (Location #: 19)  
Above ceiling

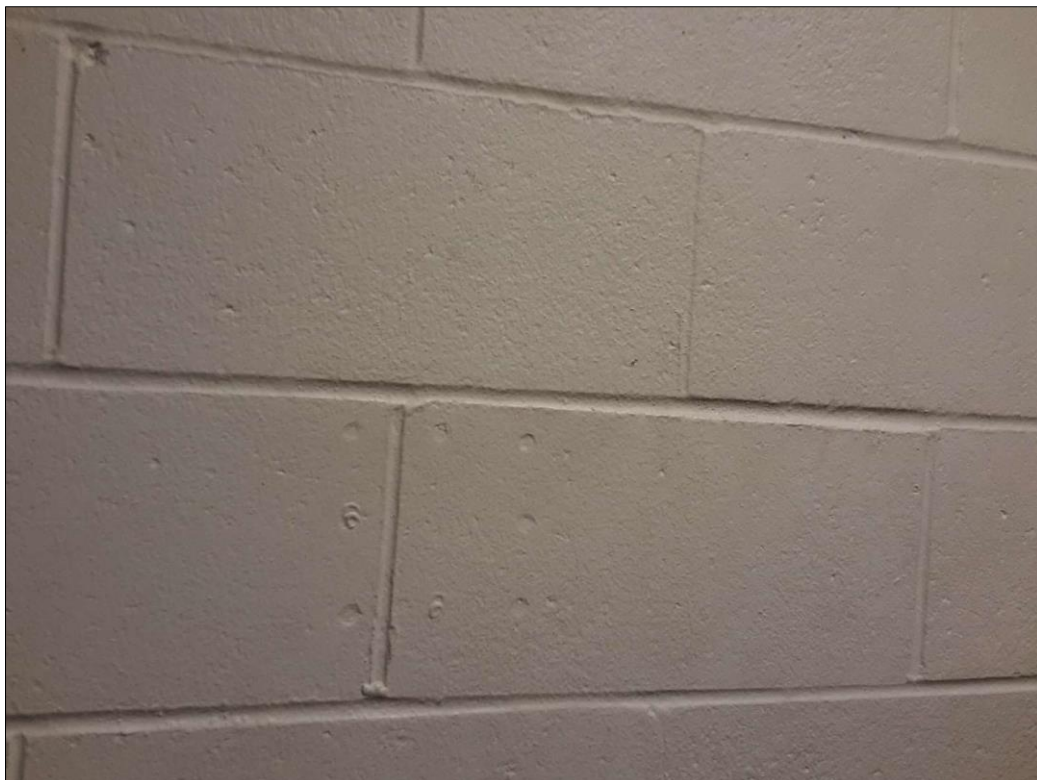
S0087C (None), Wall, Paint, Storage (Location #: 19)

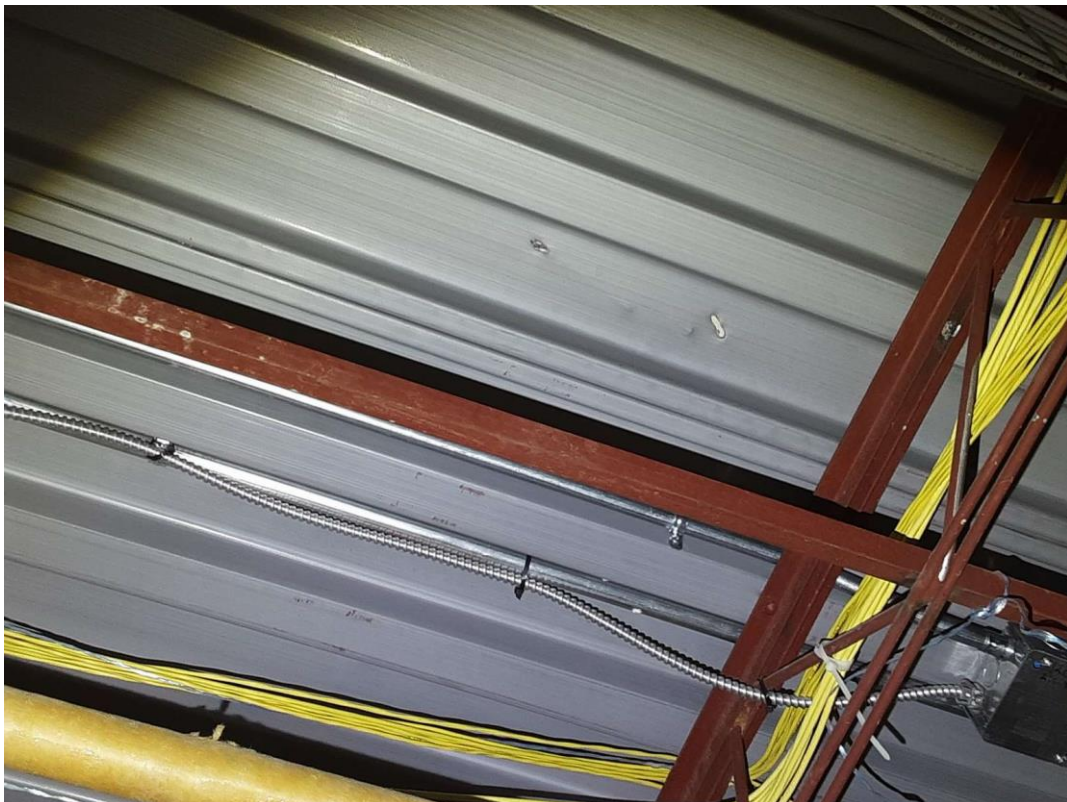
V0001(Lead, High), Red, Structure, Corridor (Location #: 28)  
On steel beams and joists

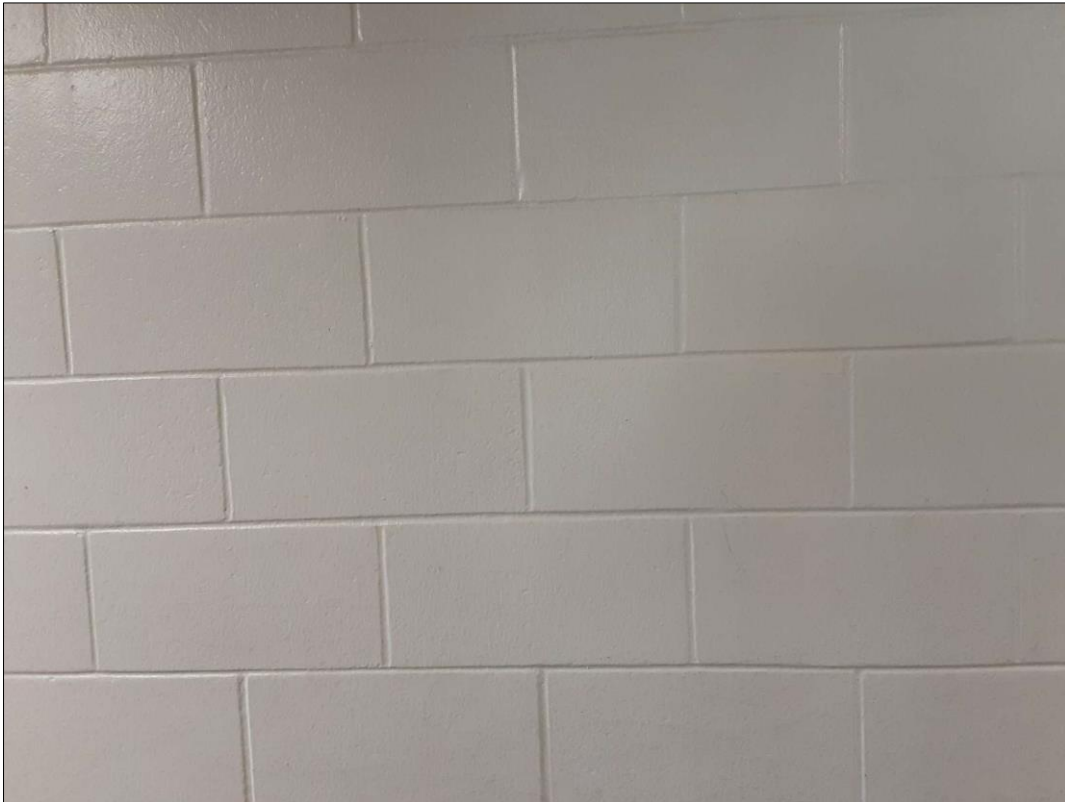
V0005(Lead, High), Wall, Corridor (Location #: 32)

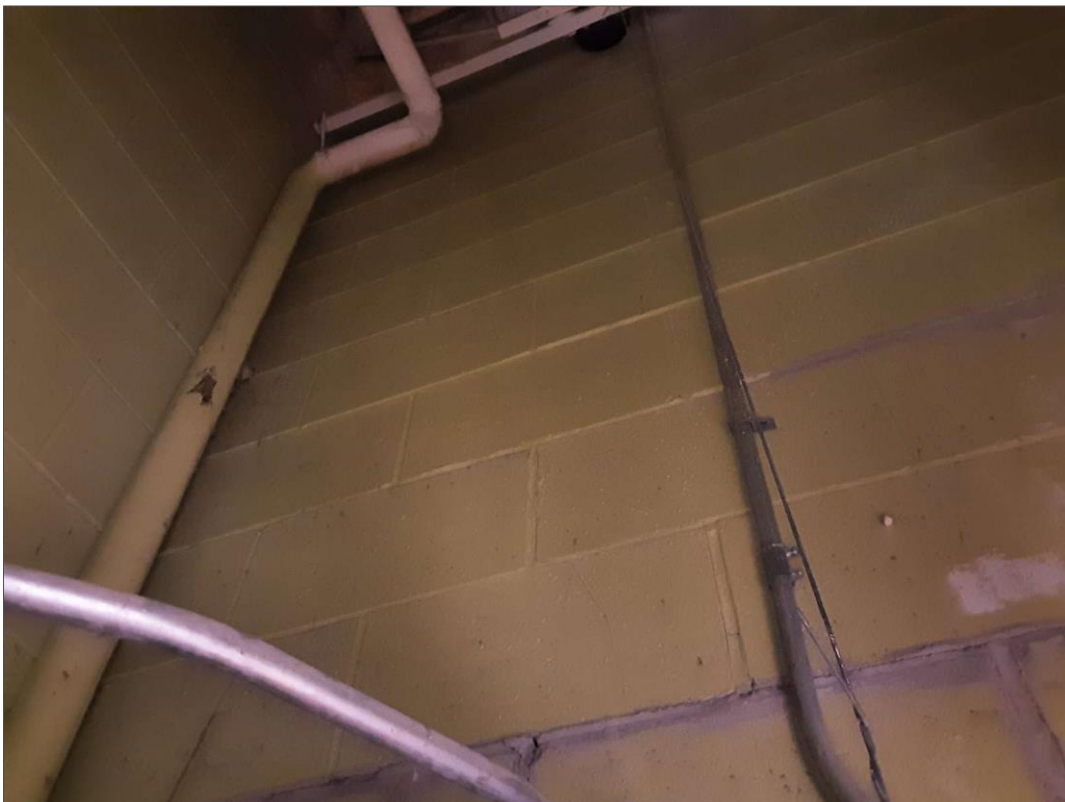
L0014(Lead, High), Light green, Wall, Storage (Location #: 19)  
Above ceiling

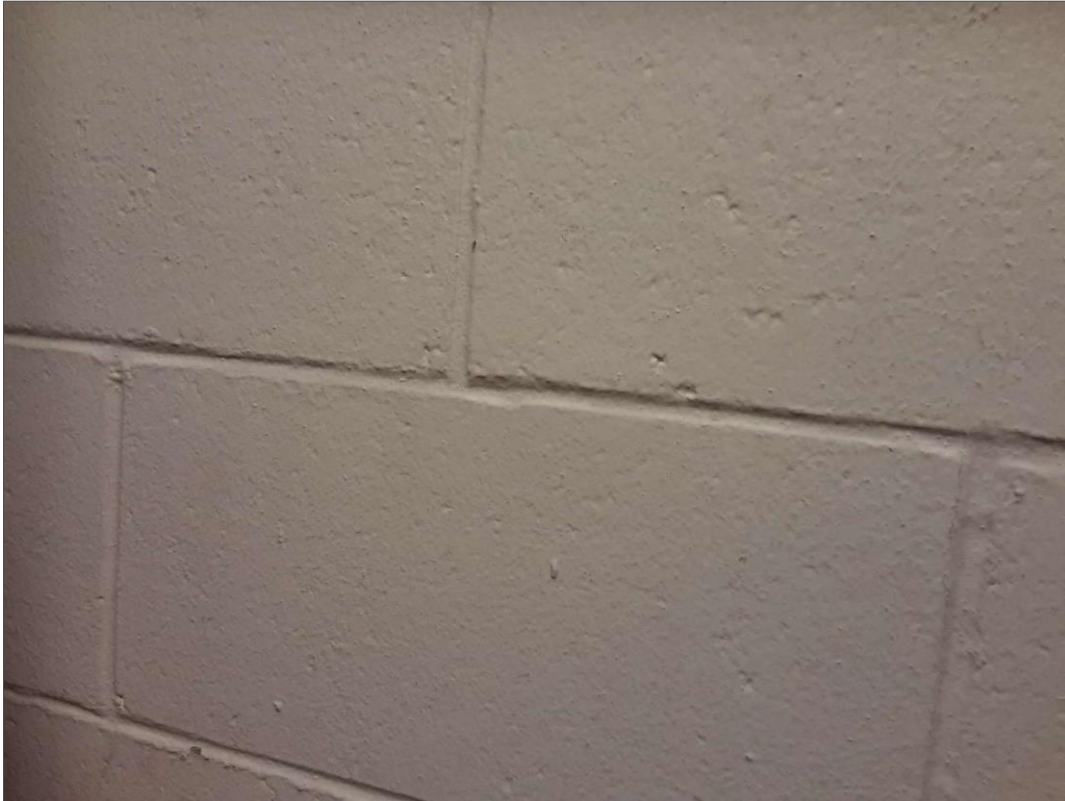
L0015(Lead, Low), White, Wall, Storage (Location #: 19)

For paints identified as having low levels of lead (i.e., equal to or above 0.009% (90 mg/kg) but less than or equal to the EACC guideline of 0.1% (1,000 mg/kg) for lead-containing paints) special precautions are not recommended unless aggressive disturbance (grinding, blasting, torching) is planned.

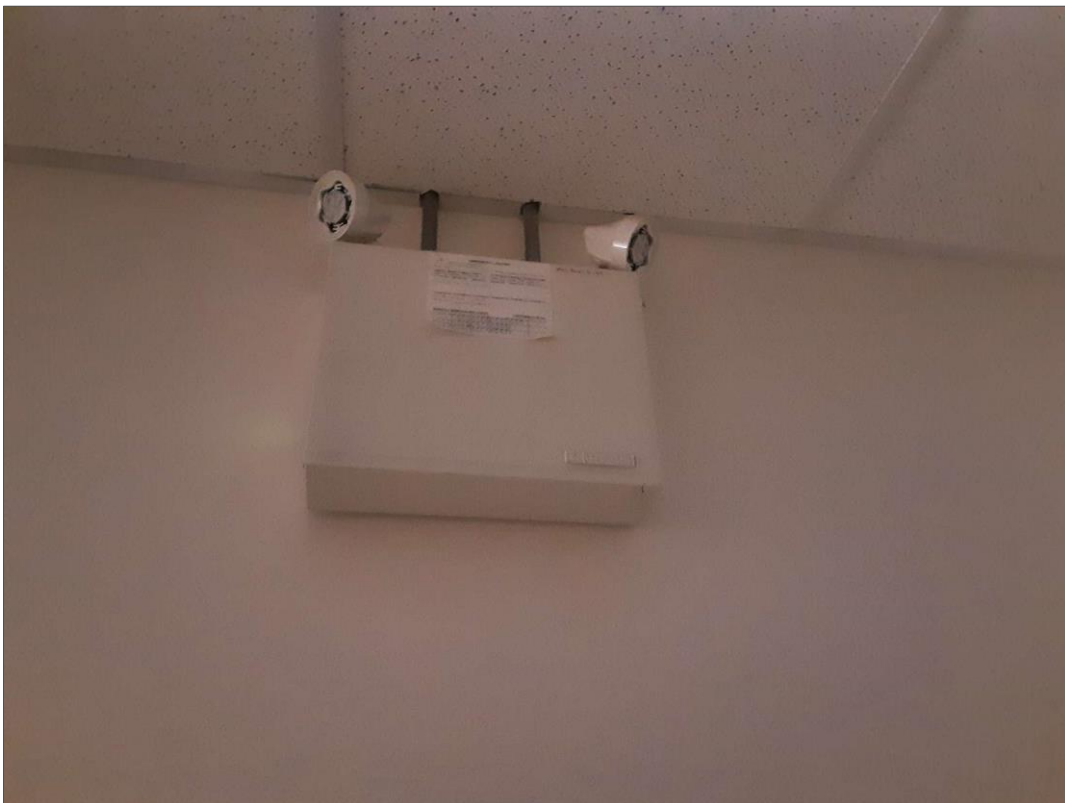
Pb Products, V9000(Yes), BATTERIES IN EMER. LIGHTS, Corridor (Location #: 34)

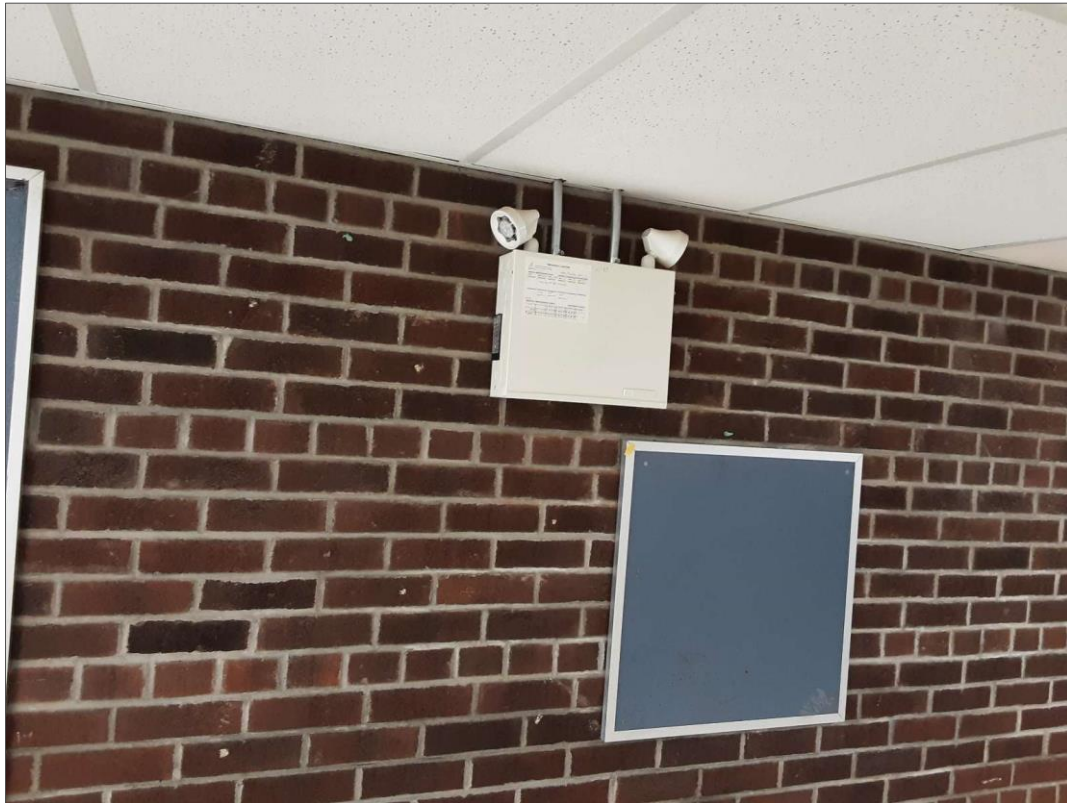
Pb Products, V9000(Yes), BATTERIES IN EMER. LIGHTS, Corridor (Location #: 47)

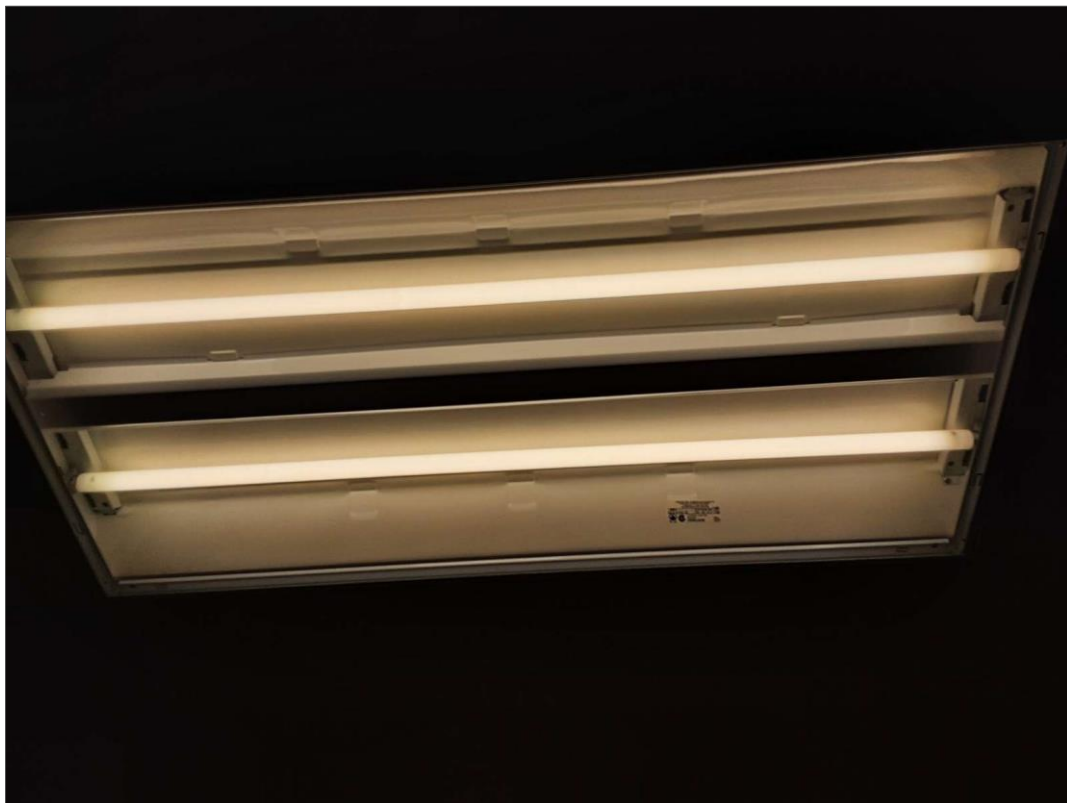
Mercury, V9000(Yes), LIGHT FIXTURE, Electrical Room (Location #: 8)

Do not break lamps. Recycle and reclaim mercury from fluorescent lamps when taken out of service. Mercury is classified as a hazardous waste and must be disposed of in accordance with applicable regulations.

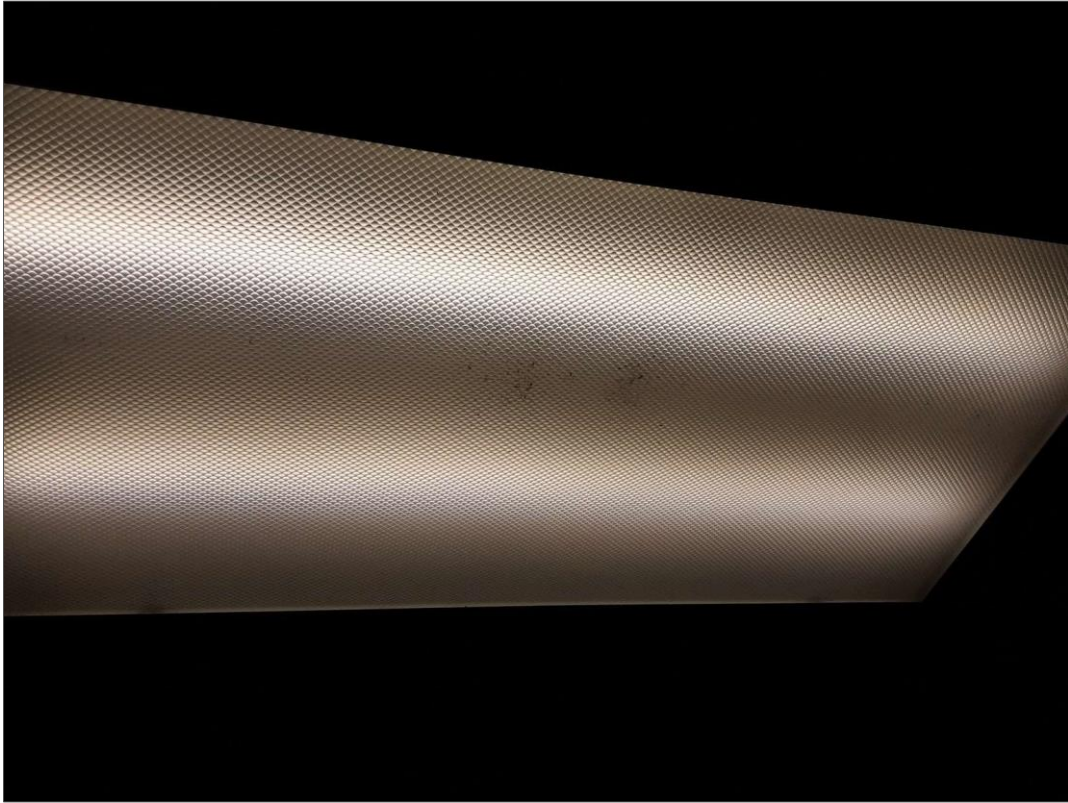
Mercury, V9000(Yes), LIGHT FIXTURE, Corridor (Location #: 28)

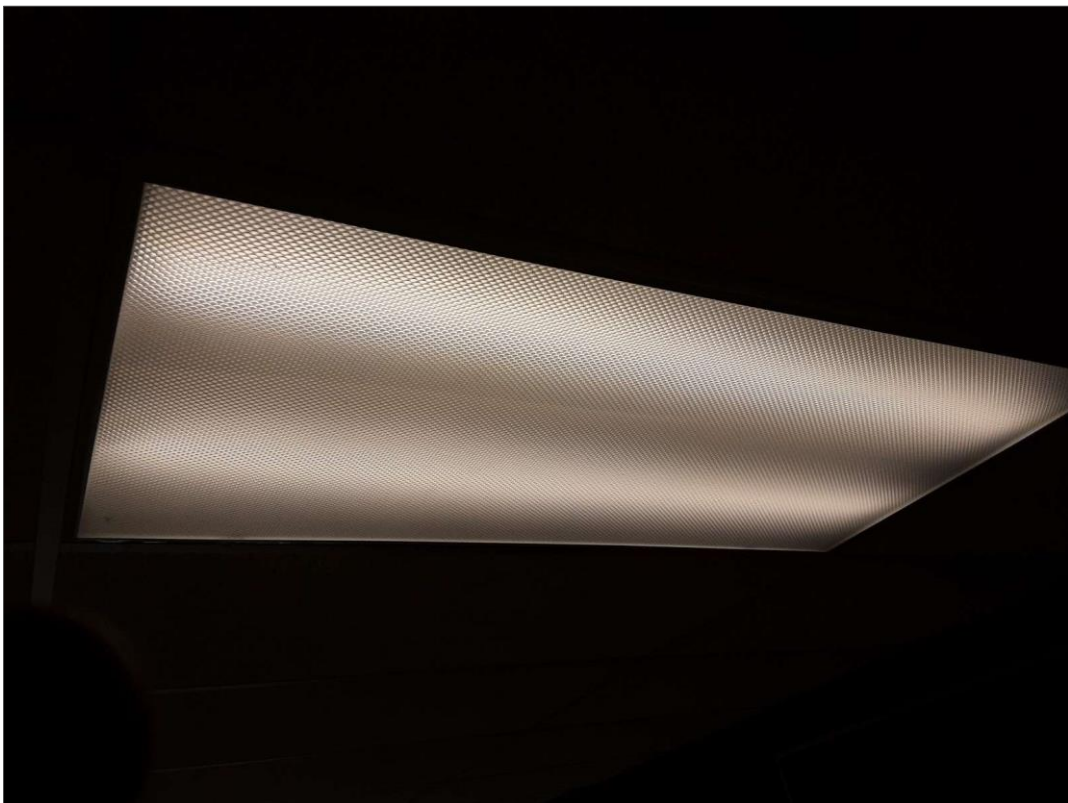
Mercury, V9000(Yes), LIGHT FIXTURE, Corridor (Location #: 47)
