Hazardous Building Materials Assessment (Pre-Construction)

Toronto Fire Services Station 212
8500 Sheppard Avenue East,
Toronto, Ontario

September 26, 2023

Pinchin File: 331484.000

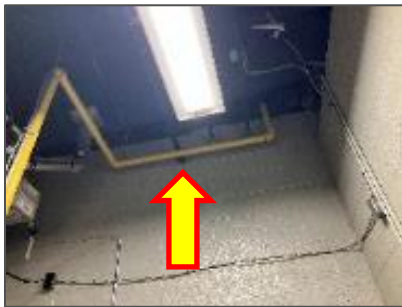
Uninsulated pipe, Generator Room (Location 1-02).

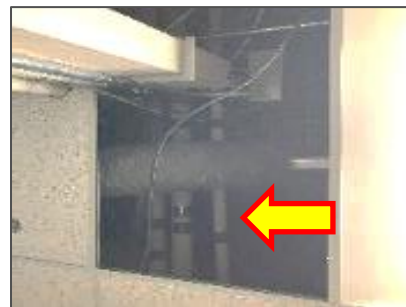
Pipe insulated with fibreglass and jacketed in canvas, Electrical Room (Location 1-10).

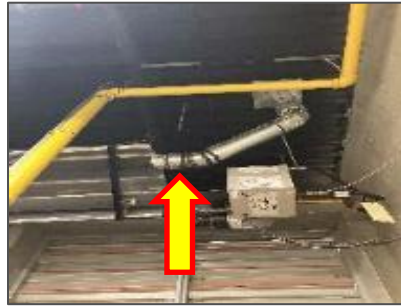
Duct mastic (dark brown color) at seams / joints on the exterior of ducts throughout the assessed area does not contain asbestos (Lab Reference No.: b299823, samples S0008A-C).

Non-asbestos brown duct mastic, Generator Room (Location 1-02).

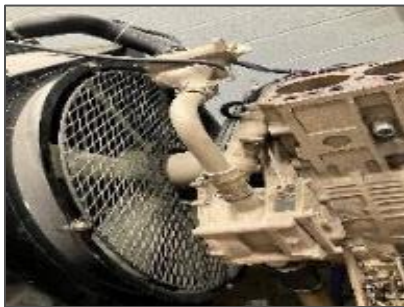
Generator, Generator Room (Location 1-02).

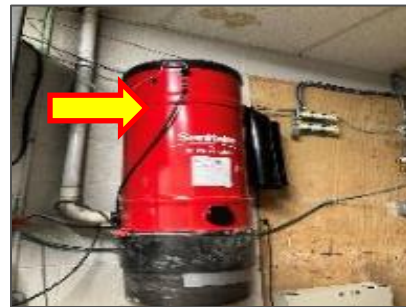
Superior Vacuum, Electrical Room (Location 1-10).

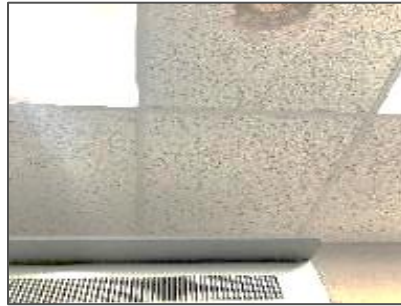
Water staining was observed on non-asbestos lay-in ceiling tiles within Electrical Room (Location - 1-10).

Non-asbestos acoustic ceiling tiles (ACT01).

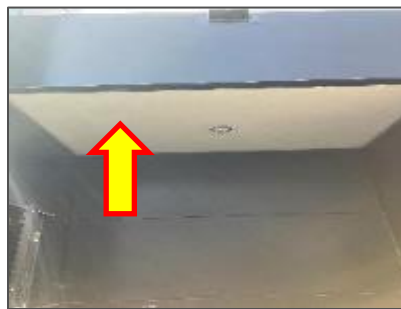
Stucco present as exterior soffits at entrance vestibule ceilings does not contain asbestos (Lab Reference.: b299823, samples S0002A-C).

Non-asbestos stucco present on ceilings, Exterior (Location 0-00).

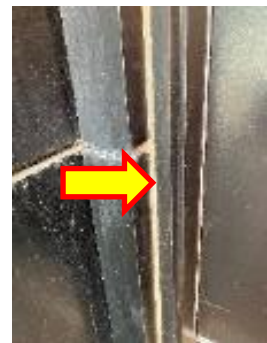
Material, Description and Application	Sample Location (Location #)	Sample Number	Asbestos	Photo
Black caulking on metal door frame	Exterior, Vestibule (Location 0-00)	Lab Reference.: b299823, S0003A-C	No

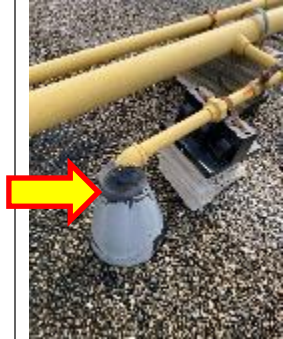
Material, Description and Application	Sample Location (Location #)	Sample Number	Asbestos	Photo
Black caulking on pipe roof penetration	Exterior, Roof (Location 0-00)	Lab Reference.: b299823, S0004A-C	No

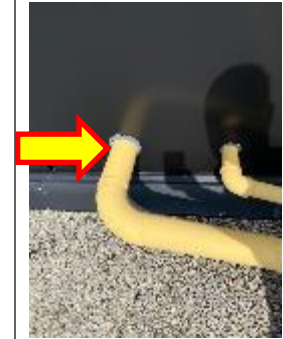
Black caulking on pipe penetration on metal cladding	Exterior, Roof (Location 0-00)	Lab Reference.: b299823, S0005A-C	No

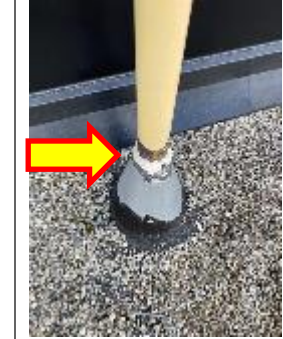
Grey caulking on pipe roof penetration	Exterior, Roof (Location 0-00)	Lab Reference.: b299823, S0006A-C	No

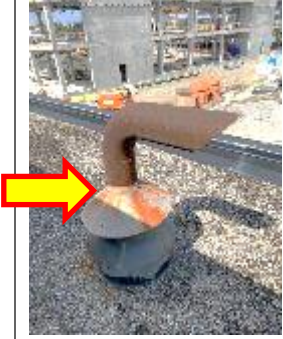
Beige caulking on pipe chimney	Exterior, Roof (Location 0-00)	Lab Reference.: b299823, S0007A-C	No

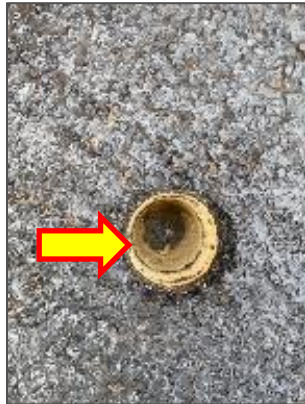
The materials associated with the built-up roof do not contain asbestos (Lab Reference.: b299824, sample S0009A-C).

Non-asbestos roofing materials, Roof (Location 0-00).

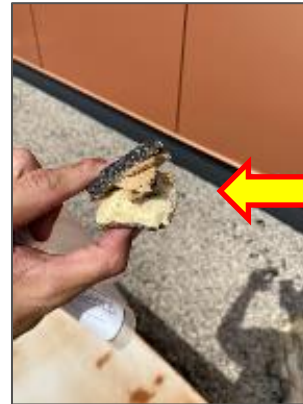
Non-asbestos roofing materials, Roof (Location 0-00).

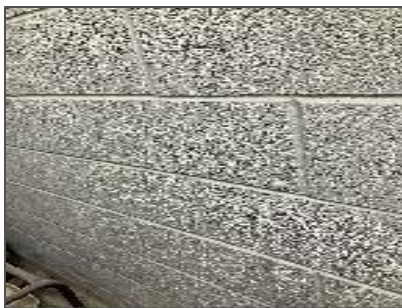
Mortar present in the concrete block masonry within Generator Room (Location 1-02) does not contain asbestos (Lab Reference.: b299823, sample S0001A-C).

Non-asbestos mortar on masonry wall, Generator Room (Location 1-02).

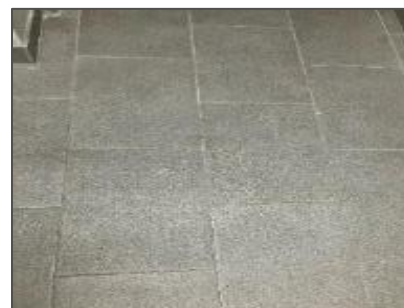
Thin set under 12"x24" grey ceramic tiles on the floor in the Electrical Room (Location 1-10) is presumed to contain asbestos until further sampling proves otherwise. Ceramic tiles on floor will not be impacted by the scope of the installation of the new natural gas system.

Presumed asbestos-containing thin-set present under 12"x24" grey ceramic tiles, Electrical Room (1-10).

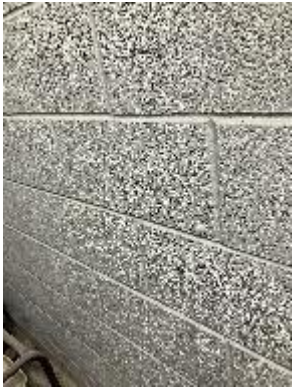
Sample Number	Colour, Substrate Description	Sample Location	Lead (%)	Photo
L0002	Grey paint on masonry wall	Generator Room (Location 1-02) Lab Reference.: R7812874	0.00019

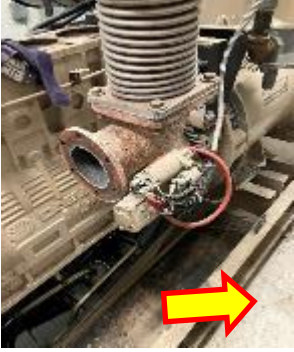
L0004	Light grey on concrete floor	Generator Room (Location 1-02) Lab Reference.: R7812874	0.00042

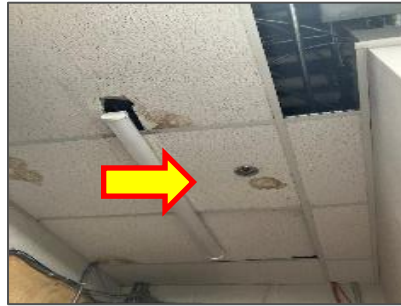
Visible water staining is present on approximately 10 square feet of non-asbestos acoustic ceiling tiles (lay-in, 2' x 4' Fissure widthwise w/ pinpoint) in Electrical Room (Location 1-10).

Water Staining on non-asbestos ceiling tiles, Electrical Room (Location 1-10).

Mould growth was not observed during the assessment. However, water staining was noted in area affected by the planned work. Remove and replace the water-staining non-asbestos ceiling tile regardless of the planned renovations.

Conduct an intrusive investigation to identify the extent of the source of the water intrusion. Rectify the source of the water staining prior to any reinstatement of removed building materials.
