Attachment C

Designated Substance Survey

Commissioners Transfer Station MRF Building, EXP, February 2023

Re: BRM-22028009-A0 Asbestos Analytical Results - Commissioners Transfer Station
MRF Building - 400 Commissioners Street, Toronto, ON

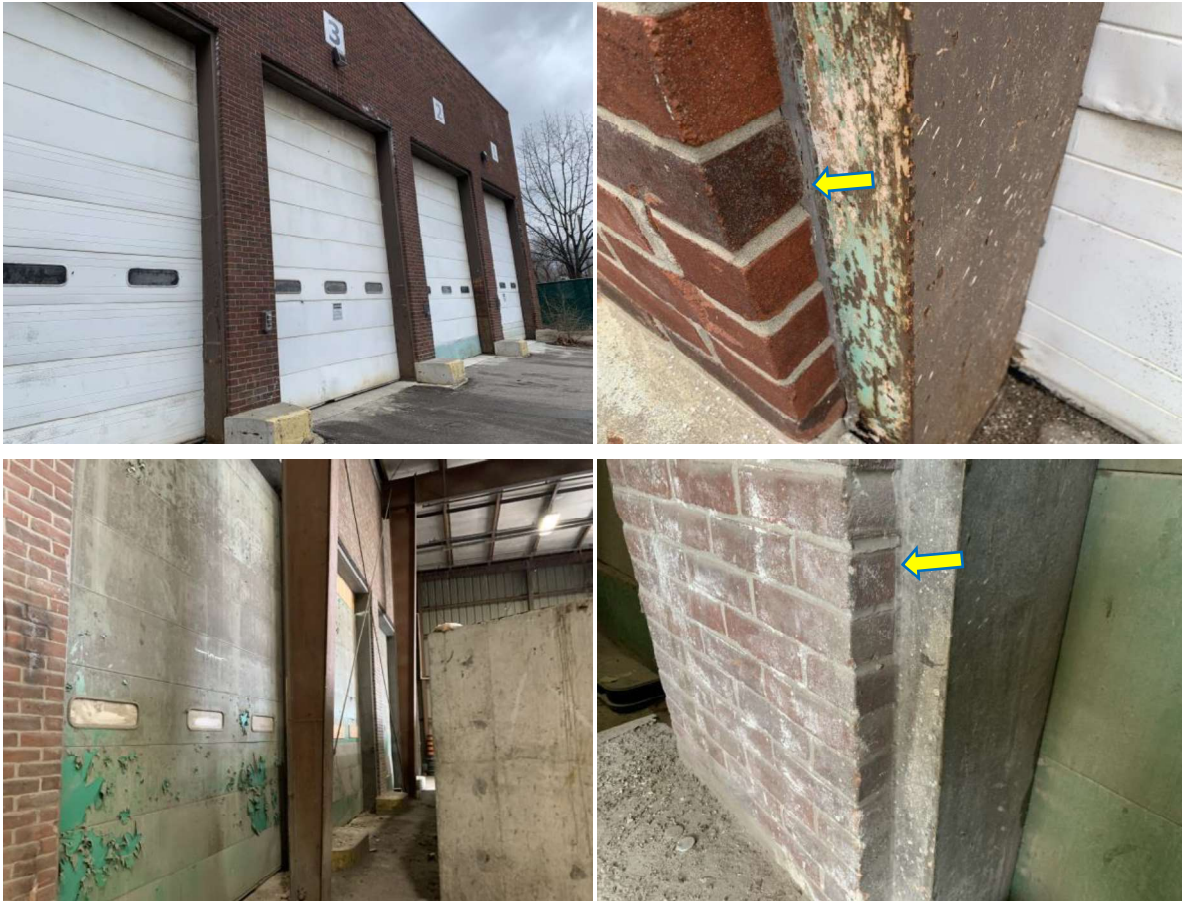
Photograph No. 1.1, 1.2, 1.3 and 1.4: View of the non-asbestos perimeter sealant joints on the exterior overhead door of the subject building.

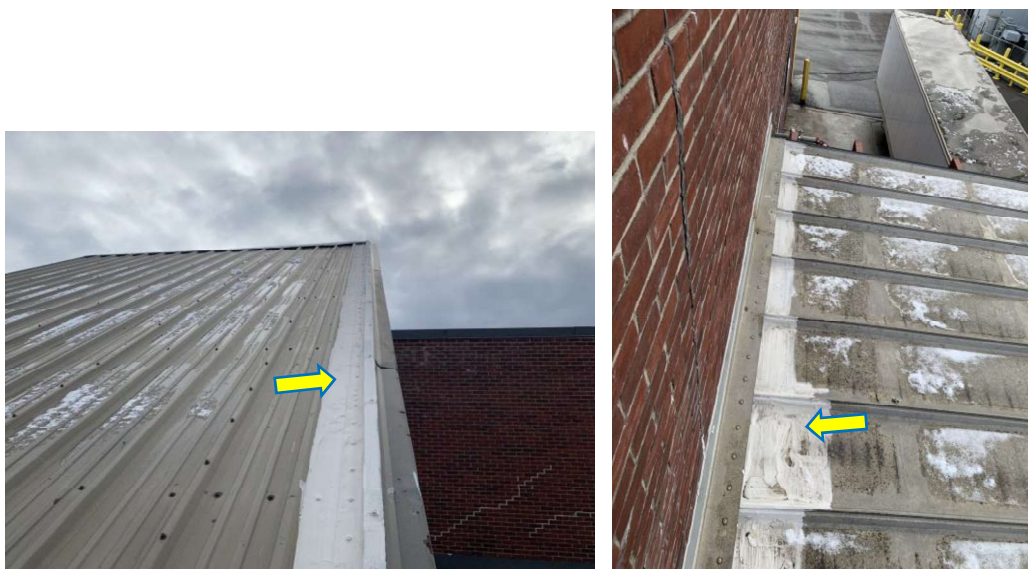
Photograph No. 2.1 and 2.2: View of the non-asbestos sealant (trowel-applied) on the main metal roof of the subject building. Similar sealant was observed on the loading dock metal roof.

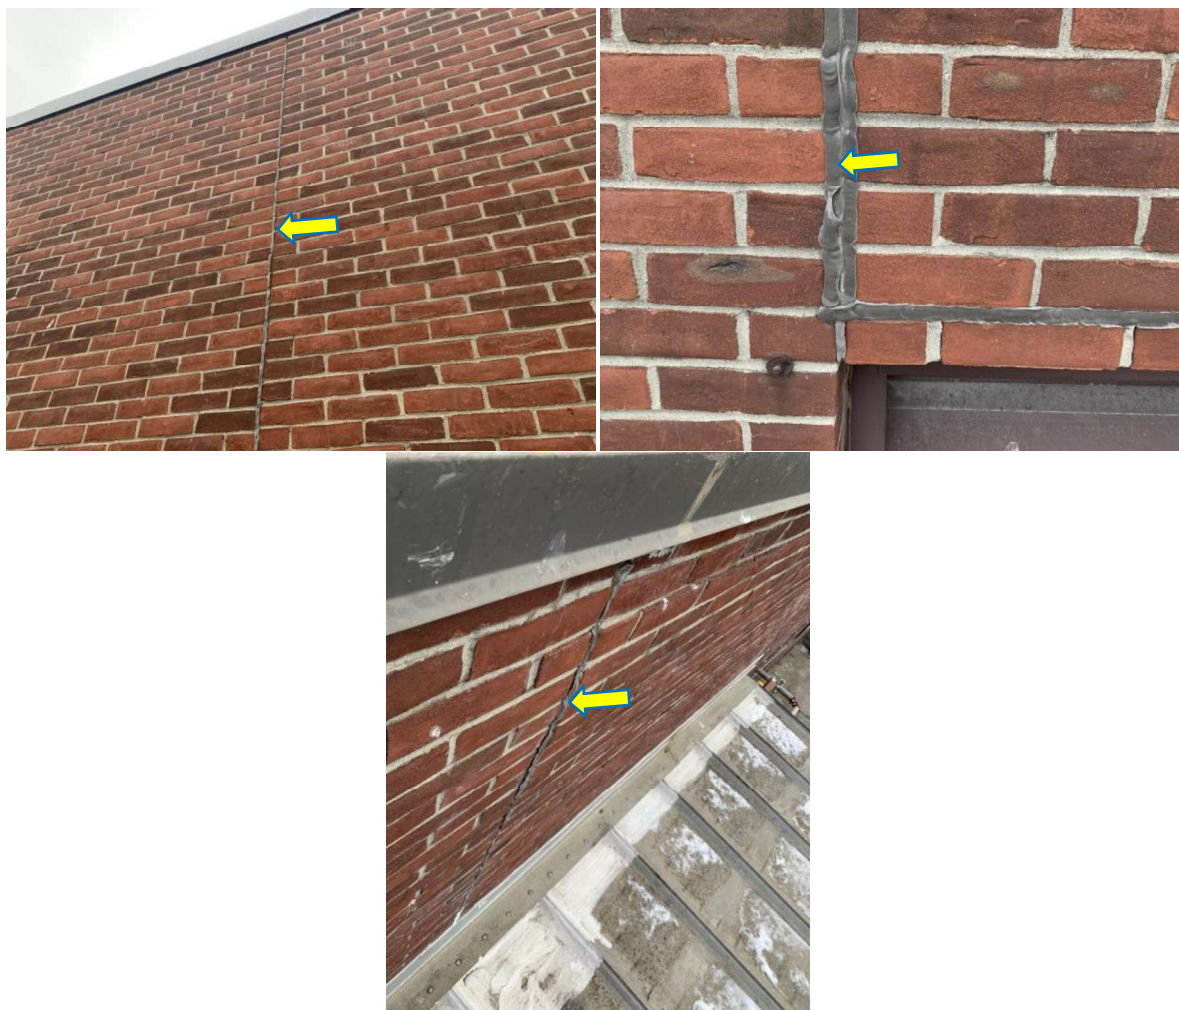
Photograph No. 3.1, 3.2 and 3.3: View of the non-asbestos brick wall joint caulking on the exterior of the subject building.

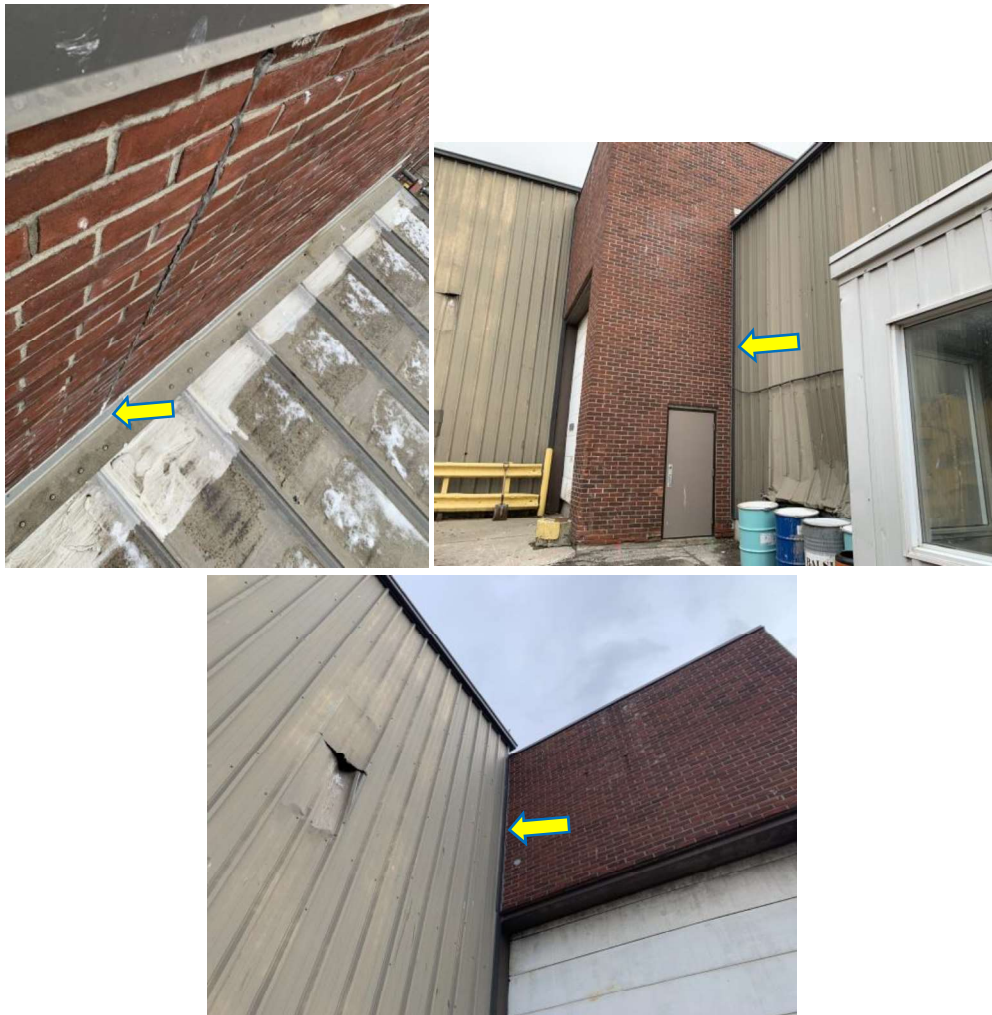
It should be noted that based on the findings of the Designated Substances Survey report prepared by Fisher Environmental Ltd. for Commissioners Transfer Station dated August 2021, the grey colour caulking associated with the brick wall and metal frame of the loading dock is identified to contain 0.5 – 5% Chrysotile asbestos. This asbestos-containing caulking material is considered non-friable ACM as per O. Reg. 278/05. Similar asbestos-containing caulking was observed on the joint associated with the metal flashing and brick wall on the roof of the loading dock. Refer to Photographs No. 4.1, 4.2 and 4.3 in Appendix B of this report.

Photograph No. 4.1, 4.2, and 4.3: View of the asbestos containing caulking associated with metal frame of the loading dock and brick wall on the exterior of the subject building.
