# DESIGNATED SUBSTANCES AND HAZARDOUS BUILDING MATERIALS ASSESSMENT REPORT

State of Good Repairs  
Roof, Pool and Mechanical Room  
Elms Community Pool  
45 Golfdown Drive  
Etobicoke, Ontario  
M9W 2H8

**Safetech Project Number: 1-3230904**

**Date of Site Work: November 23, 2023**  
**Date of Issue: December 1, 2023**

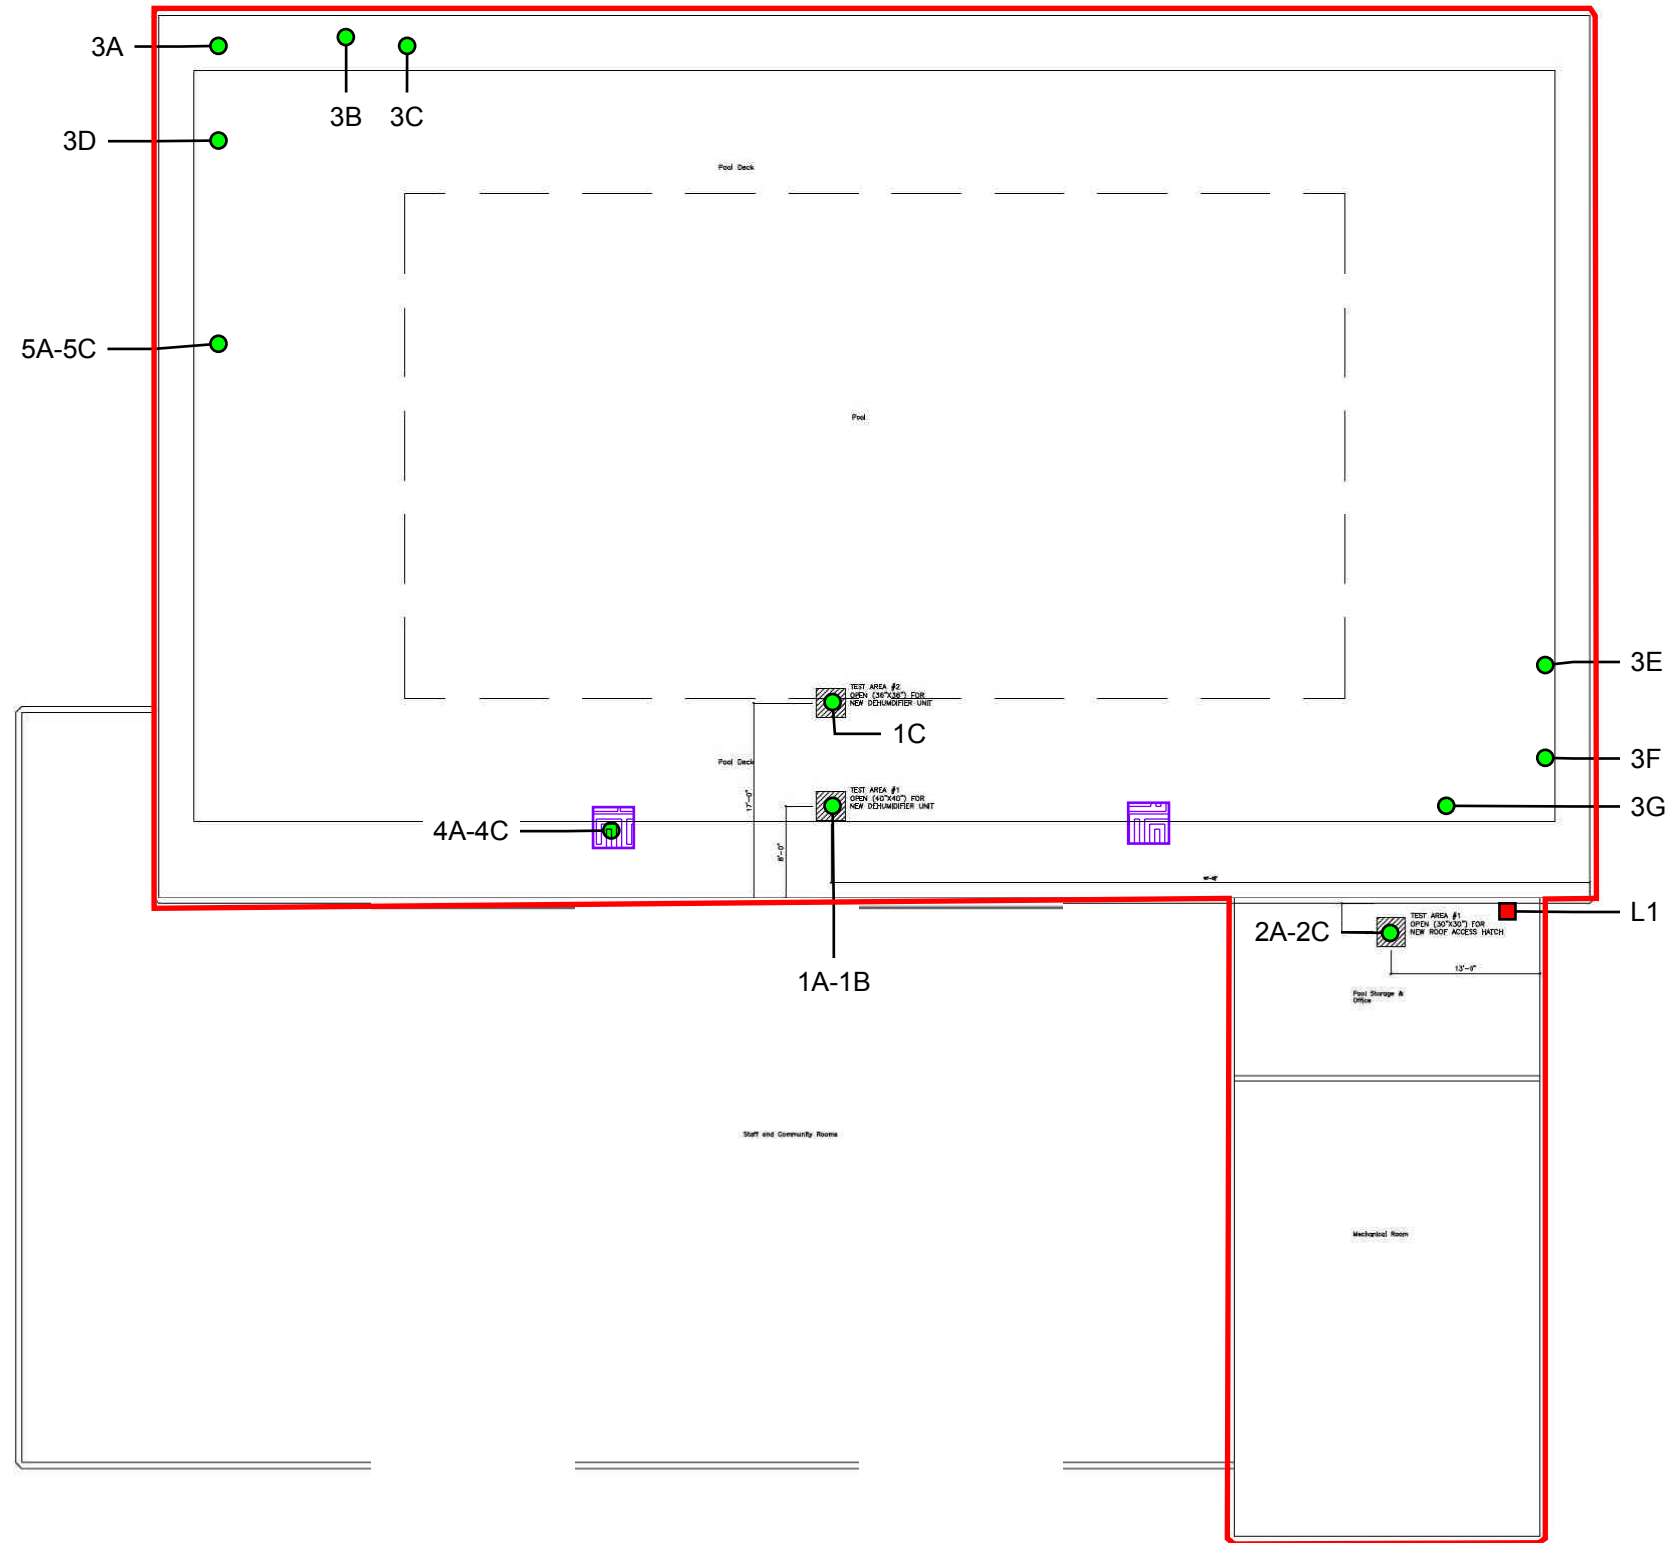
ROOF AND GROUND FLOOR

Floor	Room No.	Room Description	System	Material	Description	Classification	Friable/ Non-Friable	Condition	Est. Quantity	Unit	Access	Action
1	-	Pool Area	Pipe	Transite	Cement pipe serving as roof drain line	ACM	Non-Friable	Good	50	LF	C	8

- AREA ASSESSED
- ASBESTOS SAMPLE (NEGATIVE)
- LEAD SAMPLE (POSITIVE)
- TRANSITE CEMENT PIPE (ACM) - VERTICAL
