PRE-RENOVATION HAZARDOUS BUILDING MATERIALS SURVEY

Provincial Commander Office Renovation Project OPP Orillia General Headquarters

777 Memorial Avenue
Orillia, Ontario
L3V 6H1

**Project No.: 1103395-274117
OHE Project No.: 29999**

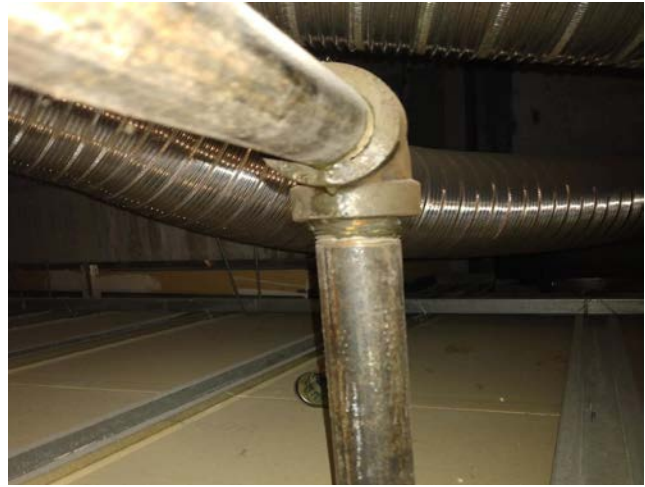
Five (5) wipe samples for lead were collected at the Subject Location. Lead was detected in one (1) wipe sample collected on the sprinkler pipe in the ceiling space in in Room 3-049. The concentration of the lead in the wipe sample collected from the sprinkler pipe was below the lead clearance standard recommended by US Navy Environmental Health Center (USNEHC). Lead was not detected in the remaining four (4) wipe samples collected in the ceiling space and within the wall cavity at the Subject Location. A detailed description of the sample locations is presented in Table B2 found in Appendix B.

Photograph 1. View of the sprinkler pipe in the ceiling space in Room 3-049. Lead was present on the wipe sample collected.
