## DESIGNATED SUBSTANCES AND HAZARDOUS MATERIALS REASSESSMENT REPORT

**Family Residence Building  
4222 Kingston Road  
Toronto, Ontario  
M1E 2M6**

**Date of Issue: December 14, 2023  
Safetech Project # 1-3230268**

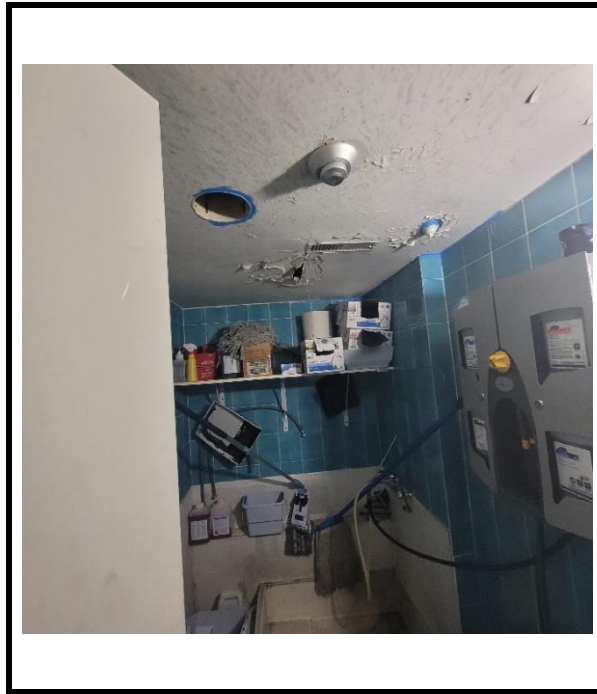
Photograph I

Significant suspect mould growth and water staining was identified to be present on drywall ceiling (50 SF) within the Laundry's Storage Room (1-21).

View of water-damaged drywall ceiling within the Laundry's Storage Room (1-21).

Remove mould-contaminated and water-damaged drywall ceiling within the Laundry's Storage Room (1-21) following Level 2 mould remediation procedures as outlined in EACC "Mould Abatement Guidelines".

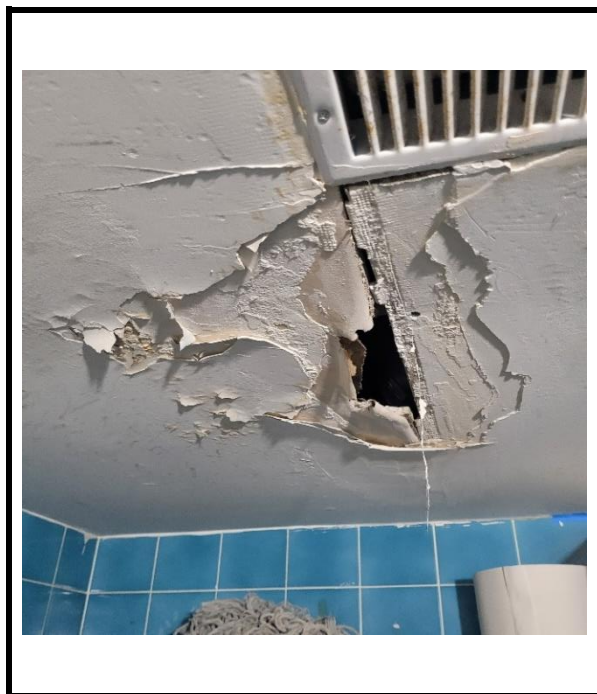
Photograph II

View of water-damaged drywall ceiling within the Laundry's Storage Room (1-21).

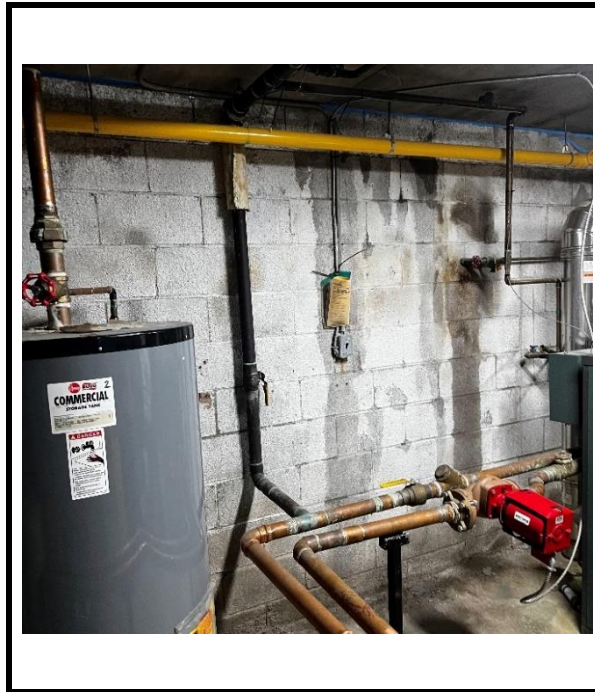
Photograph III

Water damage and water staining was identified to be present on the concrete block

View of water-damaged concrete block wall within the Boiler Room (B-06).

At this time, no mould specifications are required for the repair of concrete block wall within the Boiler Room B-06, Exit Door B-05, and Hallway B-01 of the subject building.

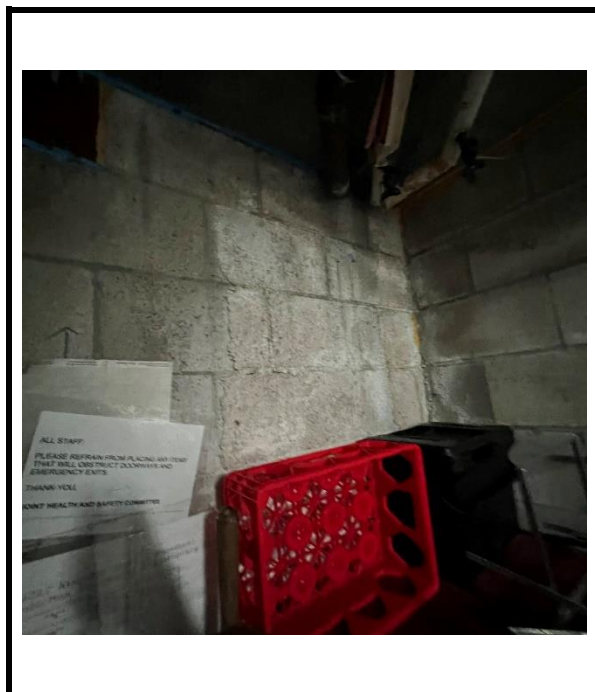
Photograph IV

View of water-damaged concrete block wall within the Basement Hallway (B-01).

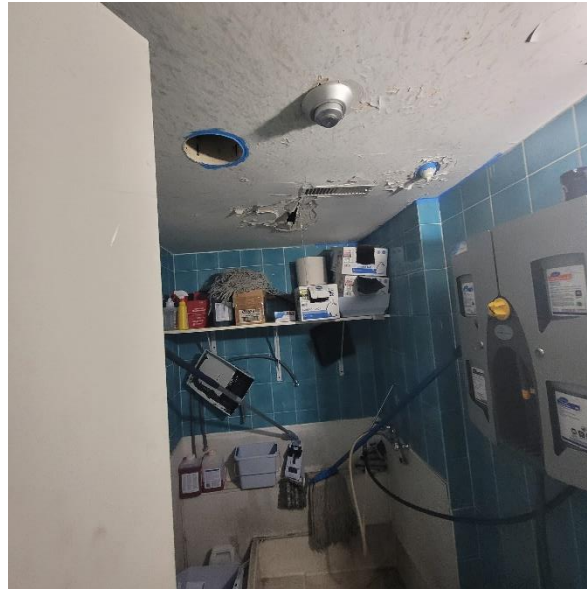
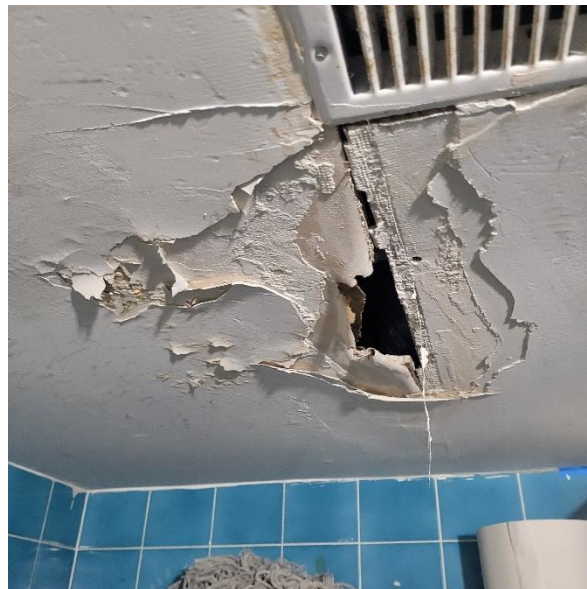
**Photos 1, 2:** View of water-damaged drywall ceiling.

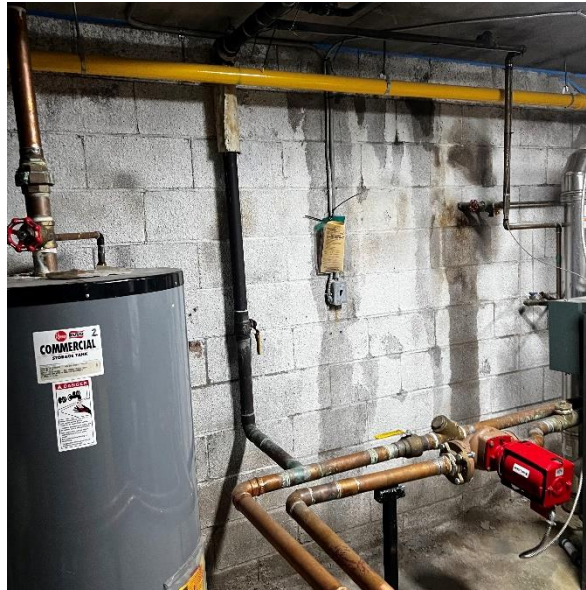
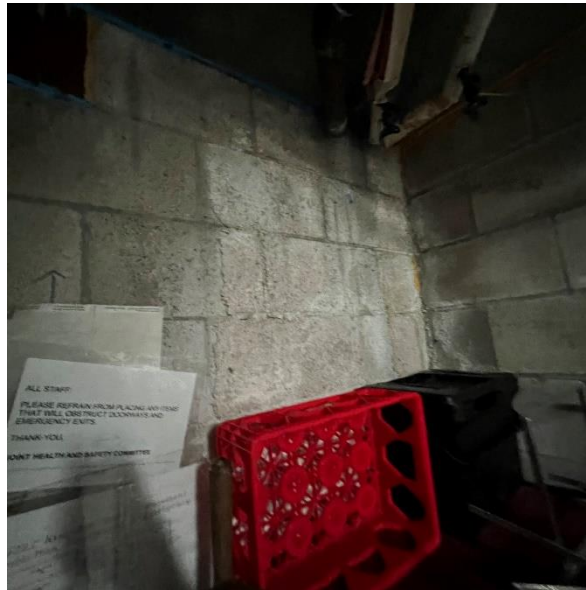
**Photos 3, 4:** View of water-damaged concrete block wall.
